# **West Branch of the St. Mary's River Restoration Project 2017 Post Construction Report**

Department of Fisheries and Oceans  
Small Craft Harbours Branch  
August, 2017

Charles MacInnis, B.Sc.  
MacInnis Natural Resource Services

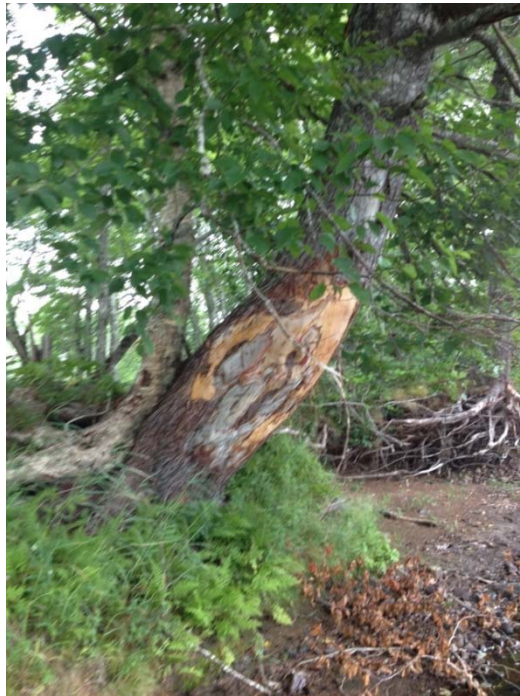
*Figure 2: Ice scour on a tree in the Upper West Branch, St. Mary's River*

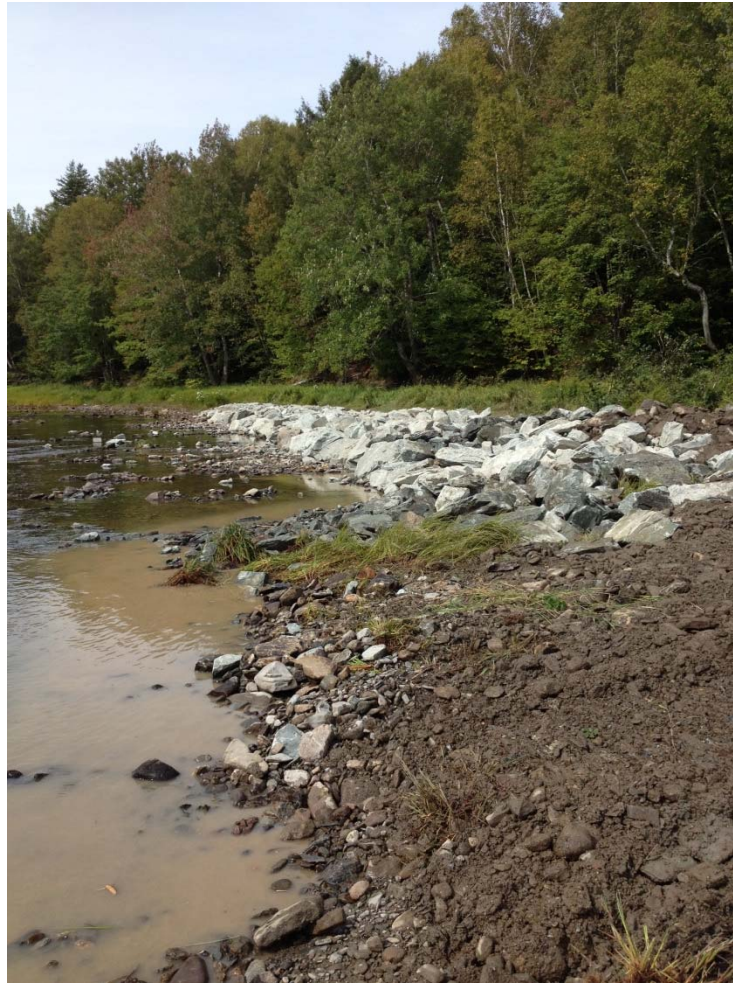
*Figure 17: Bank protection installed at Site 5.*

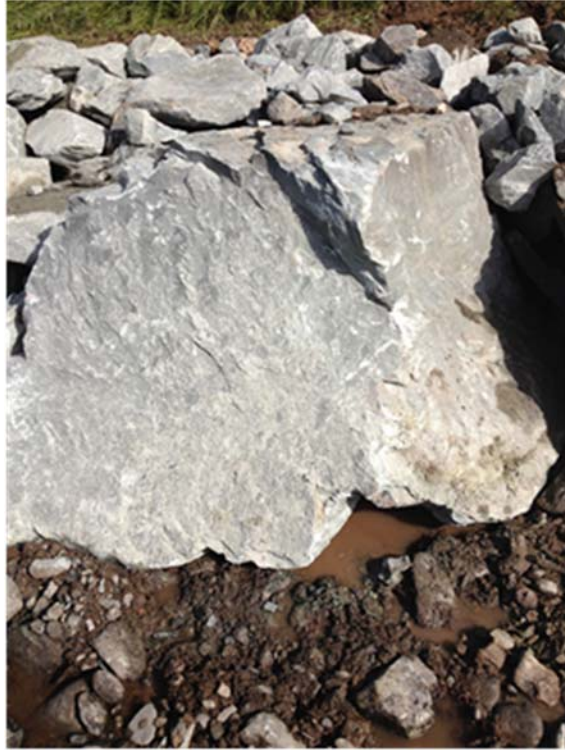
*Figure 18:* Example of two tonne rock used at Site 4 for bank protection.

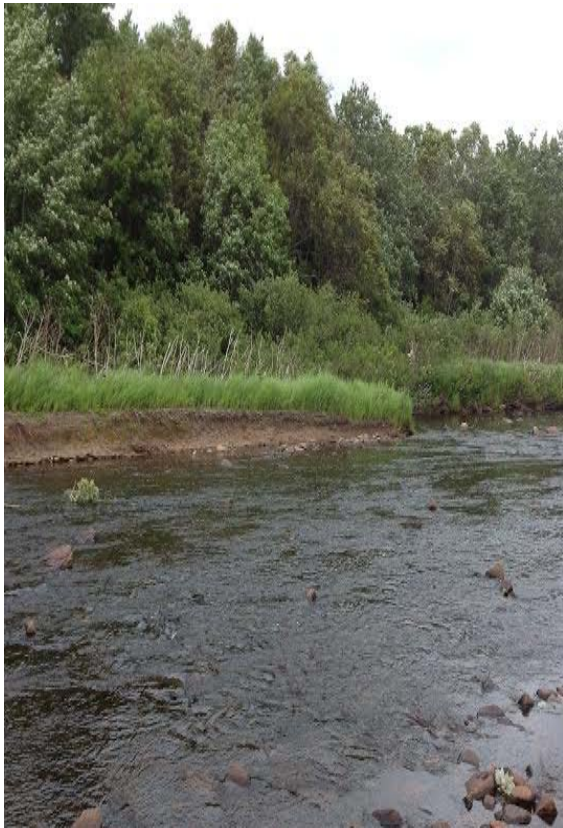
*Figure 21:* Before photo at Site 1. Bryden Brook entrance.

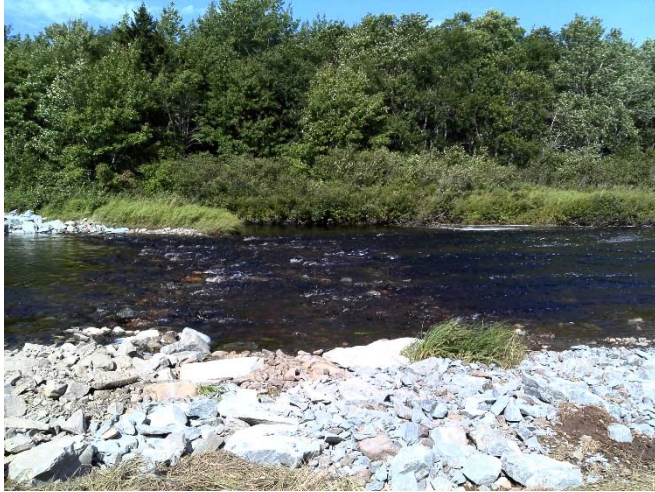
Figure 22: After picture, Site 1. Bryden Brook entrance.

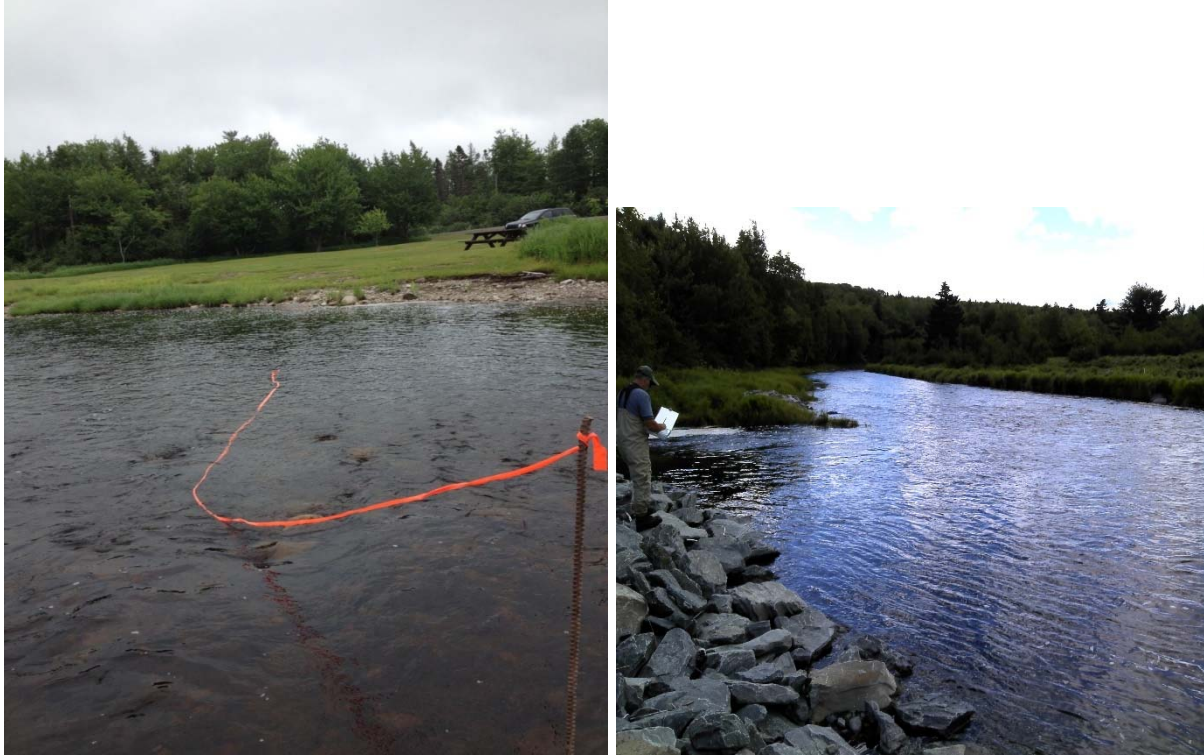
*Figure 24.* A) Before photo where sill is to be constructed and bank protection is needed (looking at the right bank, facing downstream). B) After photo looking upstream at sill and bank protection.

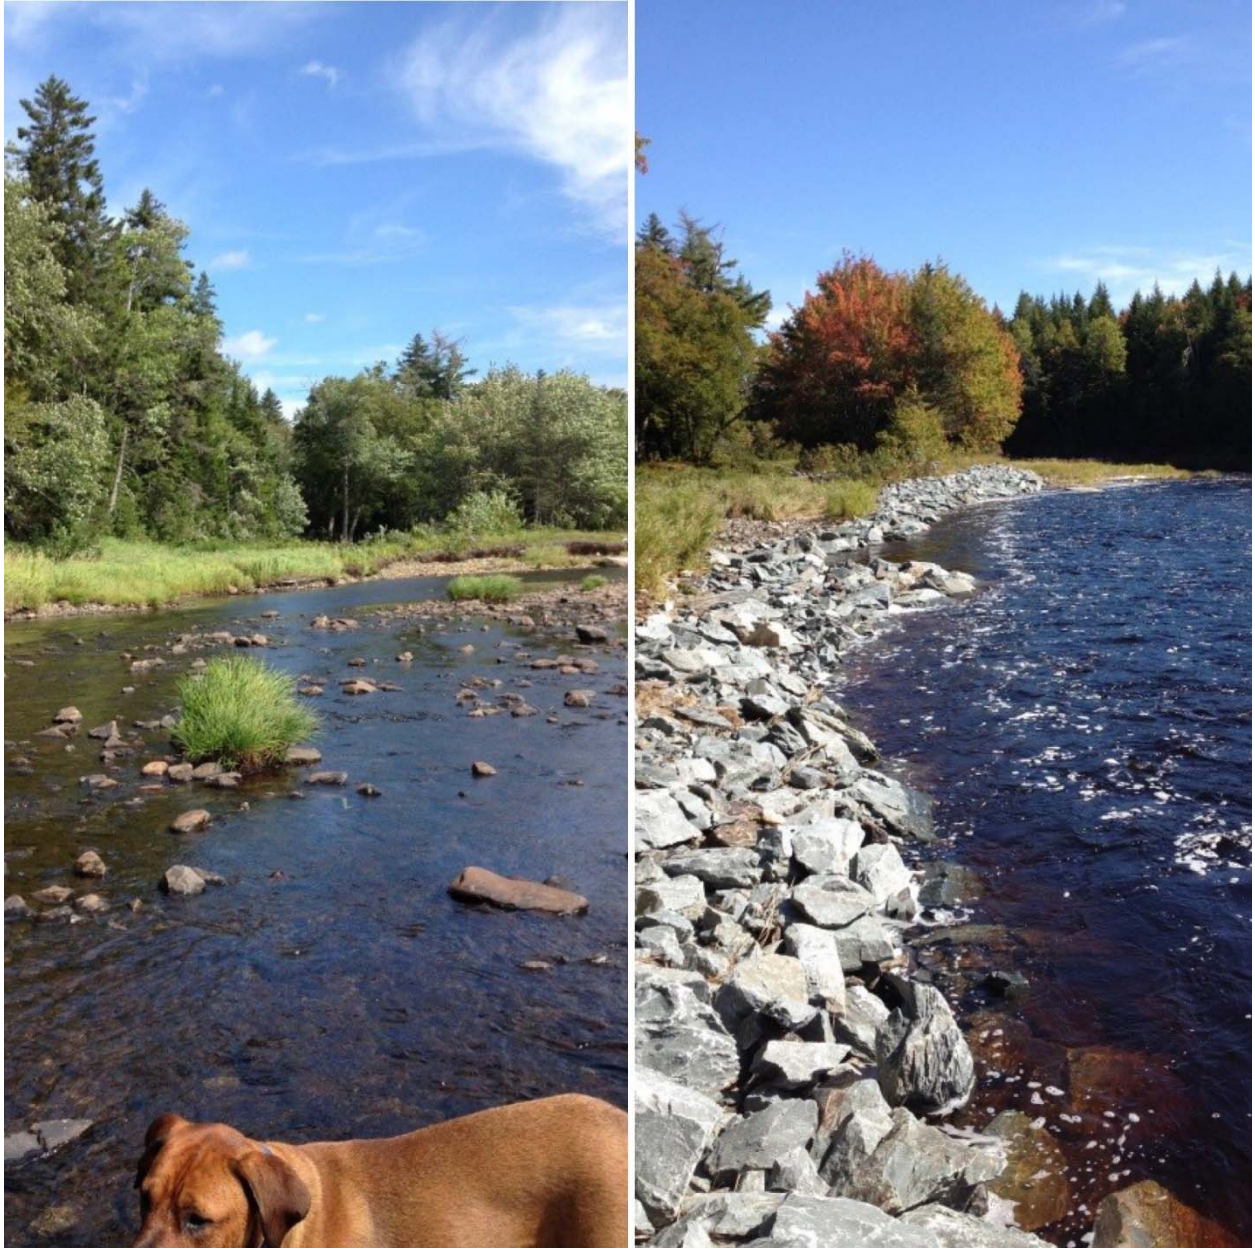
*Figure 25: Before and After, armour rock Site 5.*

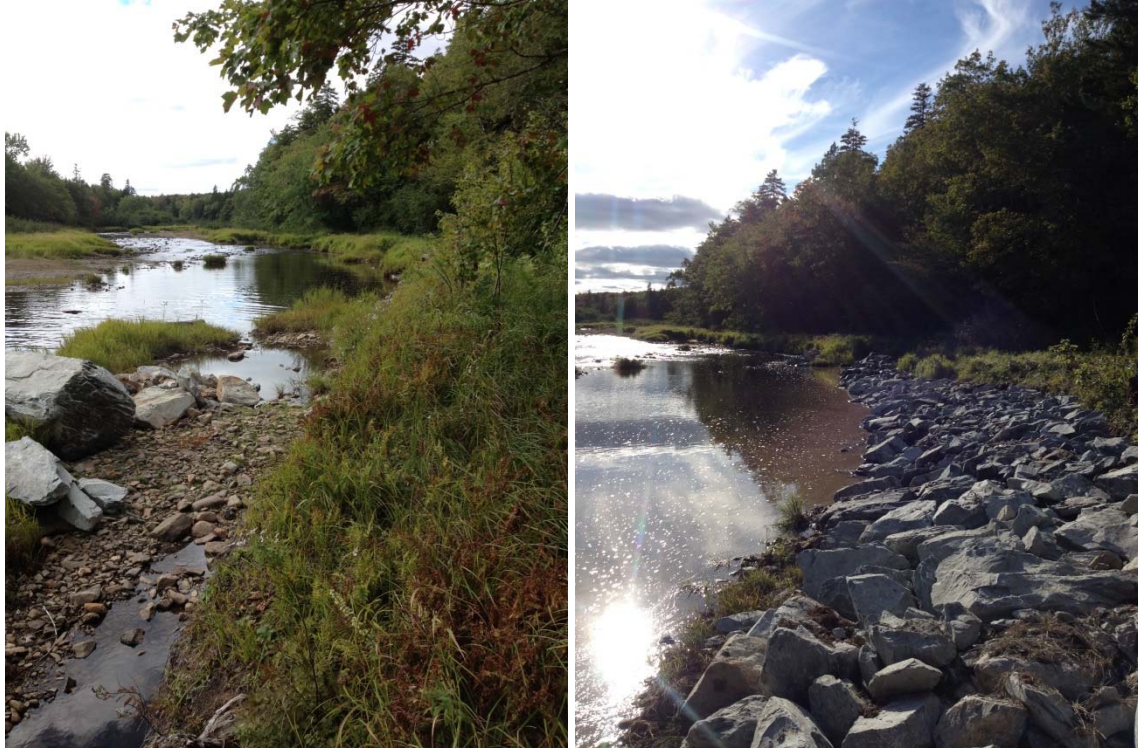
*Figure 26:* A) Before shot of the pool below sill 2 at Site 5 (structure 5.5). B) This is the bank work below sill two (structures 5.5 to 5.7). Note the 4:1 slope on the bank instead of the normal 2:1 slope. This will assist in the planting of native trees and grasses later.

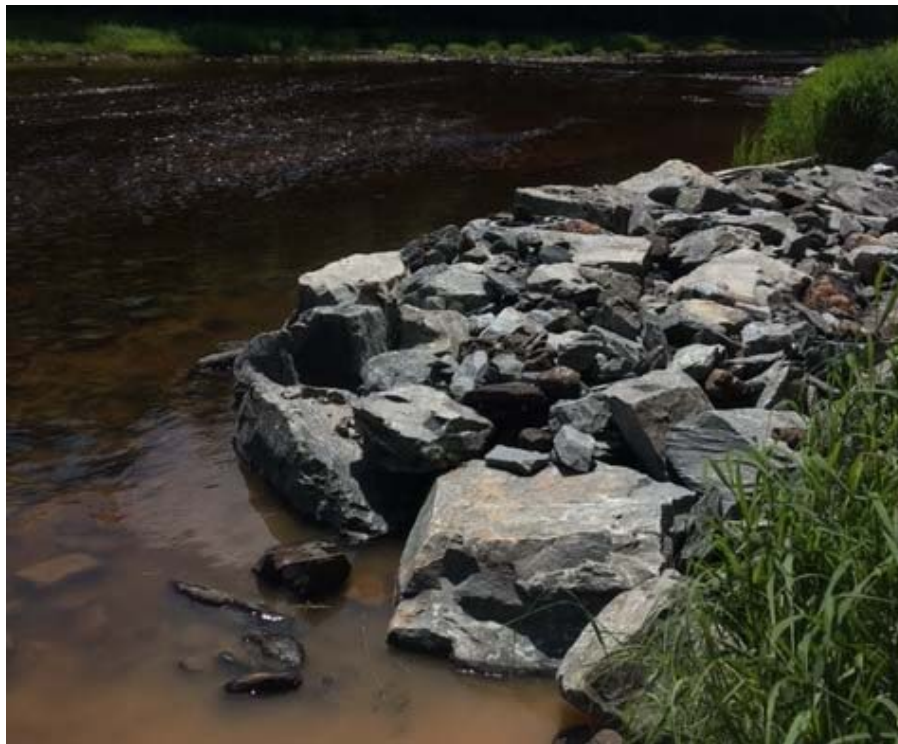
*Figure 32:* Site 6, Structure 13. Rock deflector

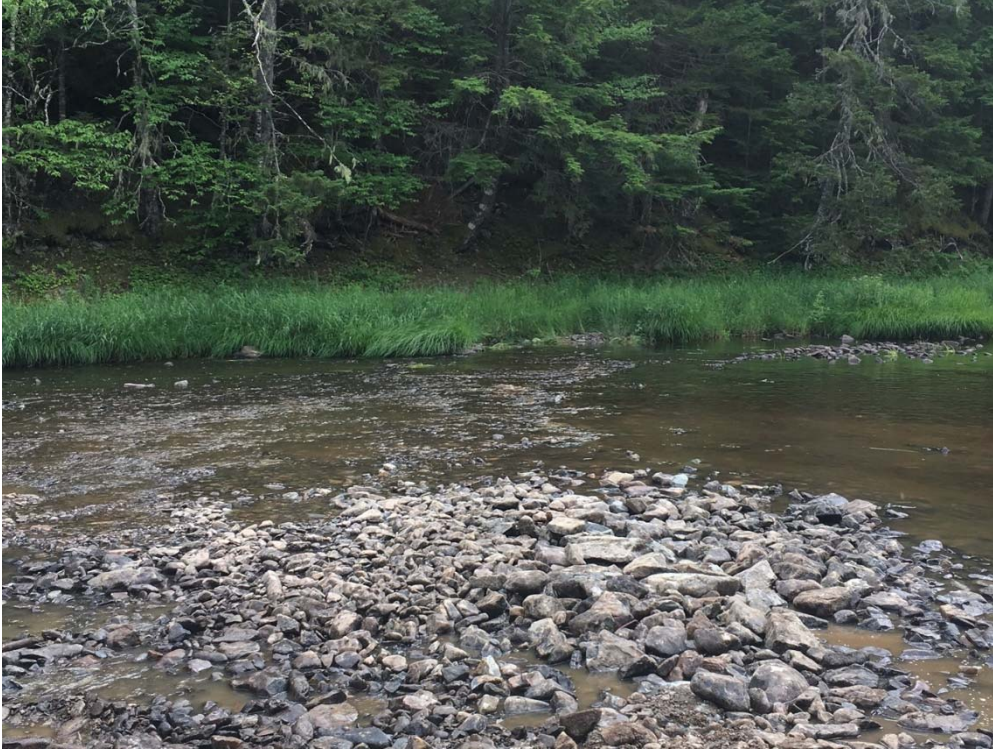
*Figure 33: Site 7, structure 2 - rock sill*

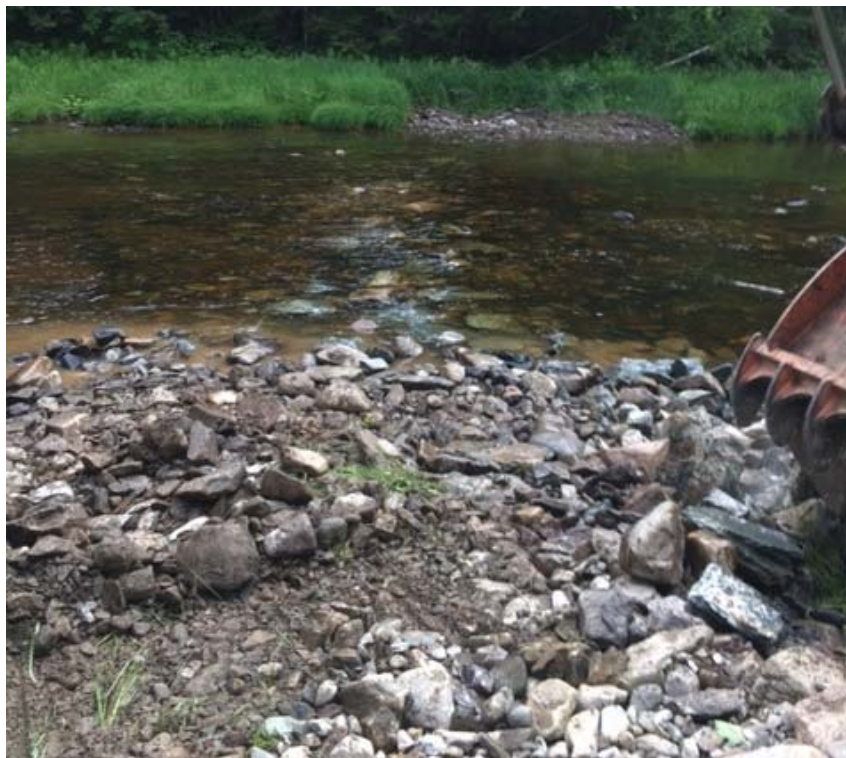
*Figure 28: Site 6, structure 6.09 during construction.*

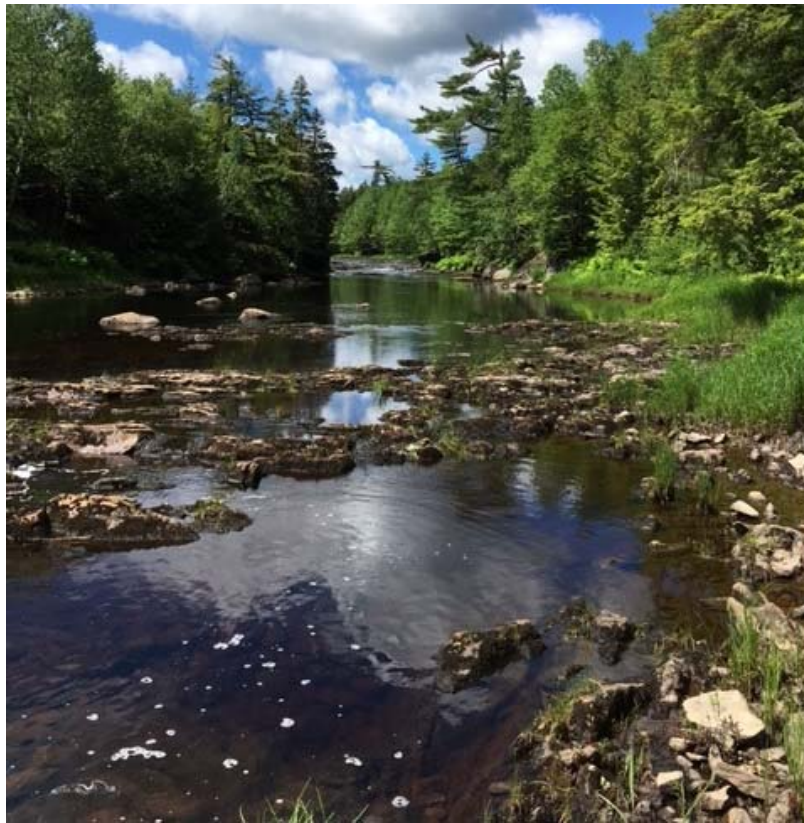
Figure 30: An example of degraded habitat from Site 7. Stream bed comprised exclusively of bedrock.

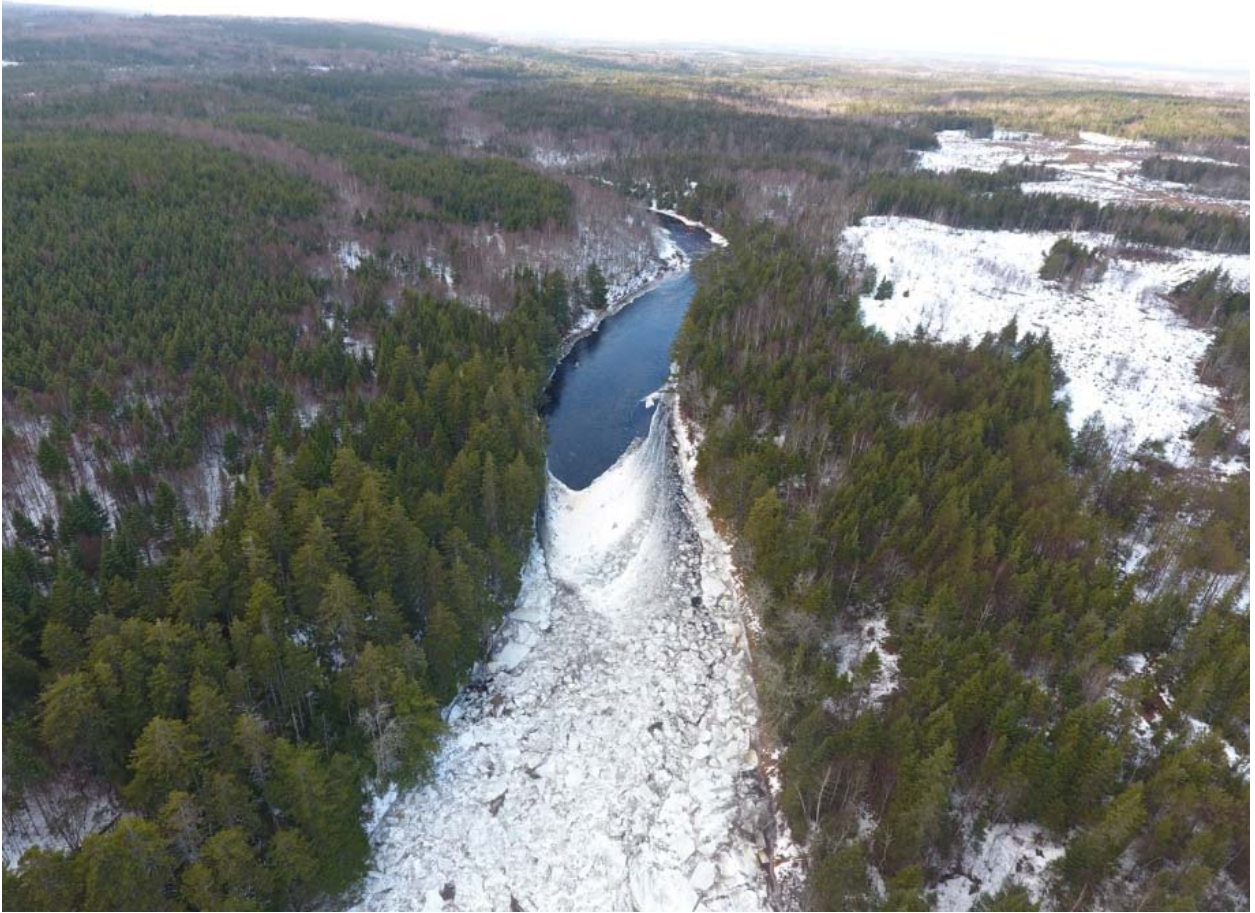
*Figure 31: Ice Production Site 7, caused by an over widened channel.*
