Stephen Rose
Natural Resources Technician
Qalipu First Nation
1 Church Street, Corner Brook, NL
A2H 2Z4

Background

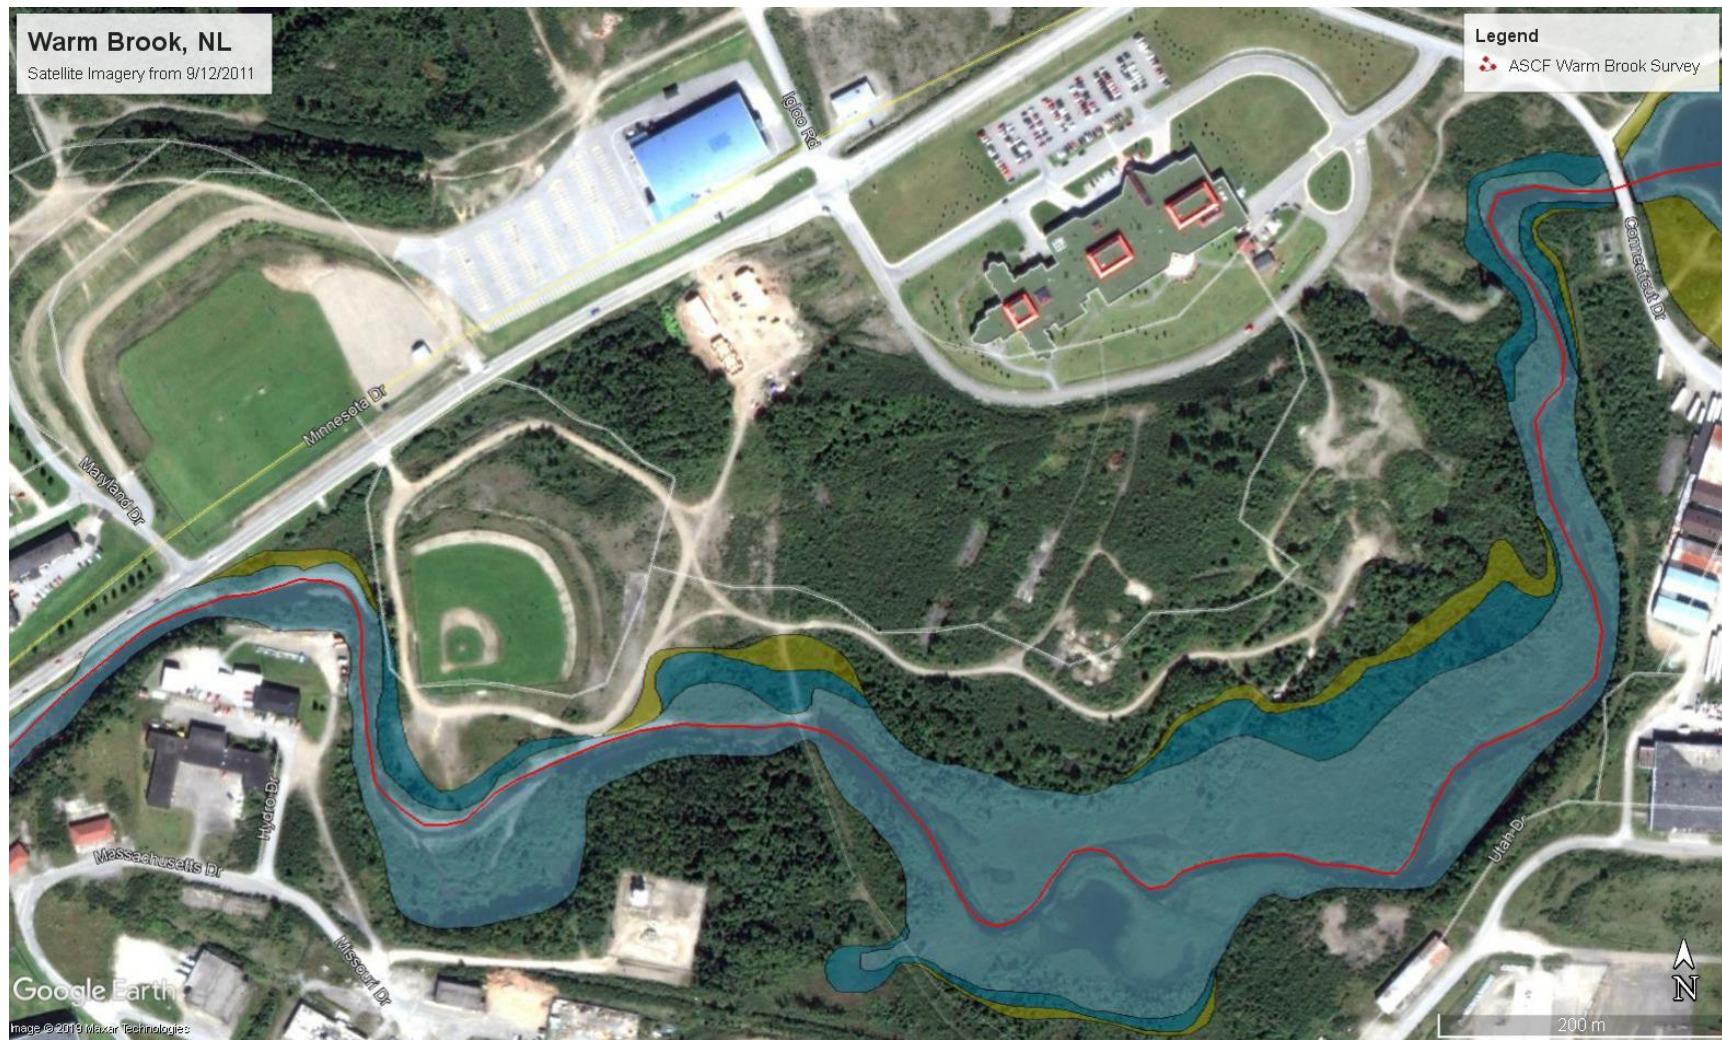
A number of developments have occurred or are currently ongoing within the riparian zone of 15m. Examples include subdivision development (Figure 1 and Figure 2) and watercourse diversion (Figure 3 and Figure 4).

Figure 1: Satellite Image 9/12/2011 - Shaded areas are as follows: Light Blue – Designated Floodway, Dark Blue – Floodway Fringe, Yellow – Climate Change Flood

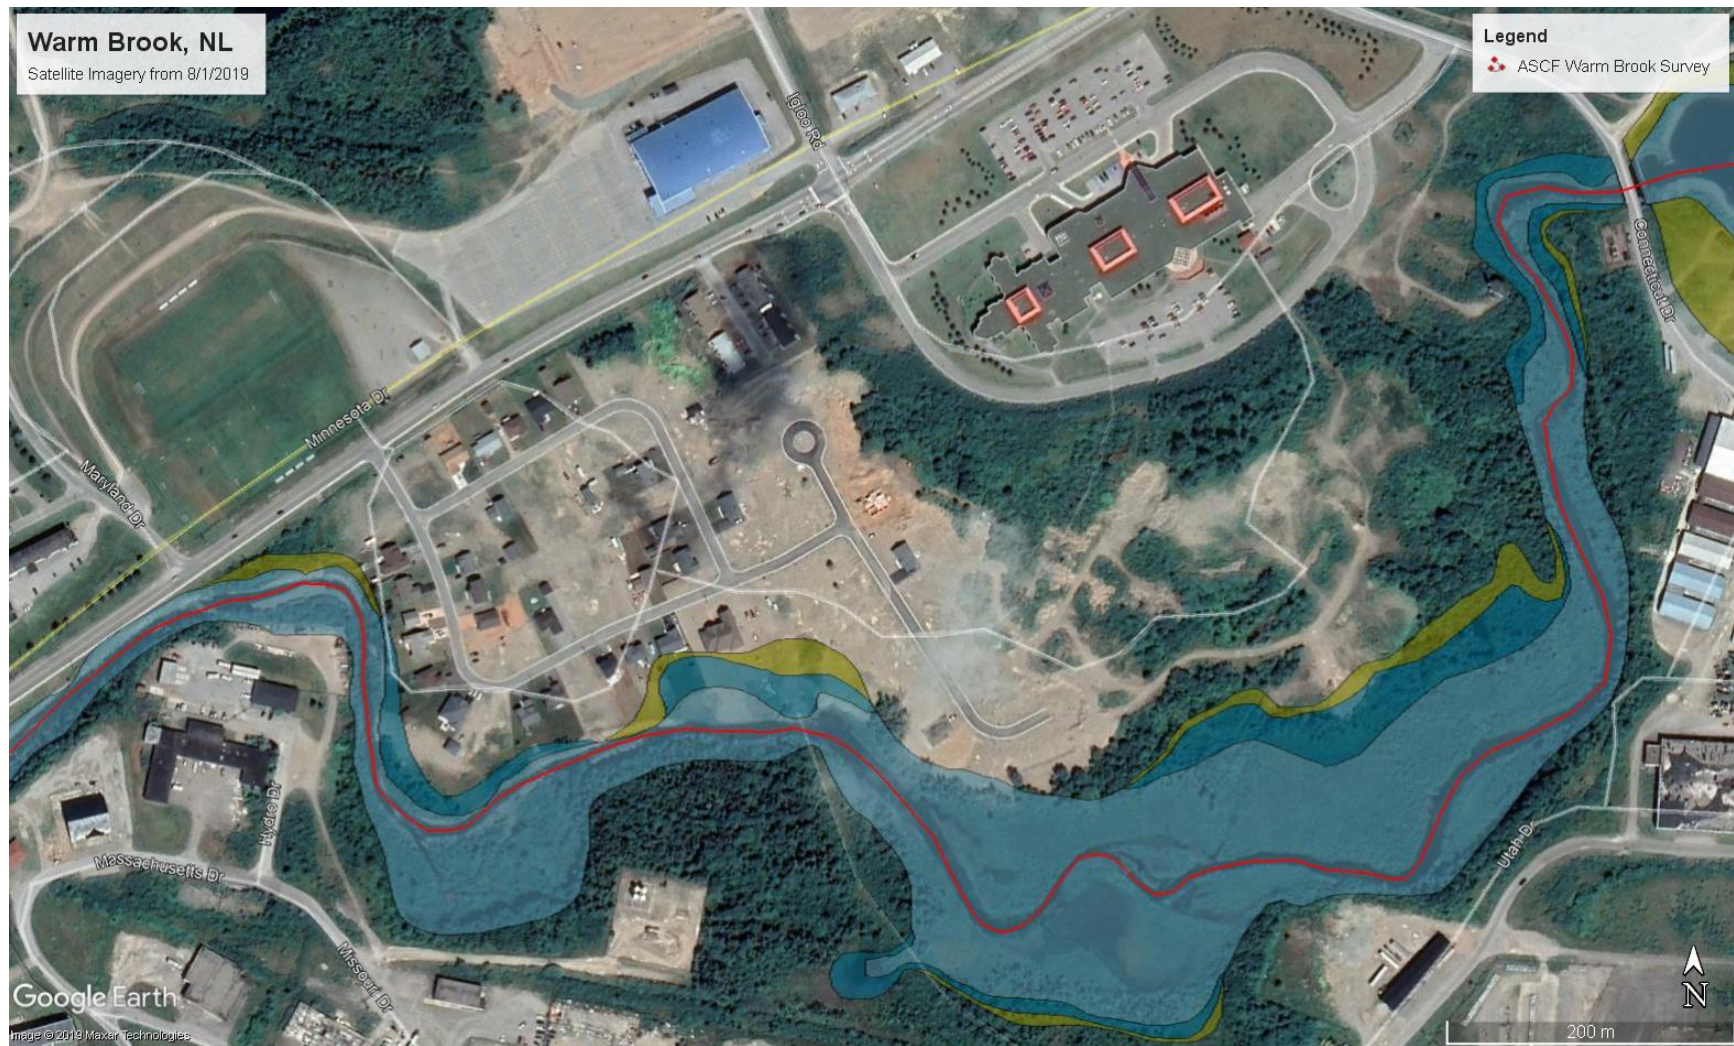
Figure 2: Satellite image 8/1/2019 - Shaded areas are as follows: Light Blue – Designated Floodway, Dark Blue – Floodway Fringe, Yellow – Climate Change Flood

- Development: Recent residential development inside flood zone and fringe area. These areas should be reserved for green zones with strong rooted vegetation to reduce the effects of sedimentation/siltation, erosion, and act as buffers for flooding events. Tree cover on riverbanks also reduce exposure. The lower ~6.5km is a highly developed area and should focus on restoring riparian vegetation and mitigating potential runoff/leachate from industrial areas which constitutes approximately 25% of the lower section of Warm Brook.

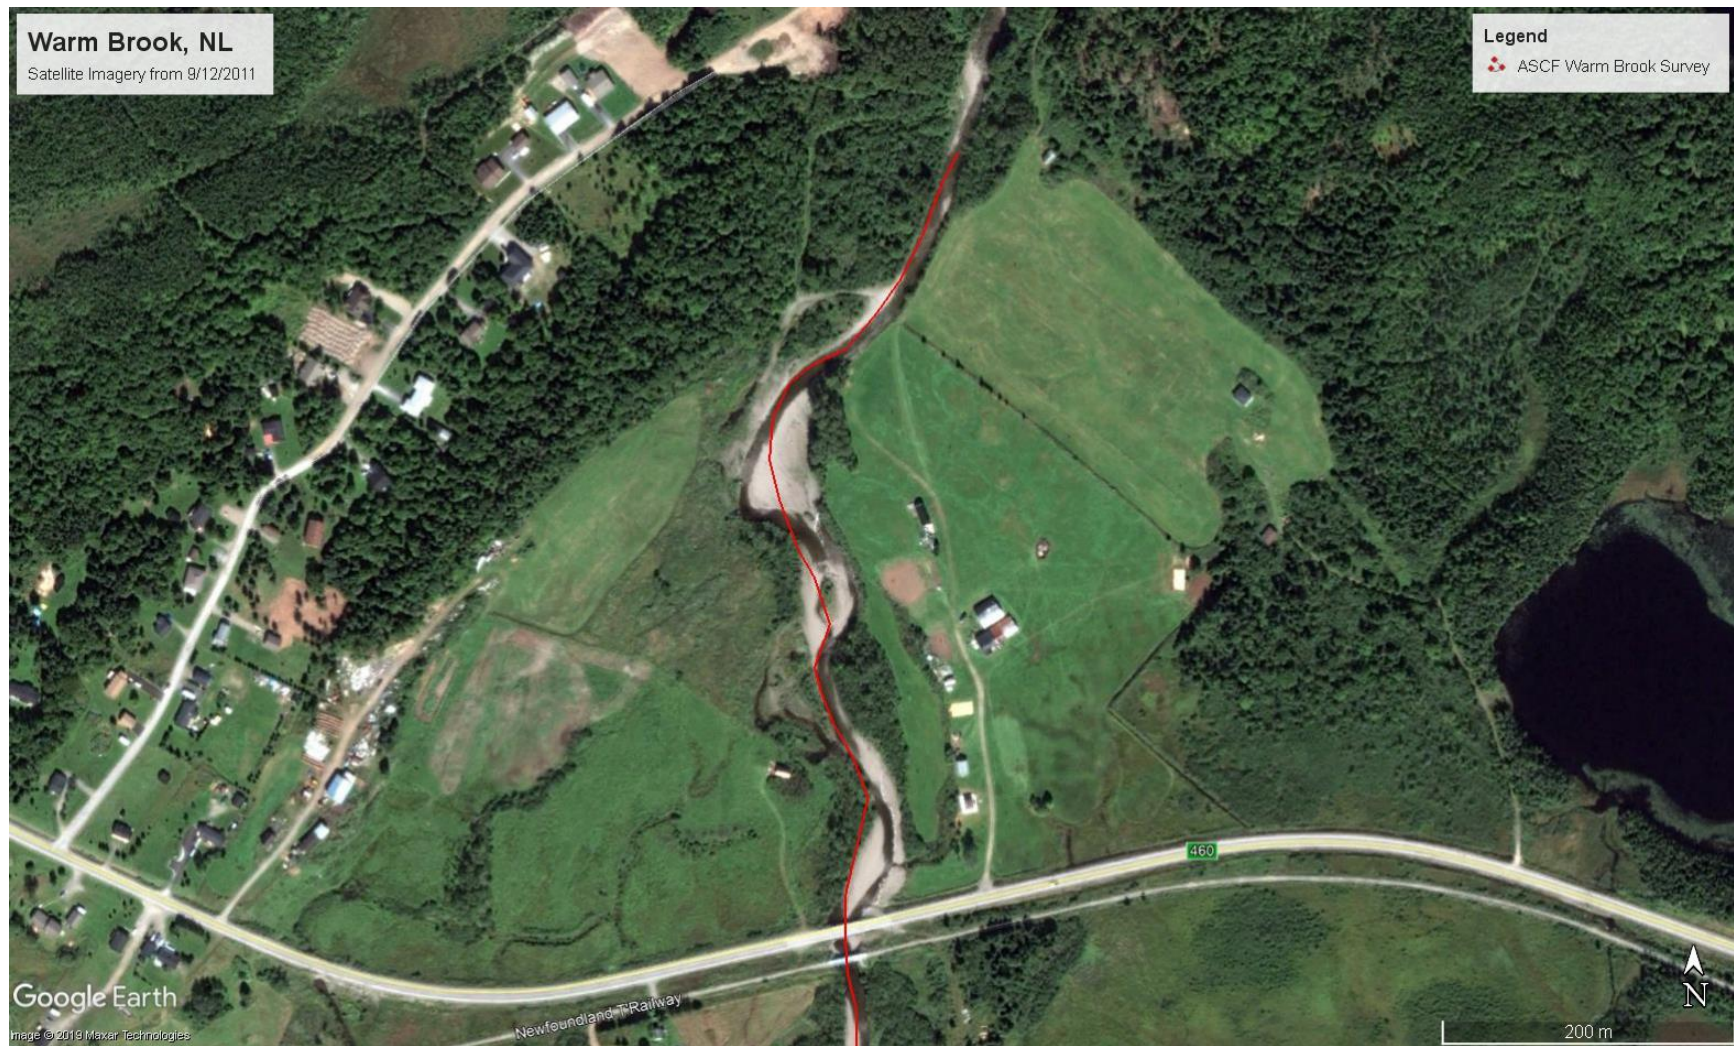
Figure 3: Satellite image 9/12/2011 – Pre watercourse diversion

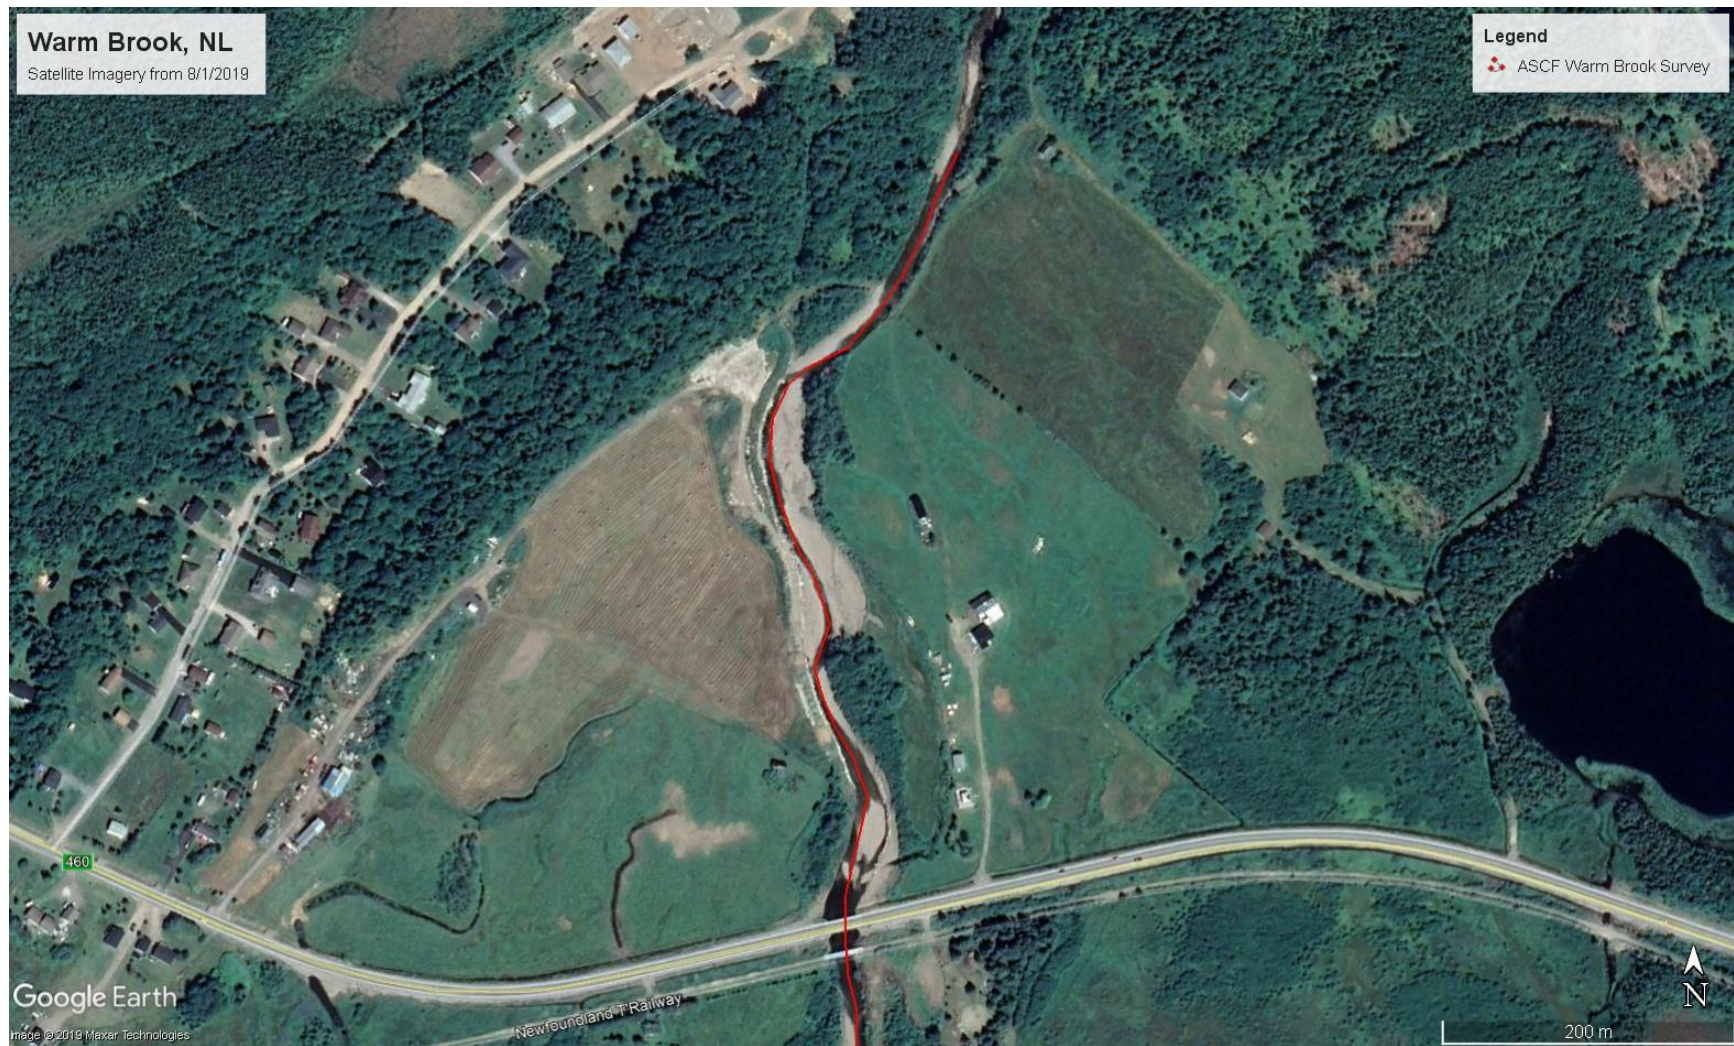
Figure 4: Satellite imagery 8/1/2019 – Post watercourse diversion

- Dredging of brook: dredging disrupts benthic habitats that support all life stages of fish, along with benthic macroinvertebrate communities.
- Alteration of natural river succession: diverting the direction of flow of a river can cause negative effects on the succession of the river. These effects can include increased erosion, sedimentation/siltation, alteration of benthic environments with respect to spawning beds for salmon and increasing the impact of flooding in downstream locations.
- Flooding: Flooding increases erosion (sedimentation/siltation), flood zones, the potential to damage infrastructure, and the potential for litter in the river system.

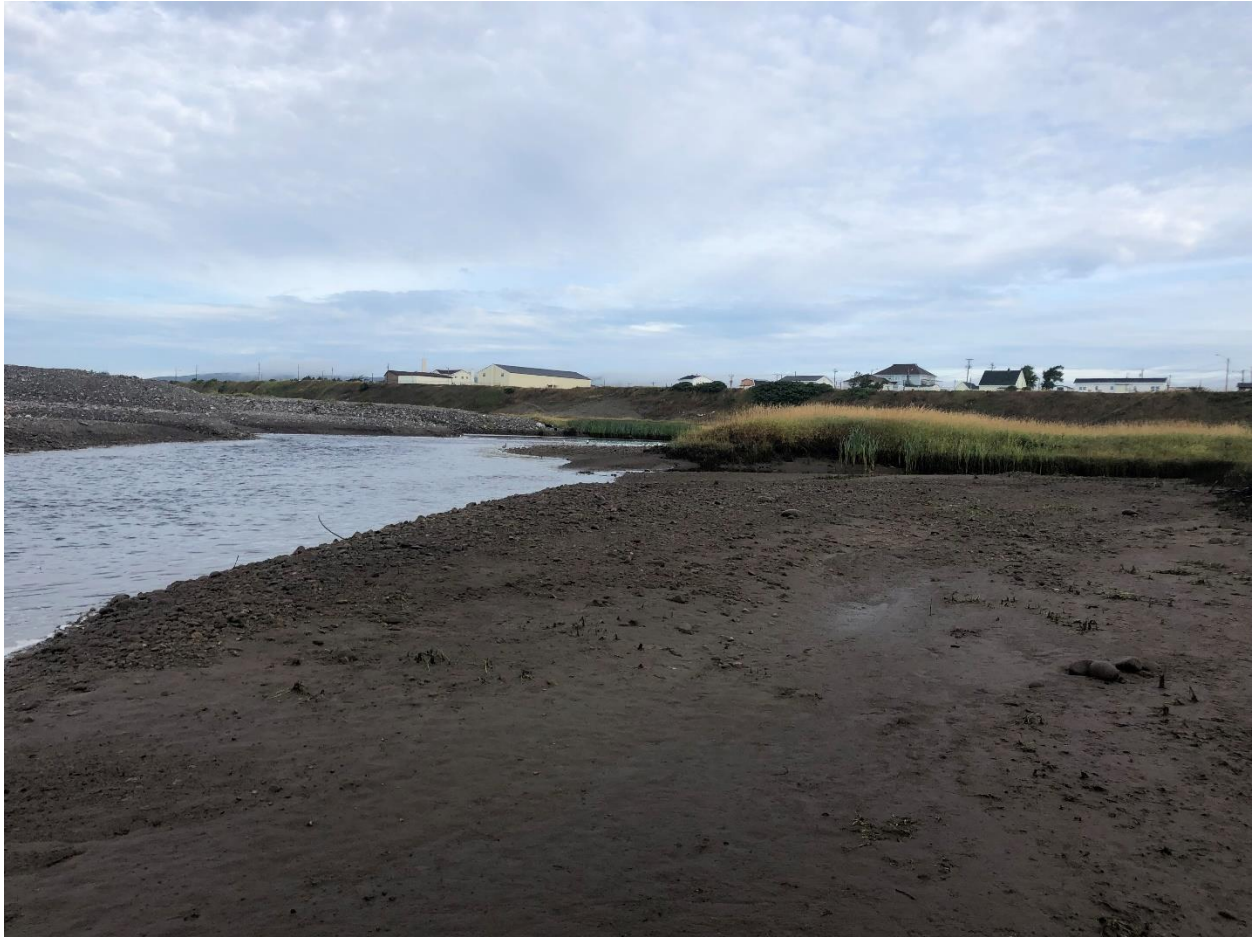
Photo 1

ID #	Coordinates		Photo	Notes
	Northing - UTM	Easting - UTM		
1	383361	5377732	1, 2	Coastal Wetland/dune area
2	383336	5377855	2	Small Bank Destabilization
3	383574	5377850	3	Banks mostly stable and vegetated
4	383609	5377848		Start of hard stabilization (gabion cages and rip rap)
5	384107	5378301		Some patchy potential spawning ground
6	384107	5378301		Bank destabilization
7	384488	5378780		Rocky substrate (poor suitability for spawning)
8	384593	5379256	4	Obstructions in river
9	384648	5379309	5	Old concrete structure
10	384792	5379408	6	Recommend planting trees on bank
11	384884	5379423	7	Riparian buffer development
12	384911	5379369	8	Riparian buffer cleared, shoreline mostly stable and vegetated. Substrate improving
13	384911	5379369	9	Concrete debris in river and riparian buffer issue
14	384979	5379258		Mostly riprap shoreline
15	385172	5379315	10, 11, 12	Development within riparian buffer
16	385212	5379319		Potential spawning habitat

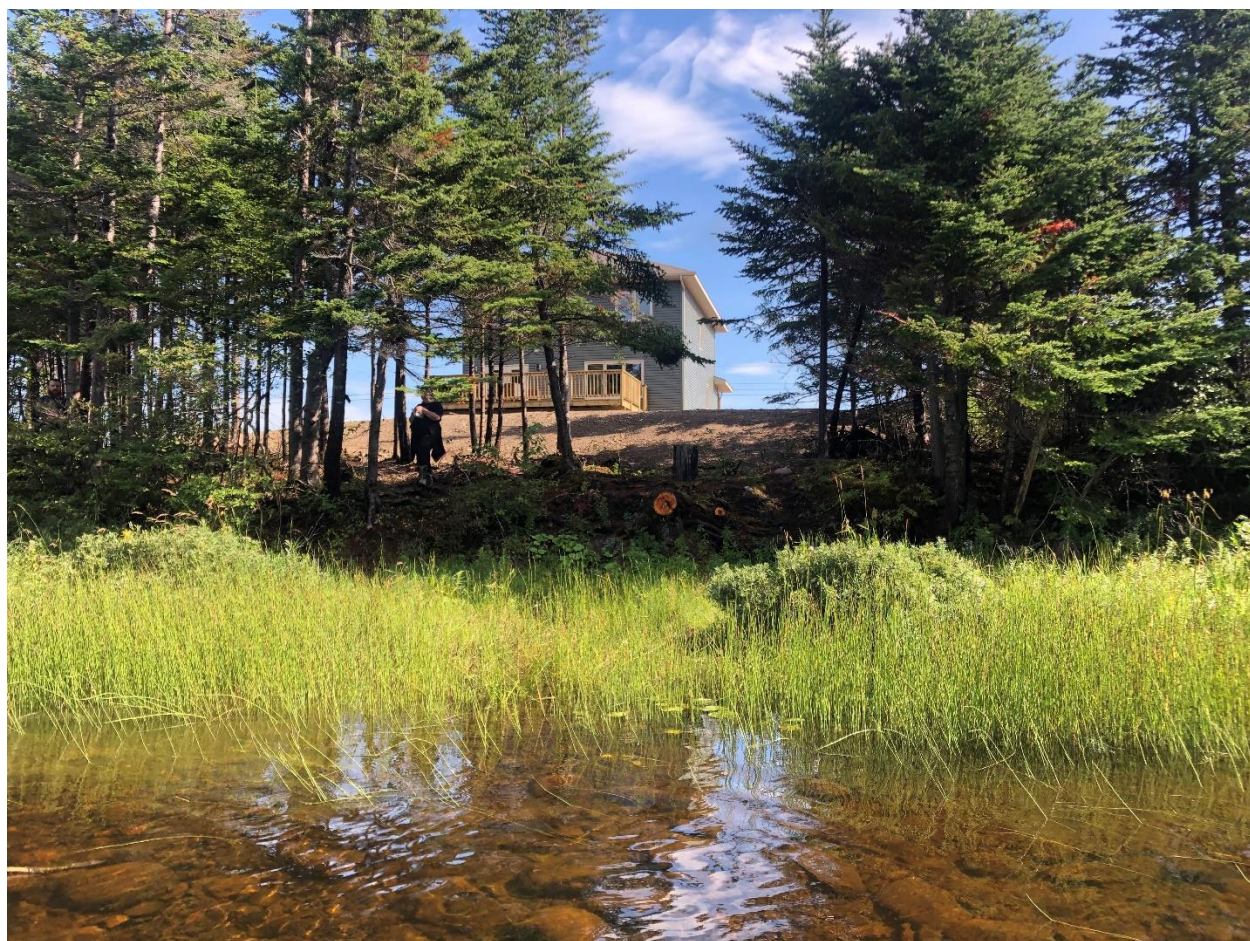
Photo 13

17	385276	5379280	13, 14, 15	Vegetation cleared within riparian buffer
Coordinates below are in decimal degrees				
18	48.5582	58.51323	16, 17	Bank destabilization and evidence of beaver cuttings
19	48.558185	58.51284	18	Suitable spawning habitat ~80ft up and downstream

- Clearing of riparian buffer: Riparian buffers should be restored to reduce impacts of flooding (erosion, sedimentation/siltation) and exposure.
- Erosion-sedimentation/siltation: negative effect on fish health and habitat (choking out spawning beds, sediment/silt in fish gills), increases flood zone areas in places with bank destabilization.

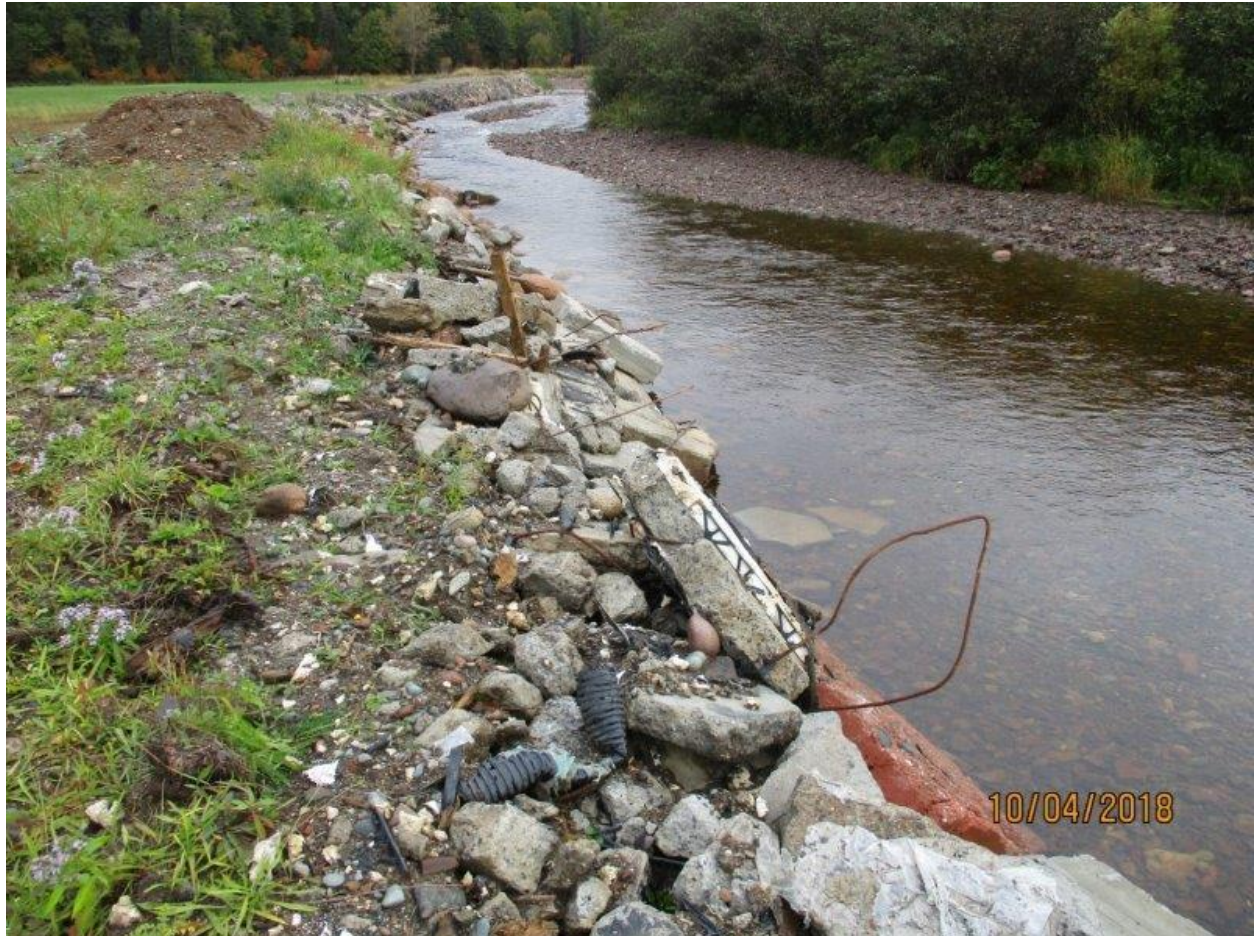
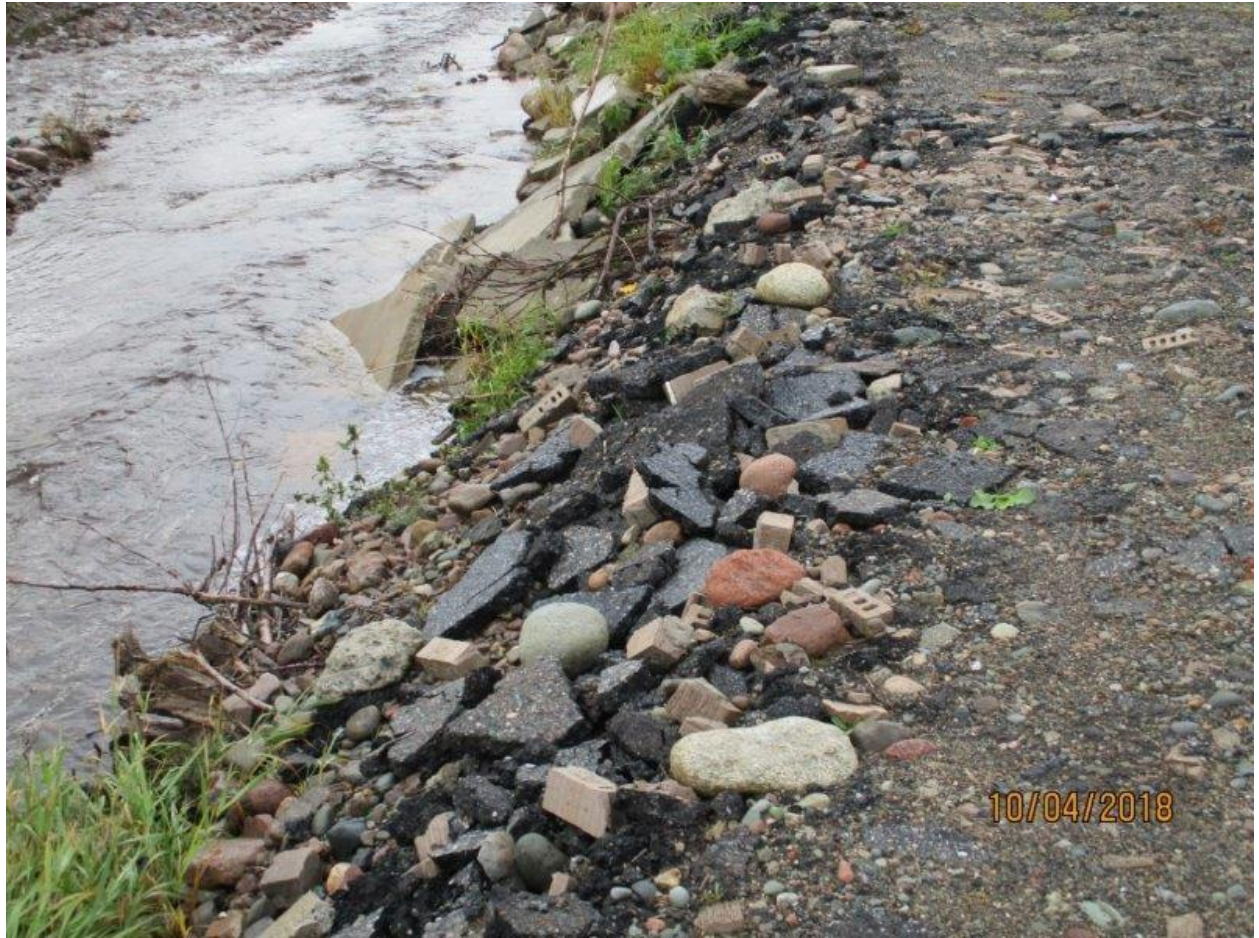
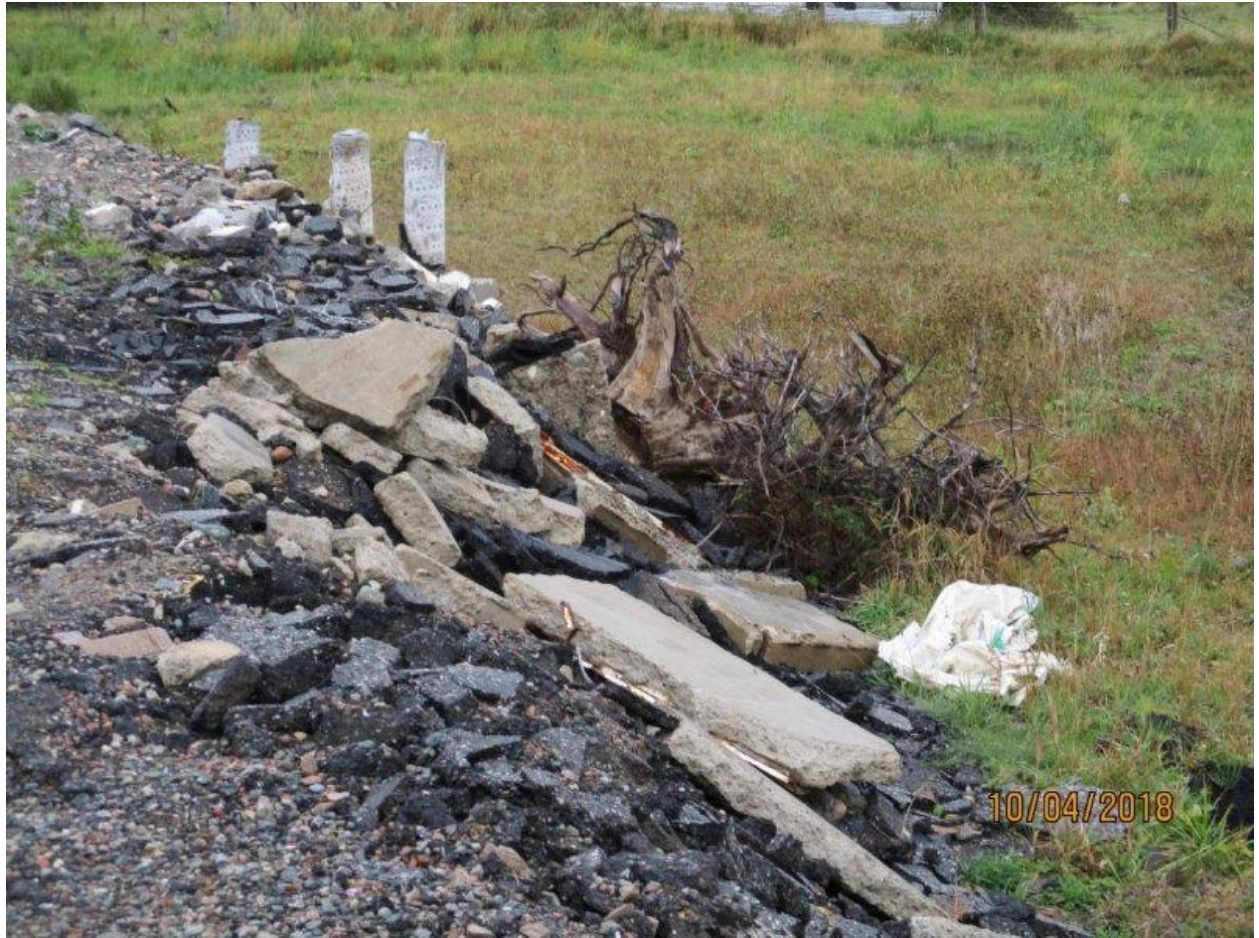
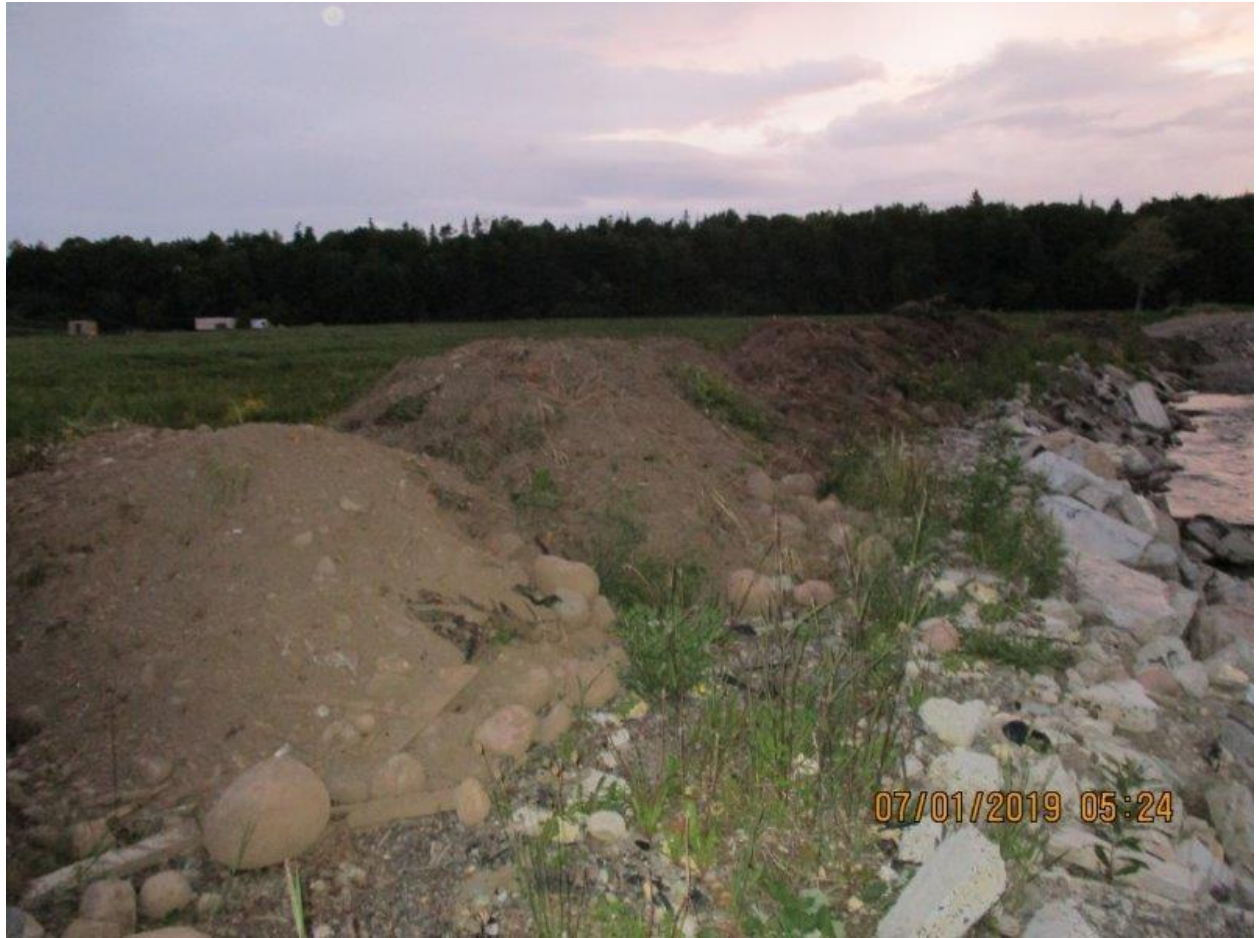
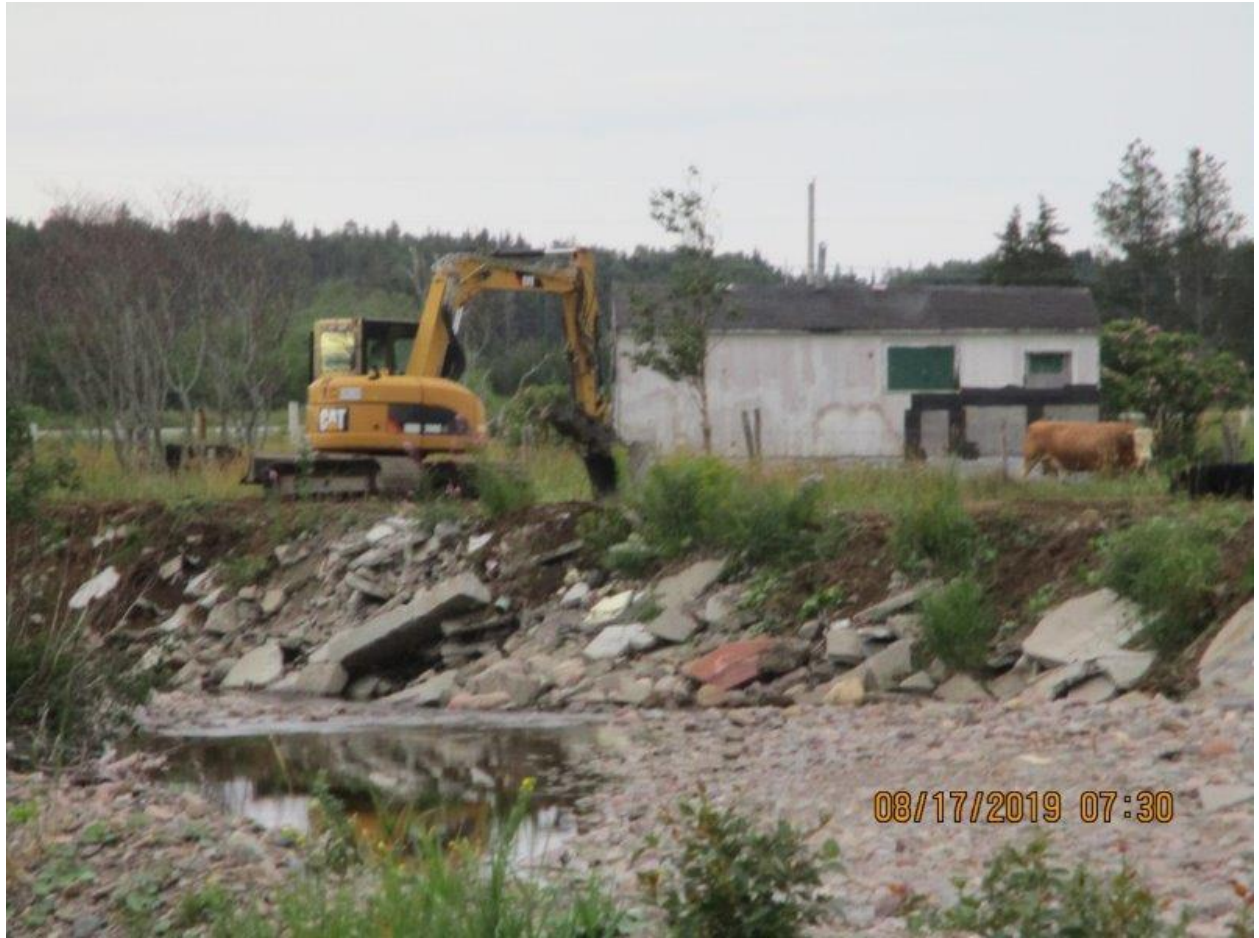
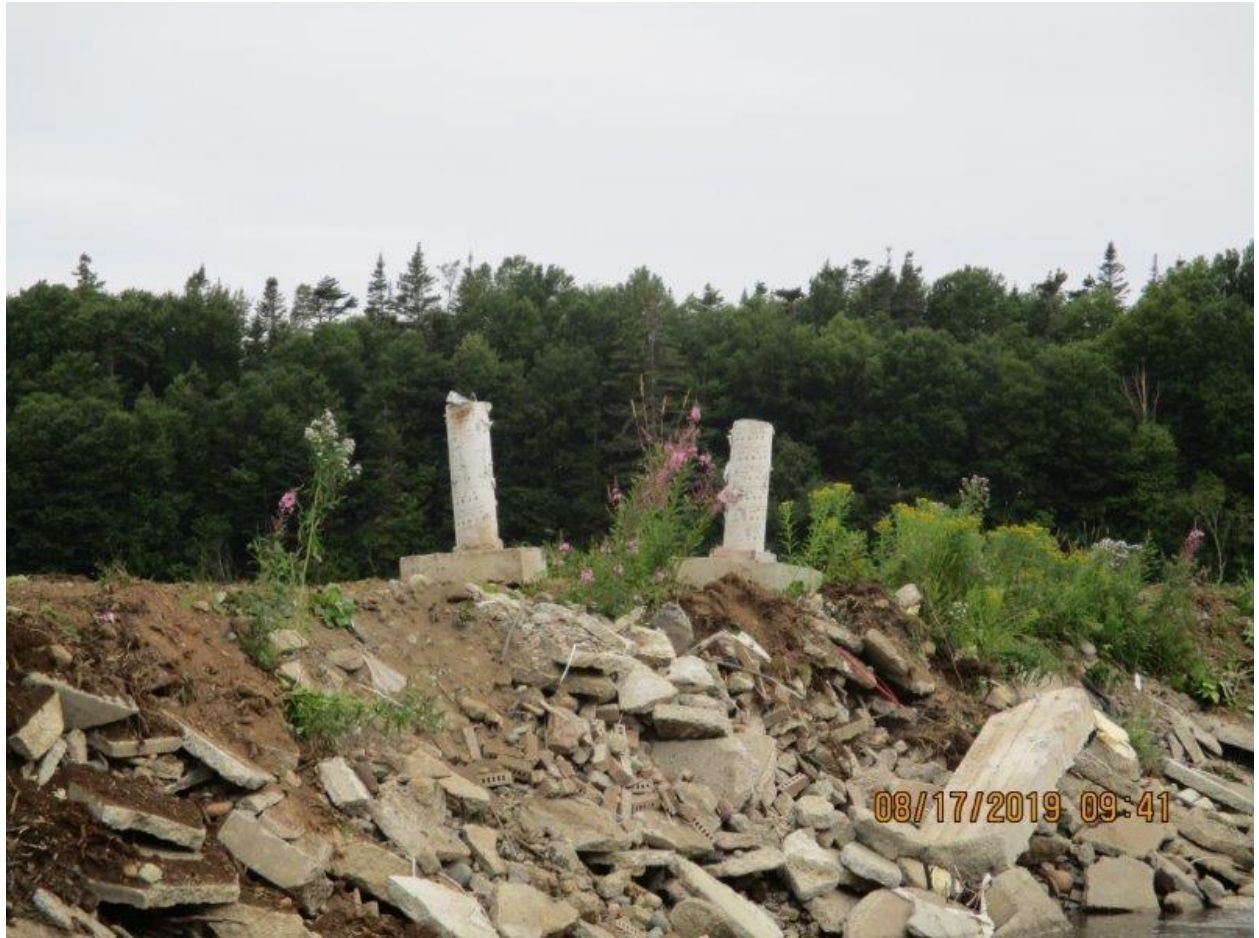
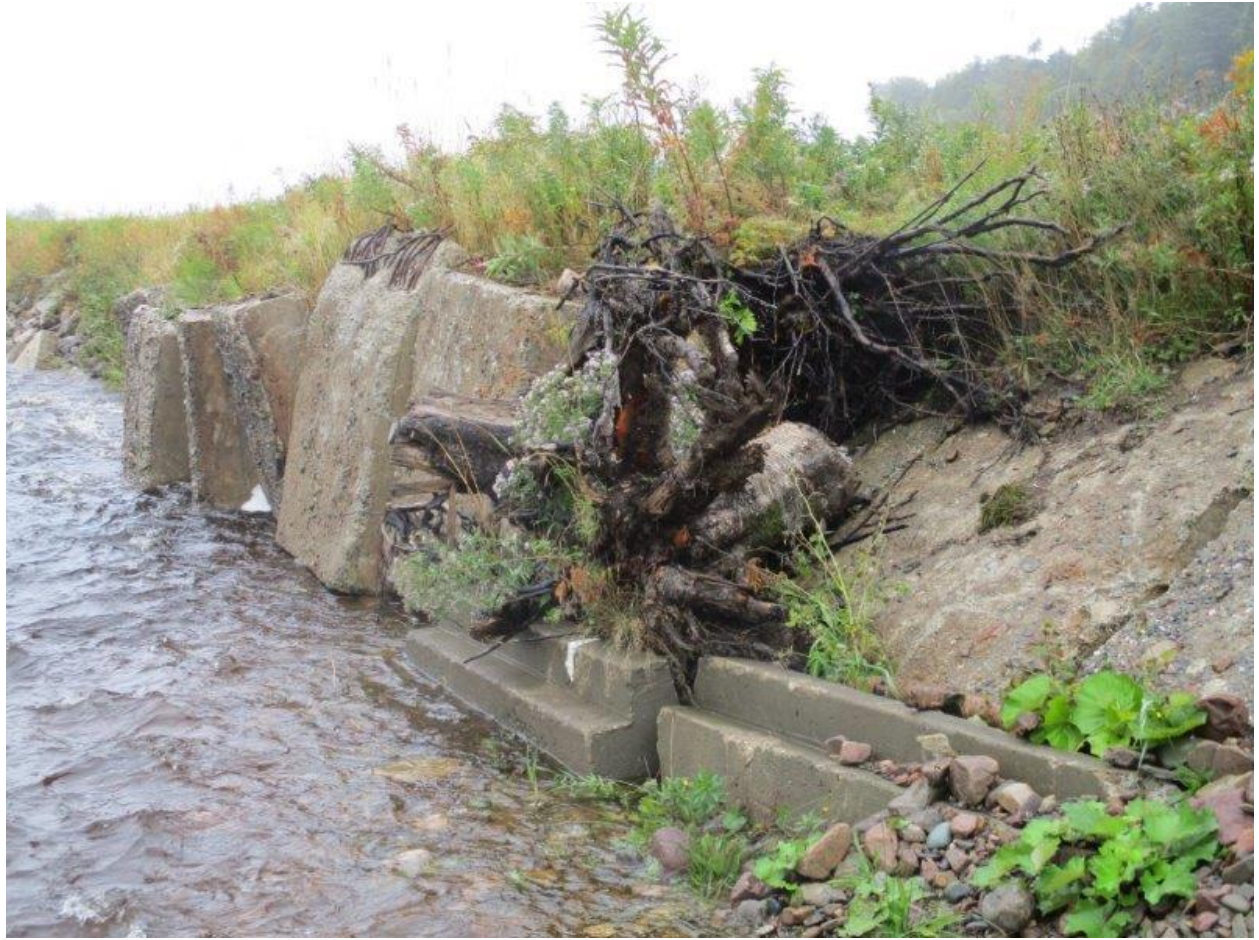
(Features 28, 29, 30)

20	48.559196	58.511806		End of potential spawning habitat, more bank destabilization and limited vegetation
21	48.559648	58.511923		potential spawning habitat ~100ft up and down
22	48.560108	58.511565		Start of potential spawning habitat
23	48.560254	58.51109		End of potential spawning habitat
24	48.560898	58.509908	19, 20	Bank destabilization and erosion
25	48.562419	58.507933	21, 22, 23	Small oxbow with erosion and bank destabilization
26	48.562717	58.507564	24, 25	Flood area
27	48.563612	58.507152	26,27, 28,29, 30,31, 32	Riparian vegetation cleared and deposition of debris within spring highwater zone
28	48.564092	58.507478	33, 34	Evidence of unapproved berm built and failed armour stone
29	48.564092	58.507478	35, 36	Armour Stone at end of drainage ditch, across from new berm
30	48.566063	58.507534	37, 38 39, 40	Construction debris deposited in unapproved berm development, alteration of river flow (see also Appendix III)

- Trash/litter: Microplastics, chemical pollution, and obstructions are all results from trash or litter entering the Warm Brook System. The effects of microplastics on aquatic and marine environments are well documented. Use of old construction debris in berms to redirect natural flow of river (asphalt, concrete, brick, steel) contribute to potential chemical leachate into aquatic systems from tar sealant and binding chemicals.

Member submitted photos documenting construction debris used in berm development
