**SHORELINE RESTORATION EFFORTS TO LIMIT SILTATION TO
ATLANTIC SALMON HABITATS IN THE NEPISIGUIT RIVER**

Technical report

**RRWMC
CGBVRR**

October 28th, 2021

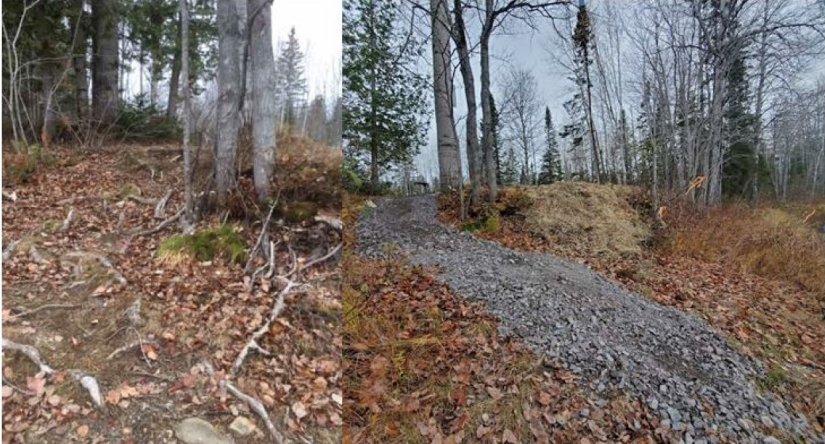
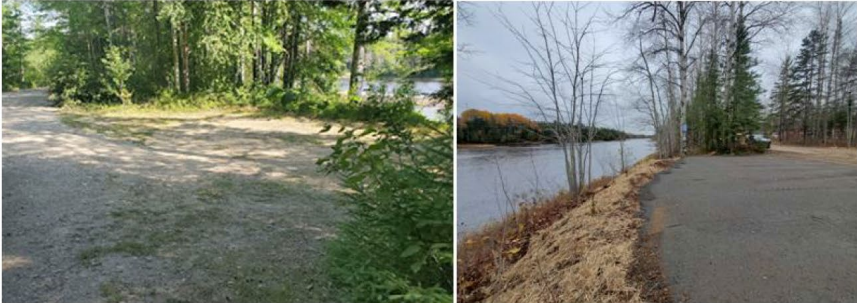
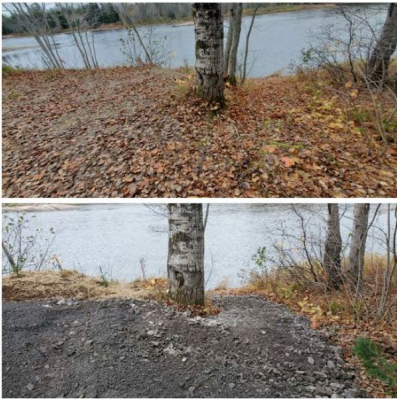
SITE 1: Below Cable Pool site.

This site is used to launch/retrieve recreational boats and also has exposed soil. The trail has been improved to create a more effective launching area for recreational boats by creating a stable trail with 0-3" rocks. Bank has been also stabilized with coconut membrane and tree/shrubs planting to prevent further erosion. The parking has been reconfigured to direct water away from the river.

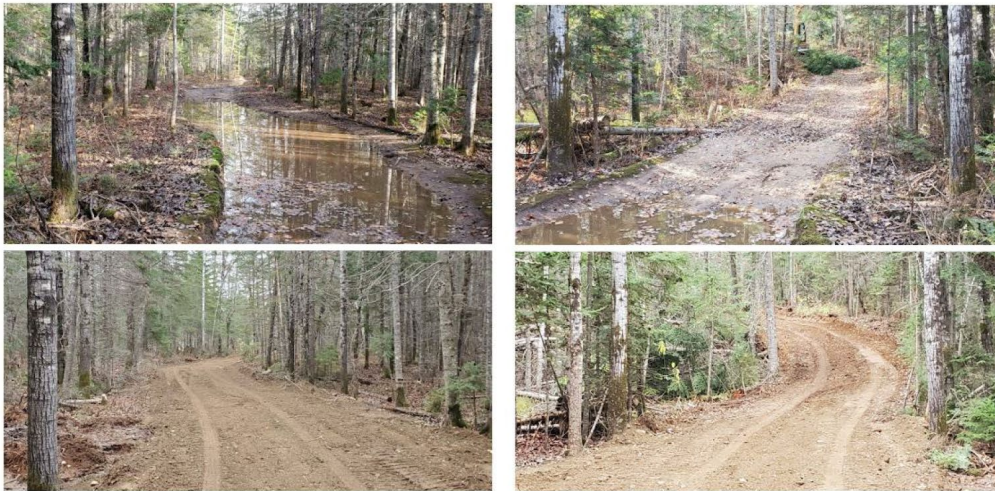
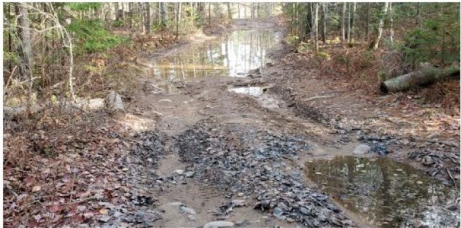
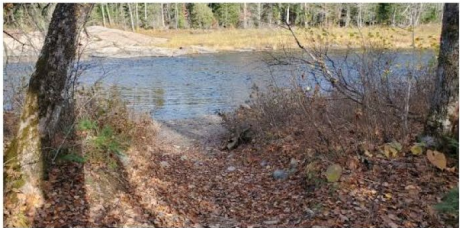
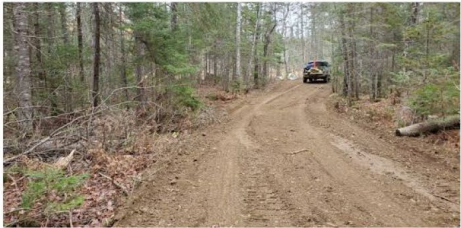
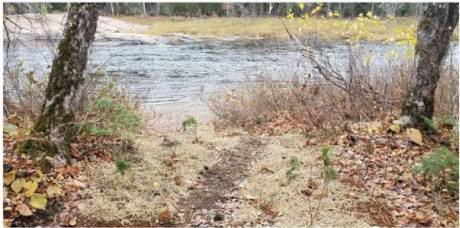
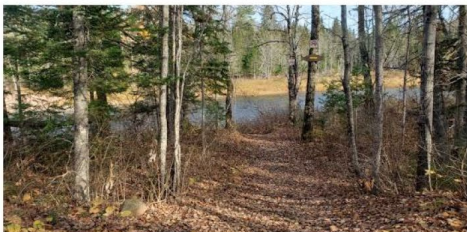
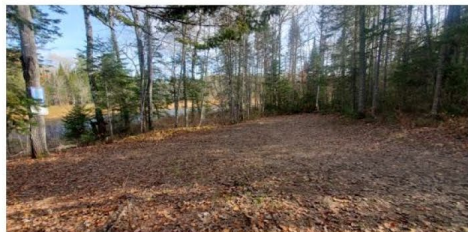
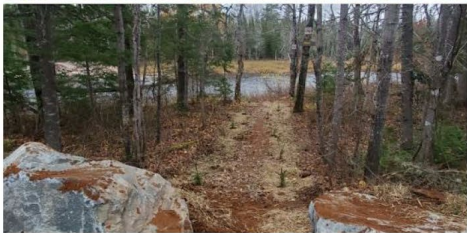
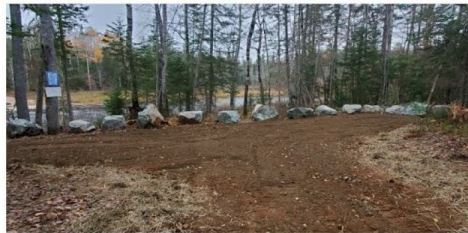
SITE 2: Long Hole pool

A narrow-wooded road leads to this beautiful pool that both ATVs and trucks use. Adjacent to the parking area is a trail that leads down to the river used by vehicles. Access to river to ATVs has been blocked using large size rocks (16), only a foot trail remains. Runoff and sedimentation has been fixed by adding a coconut membrane, top soil, seeding and shrub planting. The access road was fixed by filling large pot holes, covering entire surface and by doing diversion ditches. Entire road was compacted.

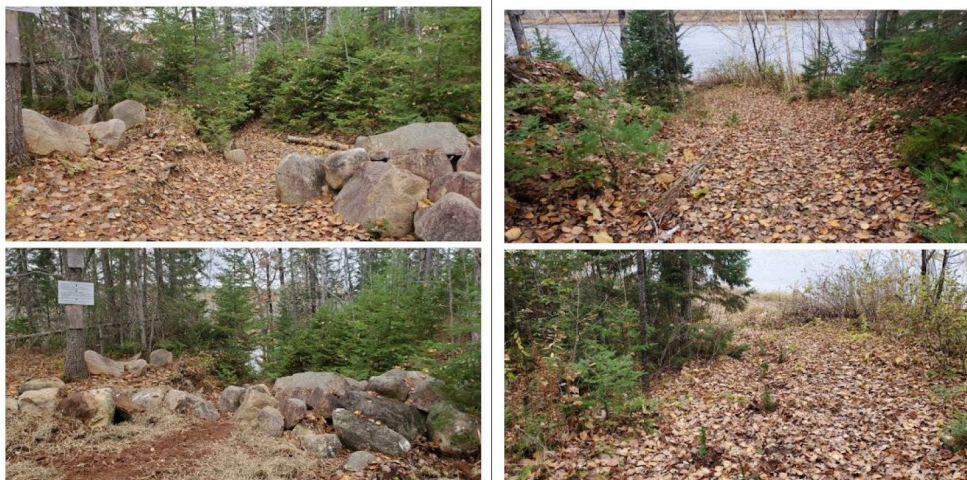
SITE 3: Blacks Meadow site.

In 2018, the Department of Natural Resources and Energy Development blocked, with rocks, the entrance to a trail leading down a fairly steep slope that was giving access to the river. Individuals soon moved these rocks to, again, to allow ATVs to go down. Without the rock barrier, and both ATV and vehicle traffic, this created runoff and sedimentation to the river. The restoration work included putting back larger rocks anchored in the ground, allowing only foot traffic to the river. Shrubs and trees have been planted on the trail.
