**DEVELOP HABITAT CONSERVATION PLANS AND RESTORATION FOR
RIVERS IN BAY ST. GEORGE
2019**

Habitat Restoration

**FLAT BAY BROOK
LITTLE BARACHOIS BROOK
MIDDLE BARACHOIS BROOK**

BAY ST. GEORGE SOUTH AREA DEVELOPMENT ASSOCIATION

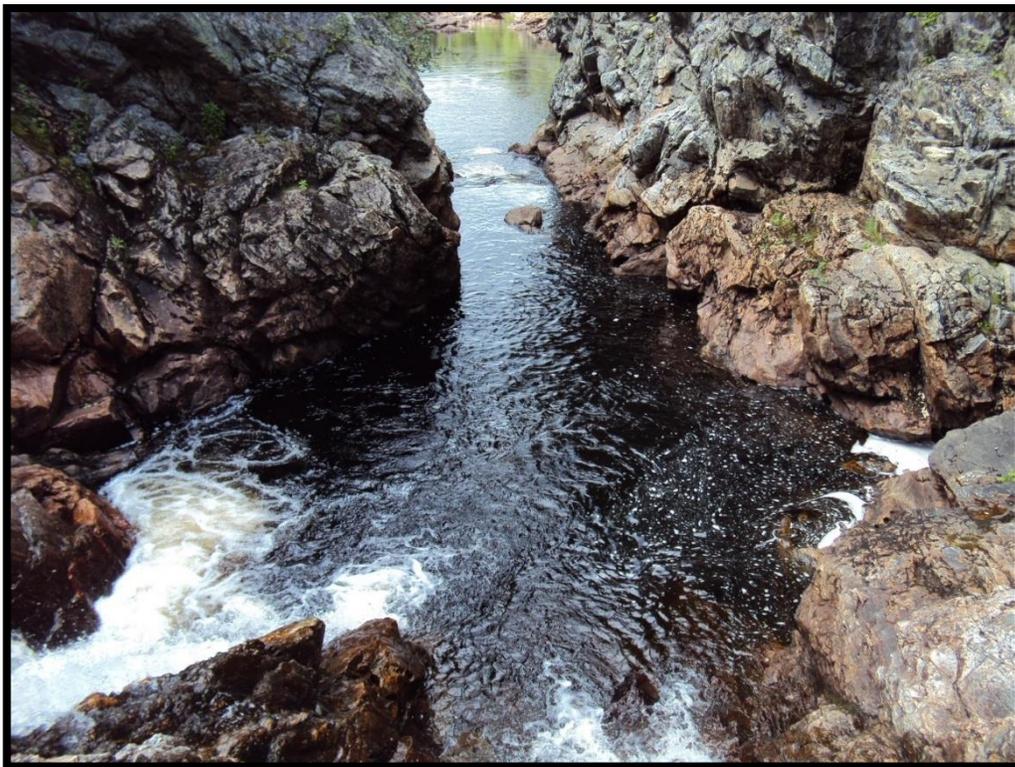
Figure 1: Pool at base of falls on Middle Barchois Brook. Rocks to be placed in the constriction to raise water levels in pool.

- 1) Place rocks in the constriction at the downstream end of the pool below the falls to raise the water level in the pool by 0.75 to 1.0 m (Fig 1). Rocks must be strategically placed such that they do not cause a barrier to upstream migrating salmon. Also, the rocks must be large enough so that they do not wash out.
- 2) Remove some small rock outcroppings at the base of the falls, on the right looking downstream; these may cause problems for salmon jumping the falls (Fig 2).
- 3) Place sandbags or a wooden diversion dam at the top of the falls to divert water to the right side of the falls (looking downstream) at low water levels (Fig 3).

- a) Rock be placed in the constriction to raise the water level in the pool below the falls by about 0.75 to 1.0 m. To keep construction costs to a minimum, needed rock material should be blasted near the site for placement in the constriction. The rock may need to be blasted a distance from the top of the gorge constriction or may have to be blasted dependent on direction from the marine biologist. Placing the rock in the constriction could be challenging since the rock has to be strategically placed and cannot cause a barrier to upstream migrating salmon. Method of placement will be determined by the low bidder in consultation with the marine biologist and may include a loader, boom truck or cable placement systems. Also, the rock has to be large enough so that it would not be washed out.

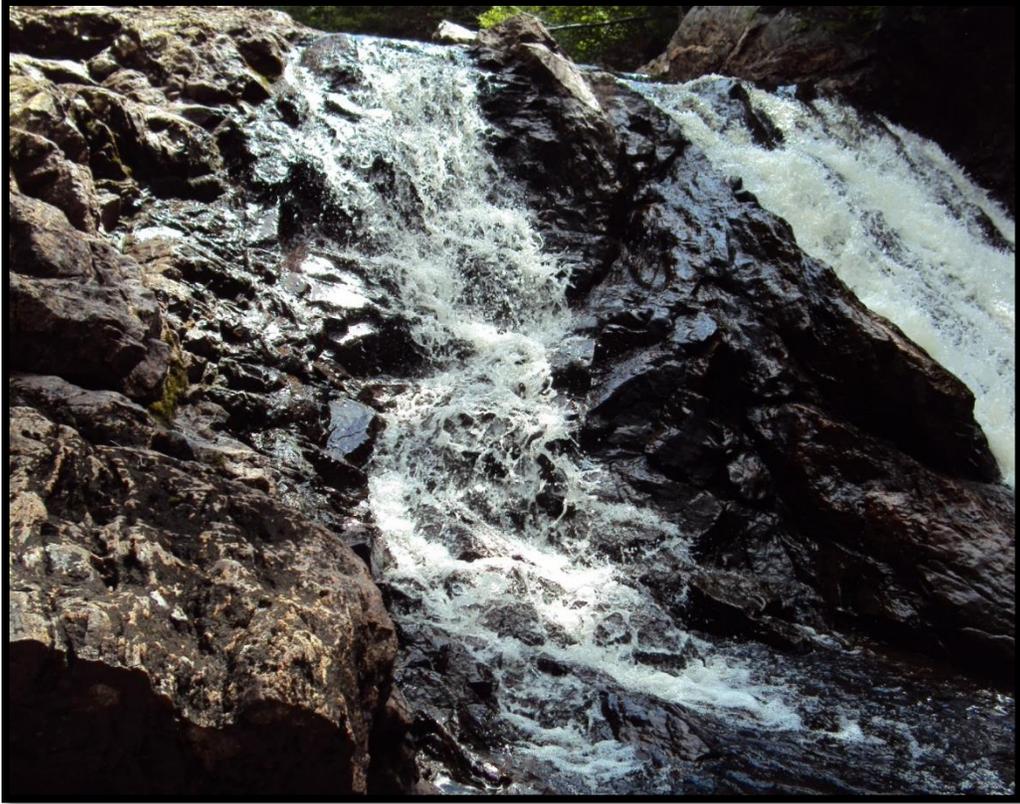
Figure 2: Photo of right side of falls (looking downstream) Middle Barchois Brook. Rocks to be removed from base of falls (right side).

- b) At the base of the falls, on the right looking downstream, there are some small rock outcroppings that may cause problems for salmon jumping the falls. These should be removed. There is only a small amount of rock that needs to be removed, possibly with jack hammer or with expansion grout. These could be disposed of into the pool.

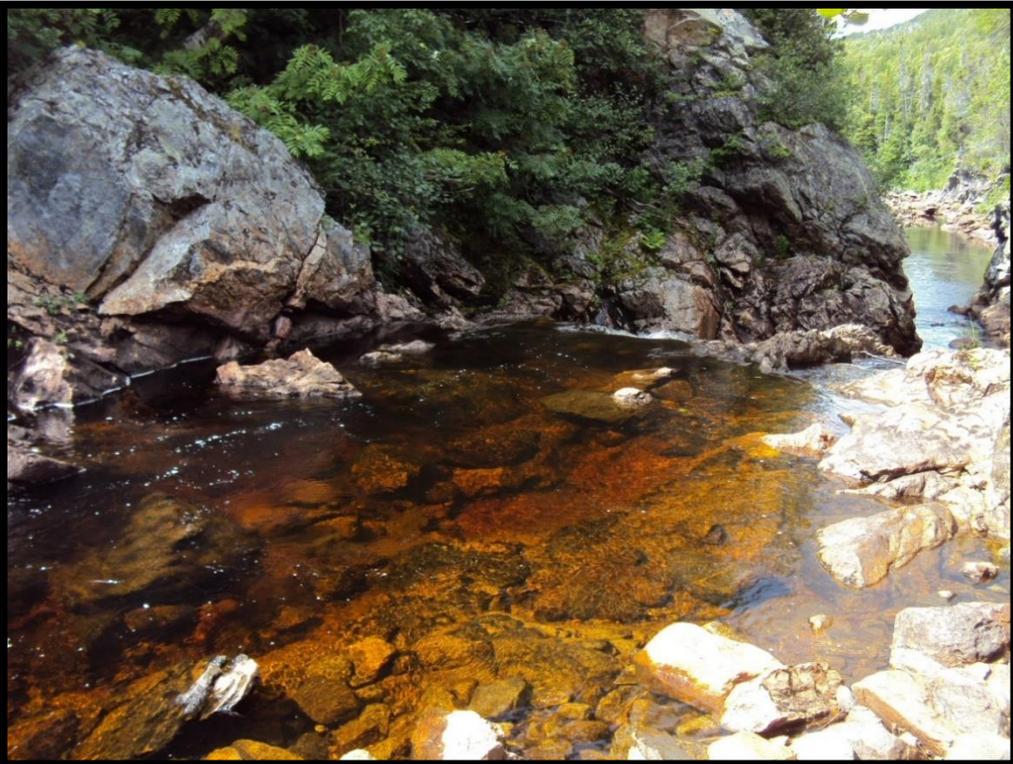
Figure 3: Top of falls, Middle Barchois Brook. Water to be diverted to right side (looking downstream).

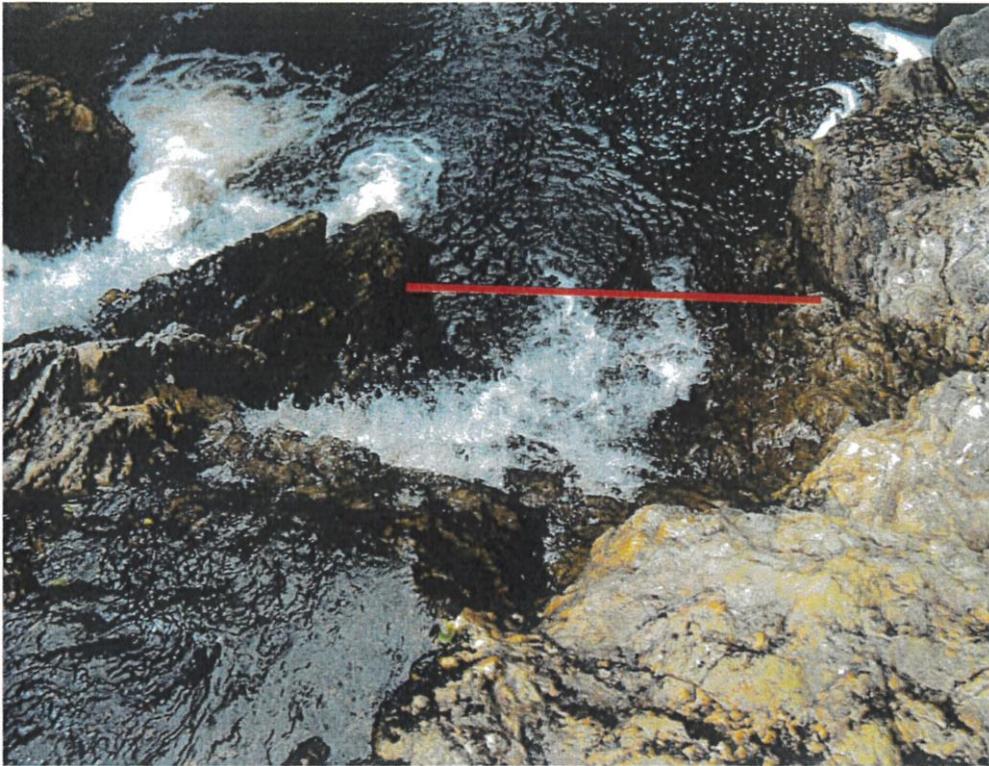
Photo 2. This photo shows the top of the left (looking upstream) channel of the falls. The width of the wetted area is approx. 0.5 m. Note the rocks at the base of the falls. These would impede salmon from jumping the falls. Also note the rocks at the base of the falls in the right (looking upstream) channel.

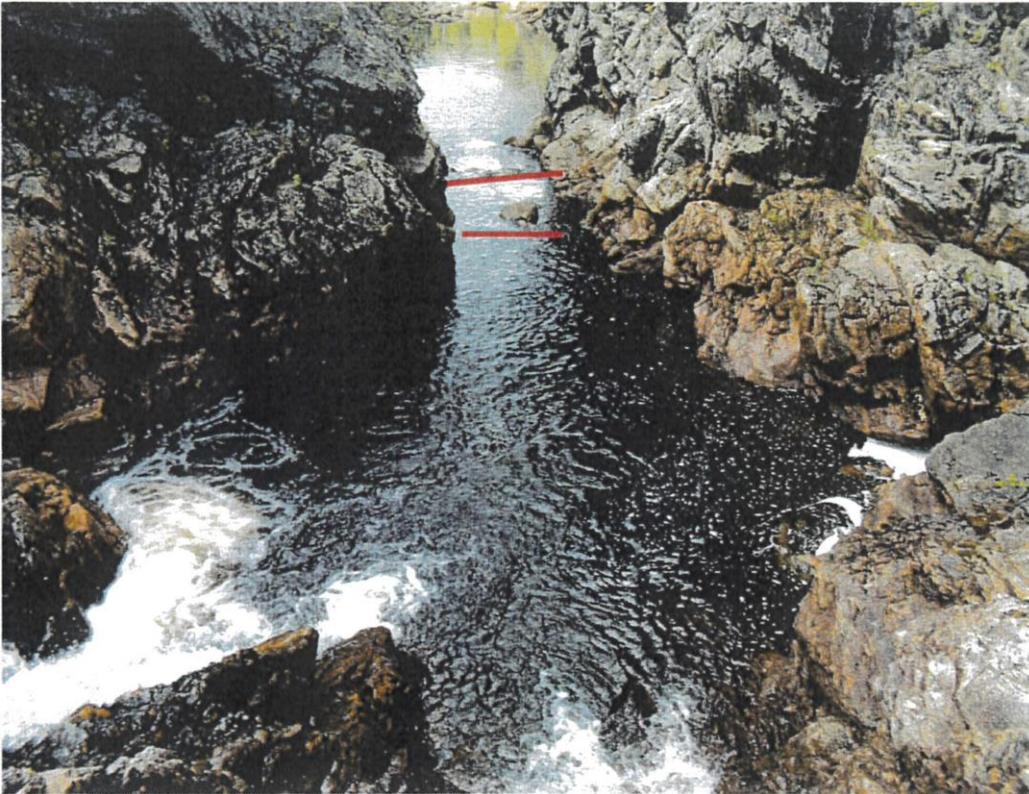
Photo 4. Pool at base of falls. Pool is approx. 10 m x 10 m. Constriction at the lower end of pool is about 2 m. Note rocks or out cropping in constriction. This constriction and rocks results in higher water level in pool during high flows as indicated by the staining of 1 m of rock walls of pool.

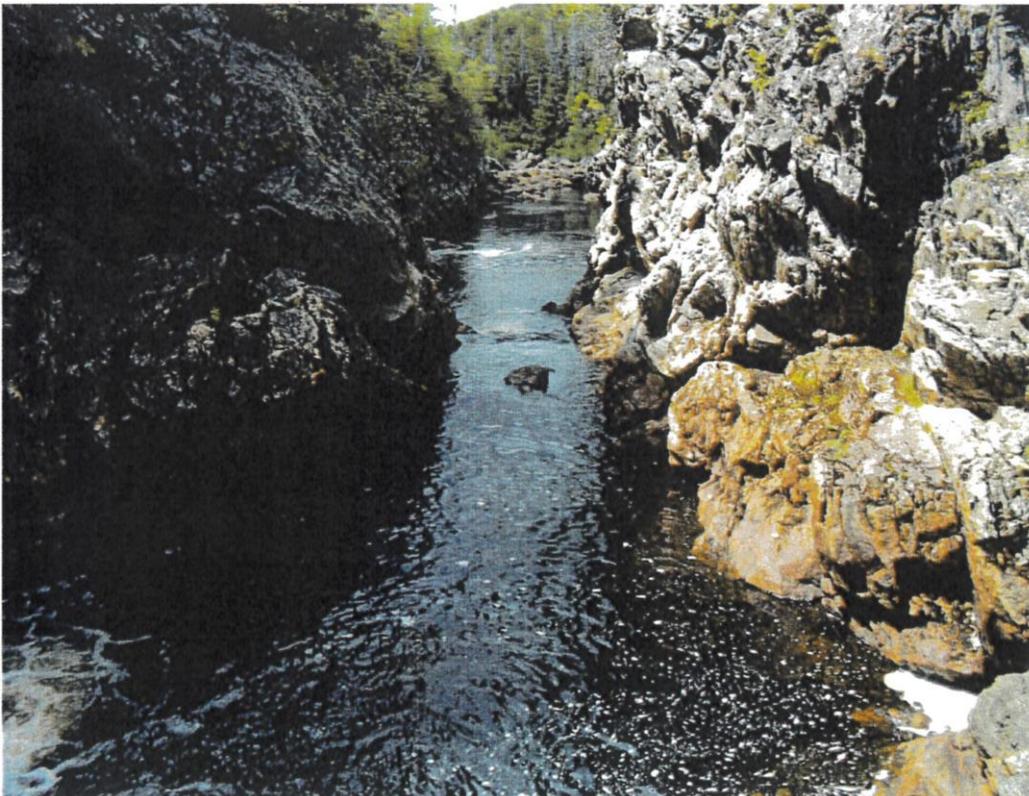
Photo 5. Constriction at downstream end of pool below falls. Note staining on rock wall, indicating increased height of pool during higher discharge.

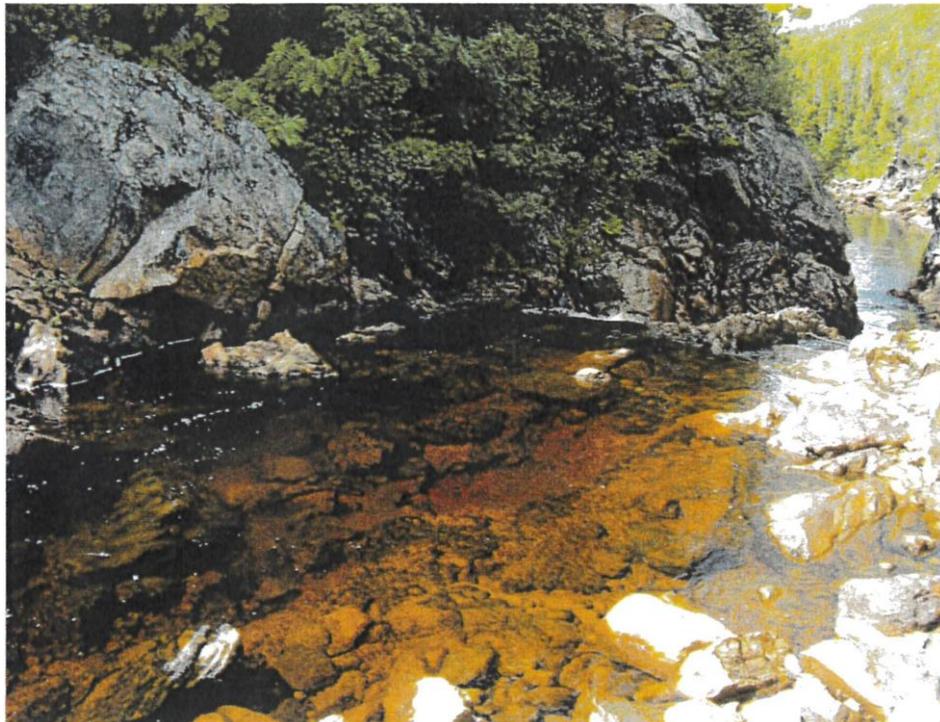
Photo 6. Pool at top of falls, approx. 5 m wide and 0.3 m deep. Rocks in pool may interfere with salmon after they jump the falls at higher discharge.

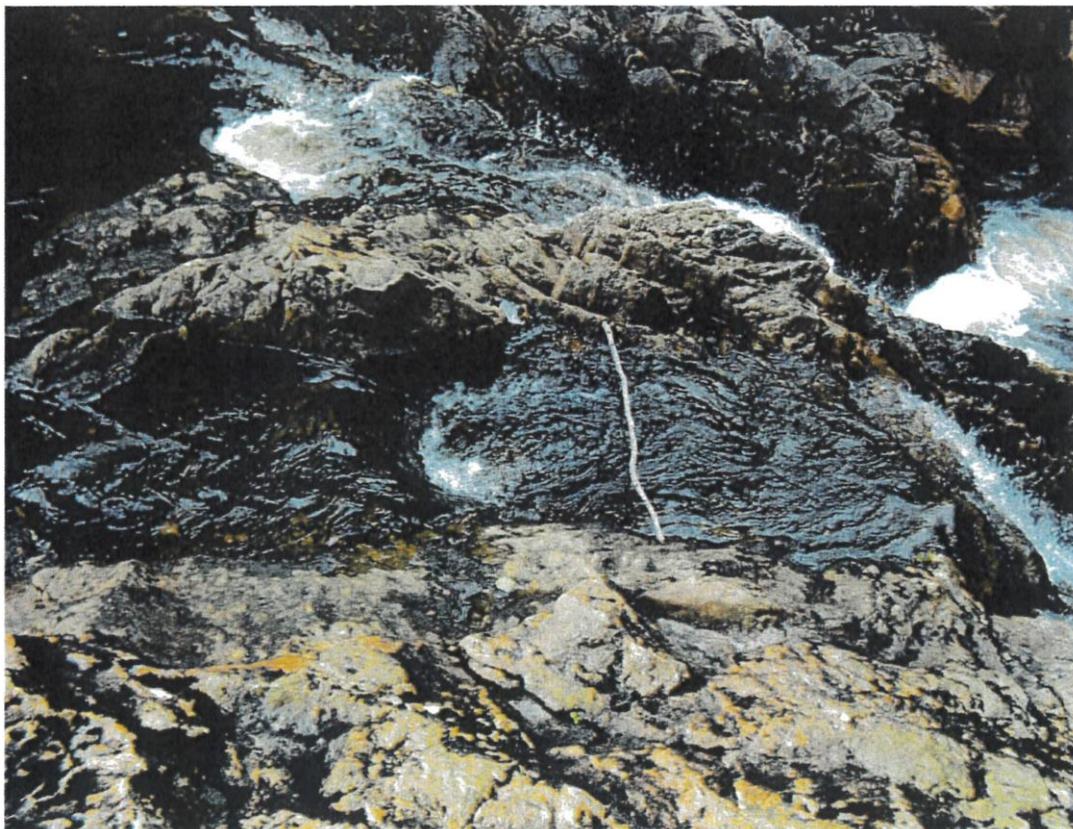
Photo 7. Crest of falls. The stick across left (looking upstream) channel is about 0.5 m. Flow in channel would be greater at higher river discharge

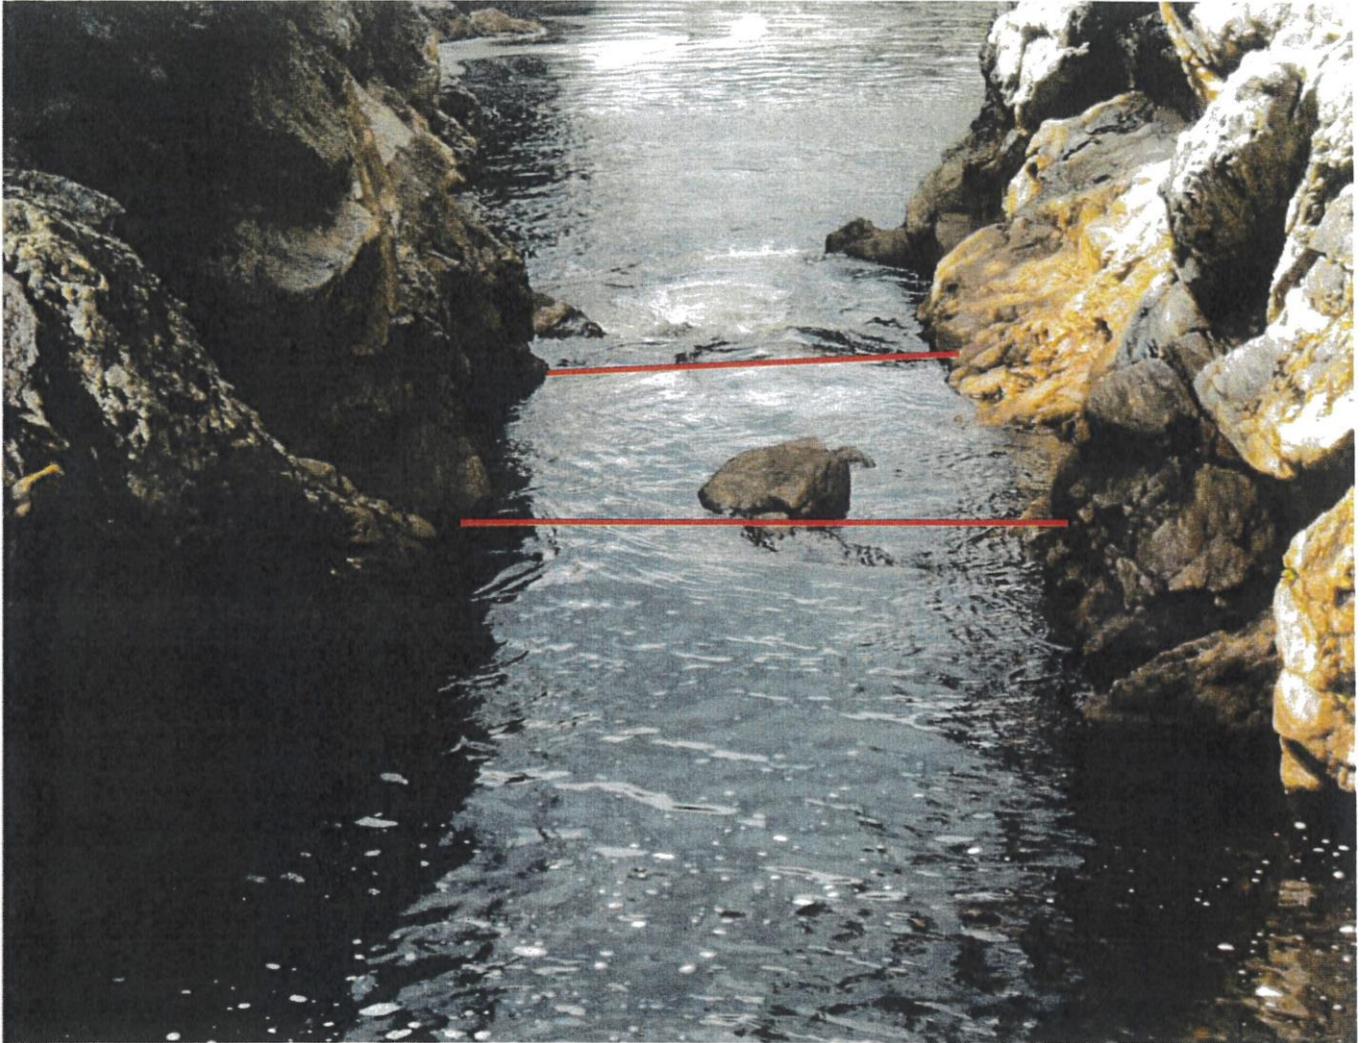
Photo 8. Gap below falls showing location for rock placement to raise water level in pool below falls.

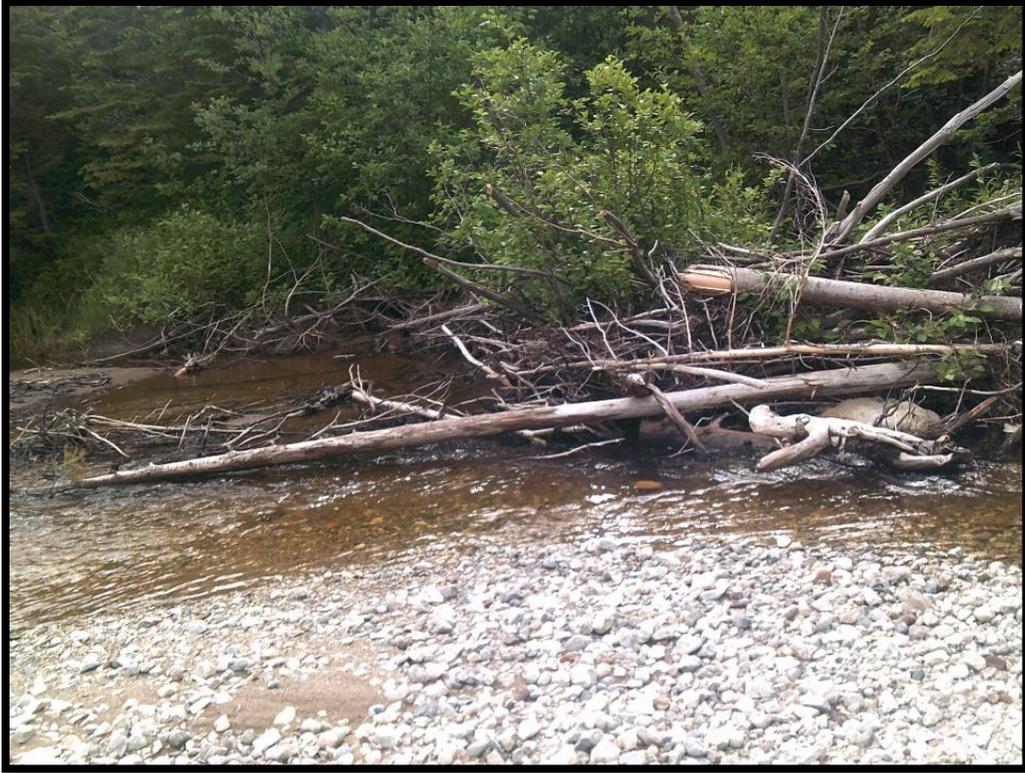
Figure 5: View of obstruction 2, Sheep Brook

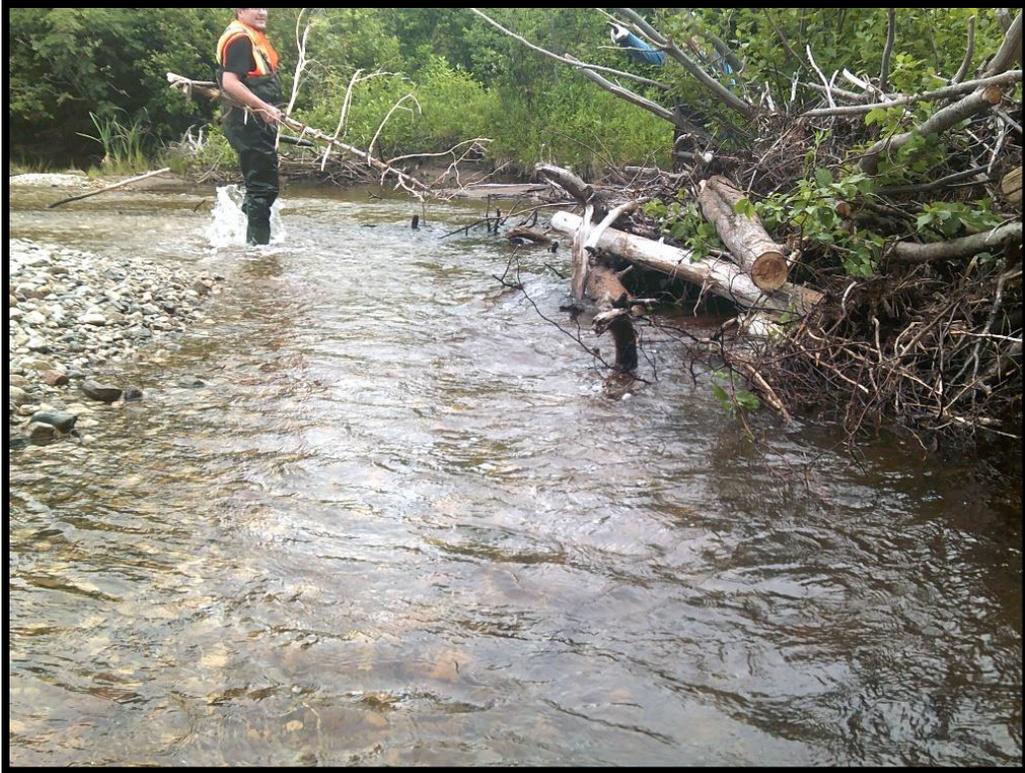
Figure 6: Removal efforts on obstruction 2, Sheep Brook

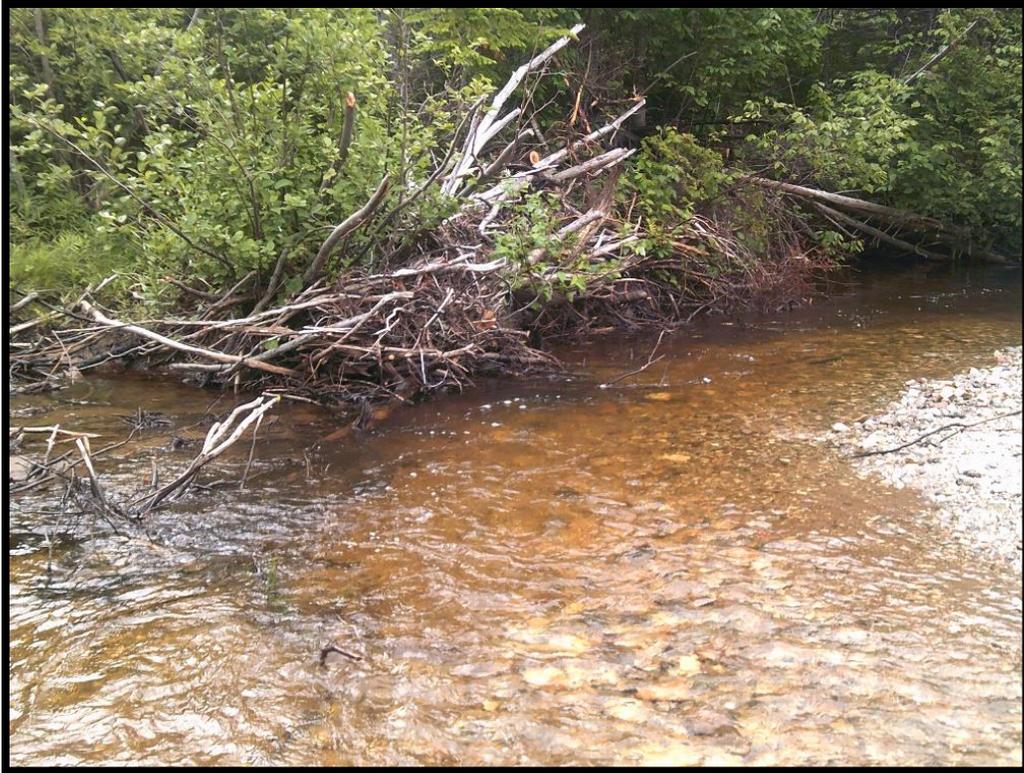
Figure 8: Improved fish passage from obstruction 2 removal, Sheep Brook

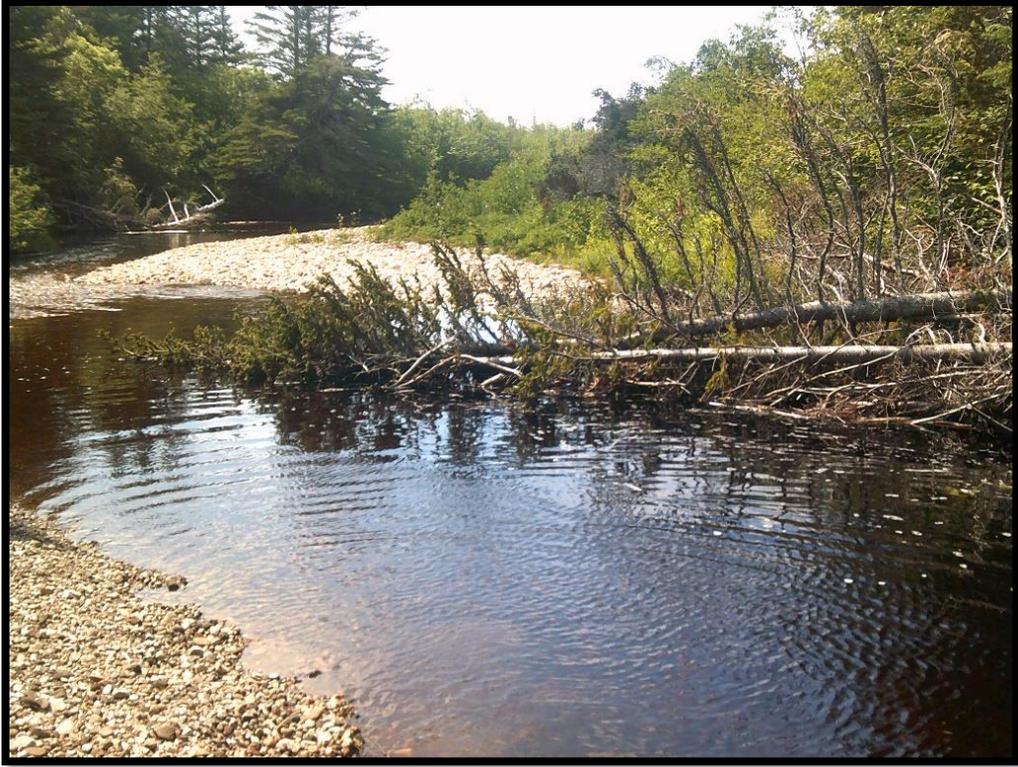
Figure 10: Downstream view of obstruction 7, St. Georges Dribble.

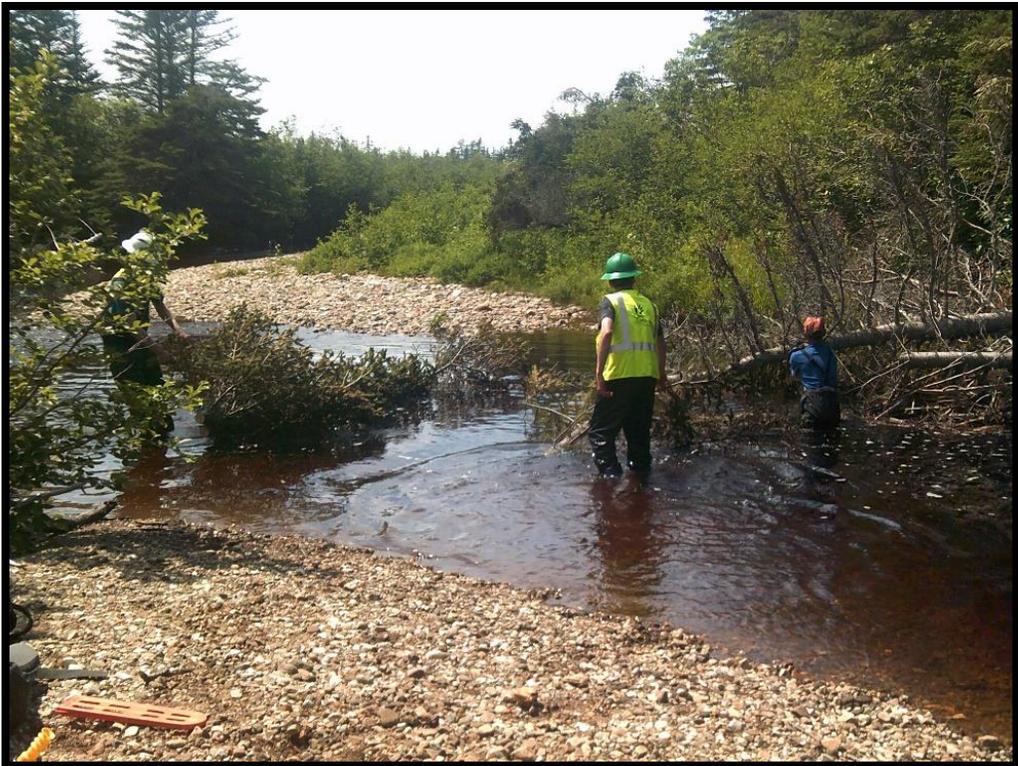
Figure 11: Obstruction 7 removal, St. Georges Dribble.

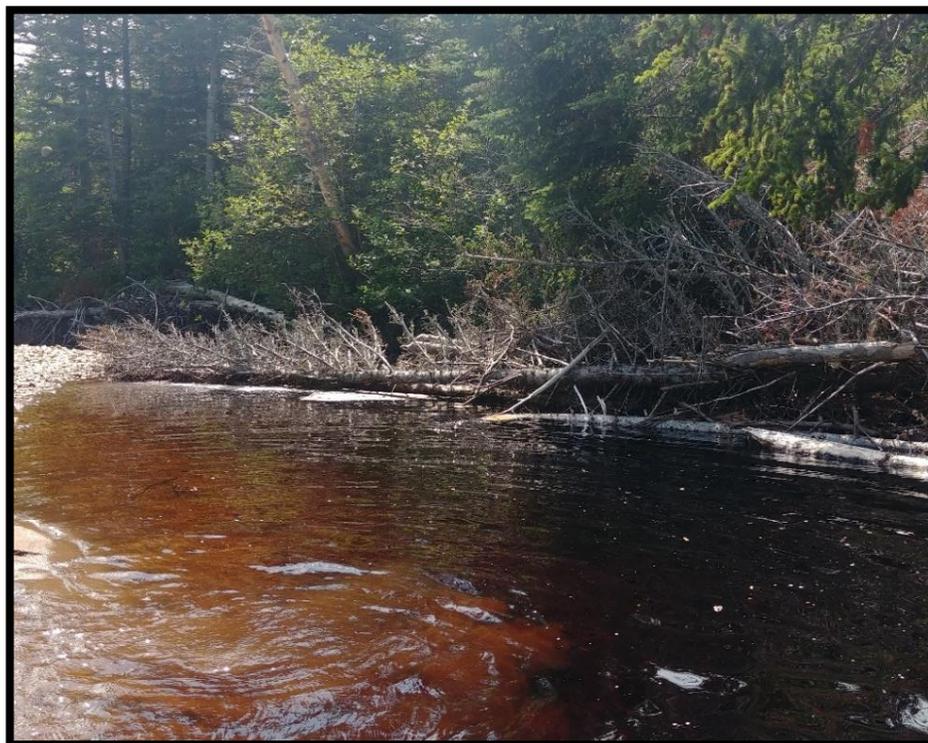
Figure 17: Upstream view of obstruction 9, St. Georges Dribble.

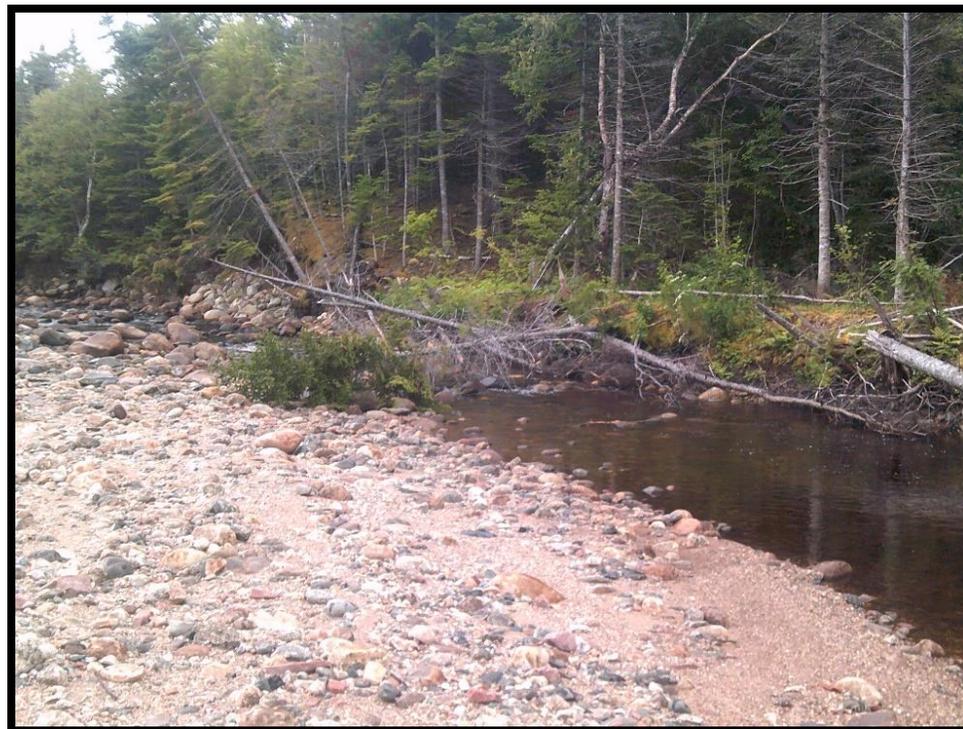
Figure 25: Upstream view of obstruction 14, St. Georges Dribble.

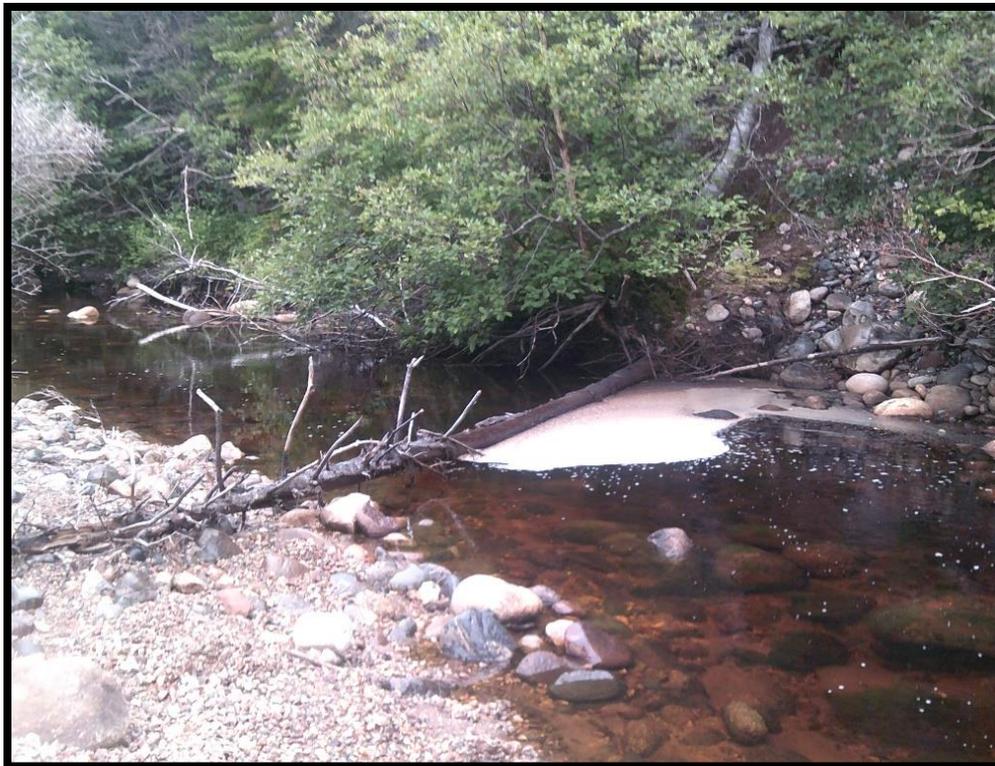
Figure 29: Downstream view of obstruction 16, St. Georges Dribble.

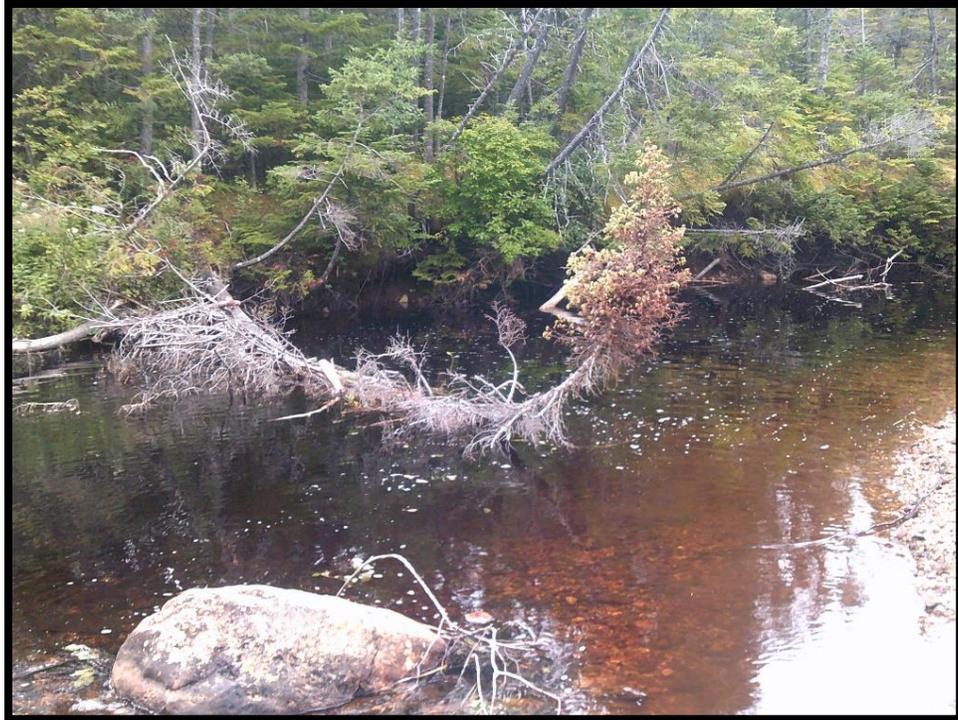
Figure 32: Upstream view of obstruction 17, St. Georges Dribble.

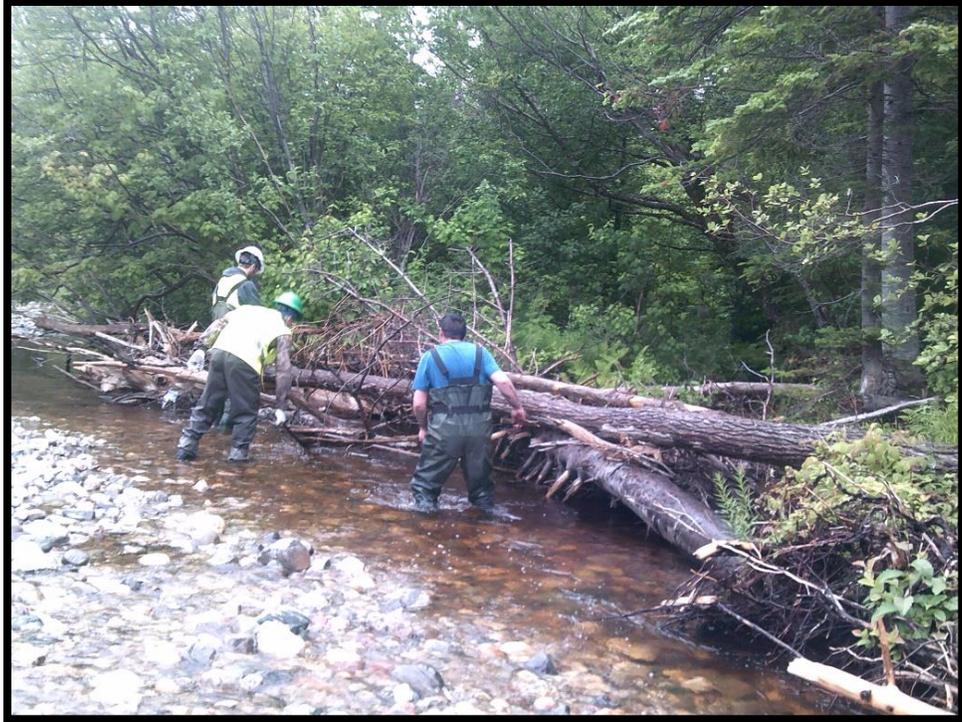
Figure 36: Downstream view of obstruction 2, Coal Brook.

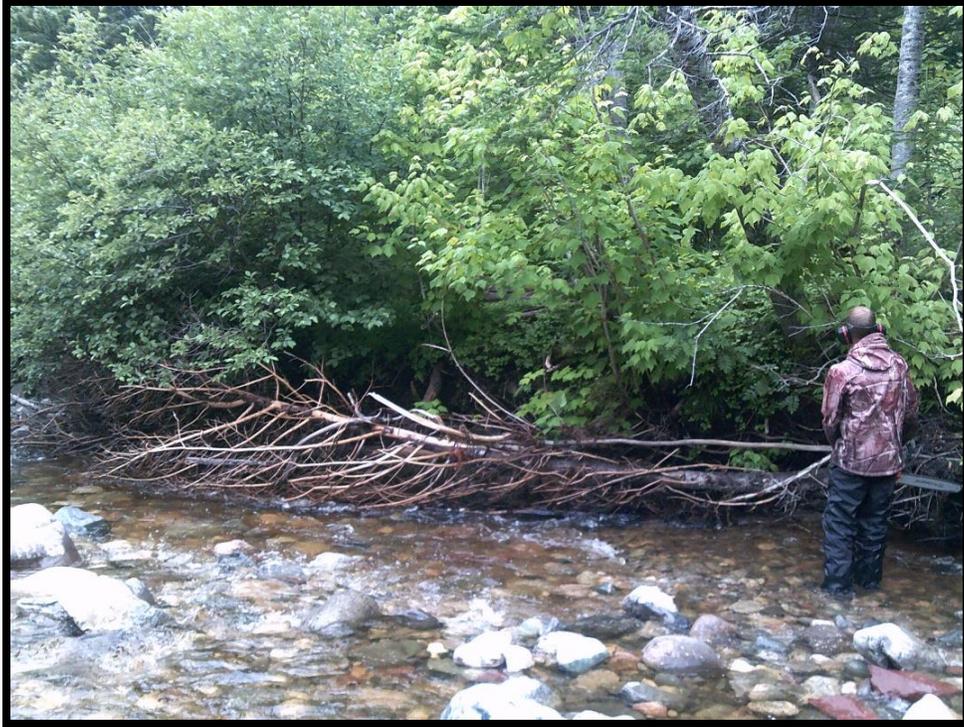
Figure 40: Side view of obstruction 5, Coal Brook.

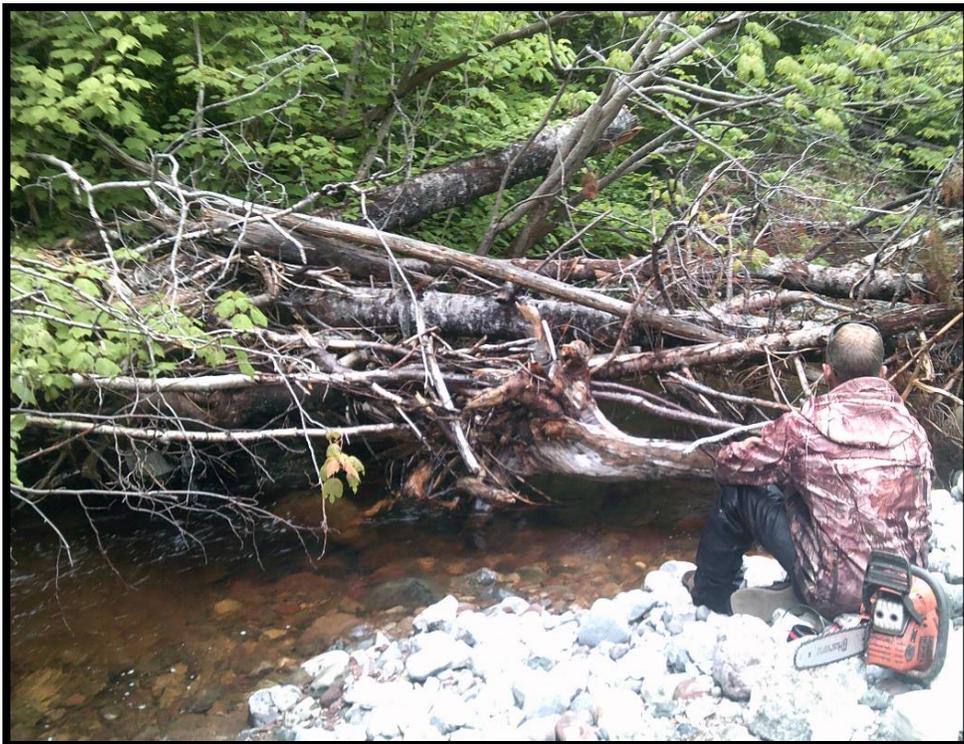
Figure 43: Downstream view of obstruction 6, Coal Brook.

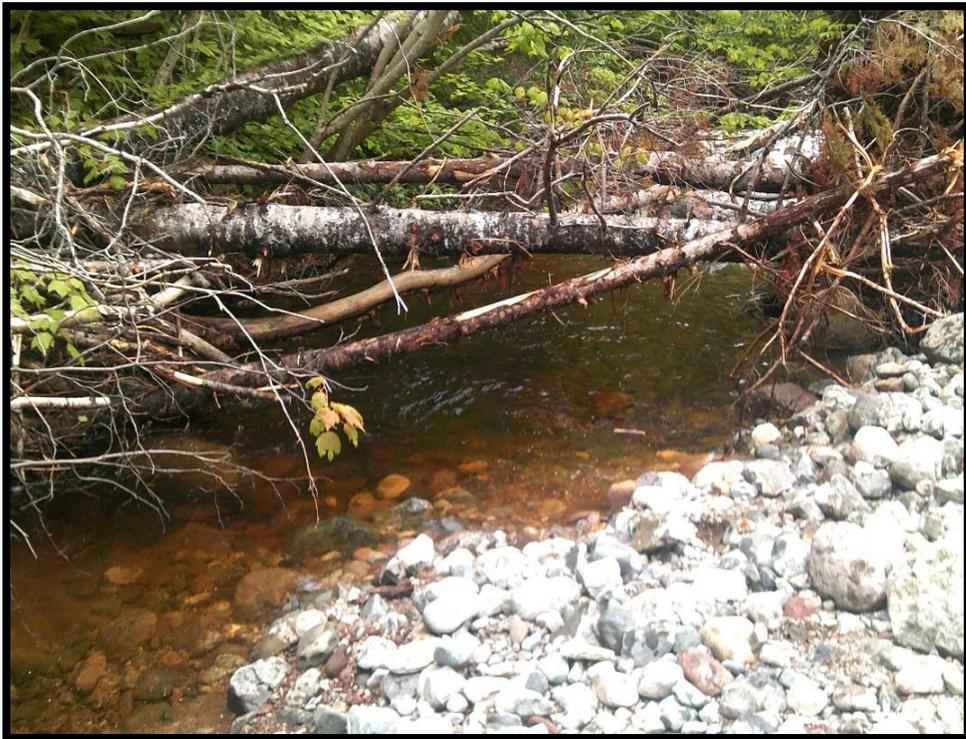
Figure 45: Improved fish passage from partial removal of obstruction 6, Coal Brook.

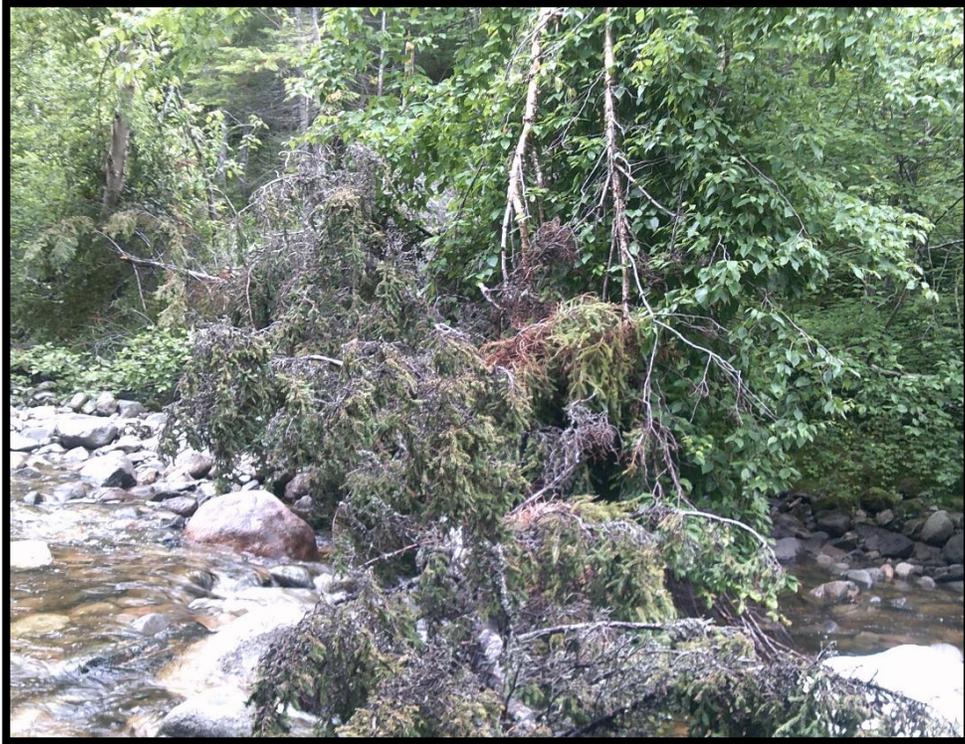
Figure 46: Side view of obstruction 9, Coal Brook.

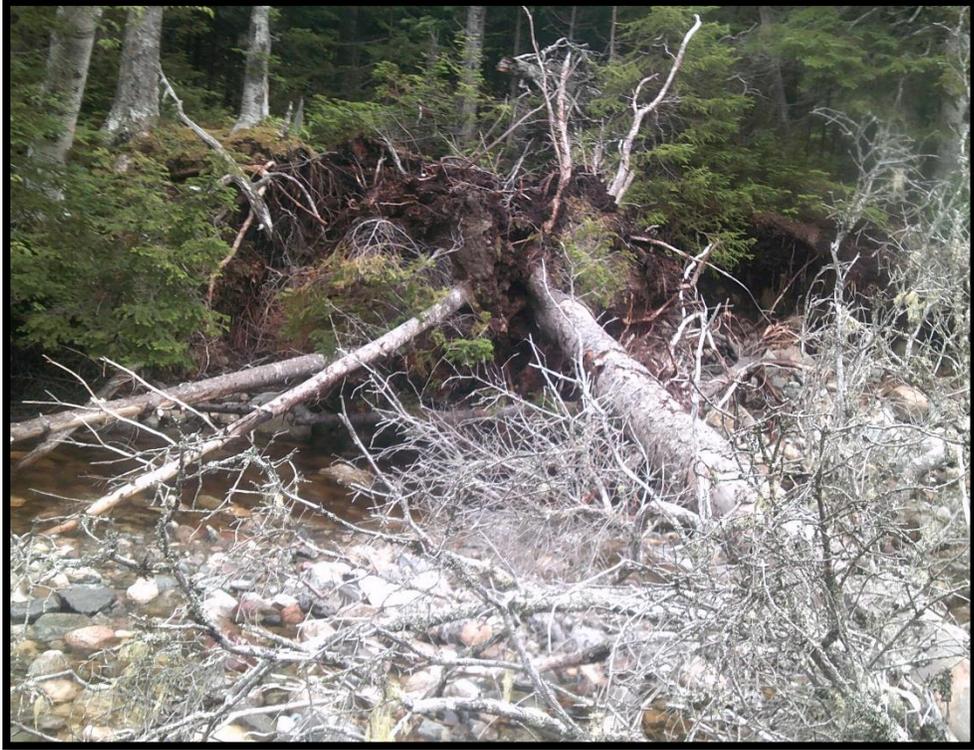
Figure 48: Side view of obstruction 10. Large woody debris caused by bank destabilization, Coal Brook.

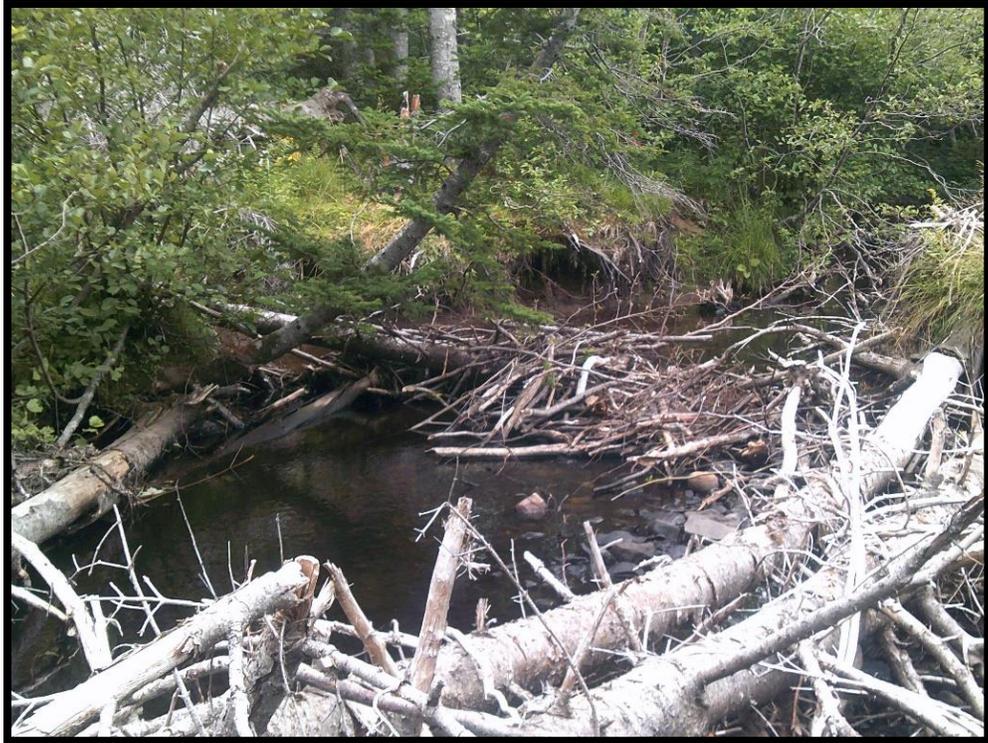
The beaver dam removed, obstruction 1 (N 48.18960, W -58.710353), had been catching lots of excess woody debris thus making it a greater obstruction to salmon migration (Fig. 52). The other two (2) dams were documented and reported to provincial authorities. They are listed as obstruction 2 (N 48.18968, W -58.711144), obstruction 4 (N 48.18979, W -58.71709), obstruction 12 (N 48.18758, W -58.70349), and obstruction 20 (N 48.18533, W -58.698039). Obstruction 12 continues to increase in size and has the entire stream blocked creating a great risk to salmon migration. There is access to this beaver dam off Camp 180 road.

Figure 52: Obstruction 1; inactive dam, Big Dribble Brook.

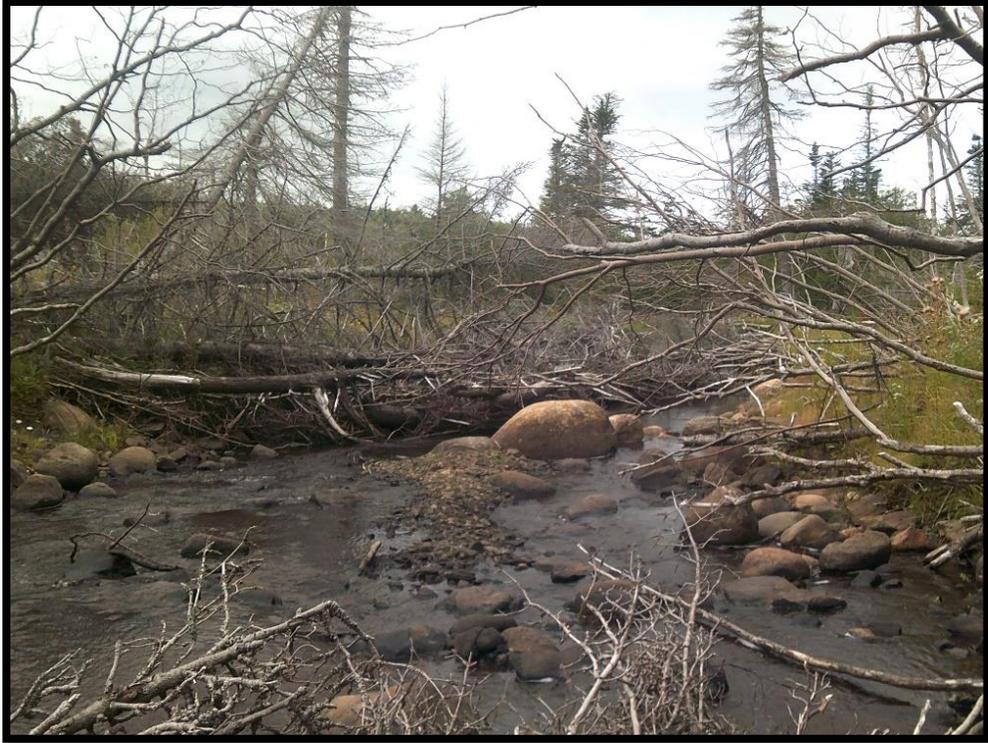
Figure 56: Downstream view of obstruction 3, Big Dribble Brook.

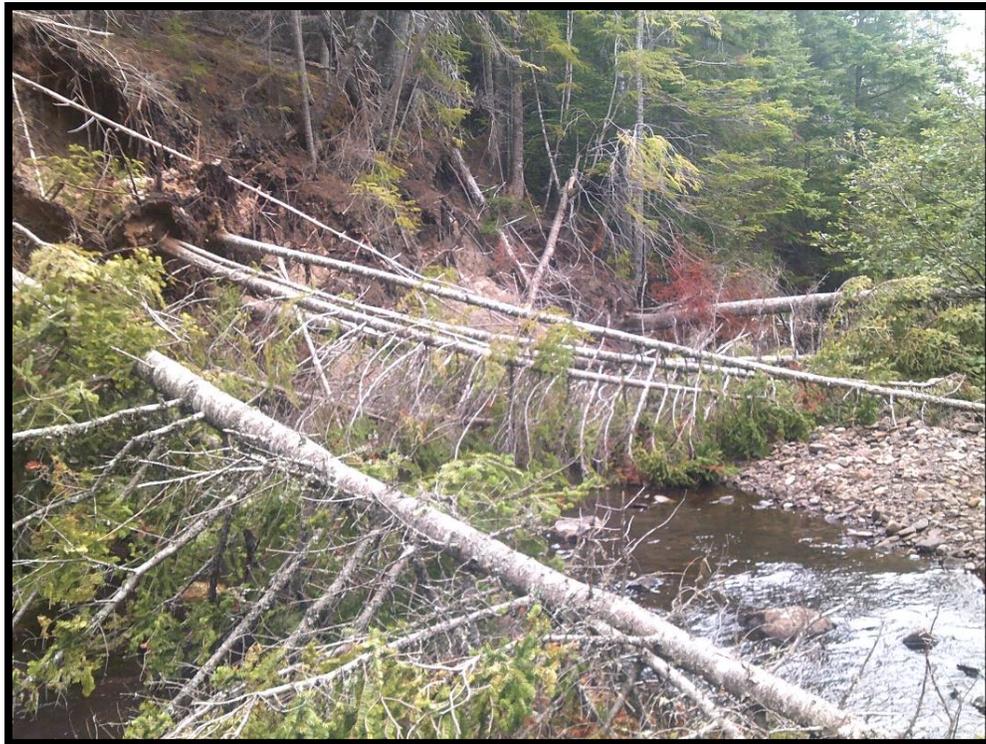
Figure 59: Upstream view of obstruction 6, Big Dribble Brook.

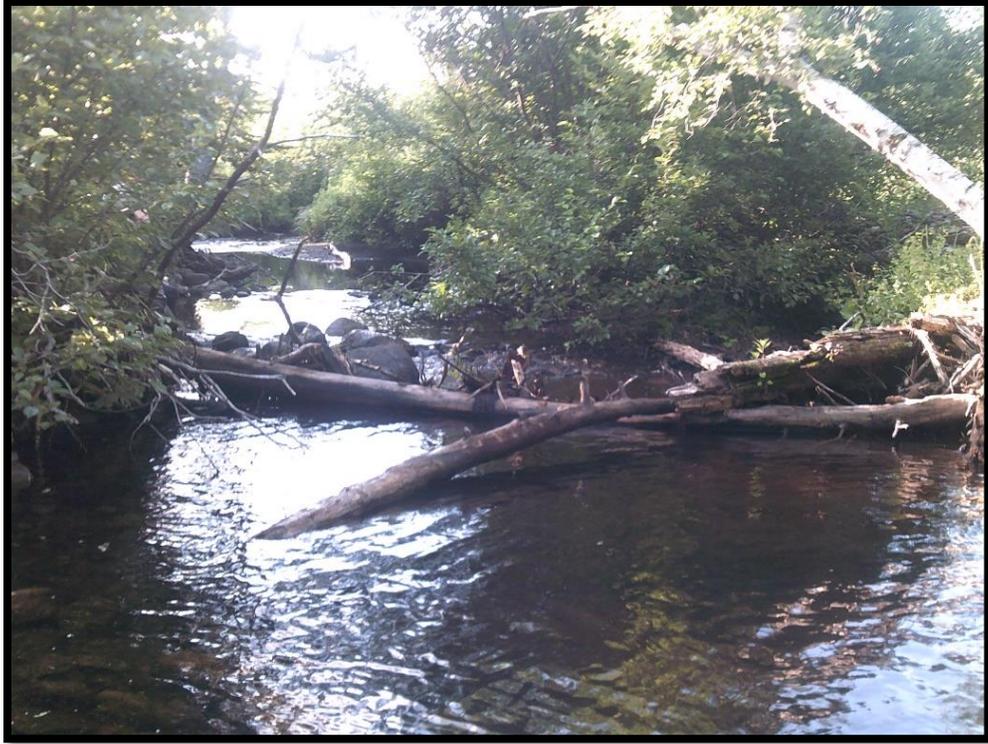
Figure 62: Upstream view of obstruction 9, Big Dribble Brook.
