**DEVELOP HABITAT CONSERVATION PLANS AND RESTORATION FOR
RIVERS IN BAY ST. GEORGE
2019**

Habitat Restoration

**FLAT BAY BROOK
LITTLE BARACHOIS BROOK
MIDDLE BARACHOIS BROOK**

BAY ST. GEORGE SOUTH AREA DEVELOPMENT ASSOCIATION

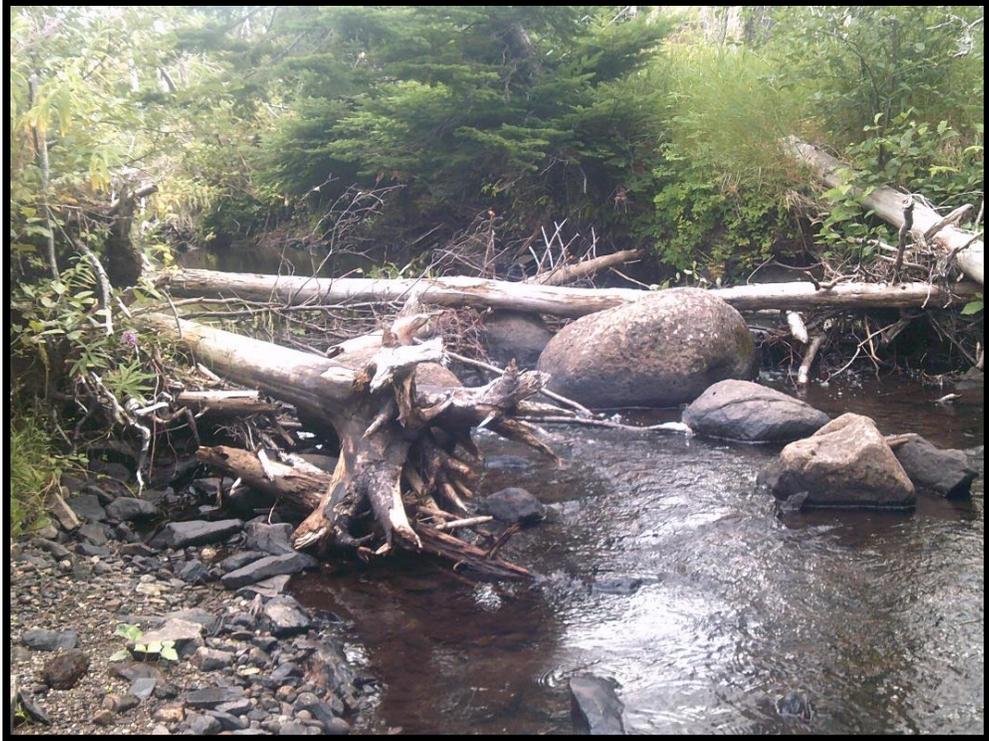
Figure 66: Upstream view of obstruction 11, Big Dribble Brook.
