# BELLEISLE WATERSHED COALITION

## Restoring Access and Assessing Barriers to Fish Passage in the Belleisle Watershed

This report is submitted in fulfilment of the 2023 Foundation for Conservation of Atlantic Salmon project # NB-2023-02 entitled, *“Restoring Access and Assessing Barriers to Fish Passage in the Belleisle Watershed”*

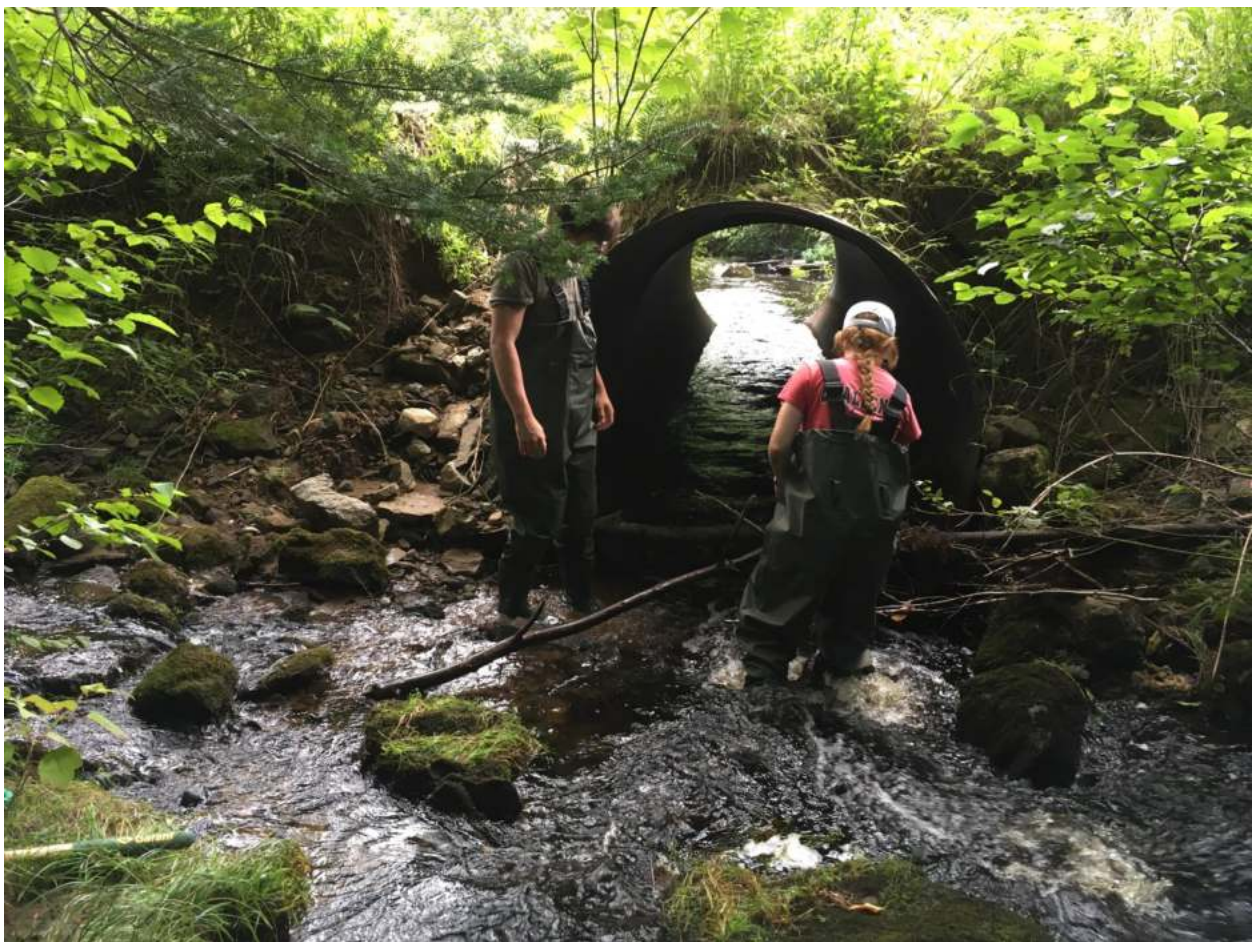
Figure 5: Staff conducting debris removal at a culvert in the Upper Watershed.

landfill to be properly disposed of. The natural debris removal process proceeded from the upstream side of the culvert (Figure 5). Removal of large branches was completed prior to removing entire logs. For large log debris it was cut into smaller pieces to ensure safety and easy of transport. All woody debris blocking each culvert was removed from both the inlet and outlet as needed to mitigate the barrier and restore fish passage. The removed organic debris was transported to a waste management facility to be composted. At each debris removal site data was collected on the type and quantity of debris comprising the blockage and added to the fish passage database for future reference. Once fish passage was restored the BWC will conduct an annual site visit to monitor of the amount and frequency of debris accumulation at each culvert. If at any site, debris accumulation continues as reoccurring issue, the BWC will investigate options to mitigate debris accumulation at each culvert as needed.

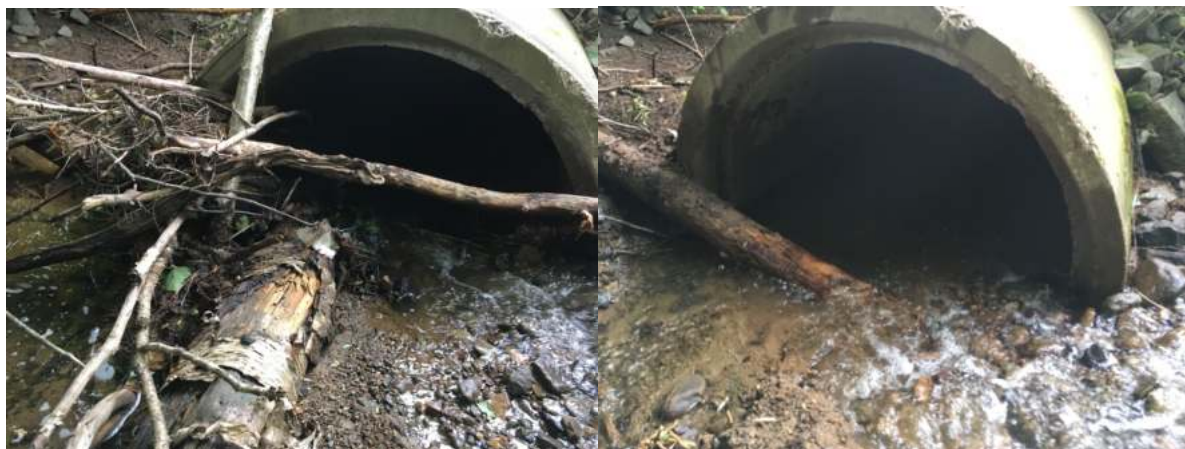
fish passage survey (Table 3, Figure 7). Results of this part of the project saw approximately 0.50 tons of mostly woody debris cleared from the inlet or outlet for culverts along with any anthropogenic rubbish (Table 3, Figure 9). In total the removal of the debris opened 50 km of watercourse with valuable salmonid habitat on six watercourses where fish passage was restricted in the upper watershed (Table 3, Figure 8).

**Figure 7 : Before and After photos of debris removal at culvert barrier ELB002.**
