## WOLASTOQEY NATION IN NEW BRUNSWICK

### **Wolastoq Watershed barrier analysis**

#### **Executive summary**

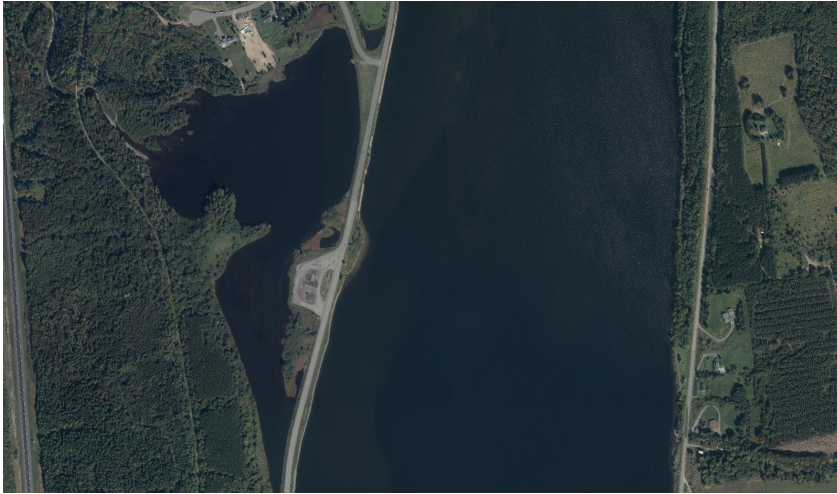
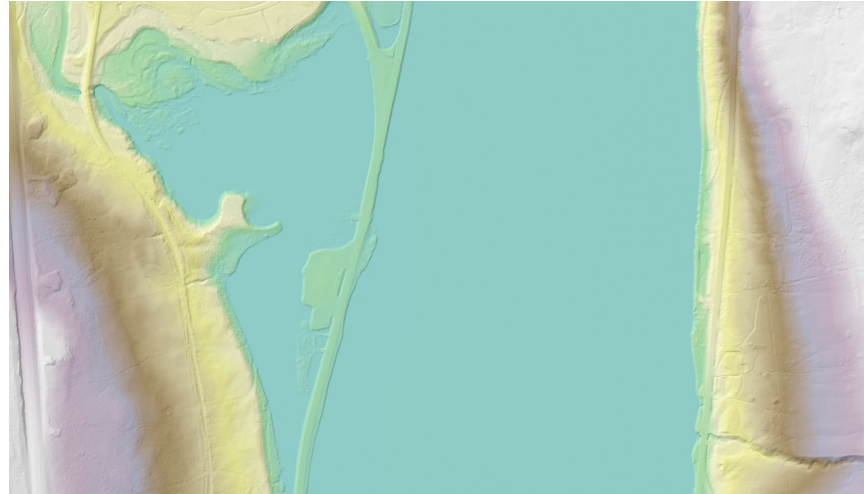
## Crossing 1

| <b>Coordinates</b> | 67.5605430°W, 46.0838734°N | <b>Notes</b> | Impoundment length is 1km in length with no visible crossing structure. If there is a crossing structure present, it would be too small for a in-stream structure for such a long impoundment. An open bottom culvert installed at the highest velocity point in the thalweg would open passage through and reduce erosion on the embankment of the impoundment. |

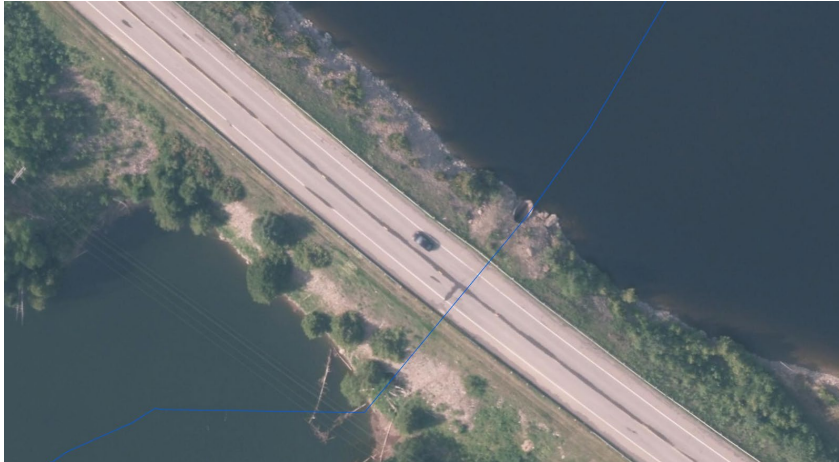
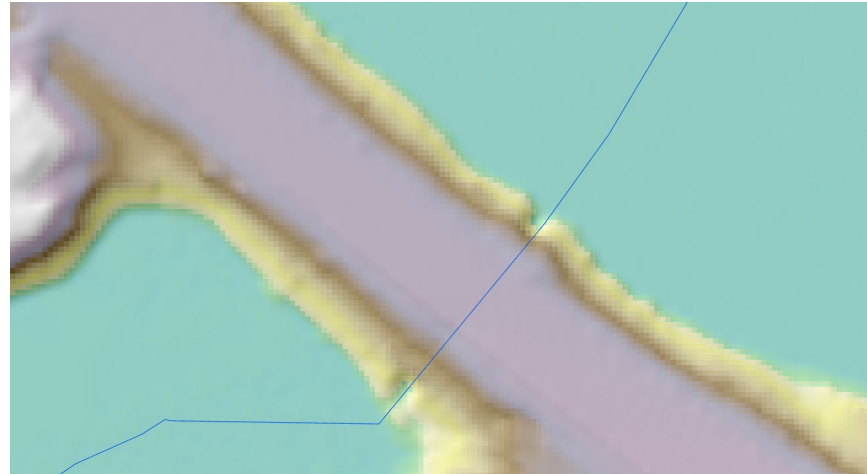
## Crossing 2

| <b>Coordinates</b> | 67.7025144°W, 46.5531401°N | <b>Notes</b> | <p>Bottom lip of the culvert is visible in Orthophotography. Slope of the culvert when measured from the culvert is below threshold but, elevation difference increases from the lip of the culvert to downstream, indicating it is a hanging culvert. Replacement is recommended because the upstream and downstream side of the culvert are not channelized stream, they are wide river, reducing the options of remediation.</p> |

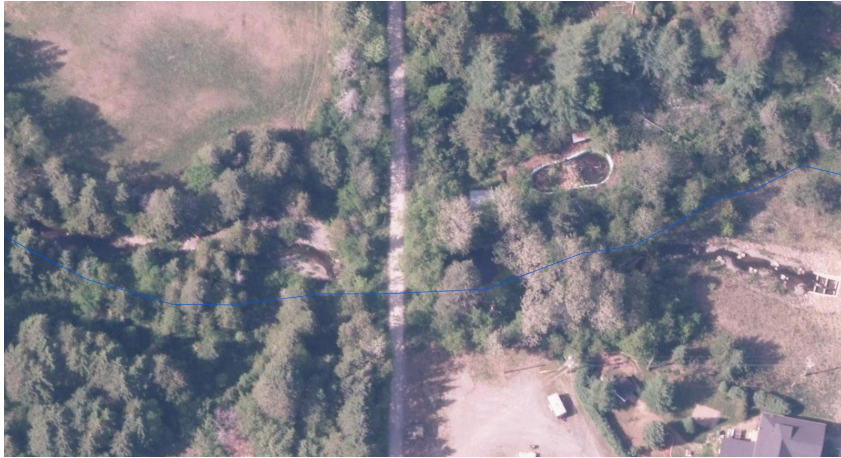
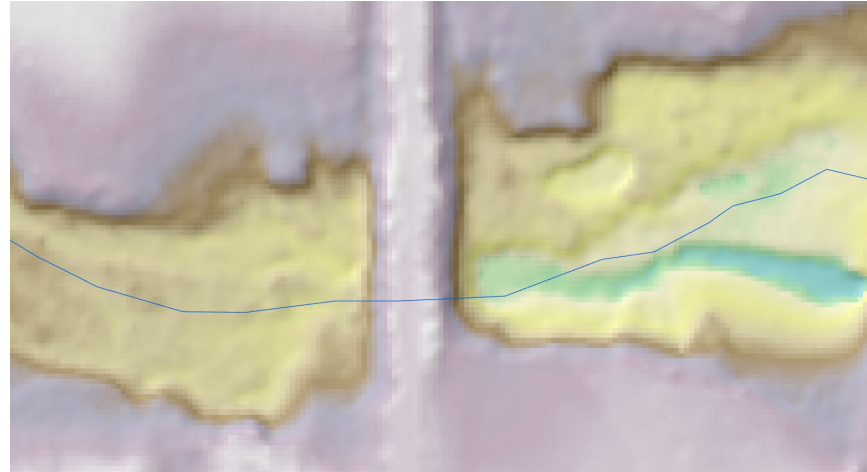
## Crossing 11

| <b>Coordinates</b> | 68.6033280°W, 47.2553542°N | <b>Notes</b><br><br>Slope exceeds 4% slope threshold. There is uncertainty on whether this crossing has any modifications like culvert baffles that could help overcome slope. The culvert upstream has baffles installed (see left side of picture 1), so there could be a possibility of baffles present in the culvert downstream; not requiring remediation if baffles are already present. If there are no baffles in place, they should be installed or the culvert replaced to maintain slopes below 2%. |

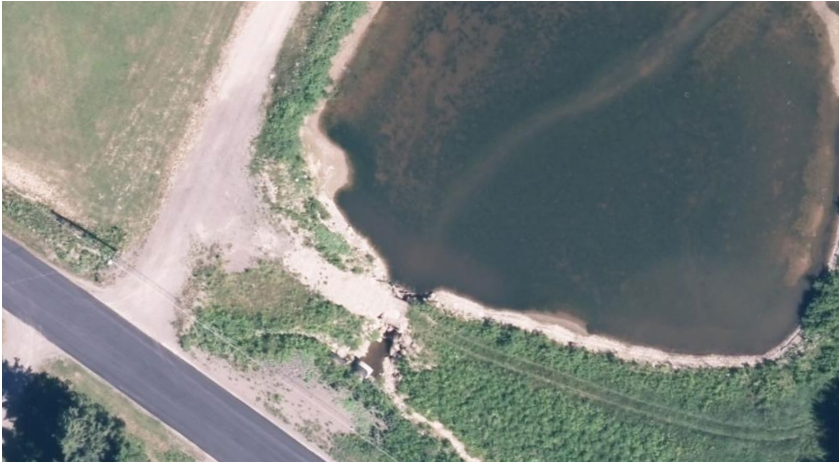
## Crossing 12

| <b>Coordinates</b> | 67.6221808°W, 47.0681112°N | <b>Notes</b> | Culvert slope exceeds threshold. The culvert being directly downstream of a head pond could have a water retention structure to maintain water level, but it is not fish passable from DEM elevation data. Should be replaced with fish passable spillway or fish ladder structure if replacement is not viable. |

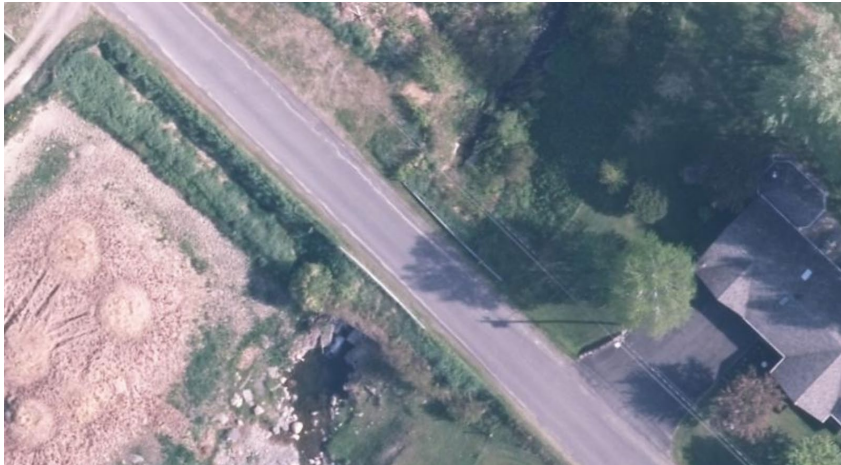
### Crossing 13

| <b>Coordinates</b> | 68.2577561°W, 47.3873344°N | <b>Notes</b> | Culvert slope exceeds threshold. Ortho shows it could be a square concrete slab culvert. The culvert should be replaced or installed baffles. |

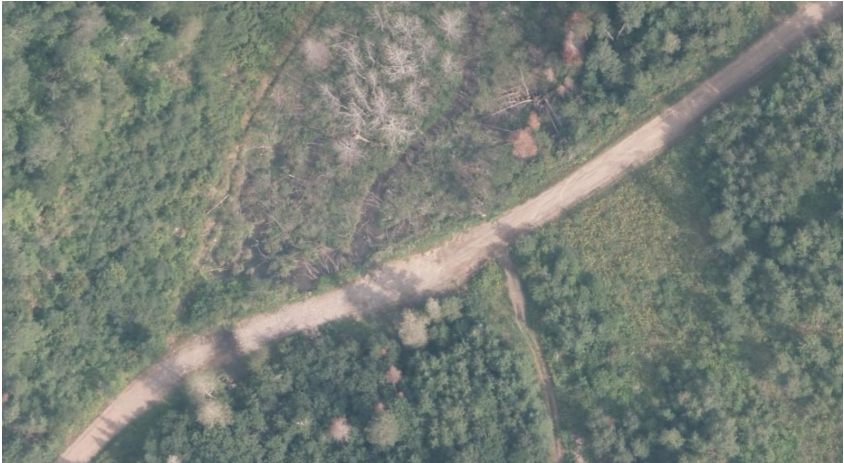
| Crossing 14 | | | |

| Crossing 14 | | | |
|---|---|---|---|
| Coordinates | 67.5858298°W, 46.9945398°N | Notes | <p>Old forestry road that has degraded to the point where there are multiple points of crossings and become less channelized. The road should be removed and replaced with a ford to allow natural flow to reoccur.</p> |

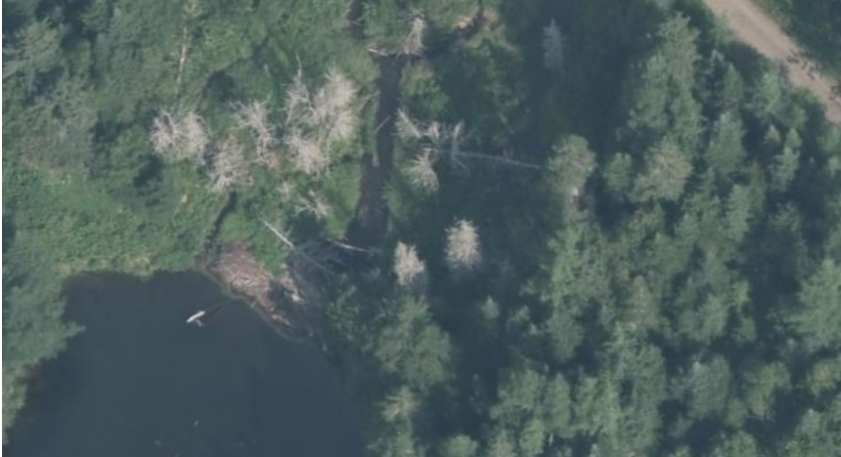
| Crossing 21 | | | |

| Crossing 21 | | | |
|---|---|--|---|
| Coordinates | 67.6265032°W, 46.9321716°N | Notes | <p>The impoundment seems to be a result of beaver activity or logging. Typically, log jams are hard to identify due to the temporal nature of LiDAR/Ortho/Sat data, but the log jam was identified in Ortho data from 2018, satellite data from 2021, and LiDAR from 2020. This gives strong enough evidence to further investigate the barrier. Removal of the log jam is recommended, if fresh beaver activity is observed, other measures like beaver exclusion devices are recommended.</p> |

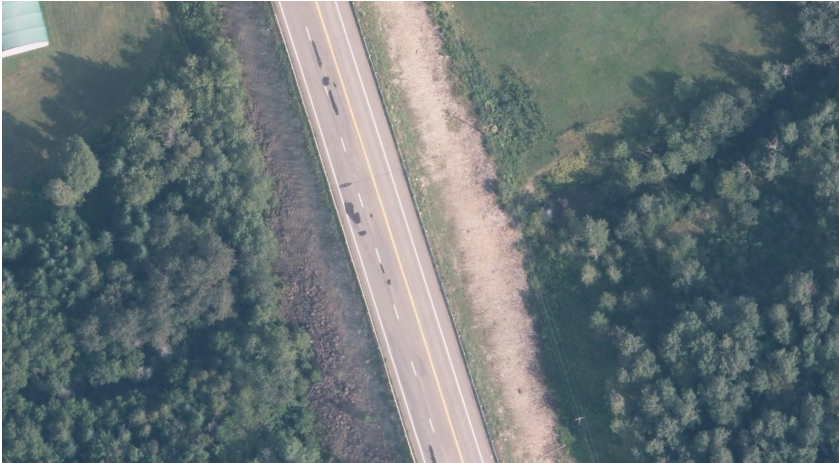
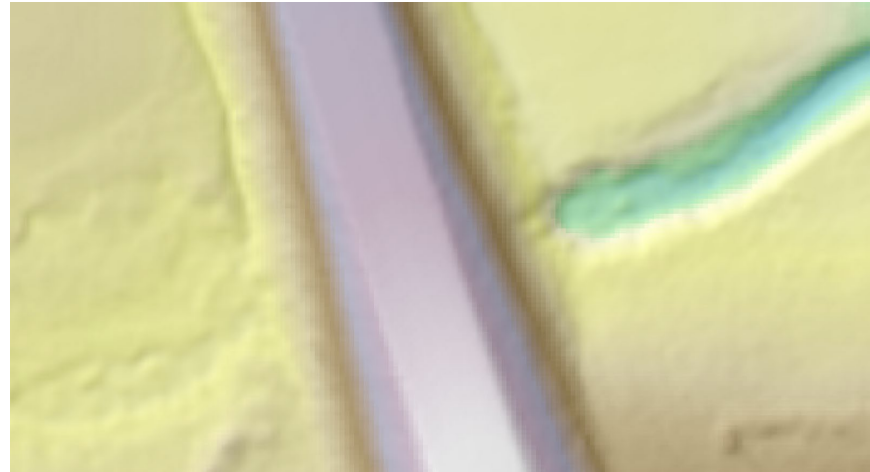
### Crossing 23

| <b>Coordinates</b> | 67.7550231°W, 47.0082618°N | <b>Notes</b> | Culvert slope exceeds slope threshold. Culvert needs to be replaced. Replacing the culvert would require significant funds since the structure is over 65m long and under an embankment almost 20 meters deep which is on a 3 lane highway. Modifying the existing structure would be the most viable and cost-effective approach. |

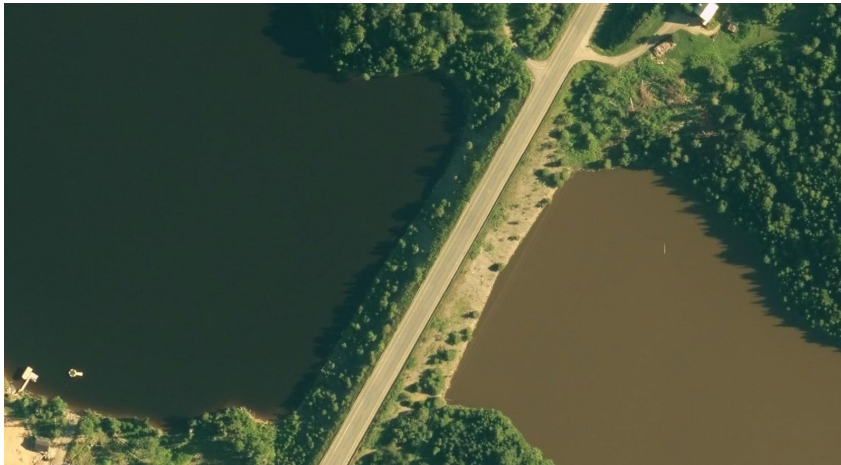
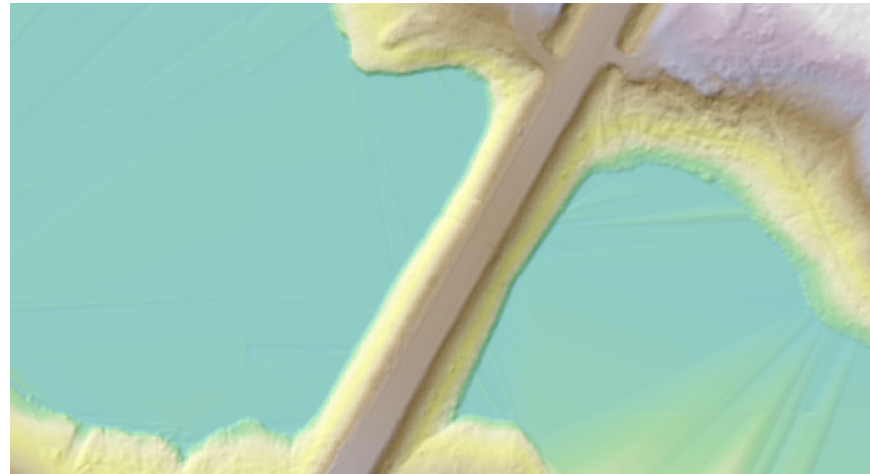
## Crossing 24

| <b>Coordinates</b> | 66.8852474°W, 45.9152209°N | <b>Notes</b> | <p>Embankment shows no evidence of a structure being present. There would be some discoloration in the water around the outlet of the culvert due to the contrast between the color of the waters on the upstream and downstream mixing in the ortho. Additionally, there is no evidence of channeling to a structure via elevation discrepancies along the embankment. It is recommended to install an open bottom culvert or bridge.</p> |

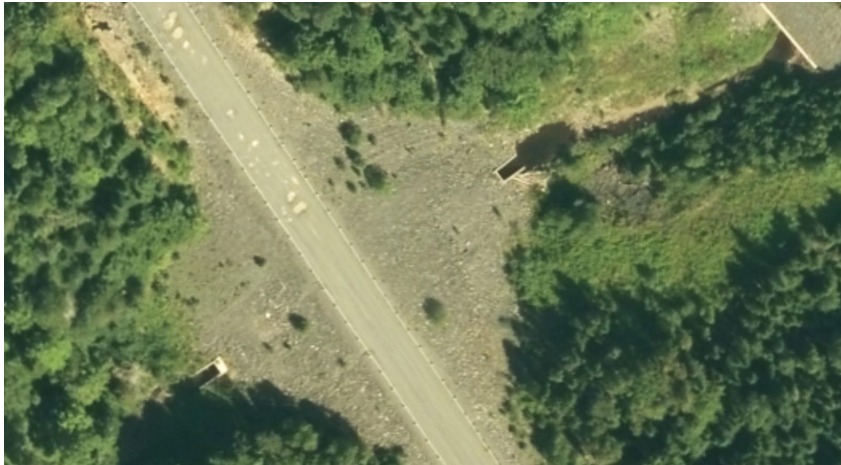
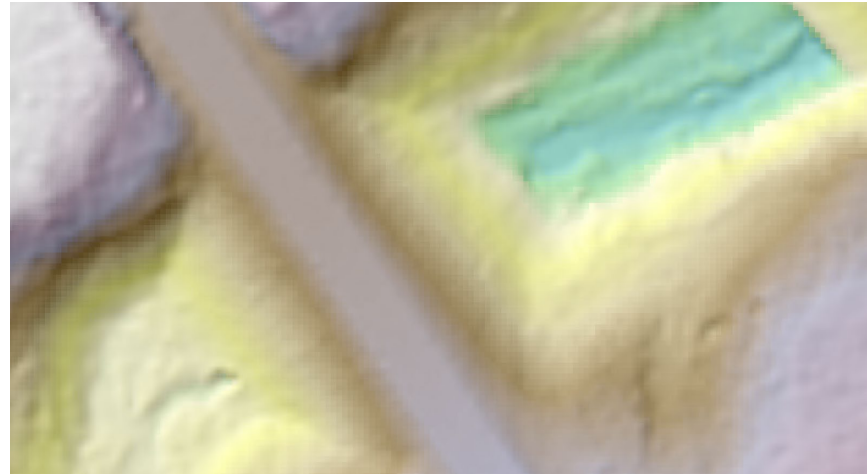
## Crossing 25

| <b>Coordinates</b> | 66.9763319°W, 45.8679668°N | <b>Notes</b> | <p>Culvert slope exceeds slope threshold. Culvert needs to be replaced. Replacing the culvert would require significant funds since the structure is 65m long and under an embankment almost 14 meters deep. Modifying the existing structure would be the most viable and cost-effective approach.</p> <p>Need to remove two barriers: The barrier downstream (Crossing 26) would need to be removed for the upstream kilometers to be restored.</p> |

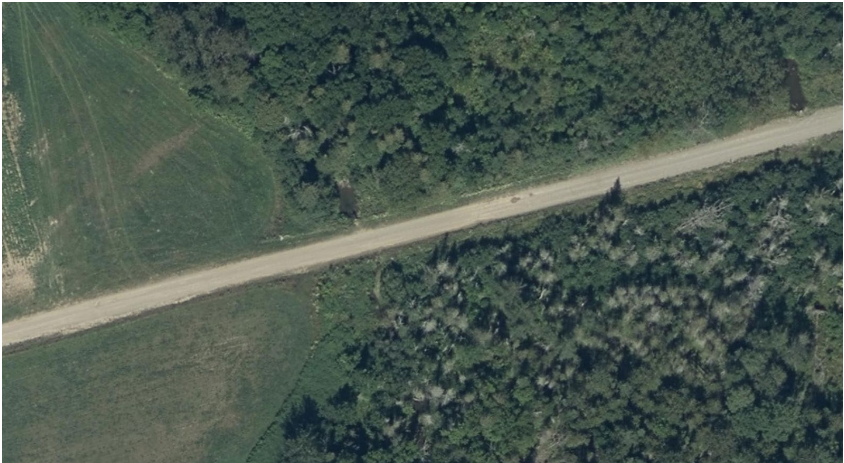
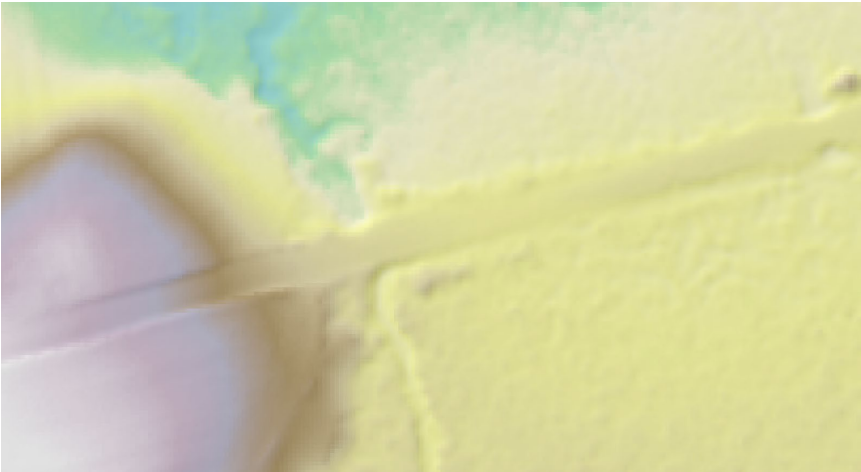
| Crossing 29 | | | |

| Crossing 29 | | | |
|---|---|--|--|
| Coordinates | 67.7382398°W, 46.5172512°N | Notes | Culvert slope exceeds slope threshold. There is another culvert 100m away on the same road, but is not part of the main channel, it appears to be a wetland or a culvert for ephemeral flow. The culvert should be replaced. |

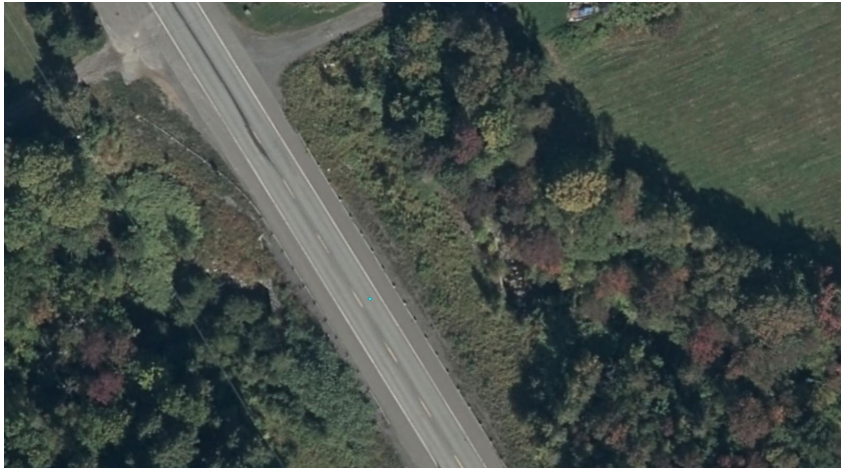
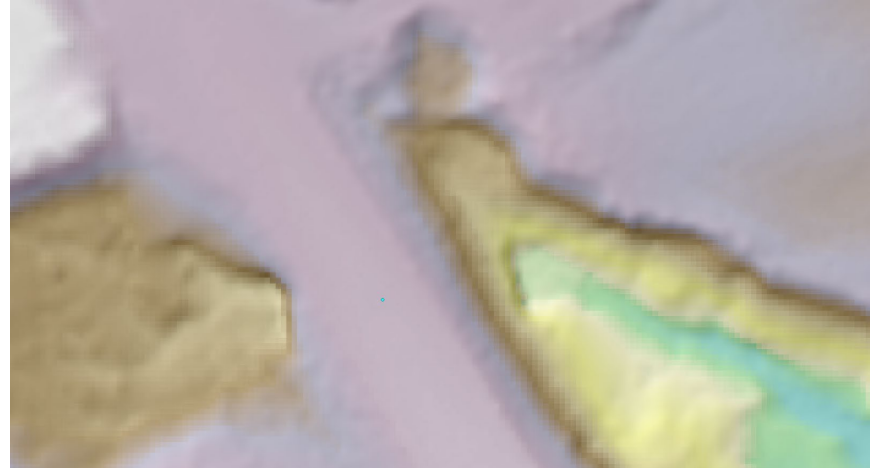
### Crossing 30

| Coordinates | 67.5439559°W, 46.0304338°N | Notes | Ortho shows evidence that the structure is an arch culvert. Baffles would be the easiest approach to help fish passage, if replacement with an open bottom culvert is not viable. |

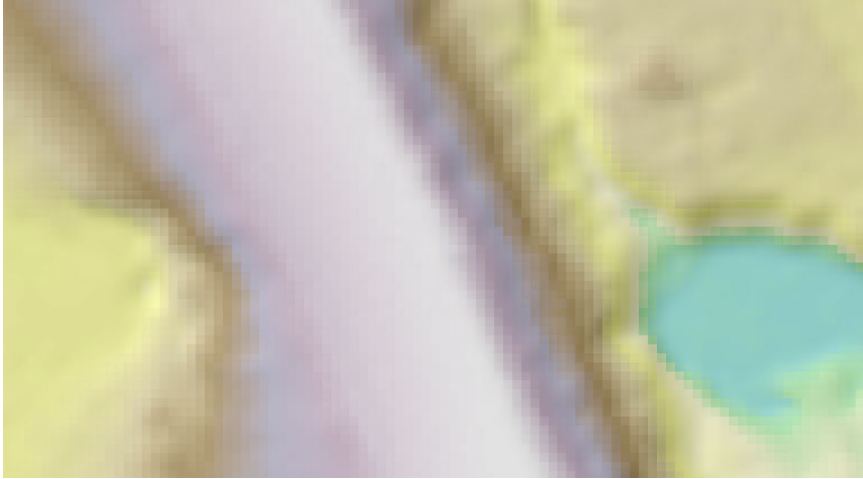
| Crossing 31 | | | |

| Crossing 31 | | | |
|---|---|--|--|
| Coordinates | 67.7264555°W, 46.9731048°N | Notes | Culvert slope exceeds slope threshold. |

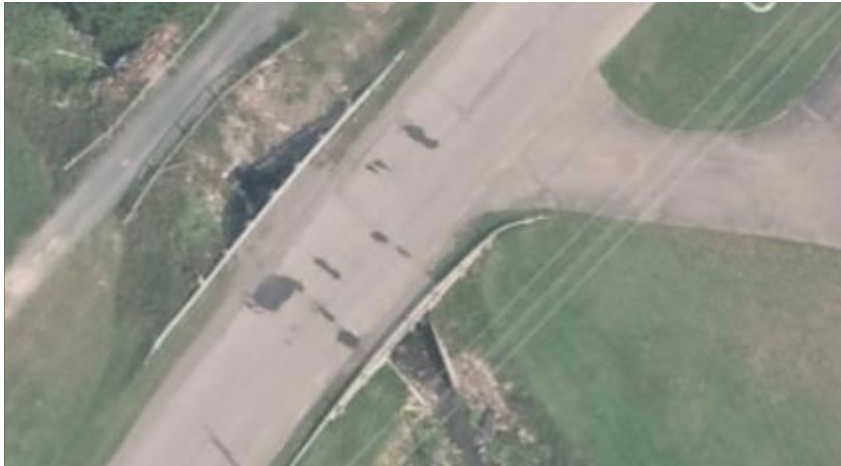
### Crossing 33

| Coordinates | 67.7000302°W, 46.9338908°N | Notes | <p>Bridge culvert slope exceeds slope threshold. Ortho shows minor channel constriction during normal flow periods, high flows could cause increased velocity reducing fish passage. The structure should be widened to accommodate high flows. The slope is too steep where baffles would not be effective so a redesign or full replacement is necessary.</p> <p>Need to remove two barriers: Crossing 32 (located 100m upstream) will need to be remediated as well to restore the upstream kilometers.</p> |

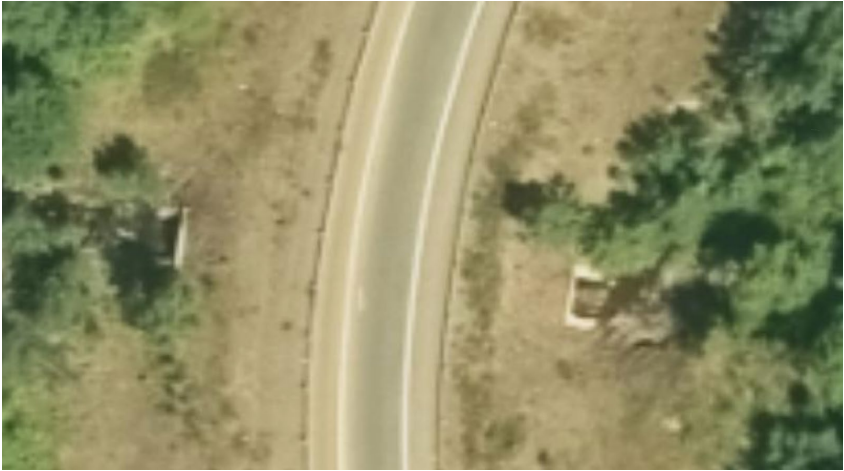
| Crossing 34 | | | |

| Crossing 34 | | | |
|---|---|--|--|
| Coordinates | 66.9303433°W, 45.8564641°N | Notes | Culvert exceeds slope threshold. Baffles could be an option; replacement would be a better option since there is slight channelization that the Ortho shows. |

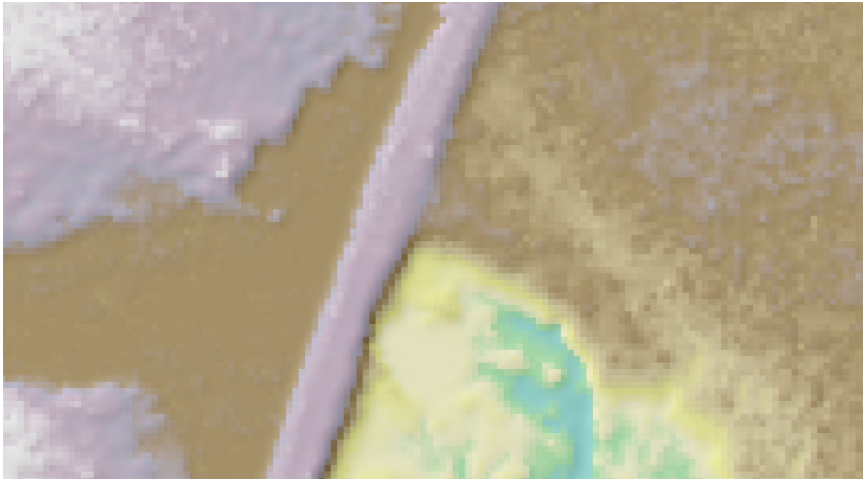
| Crossing 35 | | | |

| Crossing 35 | | | |
|---|---|--|--|
| Coordinates | 66.5960094°W, 45.7370292°N | Notes | Culvert slope exceeds slope threshold. |

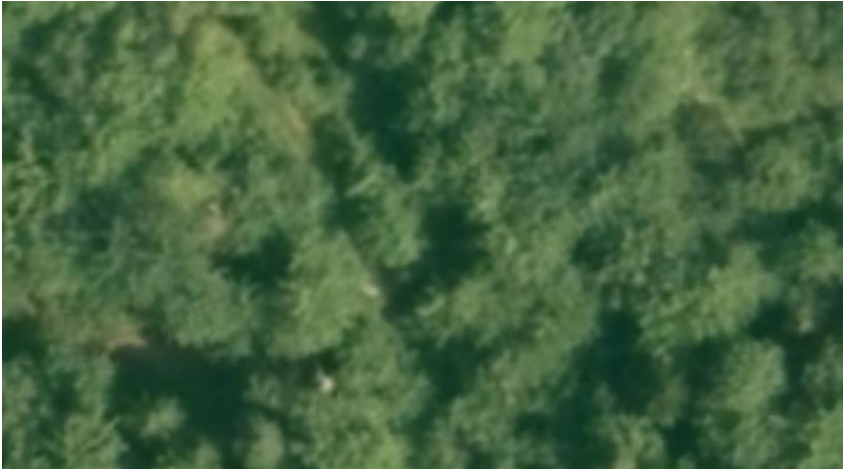
| Crossing 37 | | | |

| Crossing 37 | | | |
|---|---|--|--|
| Coordinates | 66.5071838°W, 45.6349616°N | Notes | The road has degraded; lost over 75% of the width of the road at crossing point. Recommendation is to properly decommission the road, reinforce the embankments and underlying stream bed to create a ford and restore natural flow. |

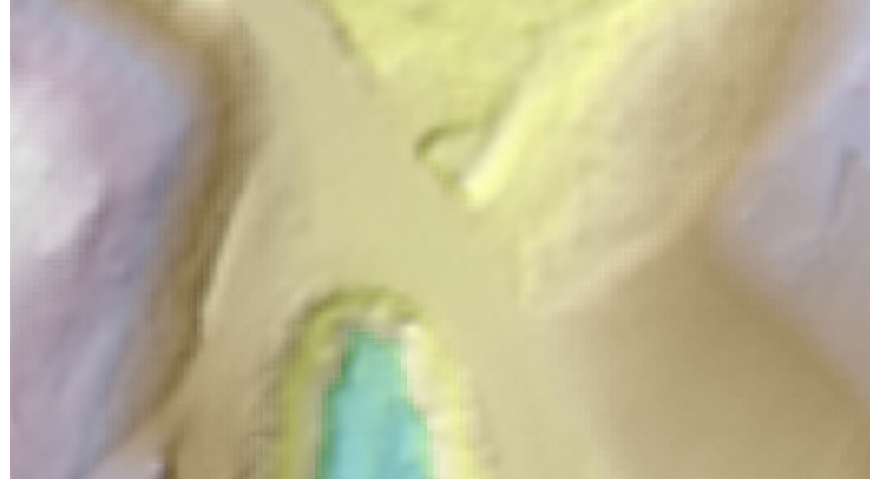
### Crossing 47

| Coordinates | 65.8824408°W, 45.6412808°N | Notes | <p>Culvert slope exceeds slope threshold. Evidence from Ortho and DEM show that it could be a hanging culvert.</p> <p>Need to remove two barriers: Crossing 46 (located 100 m downstream) will need to be remediated as well to restore the upstream kilometers.</p> |

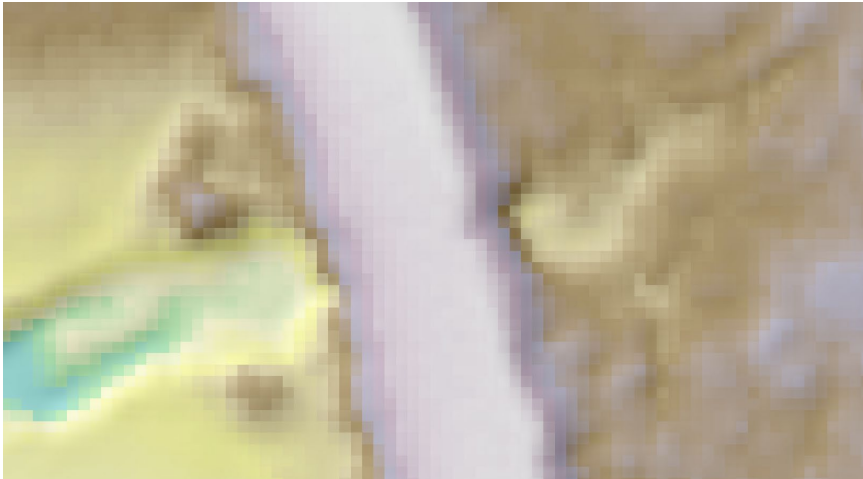
| Crossing 48 | | | |

| Crossing 48 | | | |
|---|---|--|--|
| Coordinates | 65.4904891°W, 45.6501638°N | Notes | Culvert slope exceeds slope threshold. |

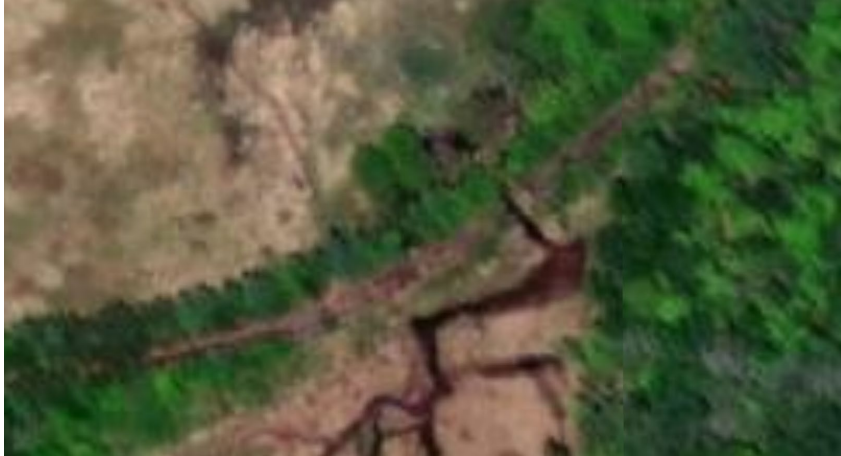
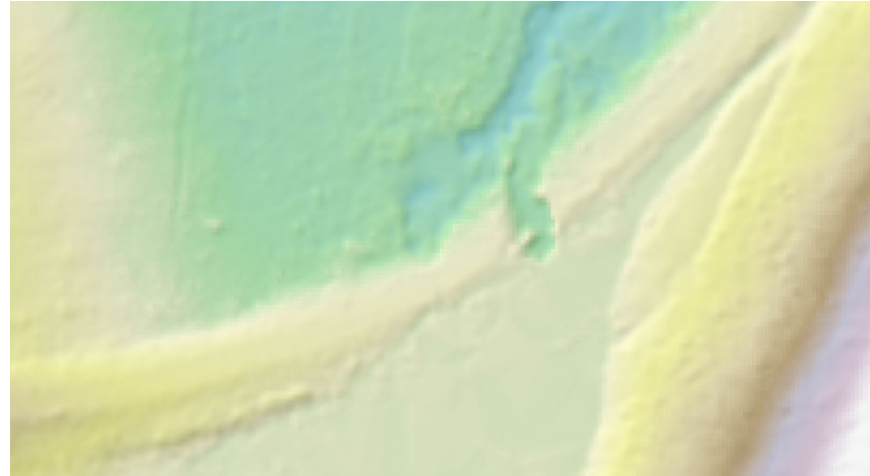
### Crossing 53

| <b>Coordinates</b> | 66.0418888°W, 45.8435568°N | <b>Notes</b> | The main channel of the stream has breached an unmaintained forest road and created a ford. Without remediation through bank reinforcement, erosion will continue and could cause increased sedimentation and creating embankments downstream which could create further barriers. |

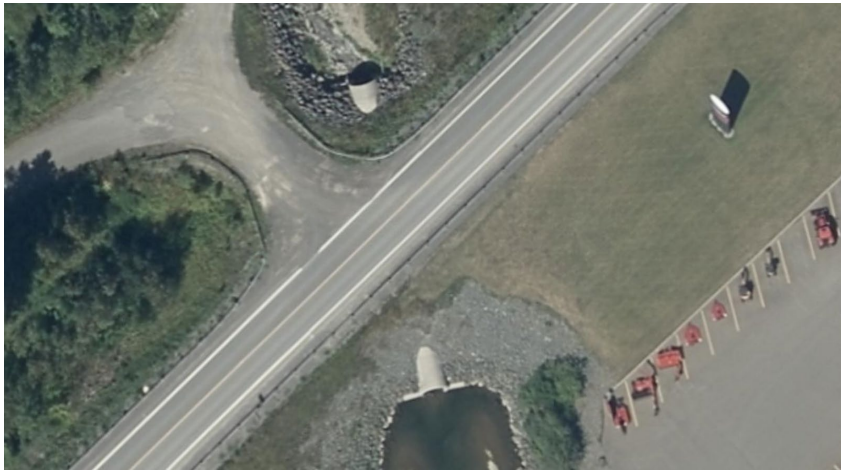
### Crossing 54

| Coordinates | 67.9473784°W, 46.4668055°N | Notes | Culvert slope exceeds slope threshold. Significant channelization (75%) to the point where concrete wings were installed to prevent scouring. No modifications should be made to the culvert, because of numerous design problems. It should be replaced with an open bottom culvert where flow will not be impeded in any flow event. |

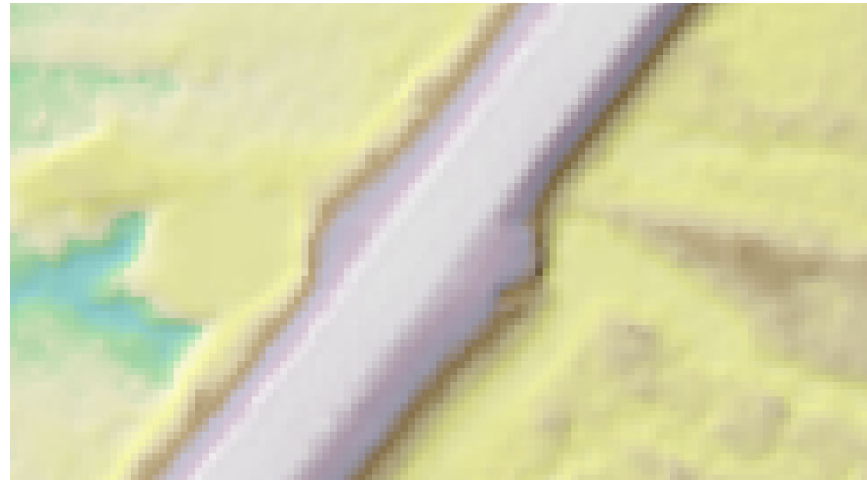
### Crossing 69

| Coordinates | 67.0276874°W, 47.3153825°N | Notes | Significant pooling on the upstream side of the culvert, indicating water is slow moving and not channelized. 20 meters downstream either fresh beaver or logging activity that has allowed a large pool to form. More channelization is needed on the upstream side and for the downstream side to be free of structures to allow fish passage |

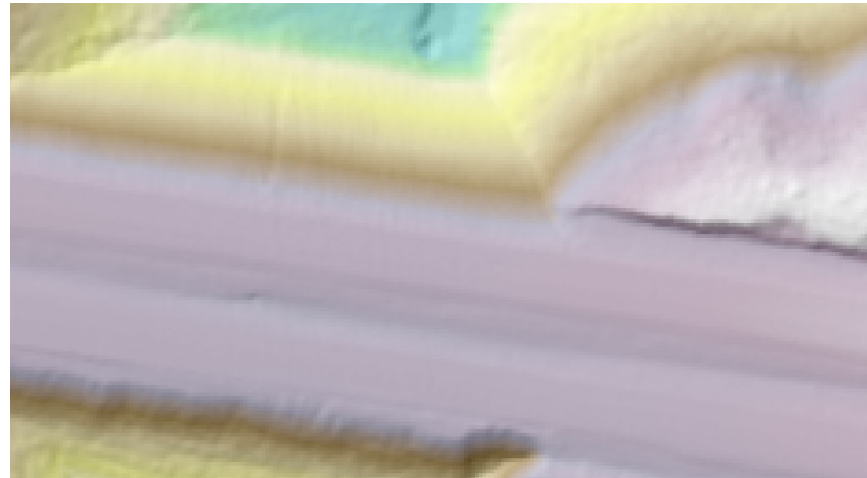
## Crossing 70

| <b>Coordinates</b> | 67.6436100°W, 46.159610°N | <b>Notes</b> | While culvert slope does not exceed the 4% threshold for strong swimming fish, the length of the culvert at a 2.5% slope could pose a problem for burst swimmers. Additionally, this would be a barrier for any non-trout species that could inhabit the area. Due to the culvert being below 20 meters of road embankment, modifying the existing structure would be most viable. From LiDAR and Ortho measurements, the diameter (taken from the outside shell of the culvert) is roughly 4 m. This could provide enough space to place baffles and resting pools within the culvert, given the water level can be high enough. Another concern is that the stream is being restricted by about 50% on the lead up to the culvert causing further increases in velocity which would make it even more unlikely to pass weaker swimmers. |

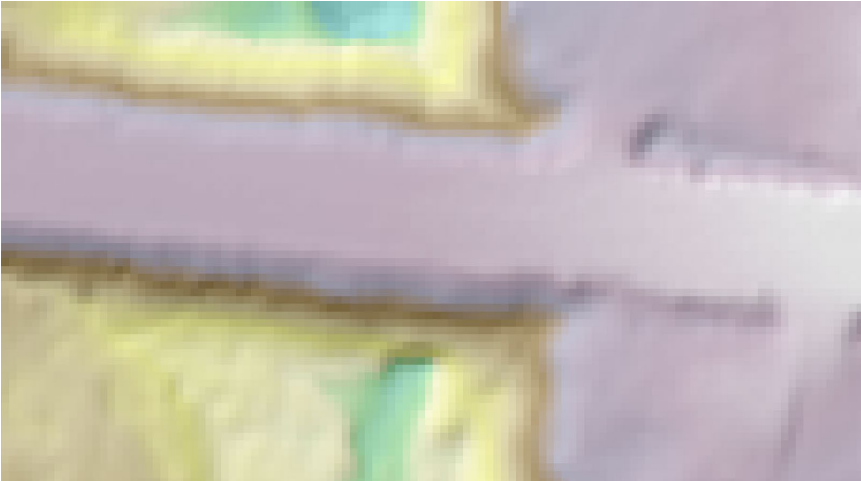
| Crossing 71 | | | |

| Crossing 71 | | | |
|---|---|--|--|
| Coordinates | 66.7800439°W, 45.9674094°N | Notes | Culvert slope exceeds slope threshold. |

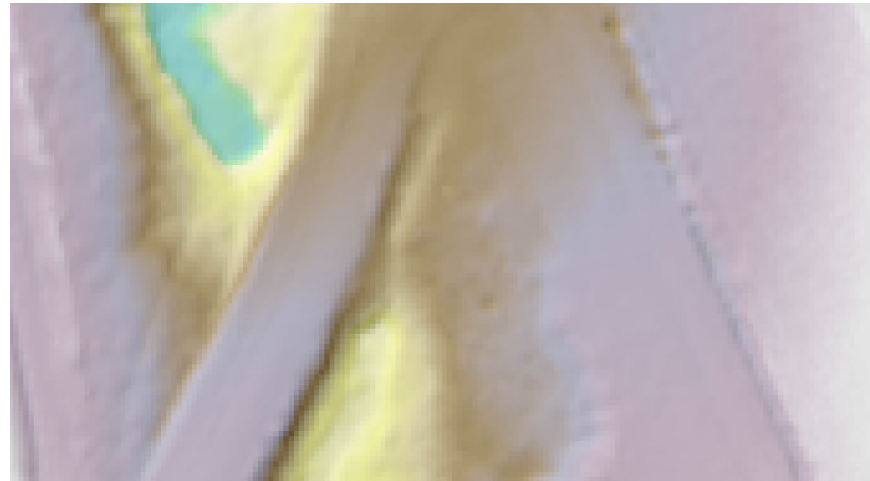
## Crossing 72

| <b>Coordinates</b> | 66.6188212°W, 45.9238103°N | <b>Notes</b> | Culvert slope exceeds slope threshold. |

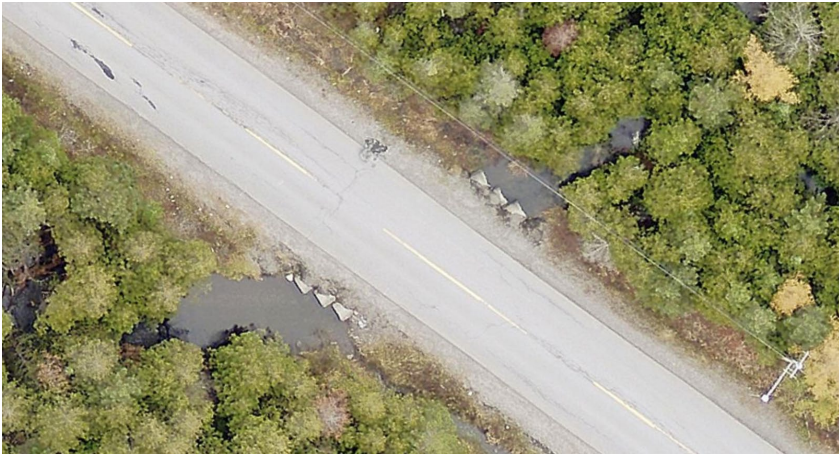
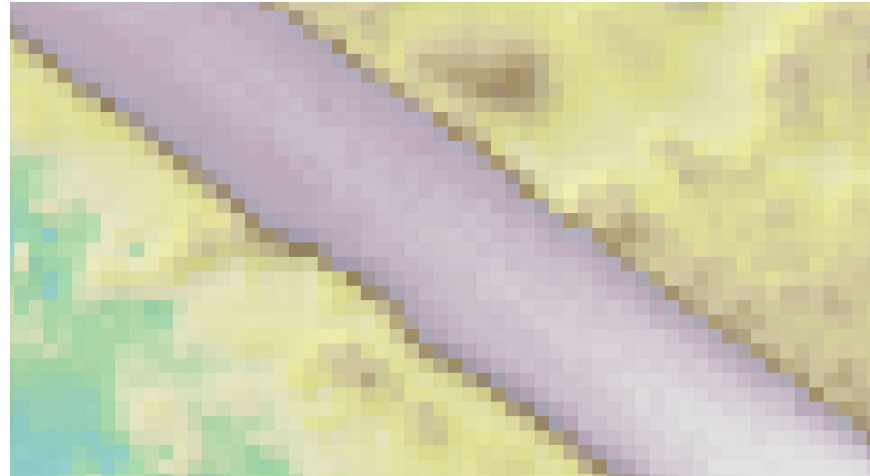
## Crossing 75

| <b>Coordinates</b> | 65.9294419°W, 45.3216751°N | <b>Notes</b> | <p>While the culvert is passable based on slope, the design of using a triple culvert is questionable. Standard practice would not space culverts that close together. By having culverts so closely spaced, the soil between them is not compact and is prone to scouring and will lead to a culvert failure. By splitting the flow between the three structures, the water level could be dramatically reduced. During Summer seasons, depending on the depth of the water, could be unpassable. A better design that would allow year-round passage is to use an open bottom arch culvert that would allow natural flow under the road embankment.</p> |

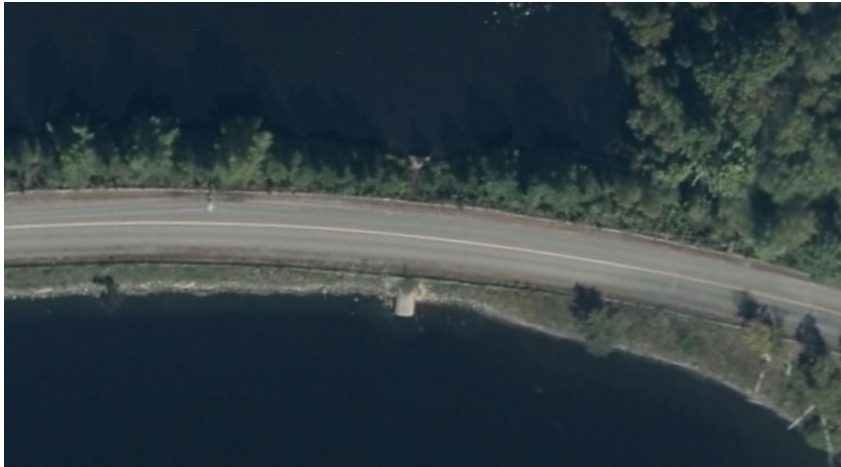
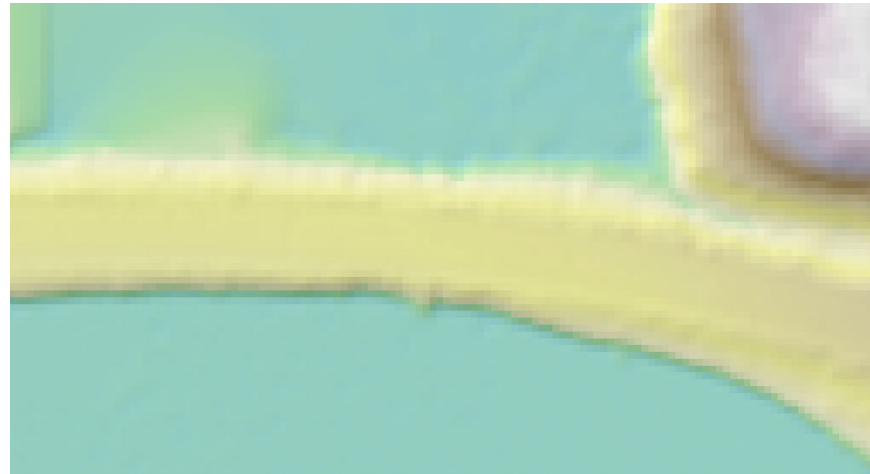
## Crossing 76

| <b>Coordinates</b> | 67.4493717°W, 45.9994730°N | <b>Notes</b> | While the culvert is passable, a single 3-m diameter culvert off the main stem of the river will result in a failure or the velocity of the water being too great due to the sheer volume from upstream. A bridge culvert would allow more upstream volume to flow into the main stem and help regulate flooding. |

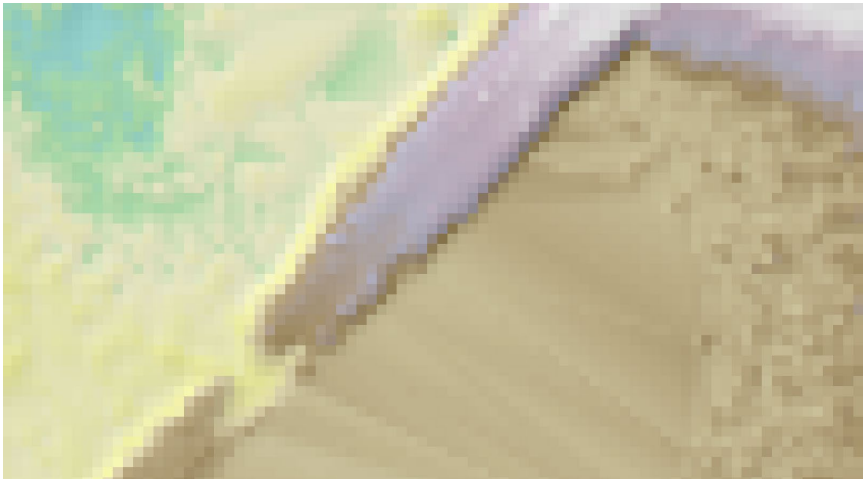
| Crossing 77 | | | |

| Crossing 77 | | | |
|---|---|--|--|
| Coordinates | 66.7293031°W, 45.5532472°N | Notes | Culvert slope exceeds slope threshold. |

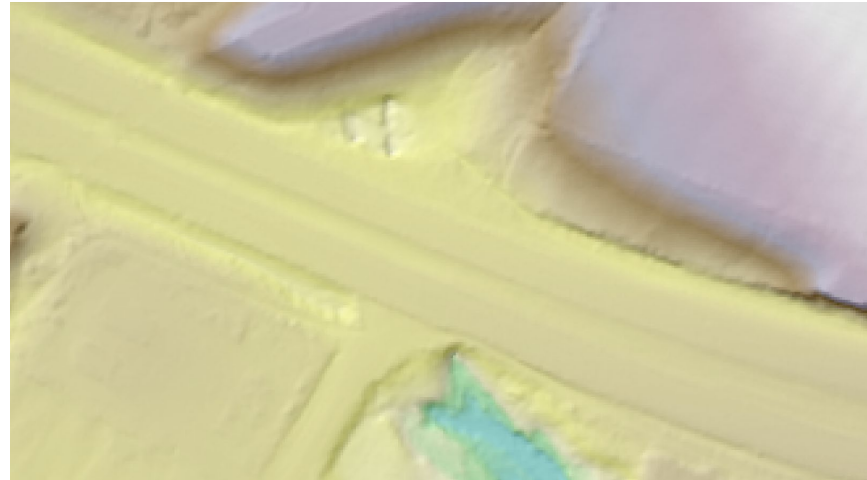
## Crossing 80

| <b>Coordinates</b> | 68.2529868°W, 47.3628336°N | <b>Notes</b> | <p>Culvert slope exceeds slope threshold. The downstream side has too many boulders where there is no unimpeded flow to the actual downstream end.</p> <p>1 km upstream (Crossing 81 or 82) need to be removed to restore upstream habitat.</p> |

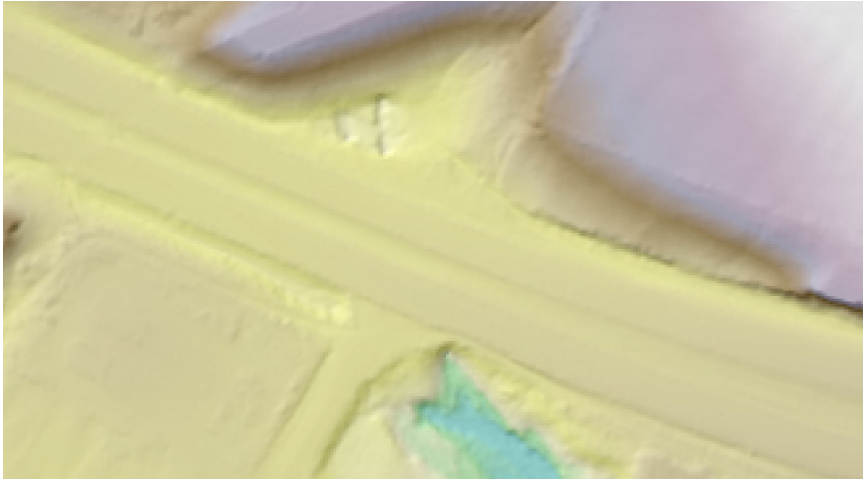
| Crossing 81 | | | |

| Crossing 81 | | | |
|---|---|--|--|
| Coordinates | 68.2529868°W, 47.3628336°N | Notes | <p>Culvert slope exceeds slope threshold.</p> <p>1 km upstream (Crossing 80 or 82) need to be removed to restore upstream habitat.</p> |

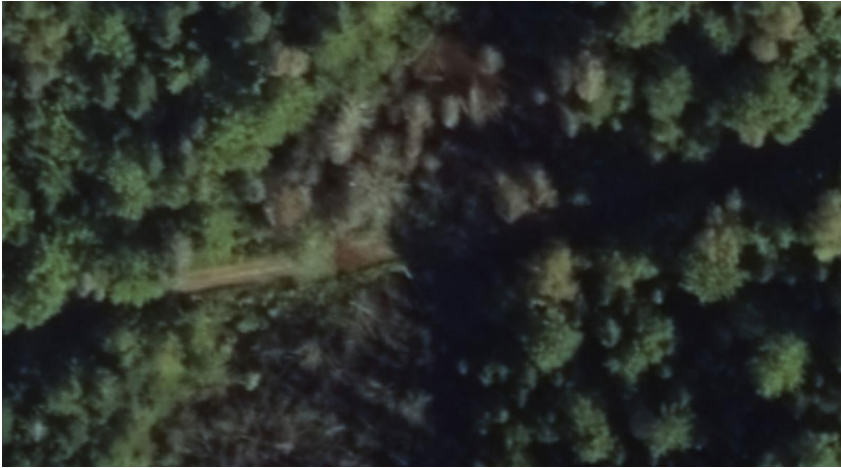
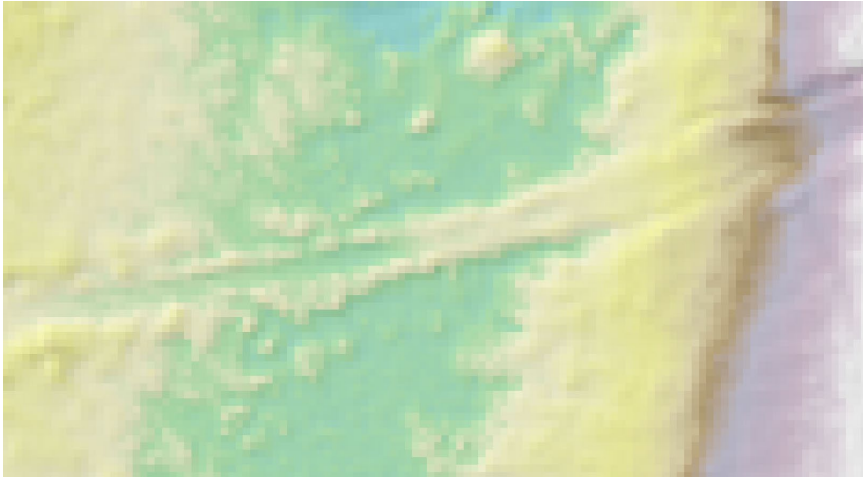
| Crossing 88 | | | |

| Crossing 88 | | | |
|---|---|--|--|
| Coordinates | 65.7132069°W, 45.9583234°N | Notes | <p>Old forest road that was not maintained or decommissioned. Multiple breaches across the road embankment, with no clear main channel. The road should be breached and install a ford to prevent further road failure which could further restrict upstream access.</p> |

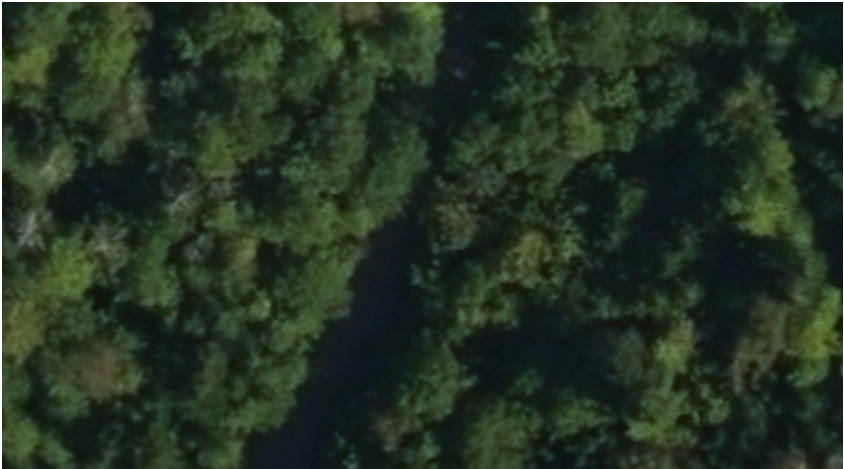
| Crossing 97 | | | |

| Crossing 97 | | | |
|---|---|--|--|
| Coordinates | 65.6916103°W, 45.7032218°N | Notes | Culvert slope exceeds slope threshold. High slope threshold would indicate a failed road embankment. |
