# **SALMON HABITAT CONSERVATION**

## **SOUTH BROOK, NEWFOUNDLAND AND LABRADOR**

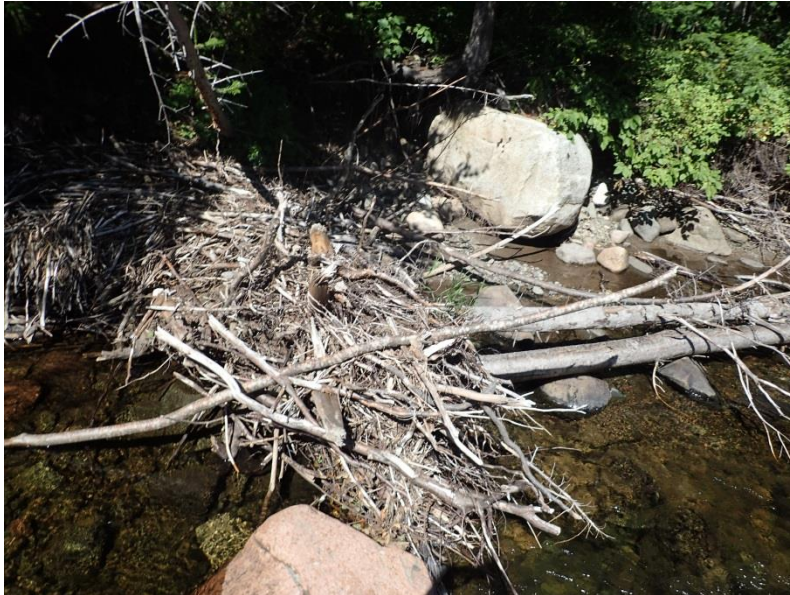
South Brook is approximately 17km in length from its outlet in Deer Lake to its head waters. With 19 tributaries, creating a watershed size of approximately 60km<sup>2</sup>, obstructions on South Brook, particularly the lower limits, can limit access to significant upstream habitats.

Obstructions can be caused by a buildup of detritus, created by local fauna, or be anthropogenic structures such as collapsed culverts. The entire length of South Brook was surveyed by foot. Nine obstructions were identified along South Brook. None were anthropogenic structures.

The severity of the obstruction was classified as either a full obstruction, or partial obstruction. Full obstructions were classified based both on their width and their height. A full obstruction was documented as any blockage which extended 80% of the stream width, and was found at a height greater than 15cm above water level. All other obstructions found within the waterway were classified as partial obstructions as fish passage would not be completely impeded.

All major stakeholders need to agree on an approach to opening up fish passage without detrimentally impacting habitat of other species. The underlying cause of some of the obstructions (erosion) should be proactively addressed.

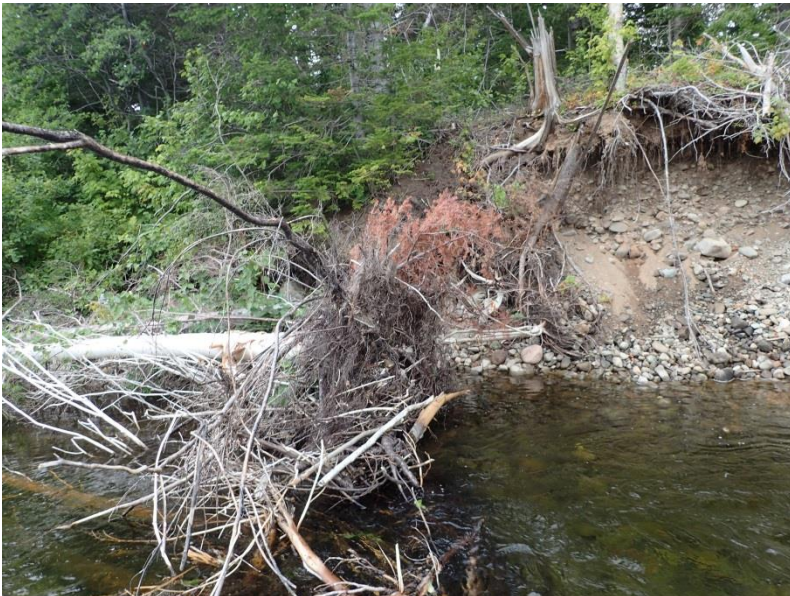
Areas of substantial erosion have been documented on South Brook. As stream banks erode siltation increases, interfering with recreational fish species. Silt fills small spaces between stream bed rocks decreasing nesting areas. Without adequate nesting areas fish eggs become unprotected sources of prey.

As stream bank erodes vegetation is lost. Overhanging vegetation creates a canopy over the water providing shade, cooling and regulating water temperatures. Overhanging branches and grasses also provide a food source for aquatic insects, which in turn become a food source for recreational fish. The root systems for this vegetation also aid in the prevention of erosion along stream banks, holding the soil together within root networks.

Areas where erosion is taking place should be remediated using natural means.

Areas where there is high potential for erosion should be proactively reinforced.
