Inverness South Anglers Association

Mull River Habitat Restoration Plan

Assessment of instream habitat and recommendations for Atlantic Salmon
Recovery

MacInnis Natural Resource Services Inc.
12/1/2020

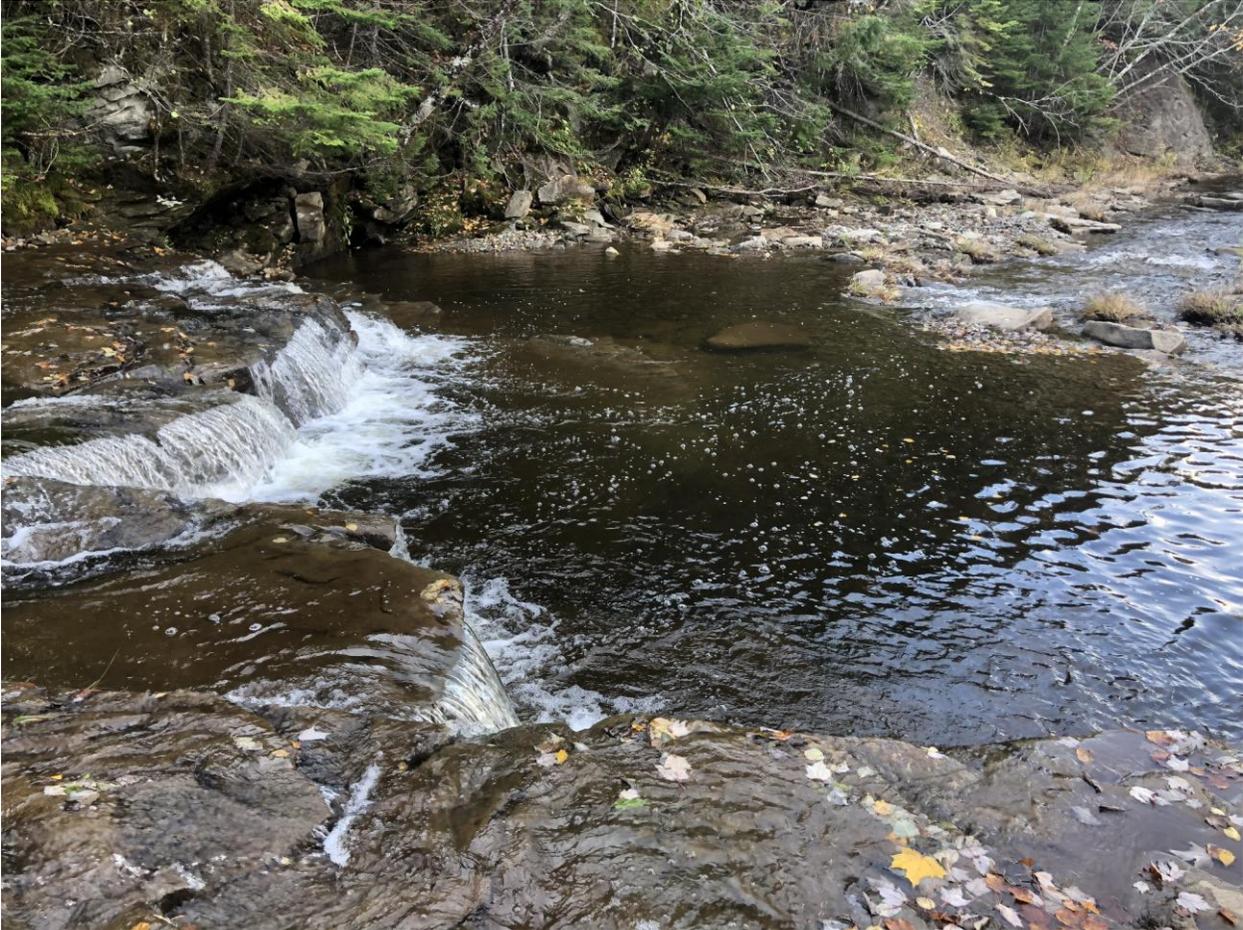
Figure 12: Bedrock outcropping at the bottom of a re-aligned channel in reach #1.

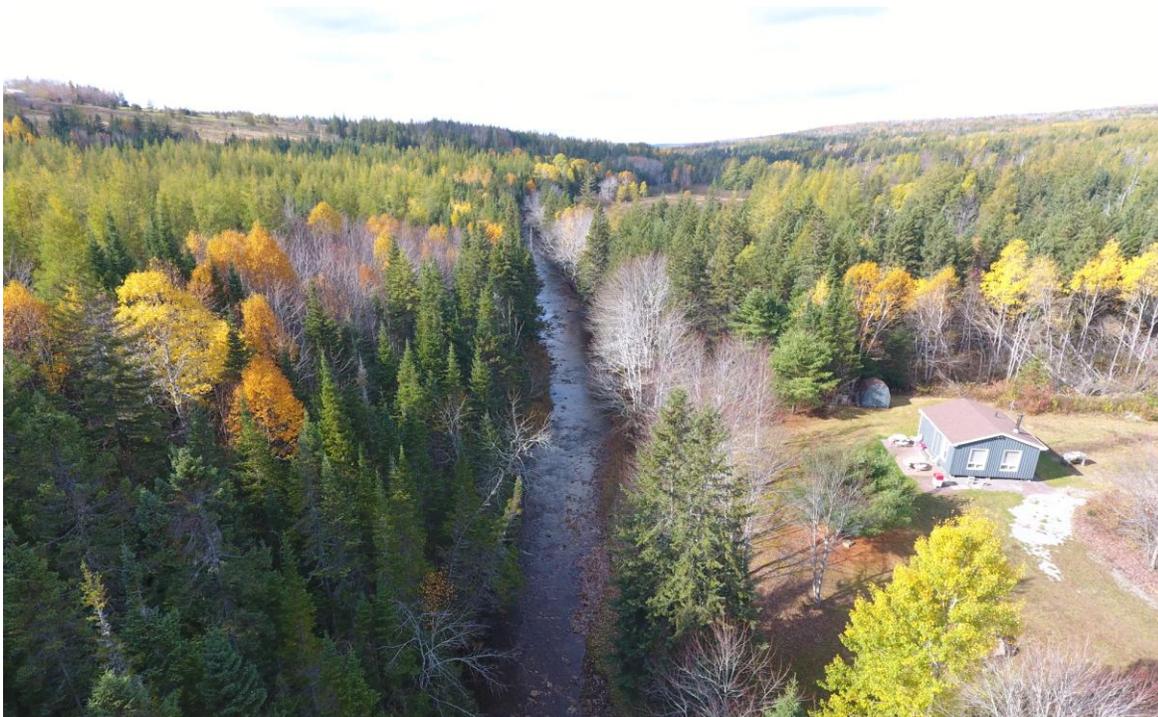
Figure 14: Looking downstream from the bedrock outcropping. The dwelling that has encroached on the flood plain is visible on right side of the photo.

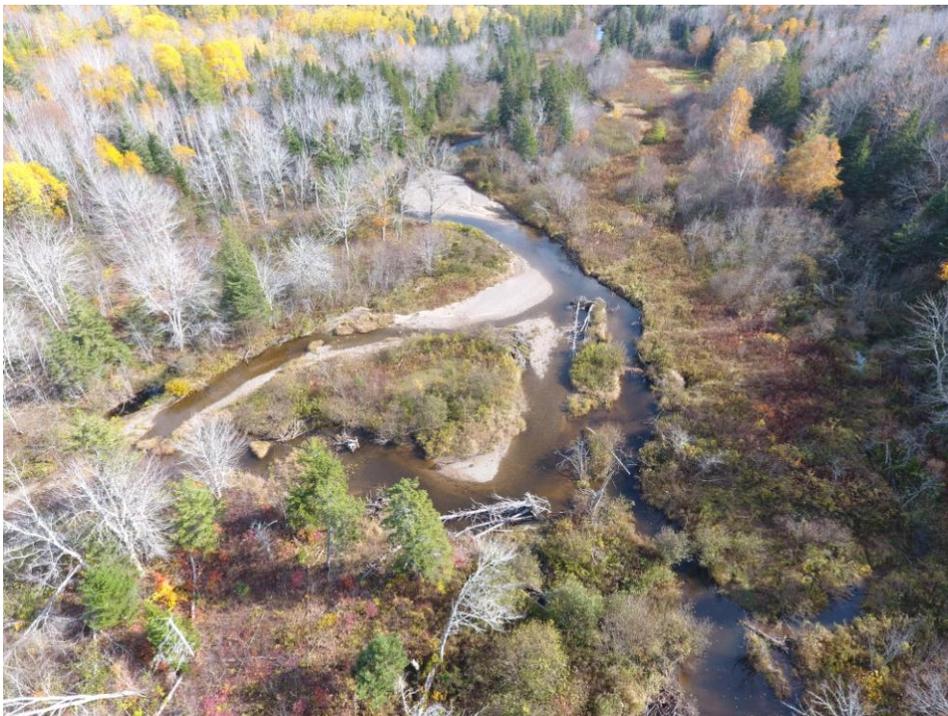
Figure 20: Aerial photo of debris complex and multi-thread channel development.

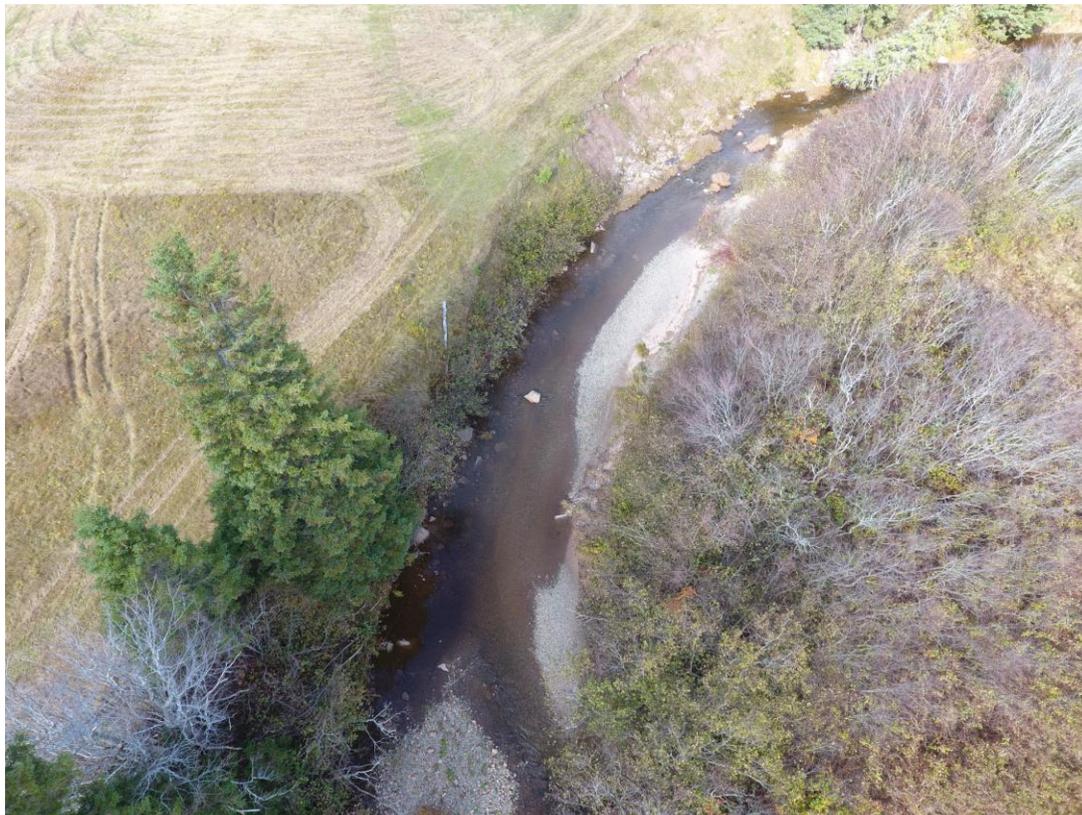
Figure 23: Bank erosion issues on the left. Restoration work should include tree planting and bank stabilization.

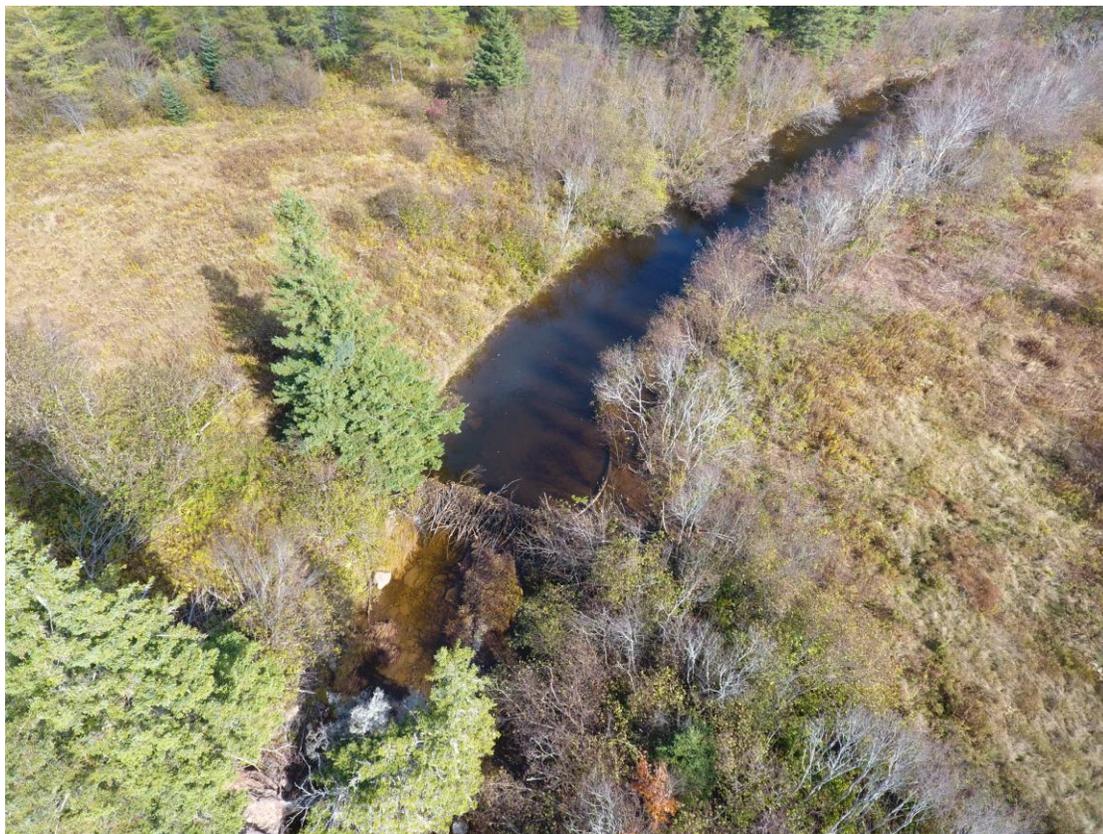
Figure 24: Beaver dam in headwaters reach #2

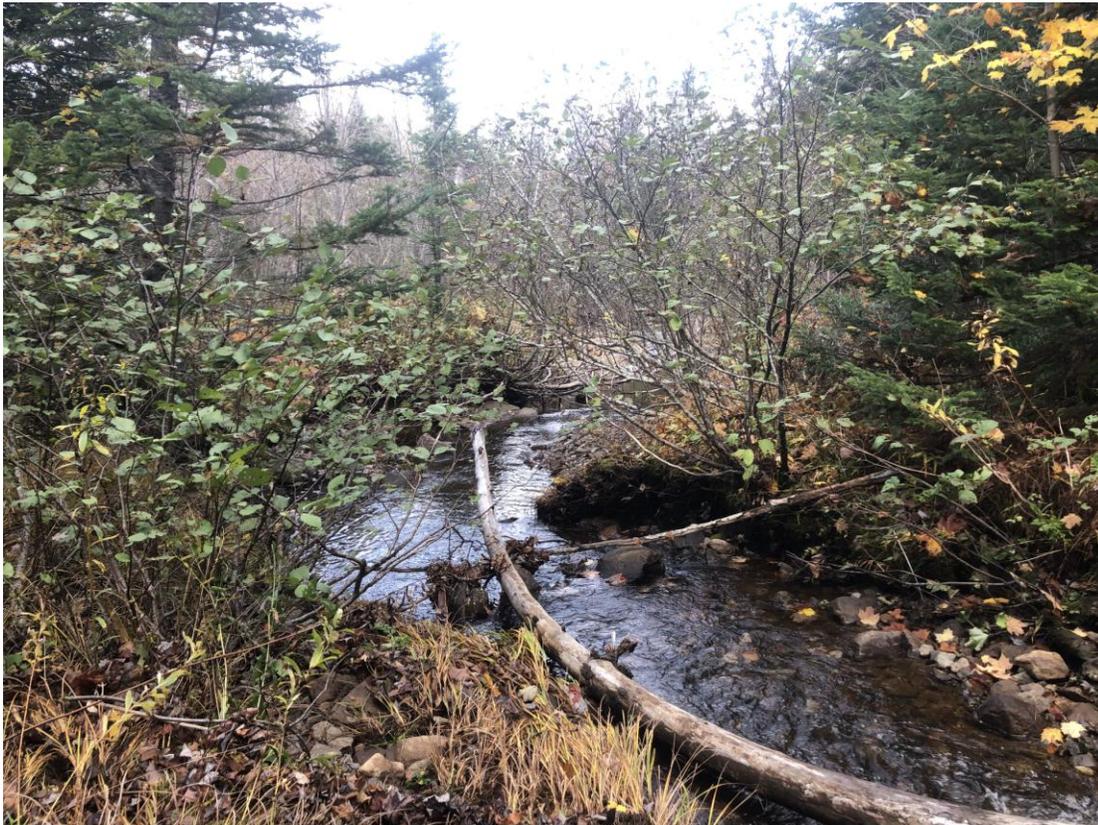
Figure 32: Downstream of the barrier culvert in reach 5. Brook trout and salmon parr were observed during site visit in October 2020.

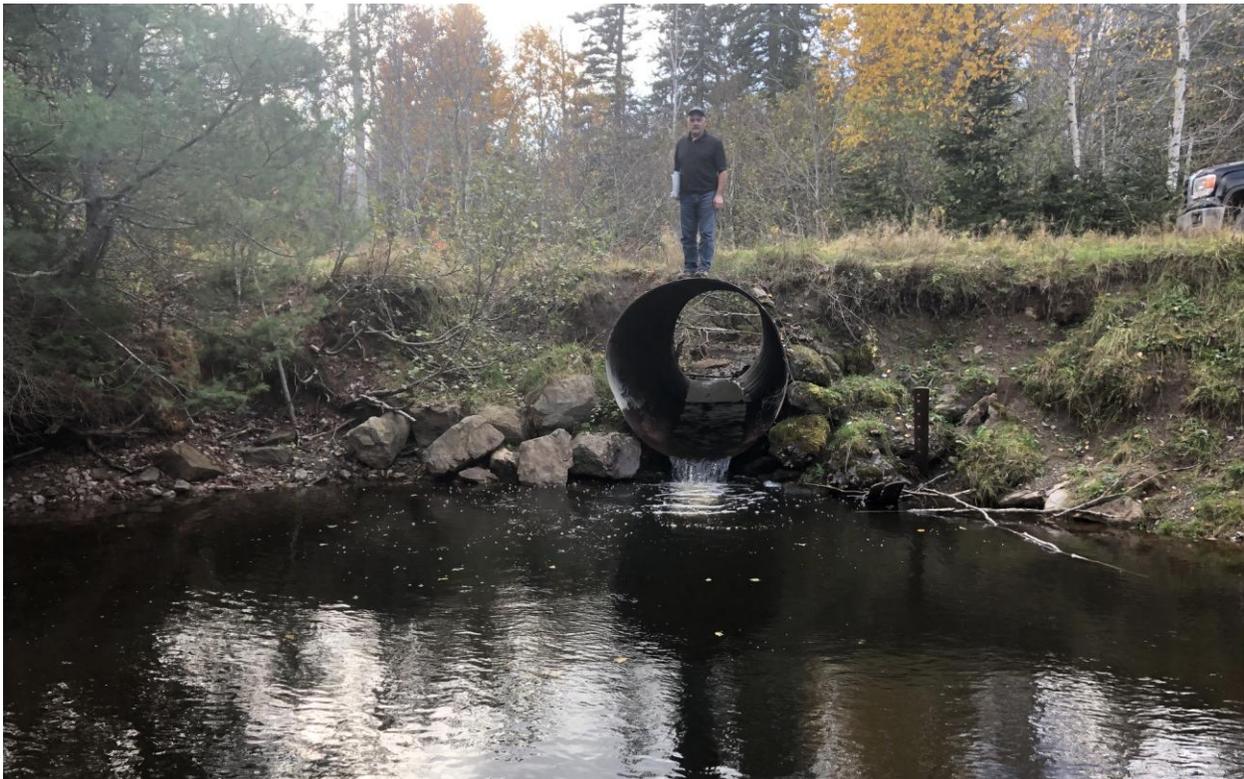
Figure 34: Barrier culvert on MacKinnon Rd on reach 5 ($61^{\circ}18'16''\text{W}$, $45^{\circ}57'12.9''\text{N}$).

Habitat fragmentation issues were observed throughout the headwater section of the Mull River, with three barrier culverts identified on MacKinnon Road. The owners (Department of Transportation) of these structures should be notified immediately that issues of fish passage exist and that remediation work will begin next year by surveying each culvert to determine remediation options. Desktop surveys of logging roads indicates that privately owned culverts may also be causing barriers to upstream migration of fish. These potential issues will require surveys in 2021. Overall the ISAA has both the experience and the reputation within the community required to implement this large-scale restoration project. Funding for this project will likely include government grants, habitat offsetting credits and private donations.

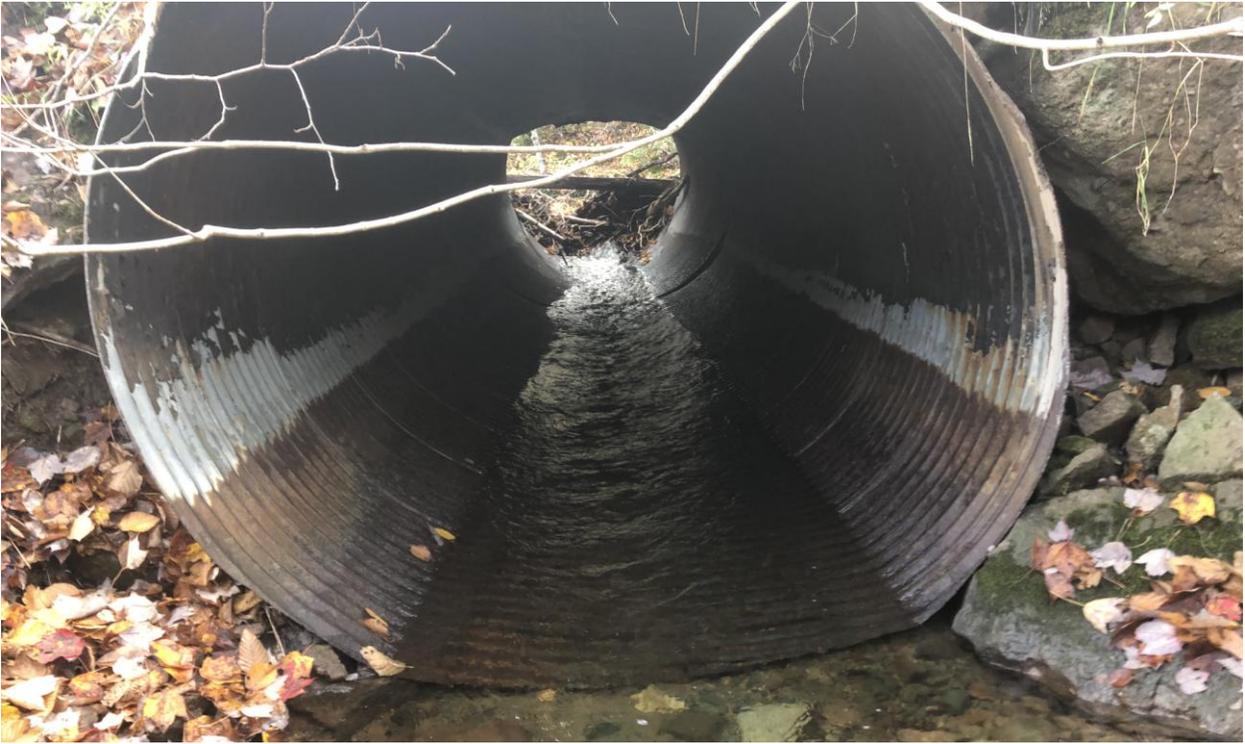
Figure 35: Partial-to-complete fish passage barrier on reach 6 MacKinnon Rd crossing ($61^{\circ}17'38.2''\text{W}$, $45^{\circ}56'60''\text{N}$).

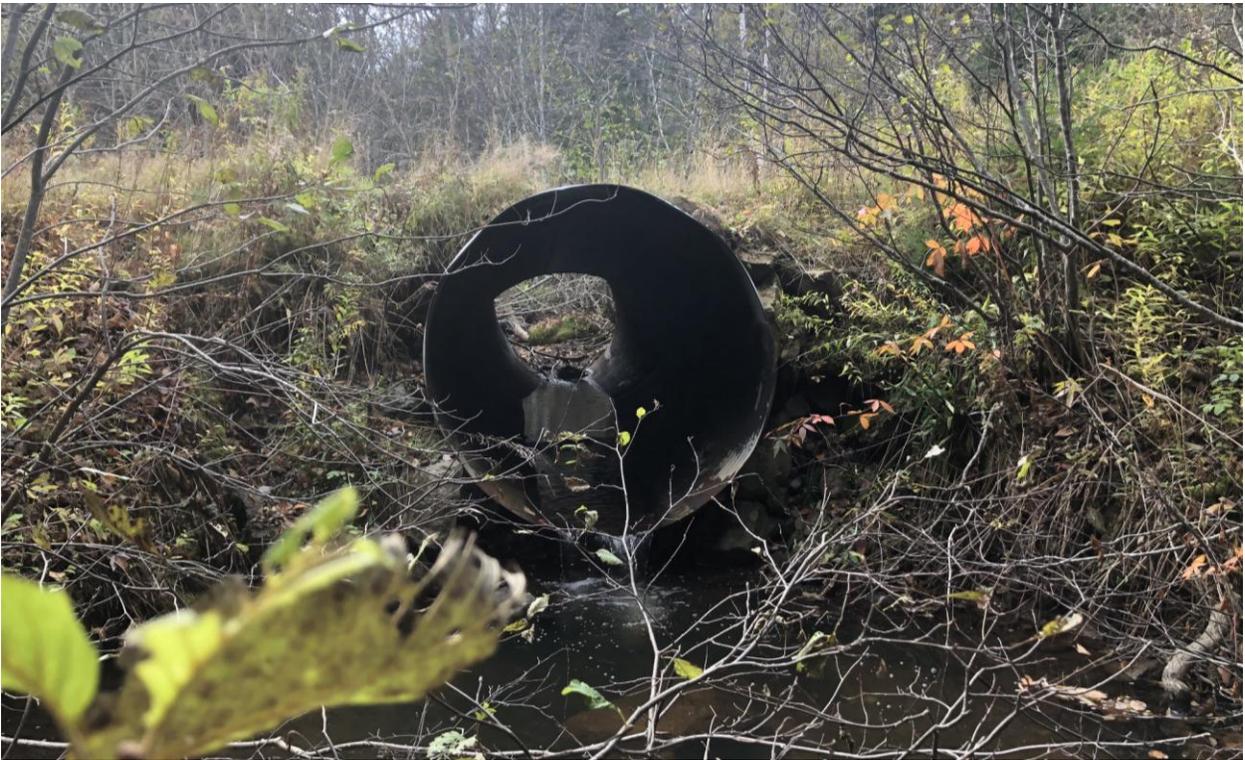
Figure 36: Complete barrier to fish passage on north branch of reach 6 - MacKinnons Rd ($61^{\circ}17'33.3''\text{W}$, $45^{\circ}57'3.4''\text{N}$).

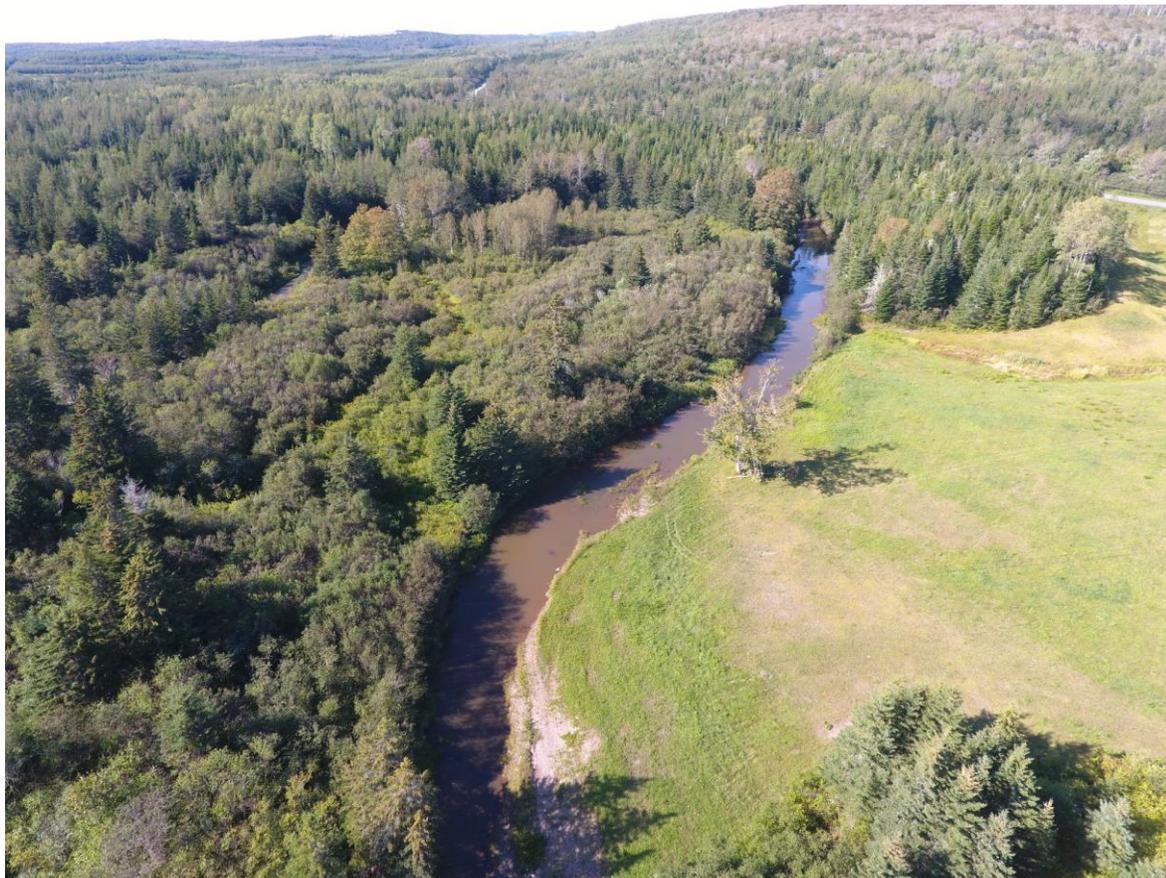
Figure 55: Looking upstream on reach #5 of the upper section. The right-side of the stream should be planted.

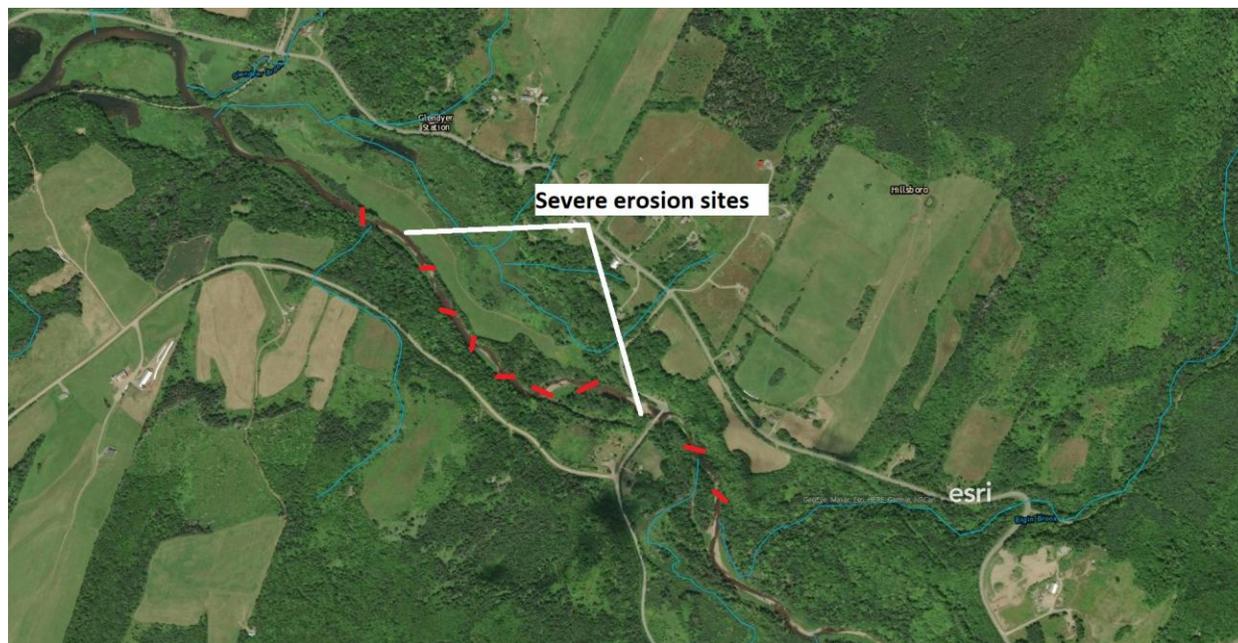
Figure 73: Approximate layout of structures. Bank stabilization work will be required to address erosion issues.

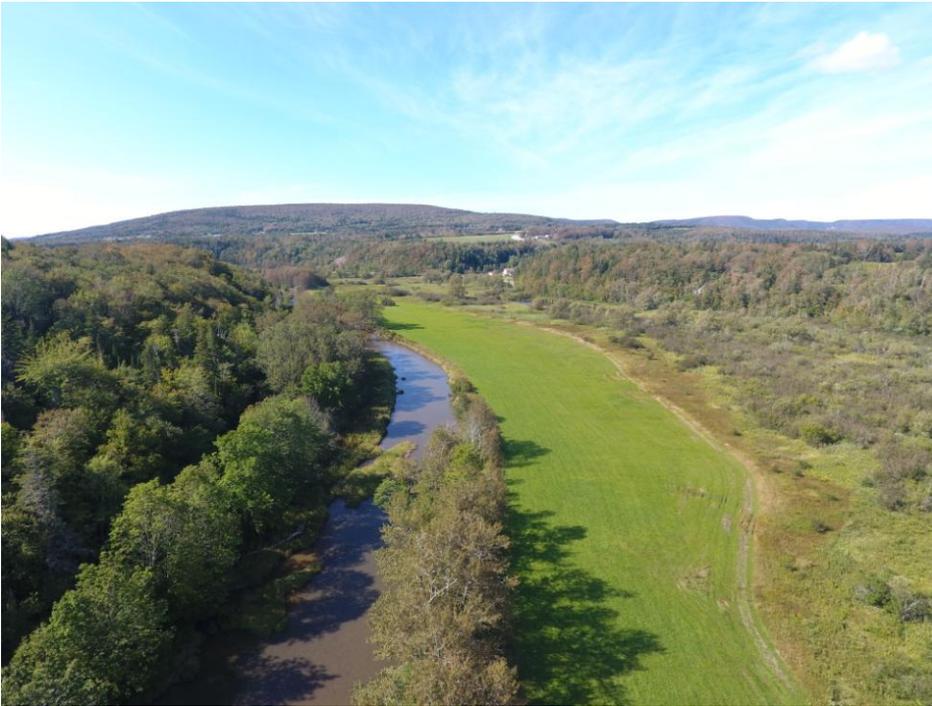
Figure 76: Erosion site at the lower extent of reach #3 of the lower section of the Mull River. Bank stabilization and tree planting are recommended here.
