**DEVELOP HABITAT CONSERVATION PLANS AND RESTORATION FOR RIVERS IN  
BAY ST. GEORGE 2019**

**CRABBES RIVER  
ROBINSONS RIVER**

**BAY ST. GEORGE SOUTH AREA DEVELOPMENT ASSOCIATION**

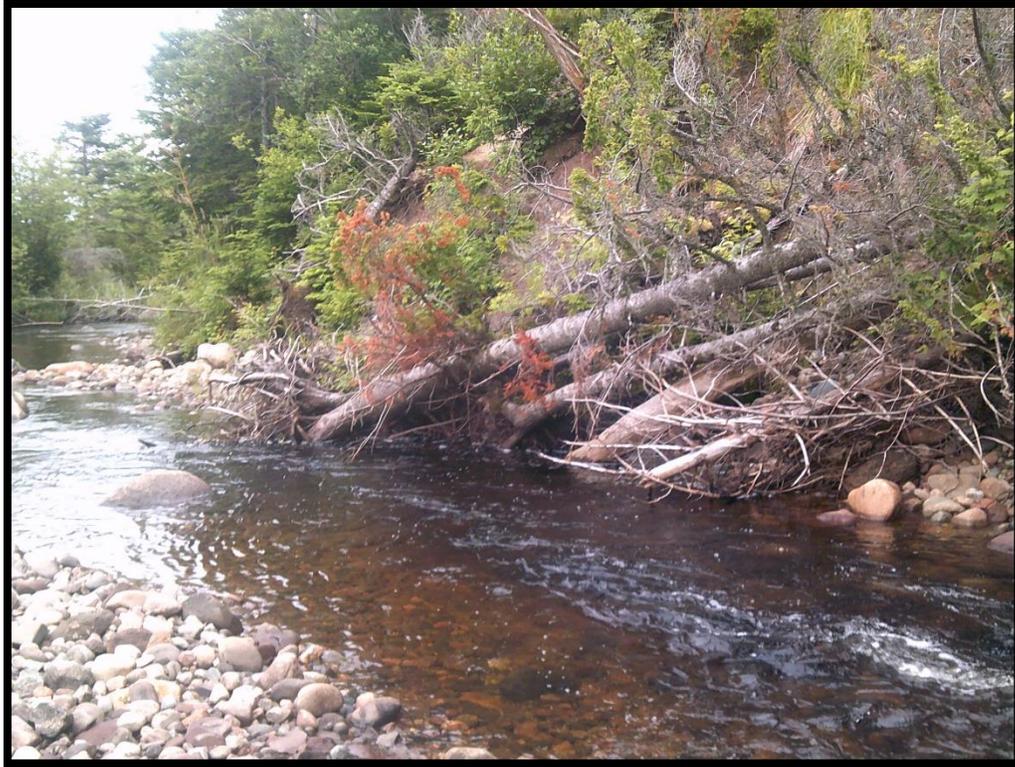
*Figure 2: Downstream view of obstruction 1, Little Crabbes.*

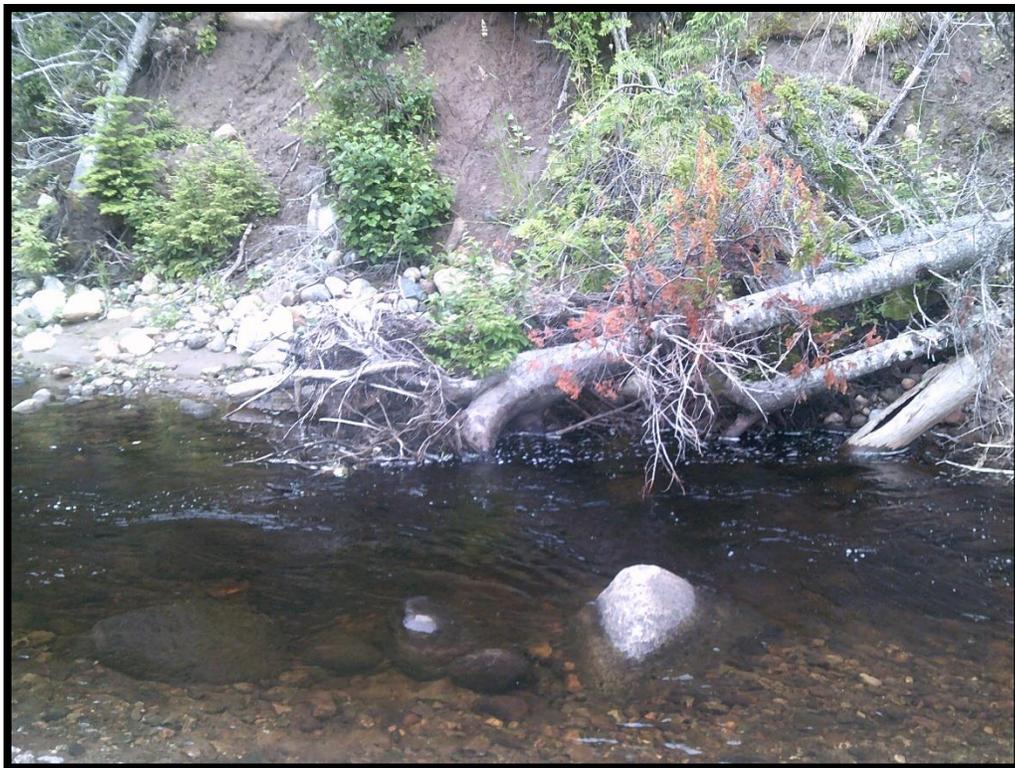
*Figure 3: Side view of obstruction 1, Little Crabbes.*

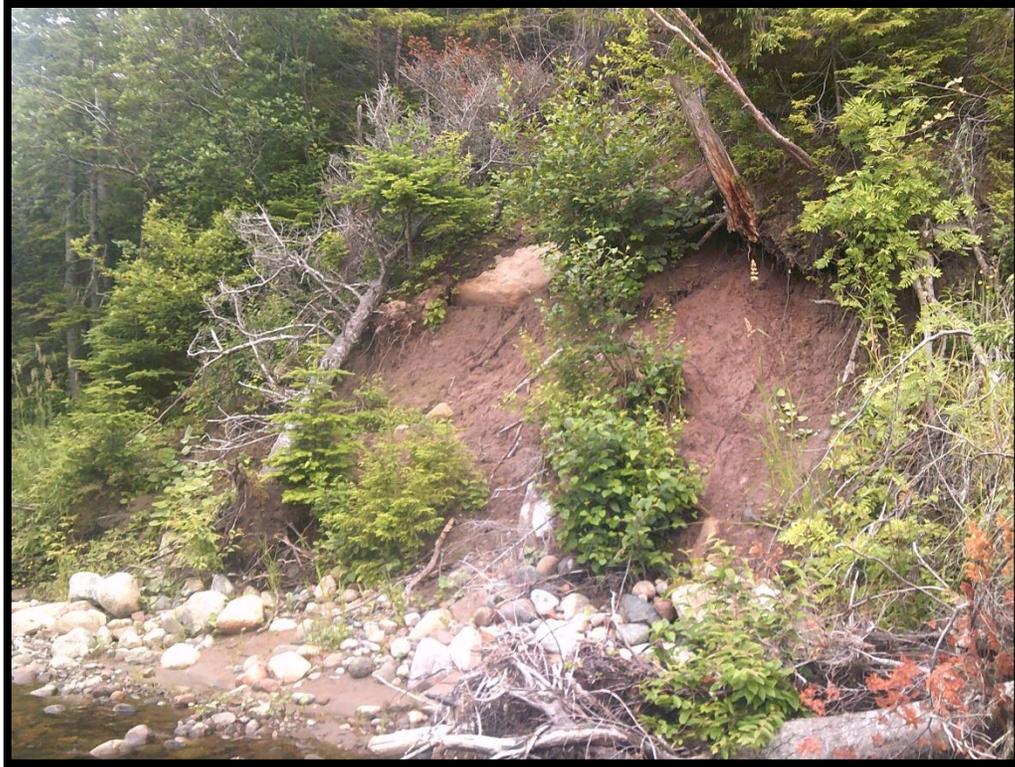
*Figure 4: Bank erosion causing obstruction 1, Little Crabbes.*

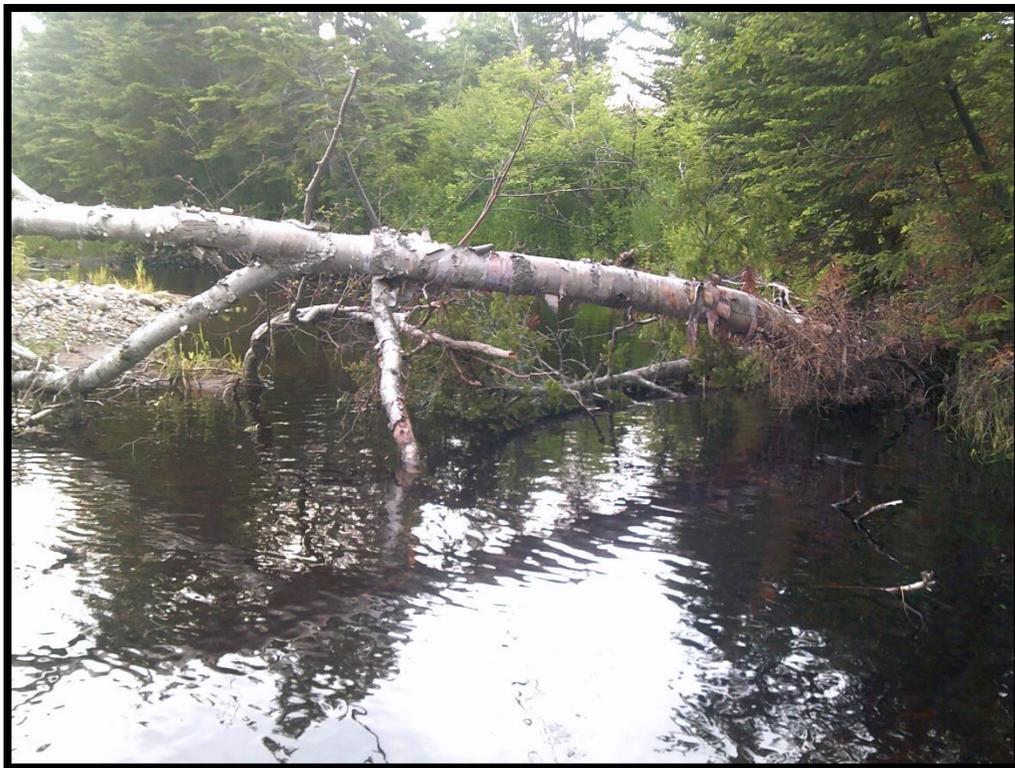
*Figure 5: Upstream view of obstruction 2, Little Crabbes.*

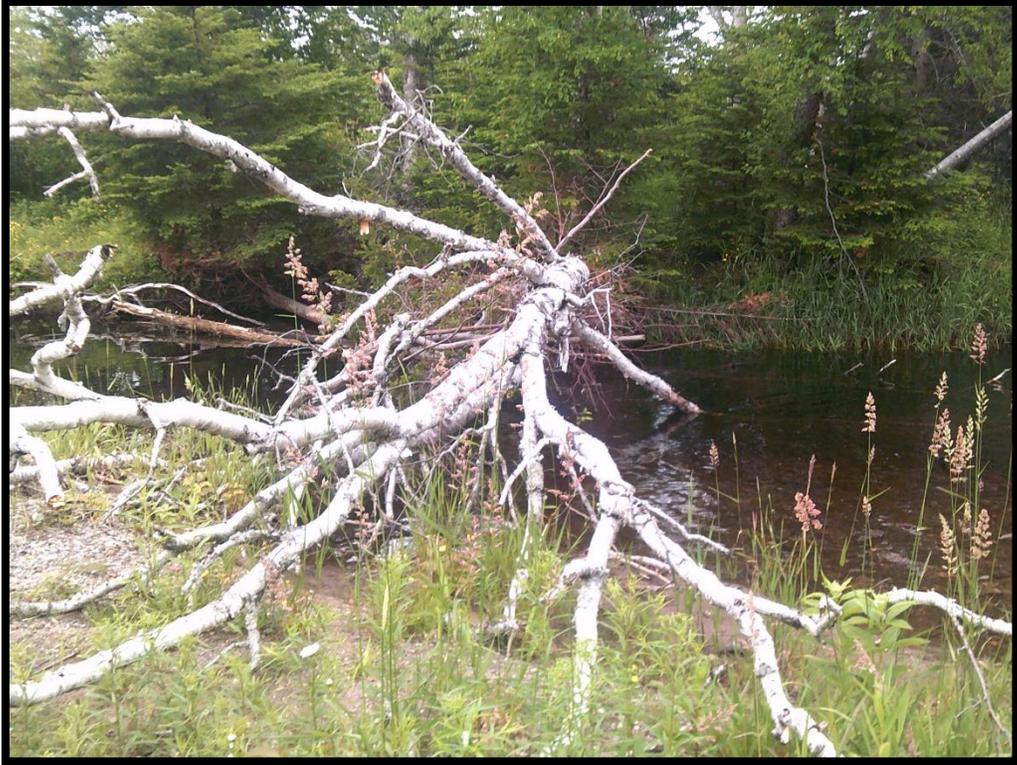
*Figure 6: Side view of obstruction 2, Little Crabbes.*

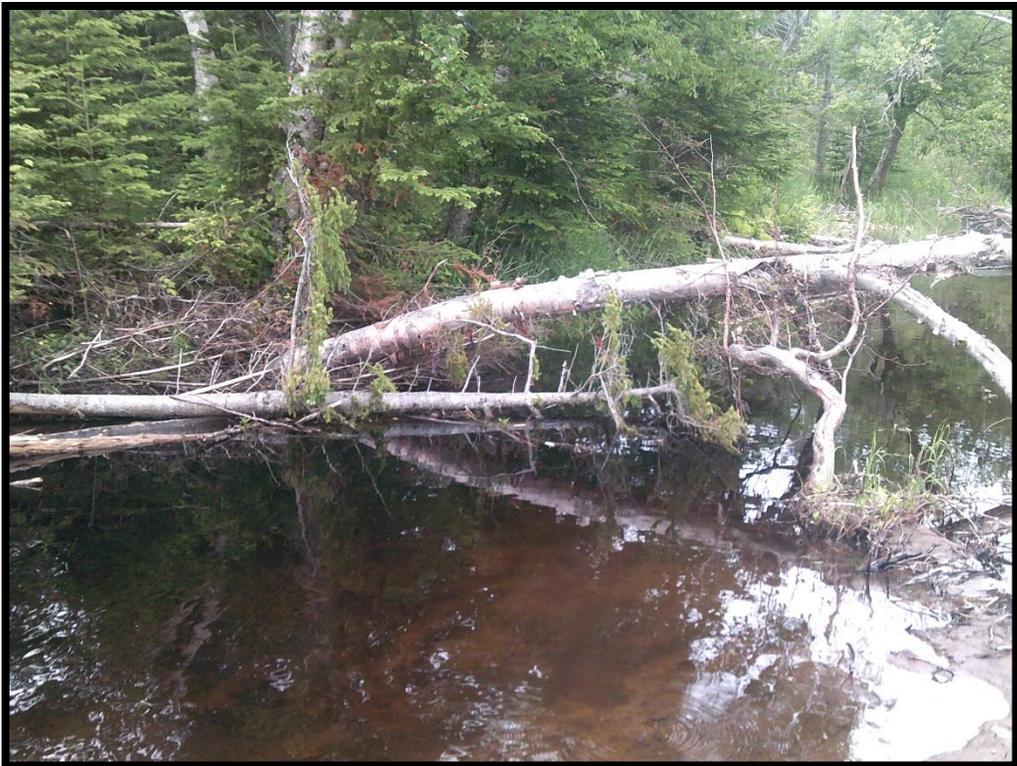
*Figure 7: Downstream view of obstruction 2, Little Crabbes.*

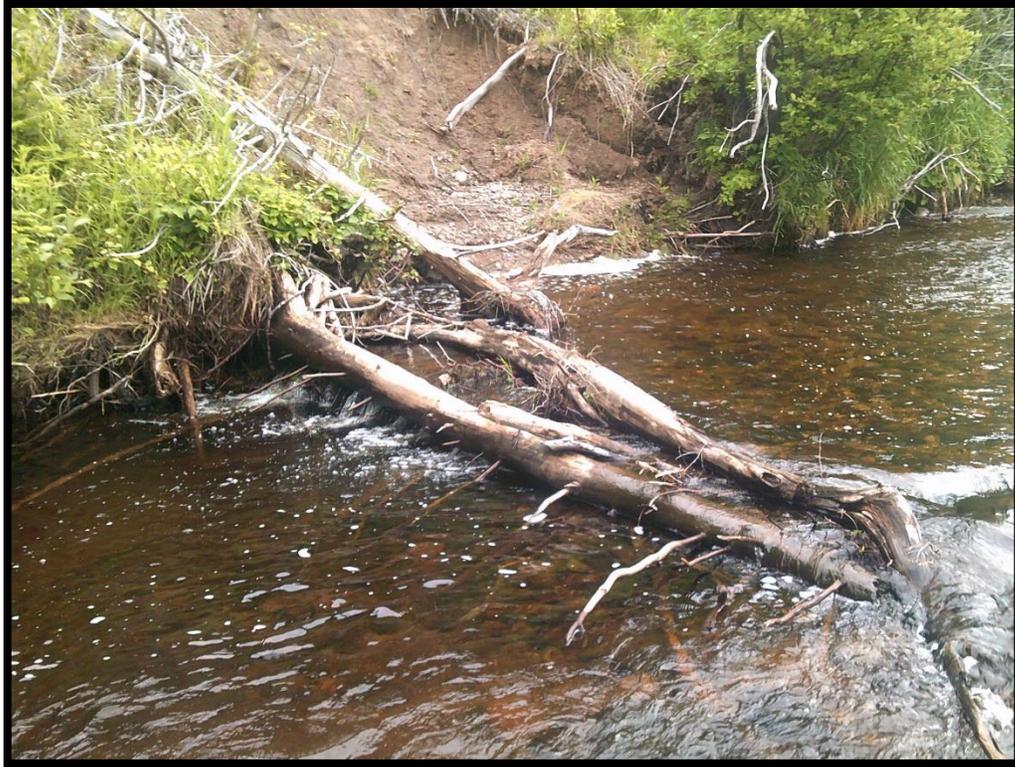
*Figure 8: Looking upstream at obstruction 3, Little Crabbes.*

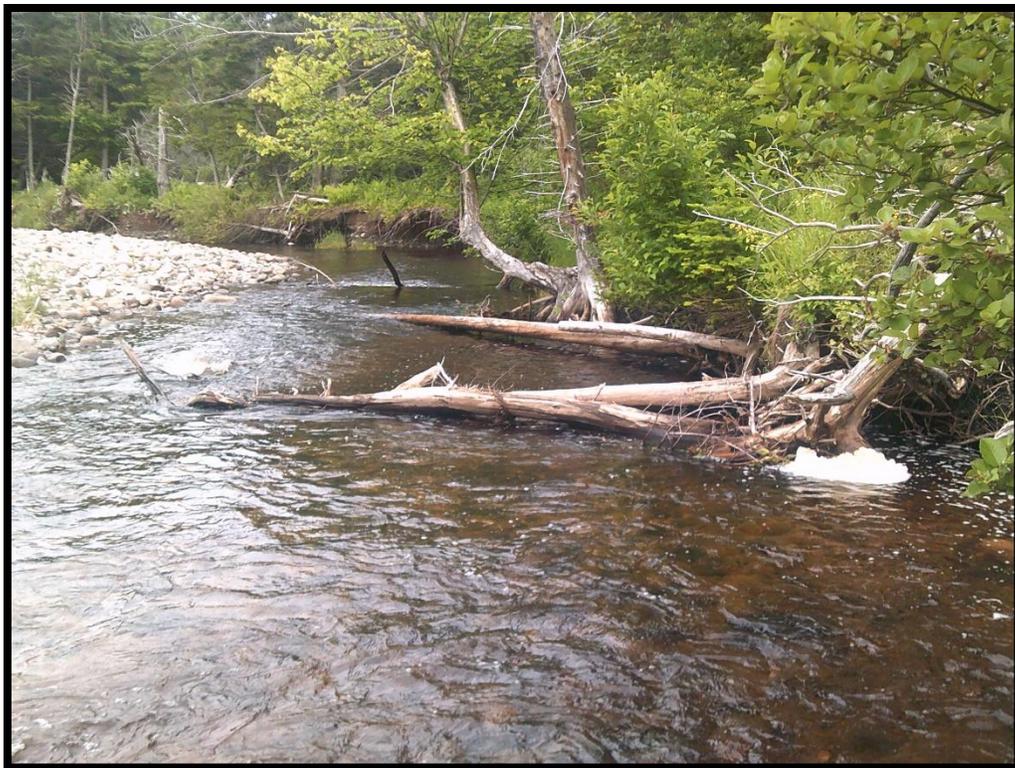
*Figure 9: Downstream view of obstruction 3, Little Crabbes.*

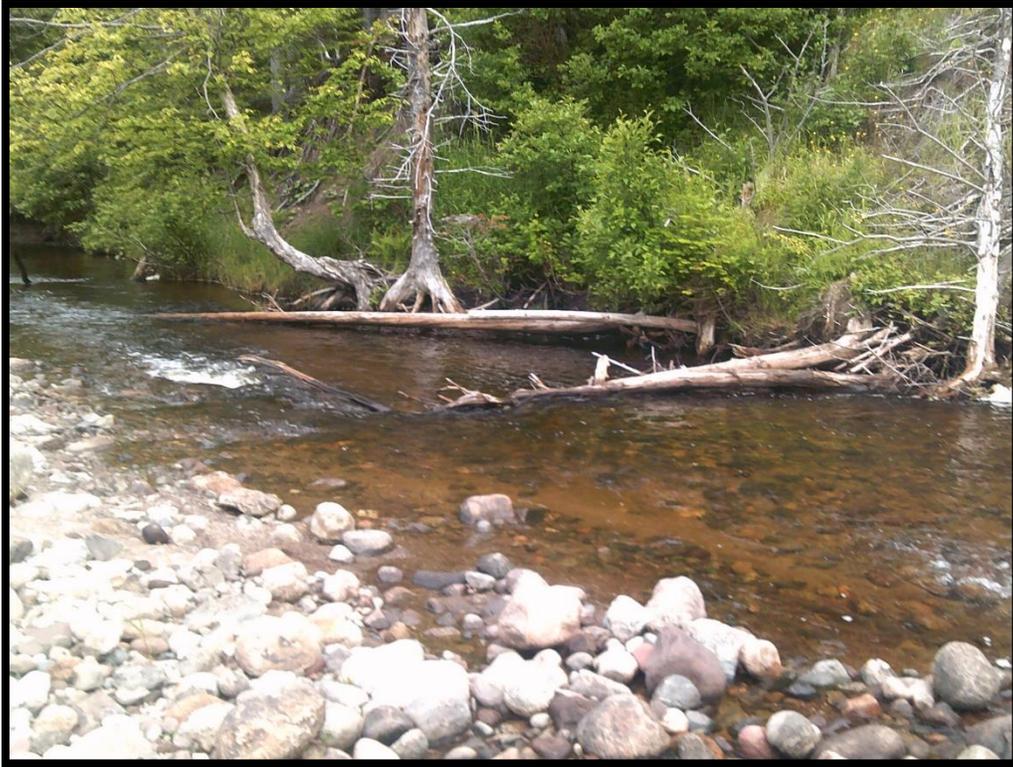
*Figure 10: Sideview of obstruction 3, Little Crabbes.*

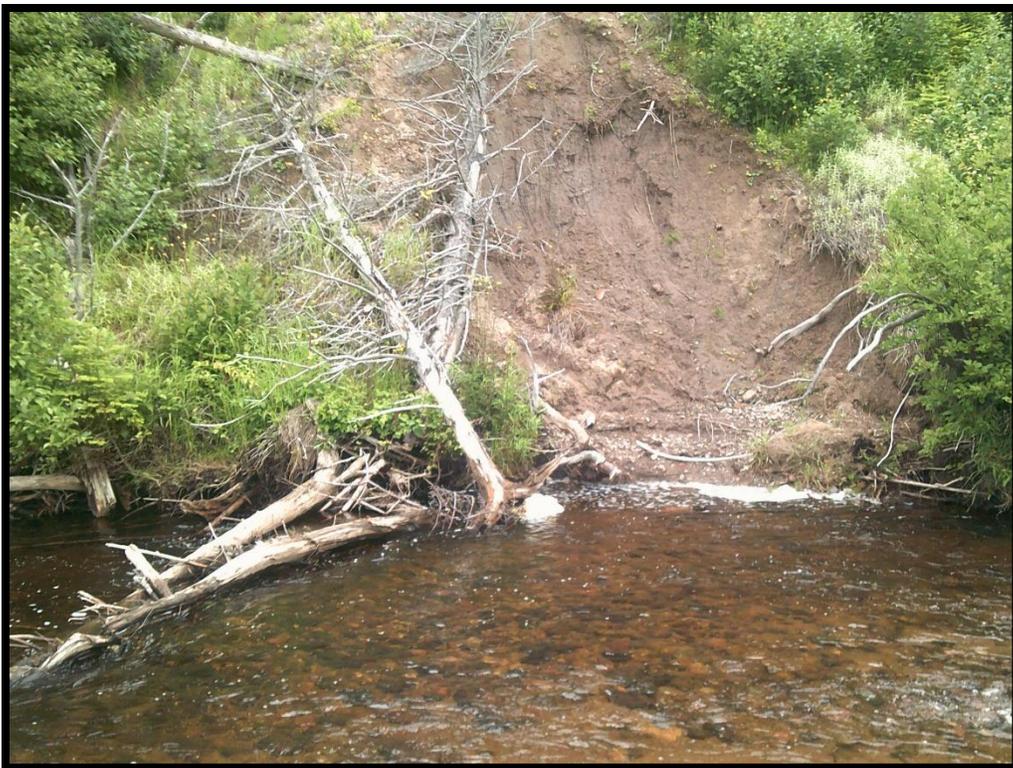
*Figure 11: Showing the erosion that caused obstruction 3, Little Crabbes.*

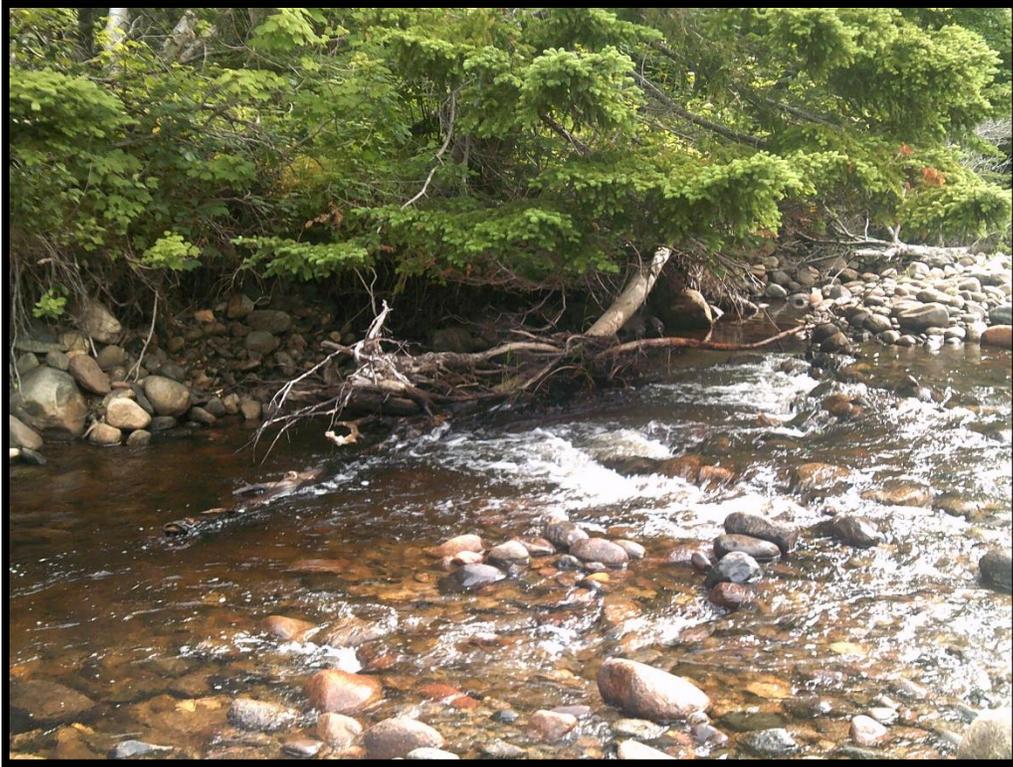
*Figure 12: Sideview of obstruction 4, Little Crabbes.*

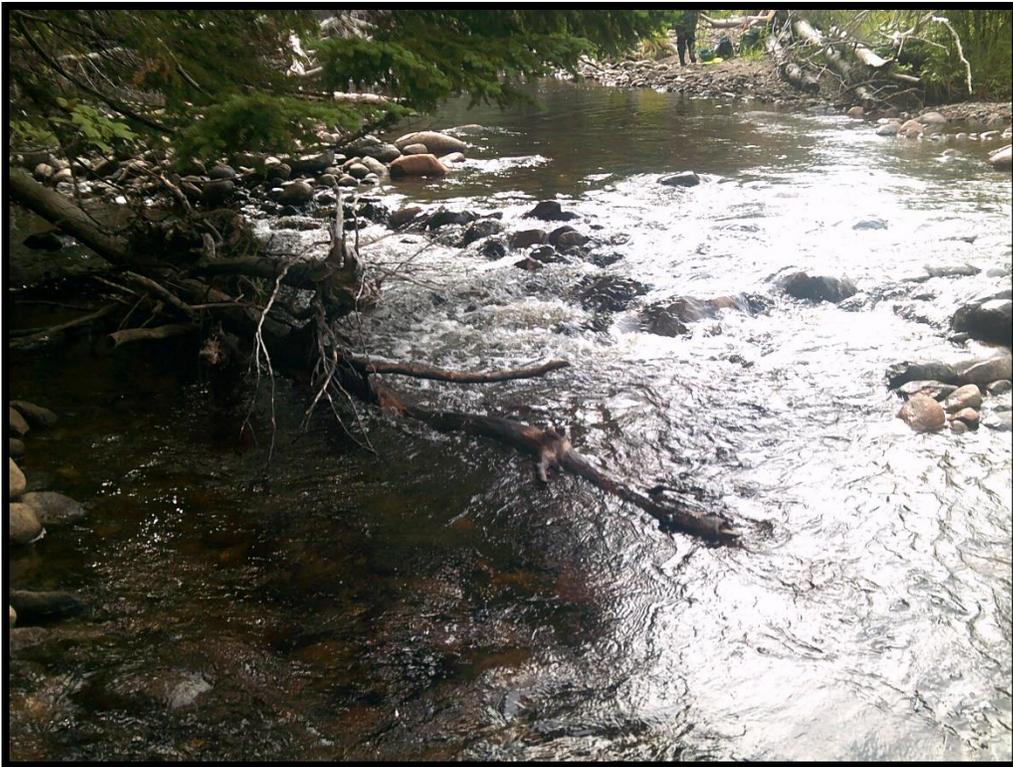
*Figure 13: Upstream view of obstruction 4, Little Crabbes.*

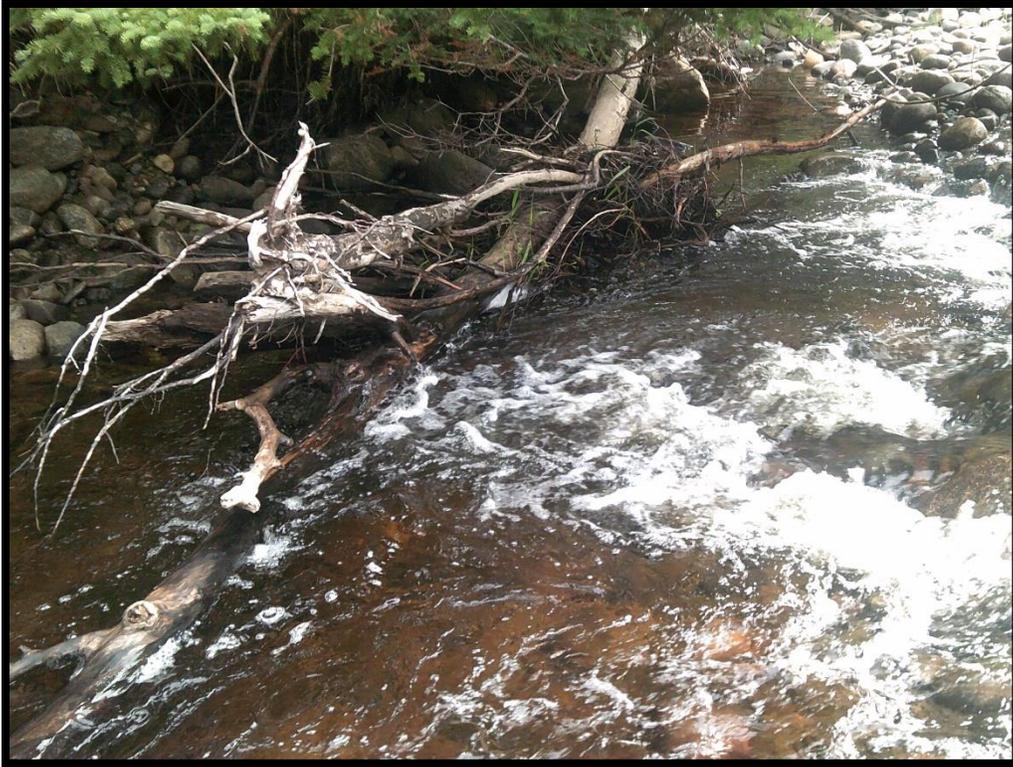
*Figure 14: Closer view of obstruction 4, Little Crabbes.*

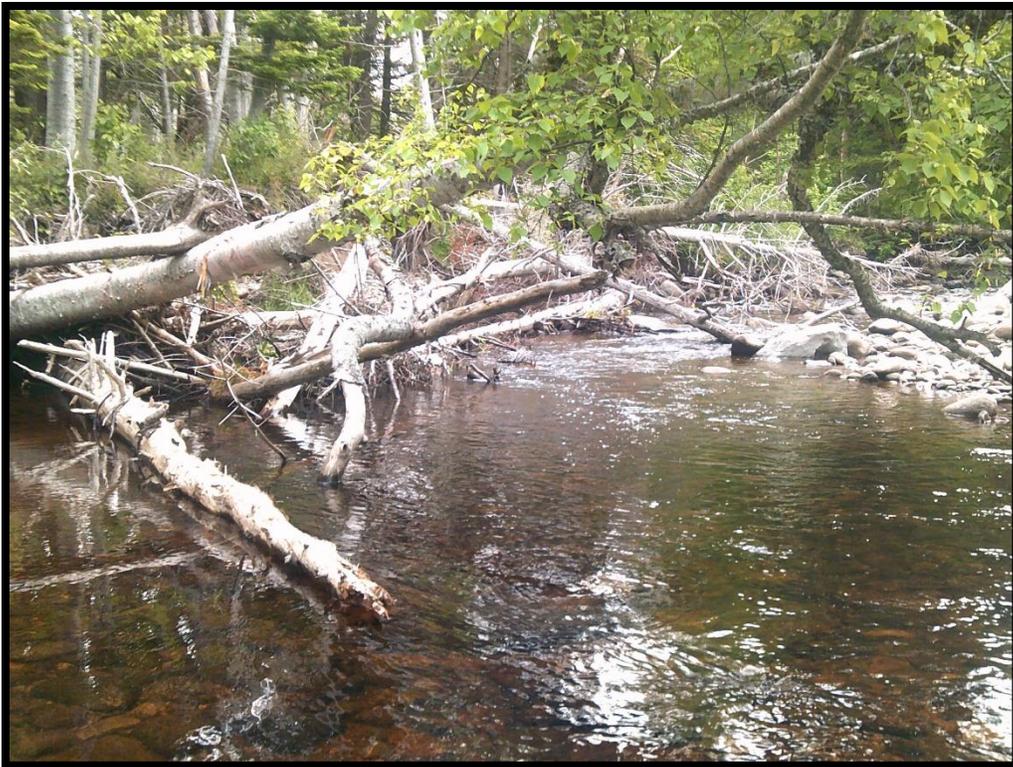
*Figure 15: Looking upstream at obstruction 5, Little Crabbes.*

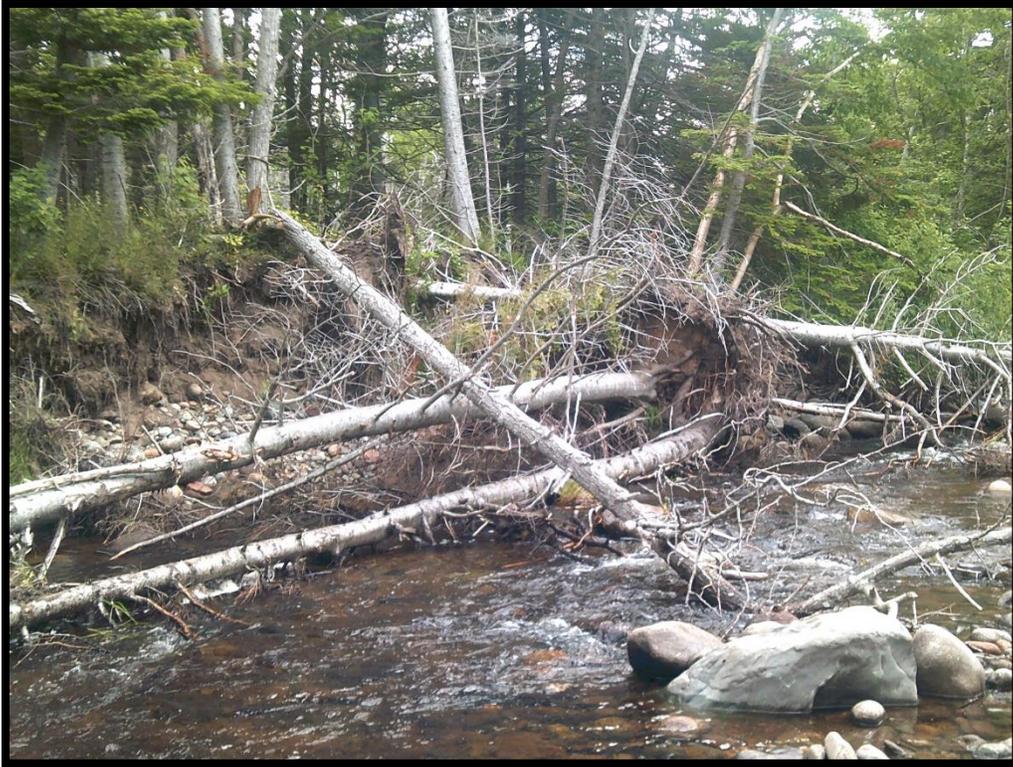
*Figure 16: Closer upstream view of obstruction 5, Little Crabbes.*

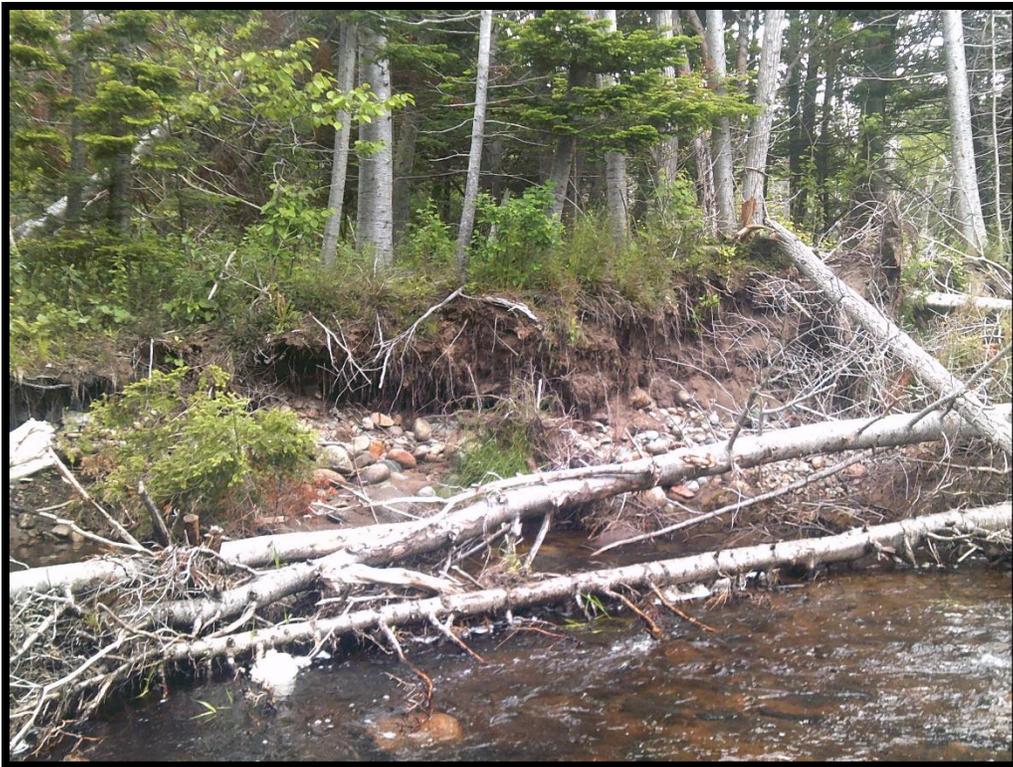
*Figure 17: Erosion causing obstruction 5, Little Crabbes.*

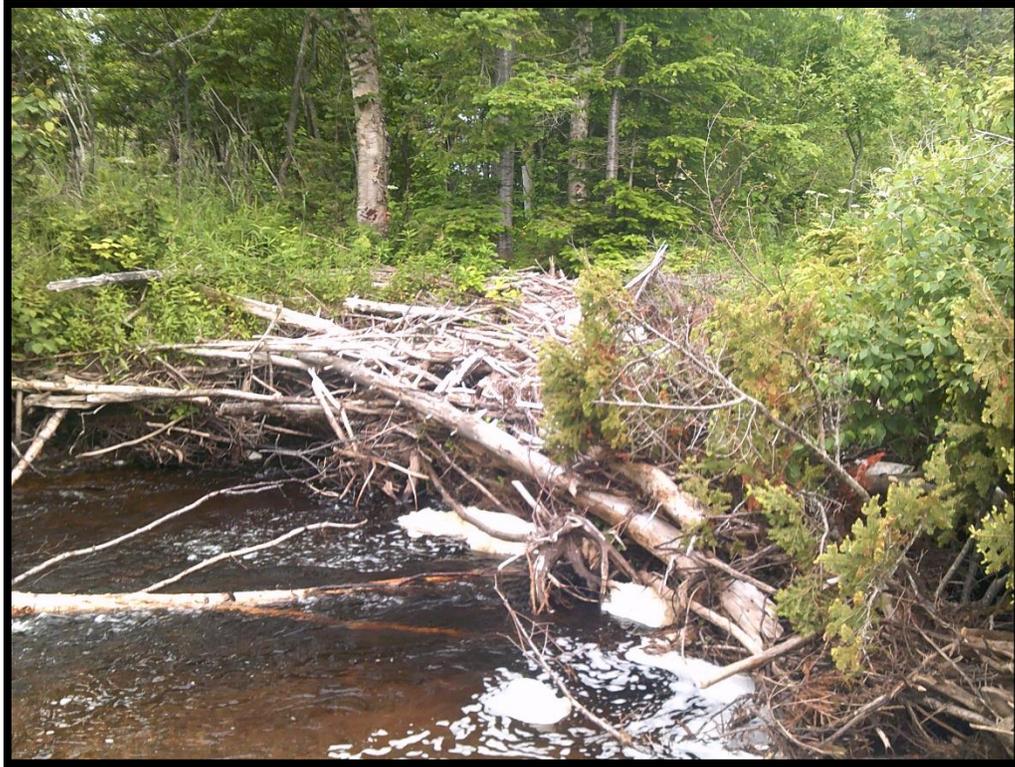
12 obstructions were recorded on Little Crabbes, most of which were identified as large woody debris (LWD). A description of the obstructions recorded are listed in table 1. After surveying Little Crabbes and analyzing the recorded obstructions, two obstructions required immediate attention. Obstruction 6 (N 48.19420°, W -58.81852°) (Fig 19-25), and obstruction 11 (N 48.19044°, W -58.78660°) (Fig 42-45) were removed due to their impact on salmon migration. The remaining obstructions were not posing an actual threat to salmon passage therefore making it more harmful to remove them. In some cases, obstructions provide shelter, food source and habitat for salmon. An example would be obstruction 10 (W 48.19241°, N -58.80455°) (Fig 40-41), where a tree has fallen in the mainstream of the tributary not causing an obstruction to salmon passage but rather providing shelter and food source.

*Figure 20: Sideview of obstruction 6, Little Crabbes.*

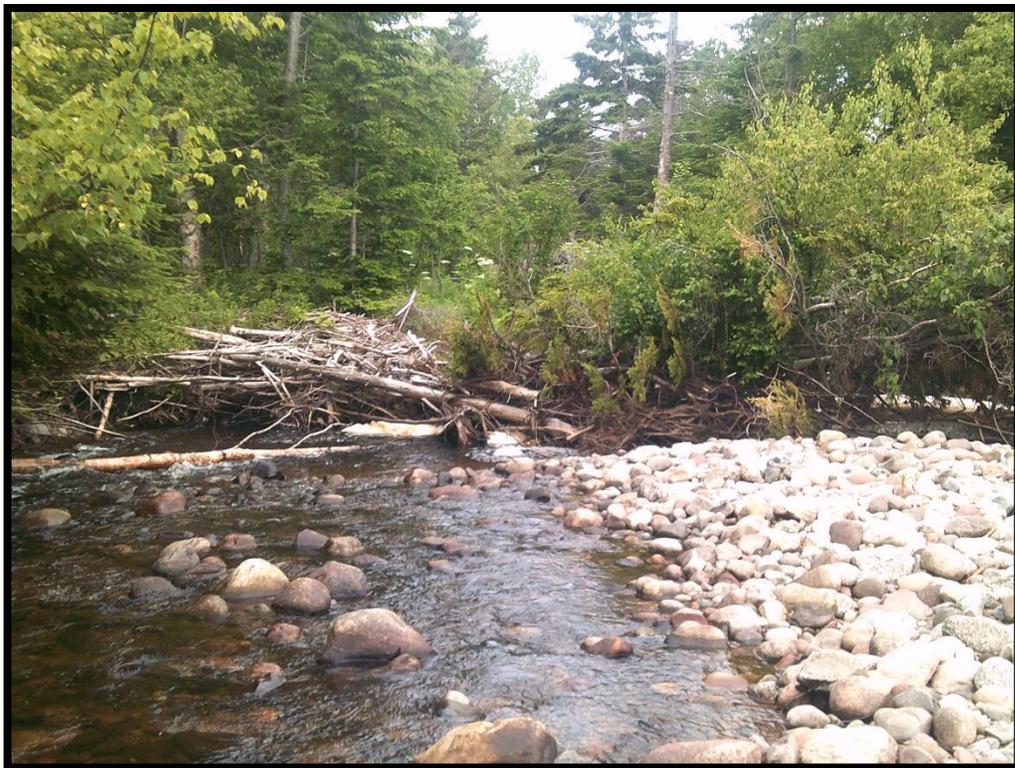
*Figure 21: Downstream view of obstruction 6, Little Crabbes.*

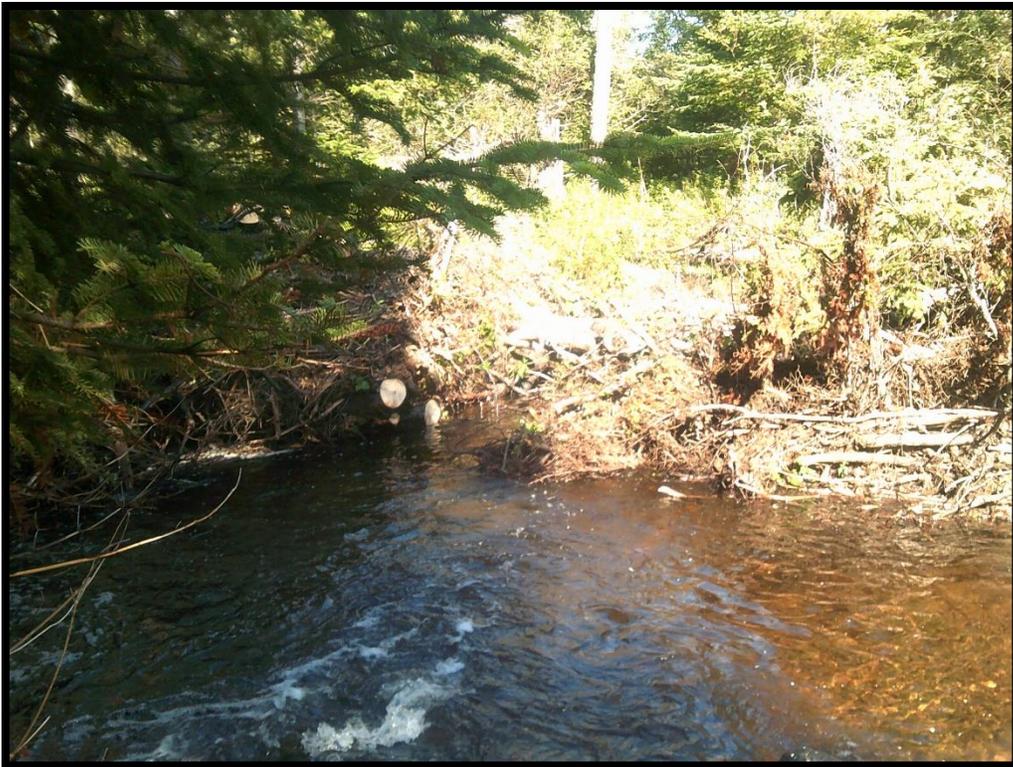
*Figure 23: Looking downstream after sections of obstruction 6 were removed, Little Crabbes.*

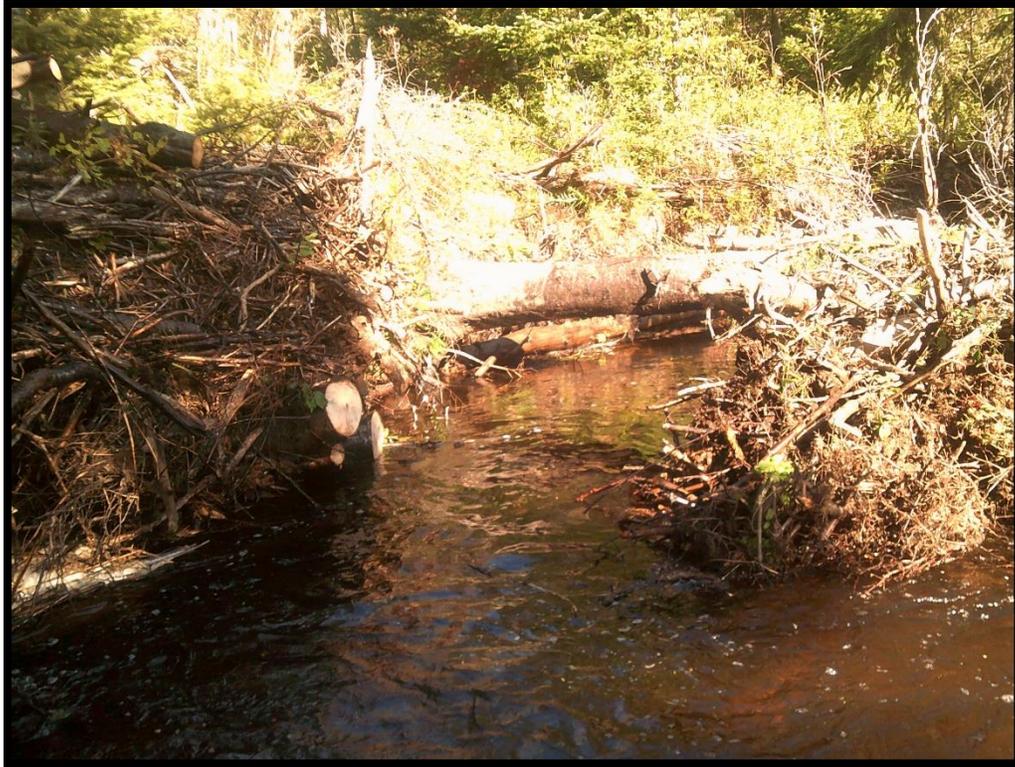
*Figure 24: Closer look at improved area on obstruction 6, Little Crabbes.*

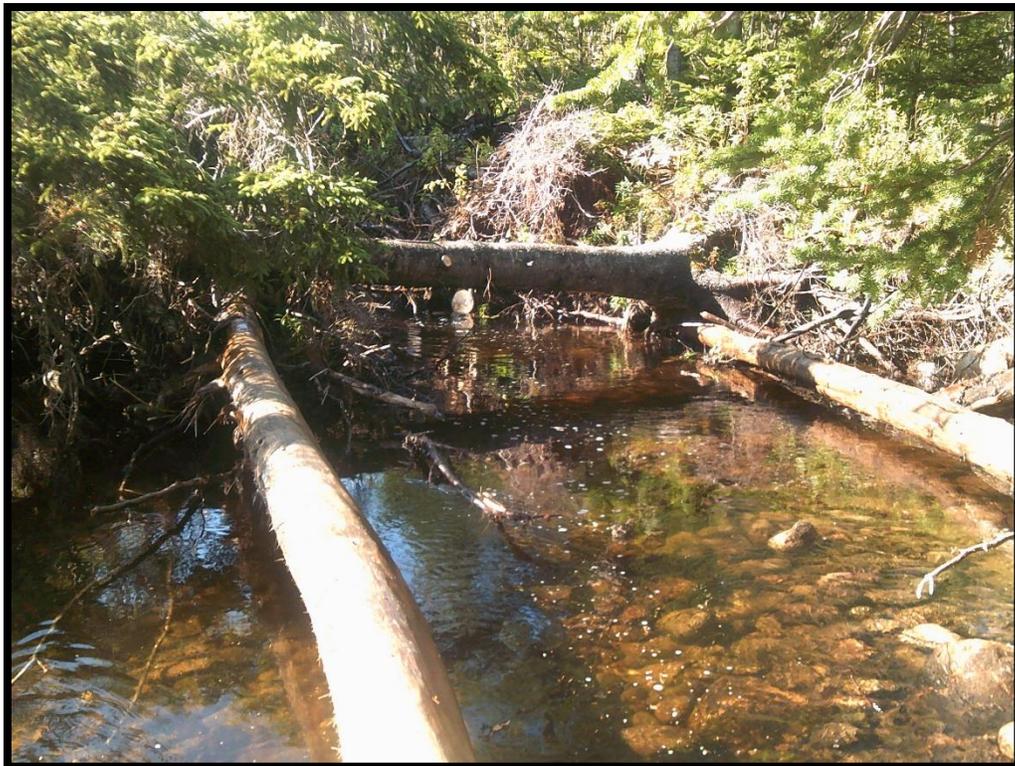
*Figure 25: Upstream view of improved area on obstruction 6. Remaining parts provide great shelter and food source, Little Crabbes.*

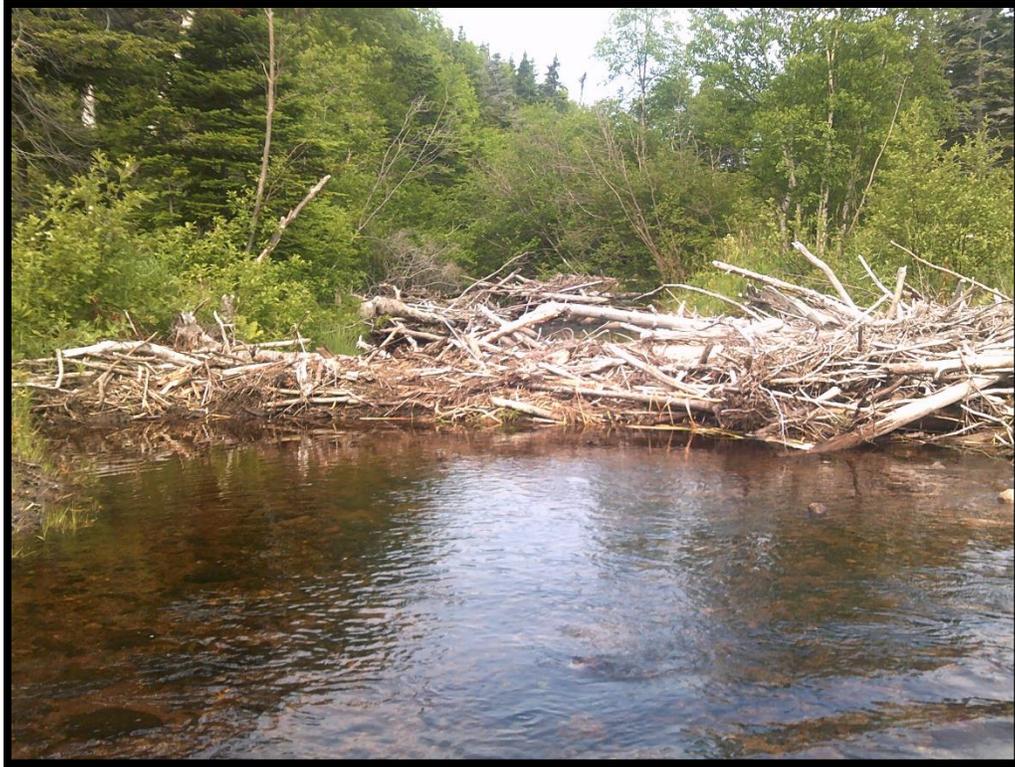
*Figure 26: Downstream view of obstruction 7, Little Crabbes.*

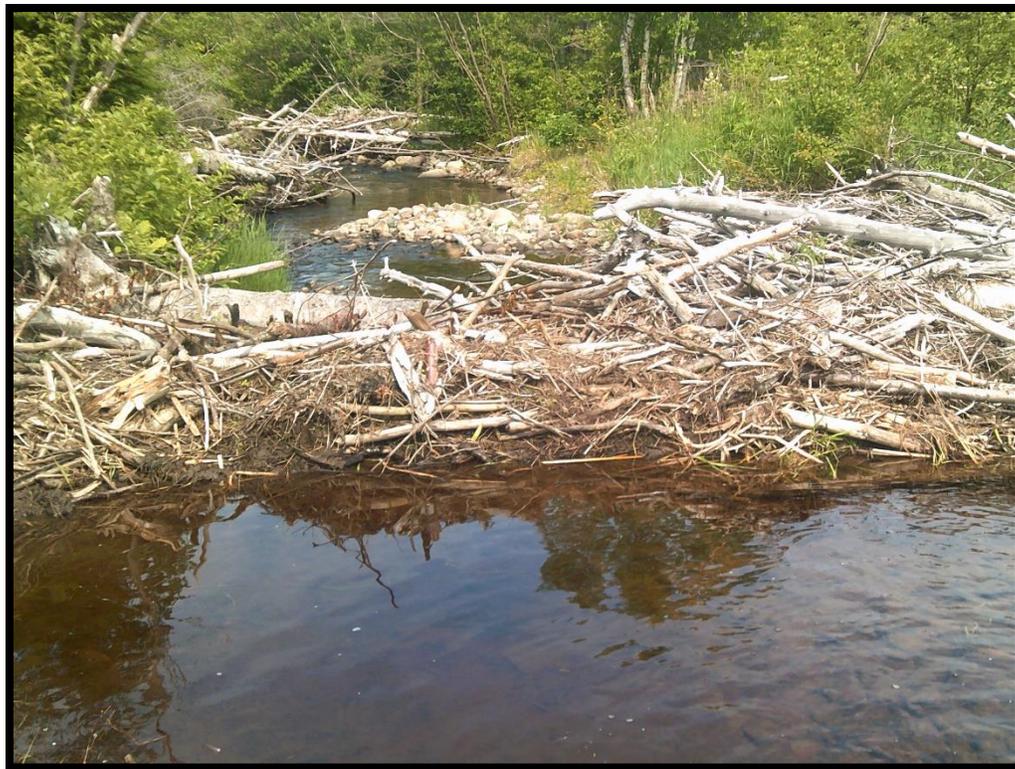
*Figure 27: Closer downstream view of obstruction 7, Little Crabbes.*

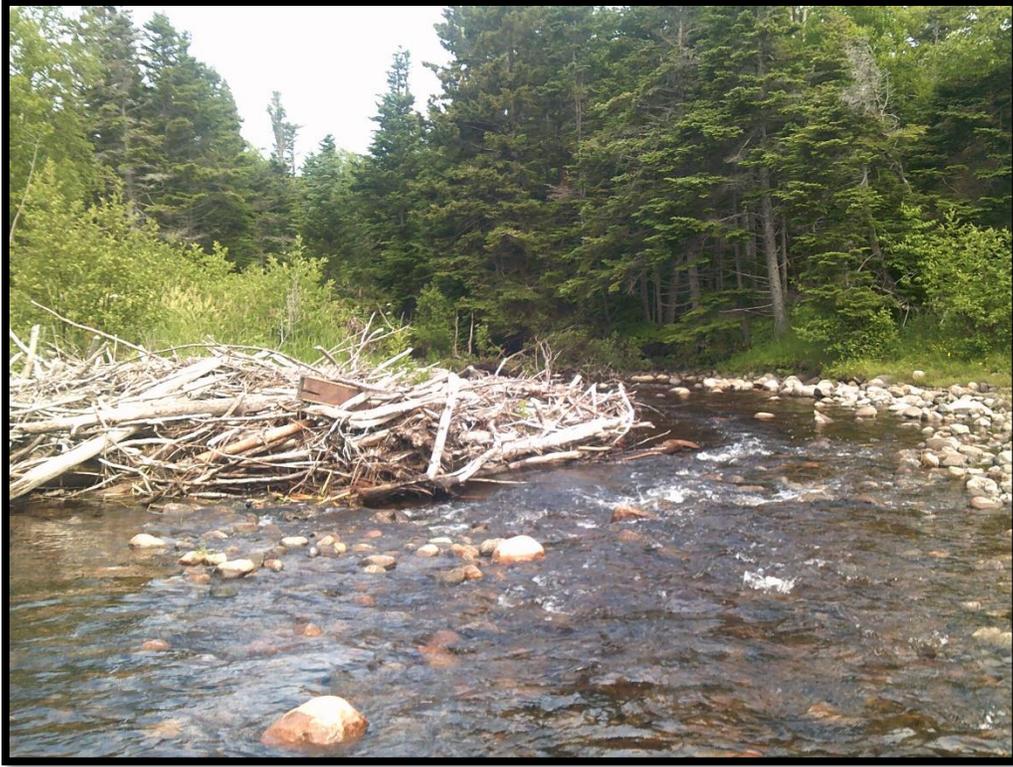
*Figure 28: Sideview showing river being diverted due to obstruction 7, Little Crabbes.*

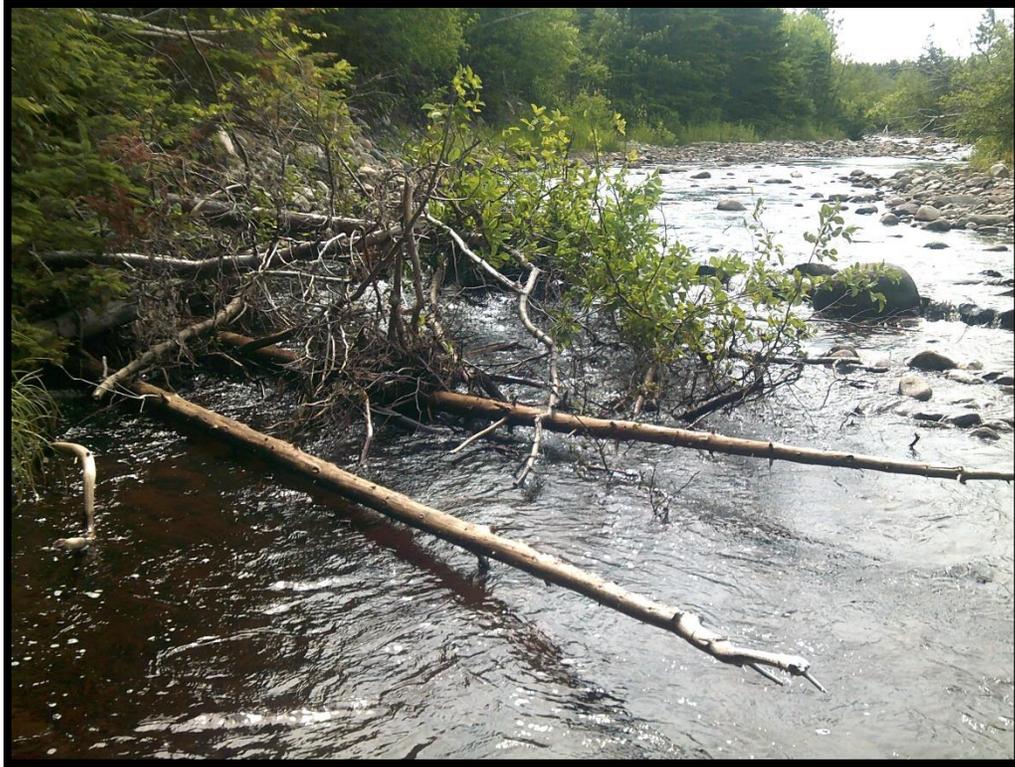
*Figure 30: Upstream view of obstruction 8, Little Crabbes.*

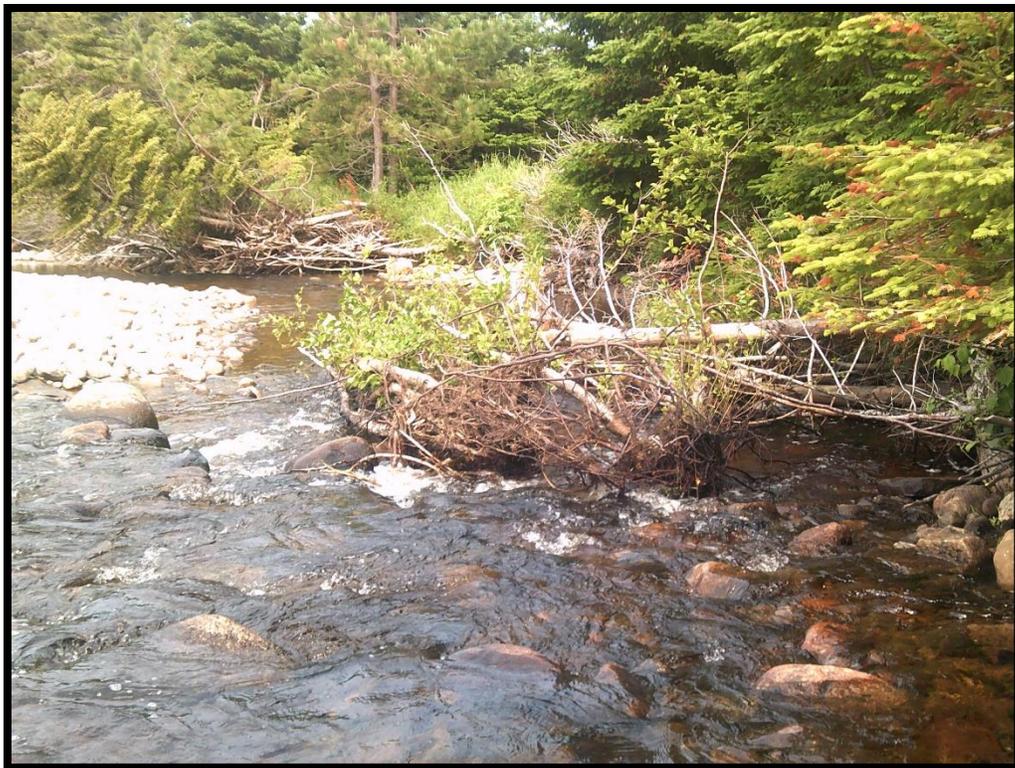
*Figure 31: Downstream view of obstruction 8, Little Crabbes.*

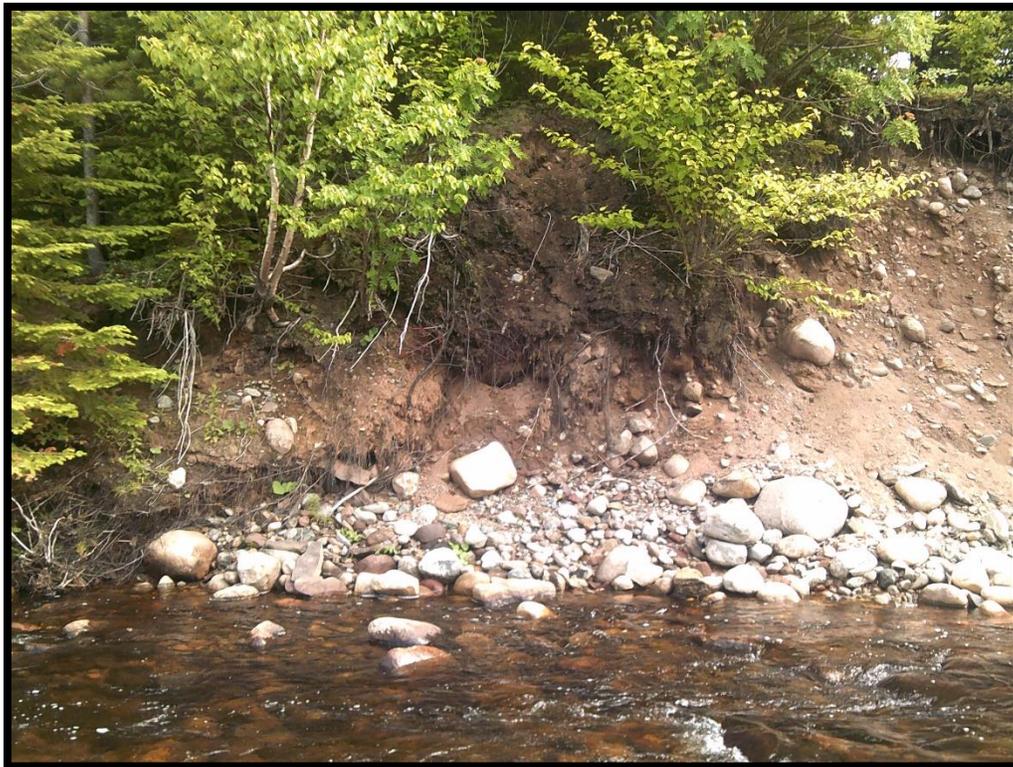
*Figure 33: Showing the erosion that caused obstruction 8, Little Crabbes.*

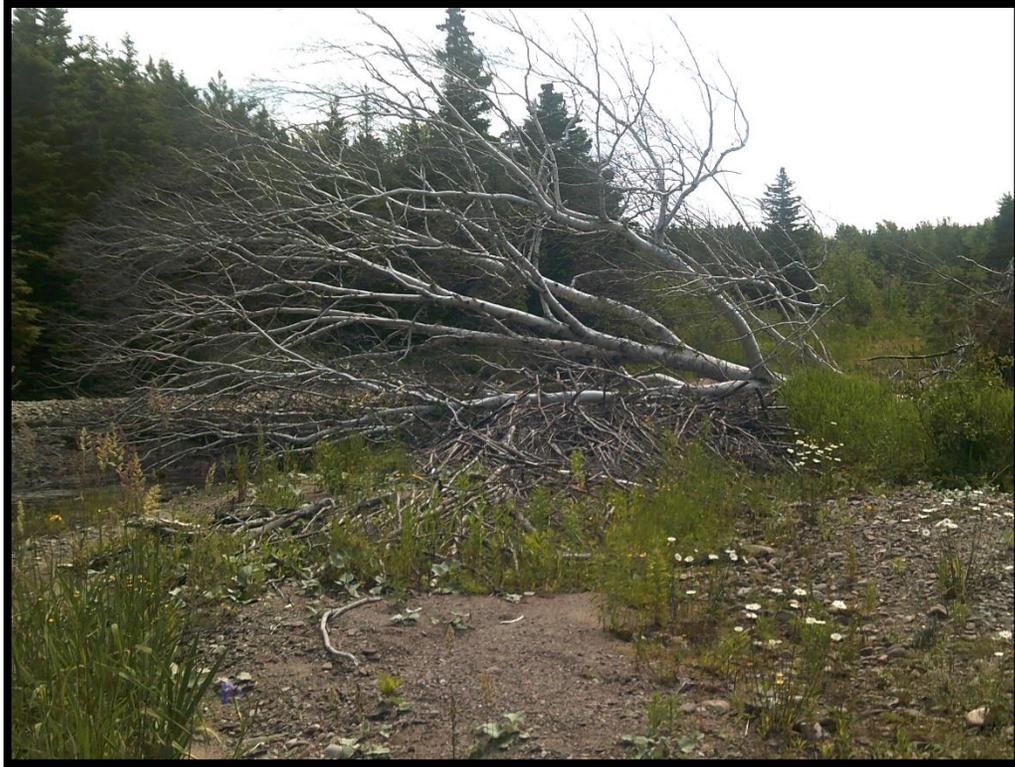
*Figure 34: Upstream view of obstruction 9, Little Crabbes.*
