**DEVELOP HABITAT CONSERVATION PLANS AND RESTORATION FOR RIVERS IN  
BAY ST. GEORGE 2019**

**CRABBES RIVER  
ROBINSONS RIVER**

**BAY ST. GEORGE SOUTH AREA DEVELOPMENT ASSOCIATION**

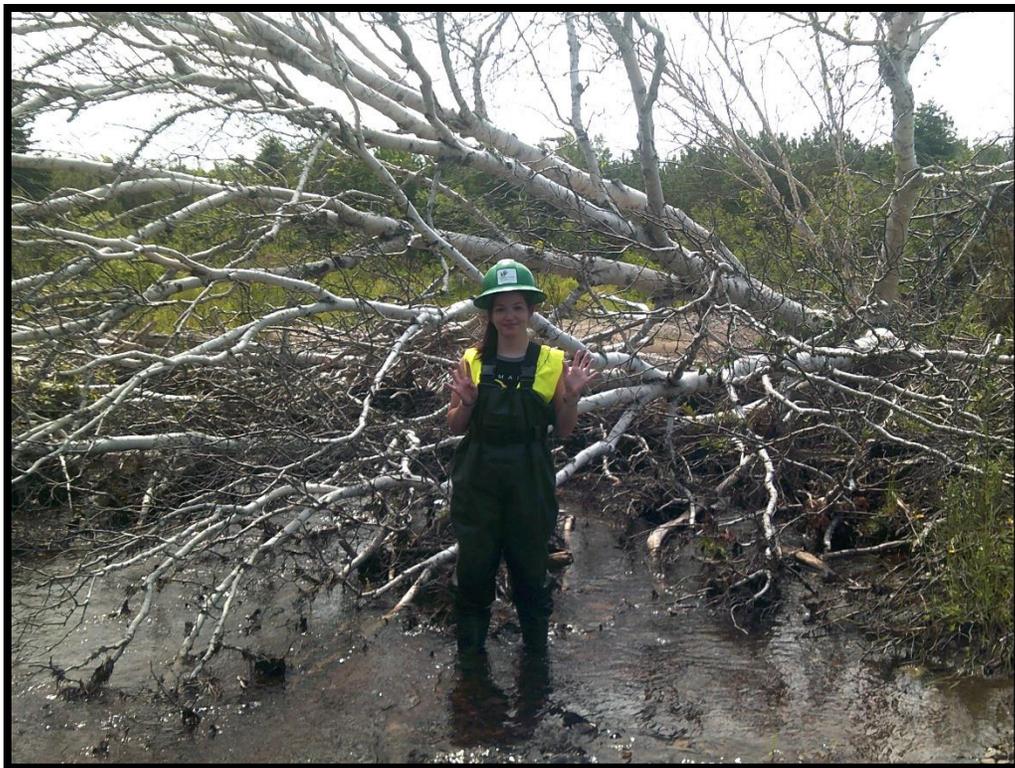
*Figure 35: Closer upstream view of obstruction 9, Little Crabbes.*

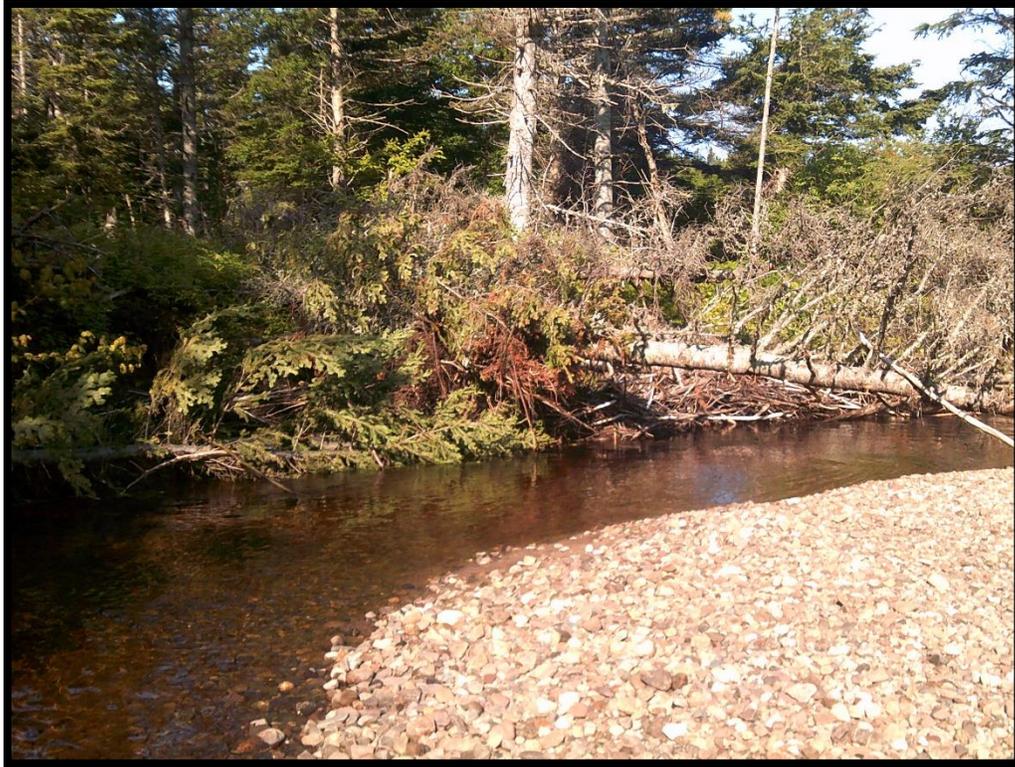
*Figure 42: Downstream view of obstruction 11, Little Crabbes*

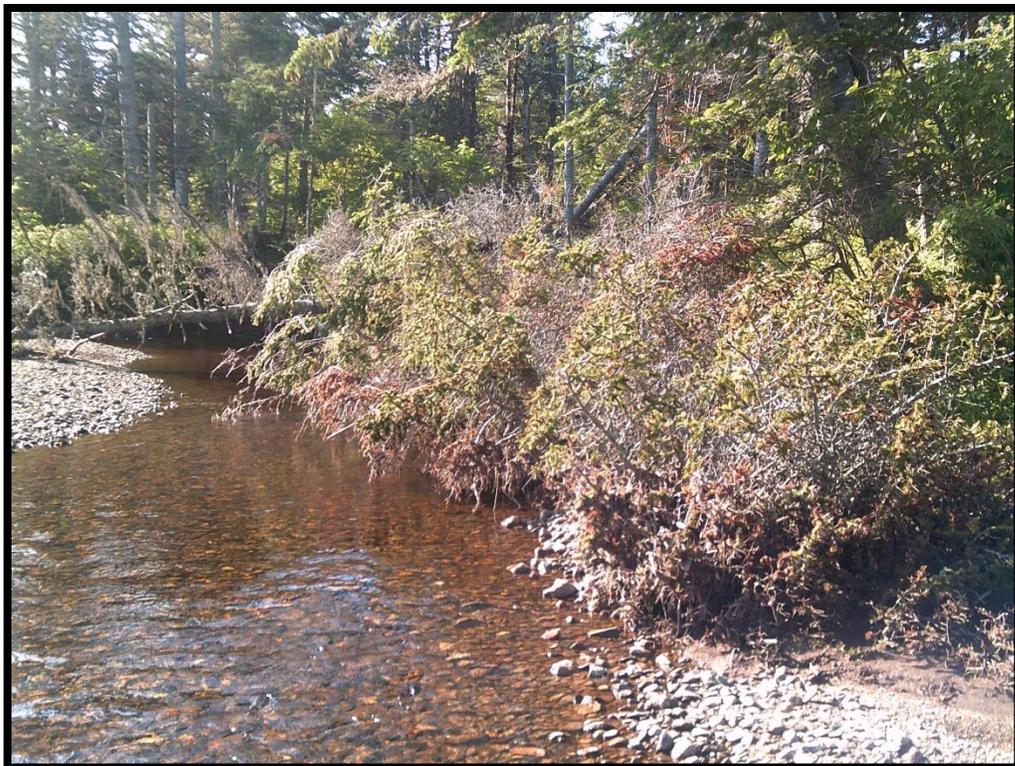
*Figure 43: Upstream view of obstruction 11, Little Crabbes.*

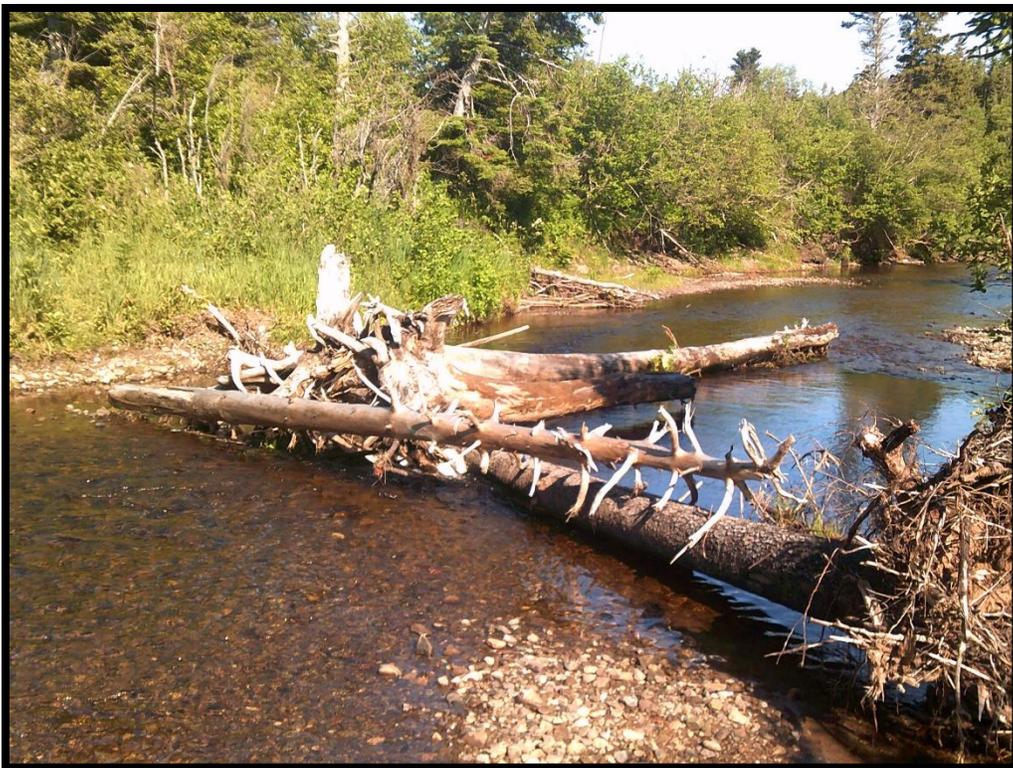
*Figure 47: Closer upstream view of obstruction 12, Little Crabbes.*

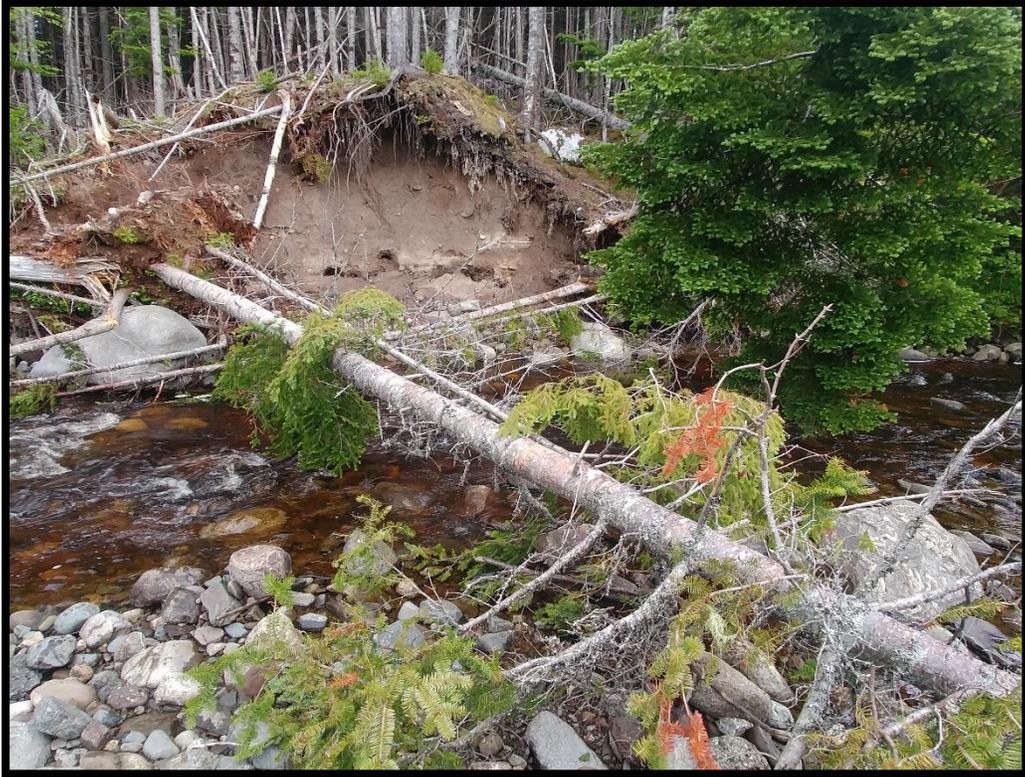
*Figure 50: Side view of obstruction 1, Northern Feeder.*

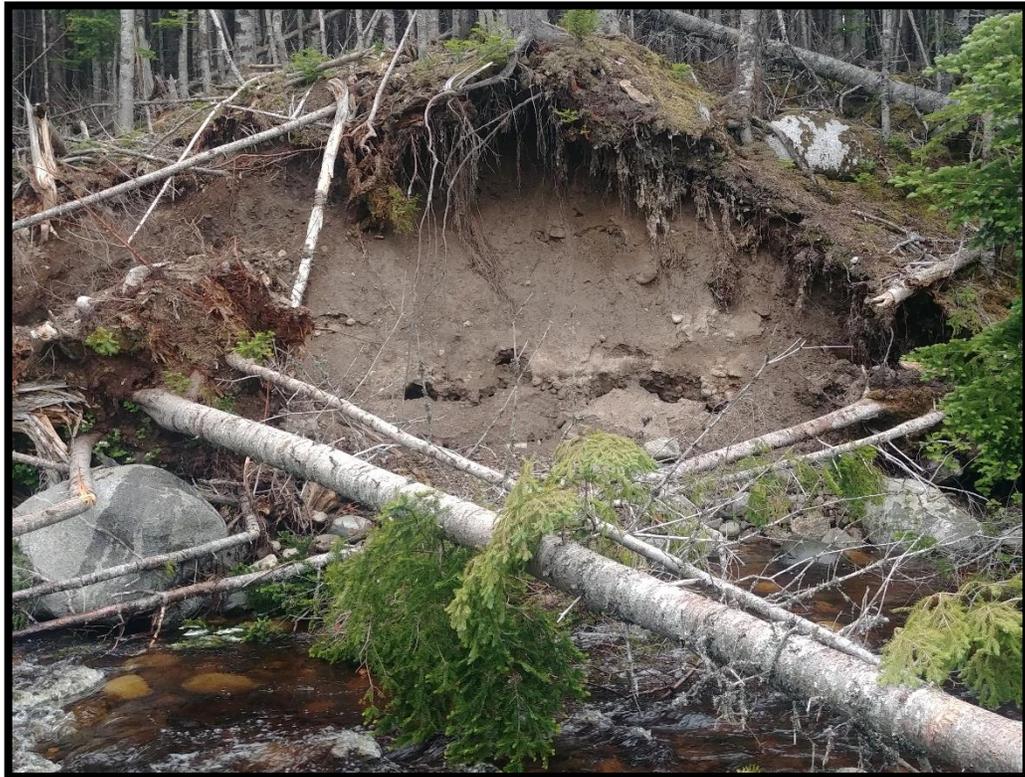
*Figure 51: Looking at the erosion that caused obstruction 1, Northern Feeder.*

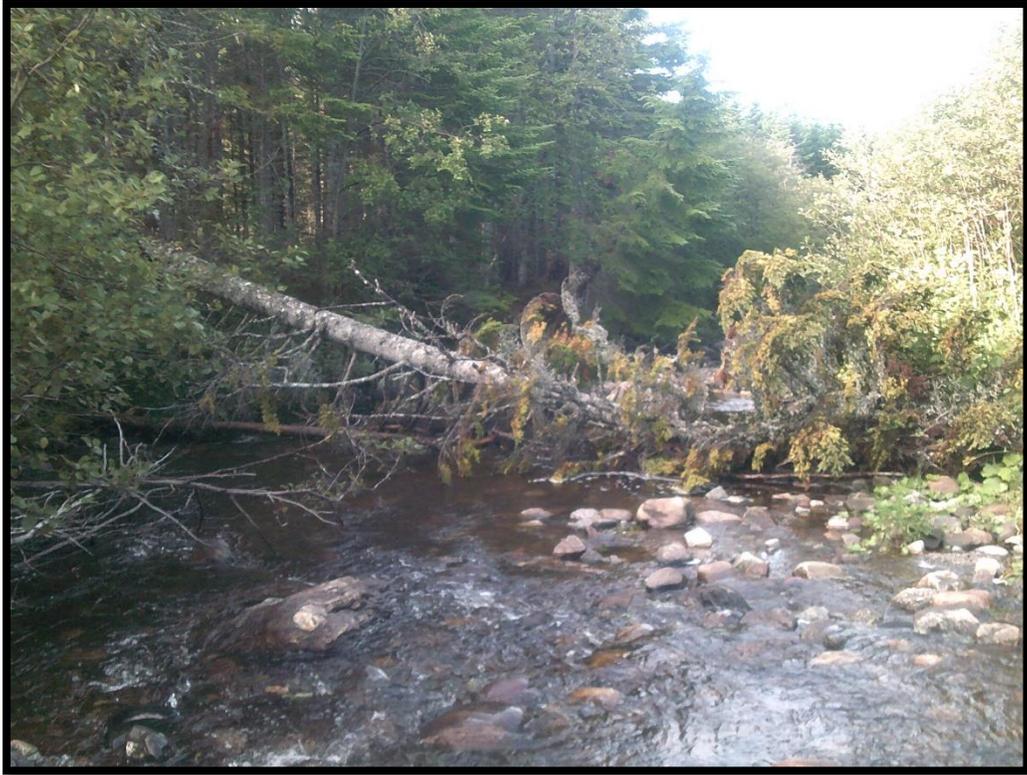
Eight (8) obstructions were observed (Table 2), most of which were large woody debris (LWD) which have the potential to restrict salmon migration. Despite there being eight (8) obstructions only five (5) were obstructing salmon passage to the point that removal was required. Obstruction 2 (N 48.24019°, W -58.64141°), obstruction 4 (N 48.23866°, W -58.74192°), obstruction 5 (N 48.24024°, W -58.63396°), obstruction 6 (N 48.23651°, W -58.61260°), and obstruction 8 (N 48.23906°, W -58.60662°) were all removed due to their impact on salmon migration (Figs. 55-87). Obstruction 1 (N 48.24019°, W -58.64079°), obstruction 3 (N 48.23944°, W -58.65159°), and obstruction 7 (N 48.23898°, W -58.60681°) were not removed as they were not restricting salmon passage to an extent that required removal. These three (3) obstructions provide great habitat and food source for salmon. A description of the obstructions recorded are included in Table 2 and photos of the obstructions with removal are in figures 50 to 84.

*Figure 52: Downstream view of obstruction 2, Northern Feeder.*

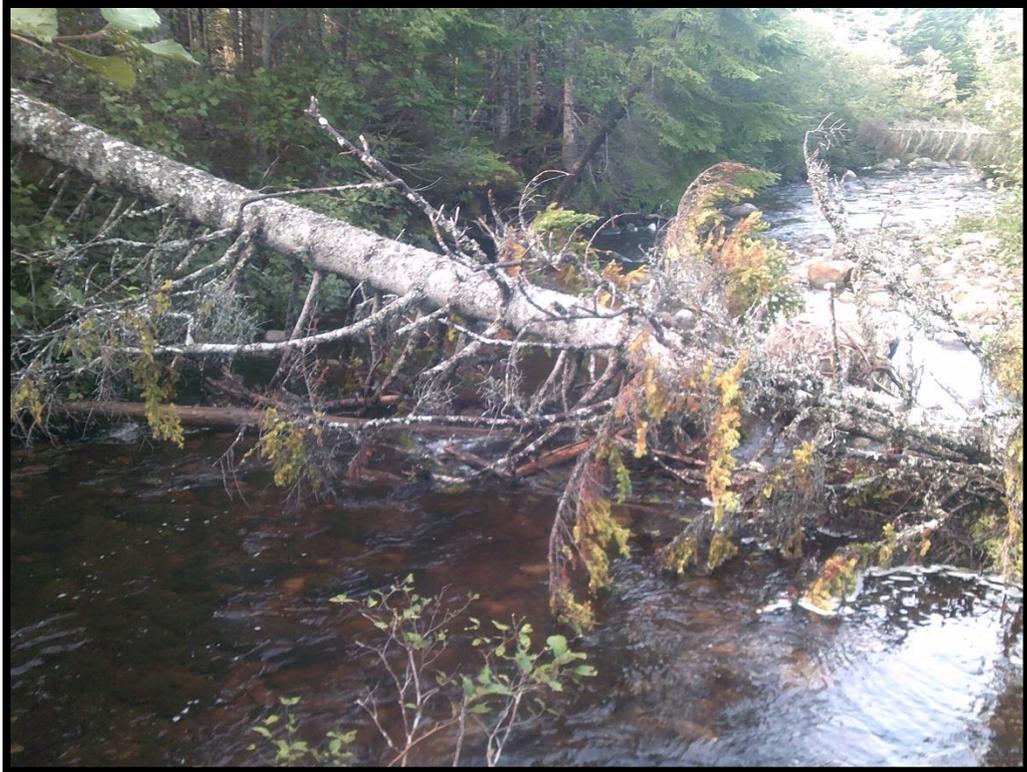
*Figure 53: Closer downstream view of obstruction 2, Northern Feeder.*

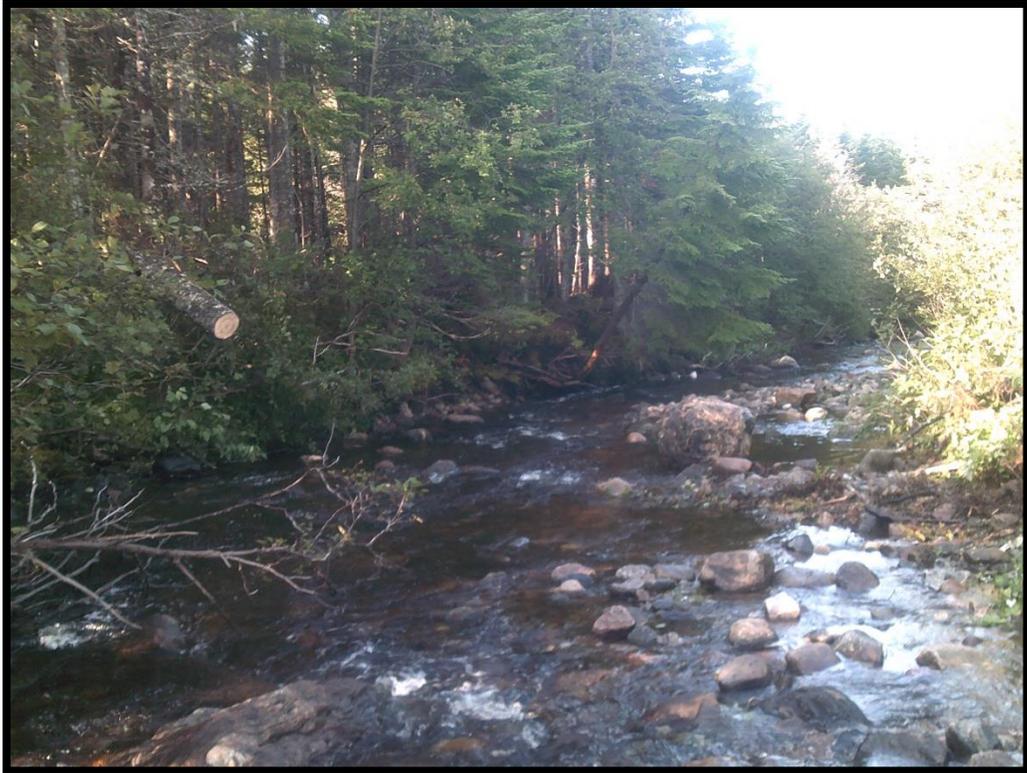
*Figure 54: Downstream view of improved fish passage from obstruction removal, Northern Feeder.*

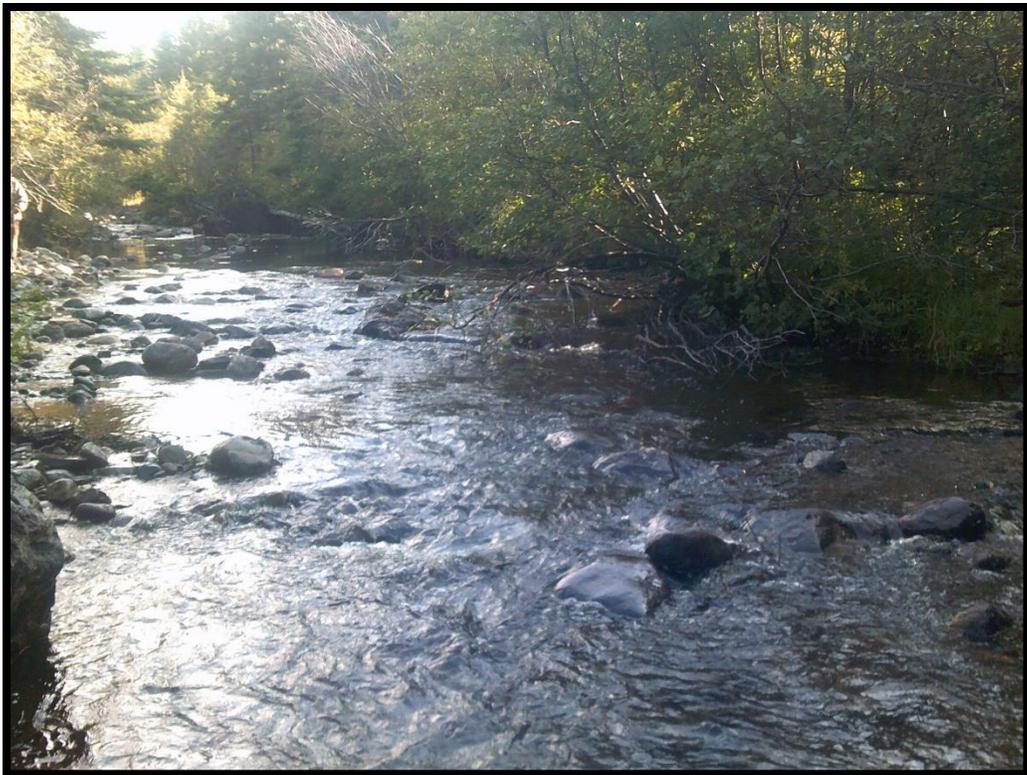
*Figure 55: Upstream view of improved habitat after obstruction removal, Northern Feeder.*

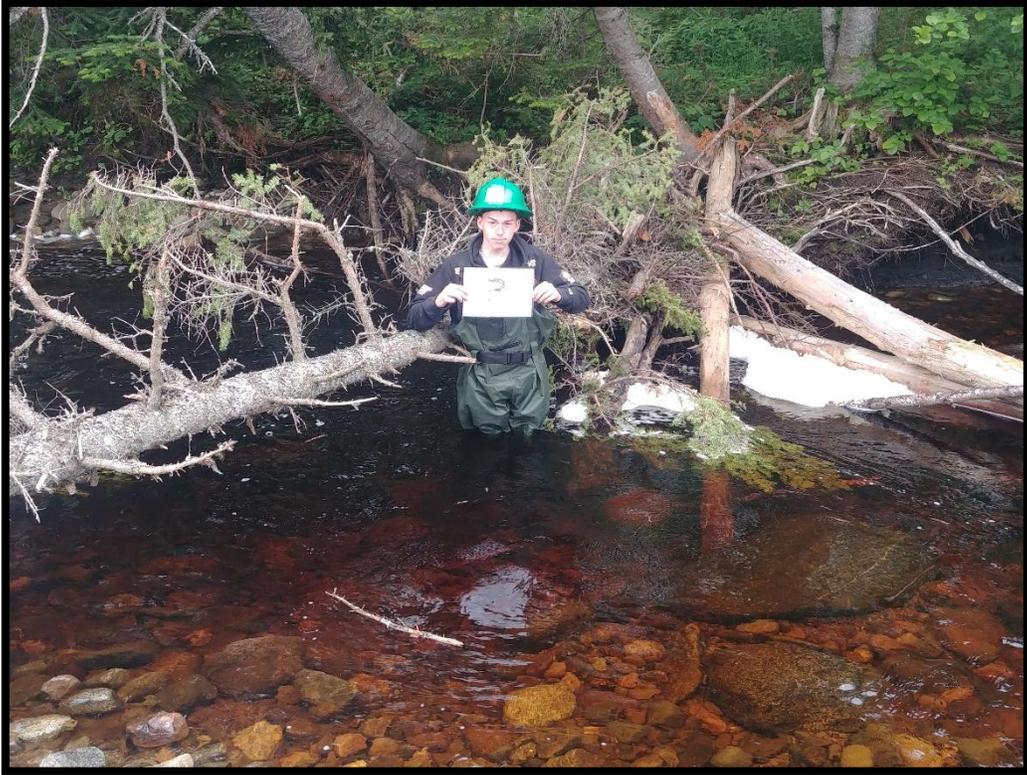
*Figure 56: Sideview of obstruction 3, Northern Feeder.*

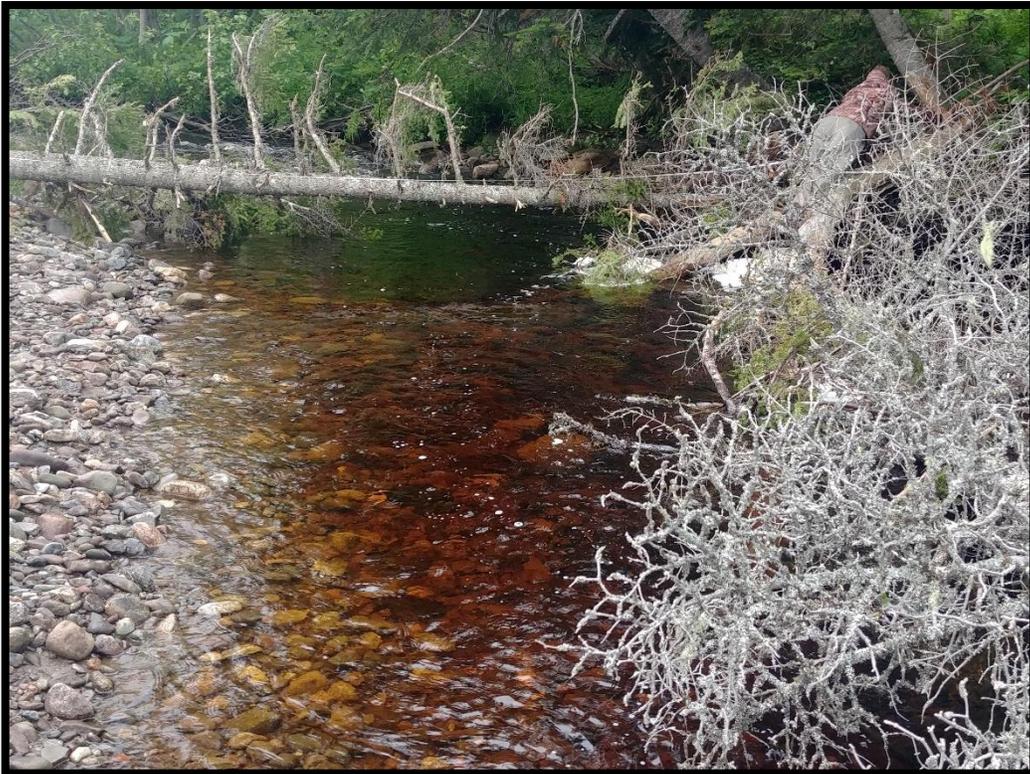
*Figure 57: Upstream view of obstruction 3, Northern Feeder.*

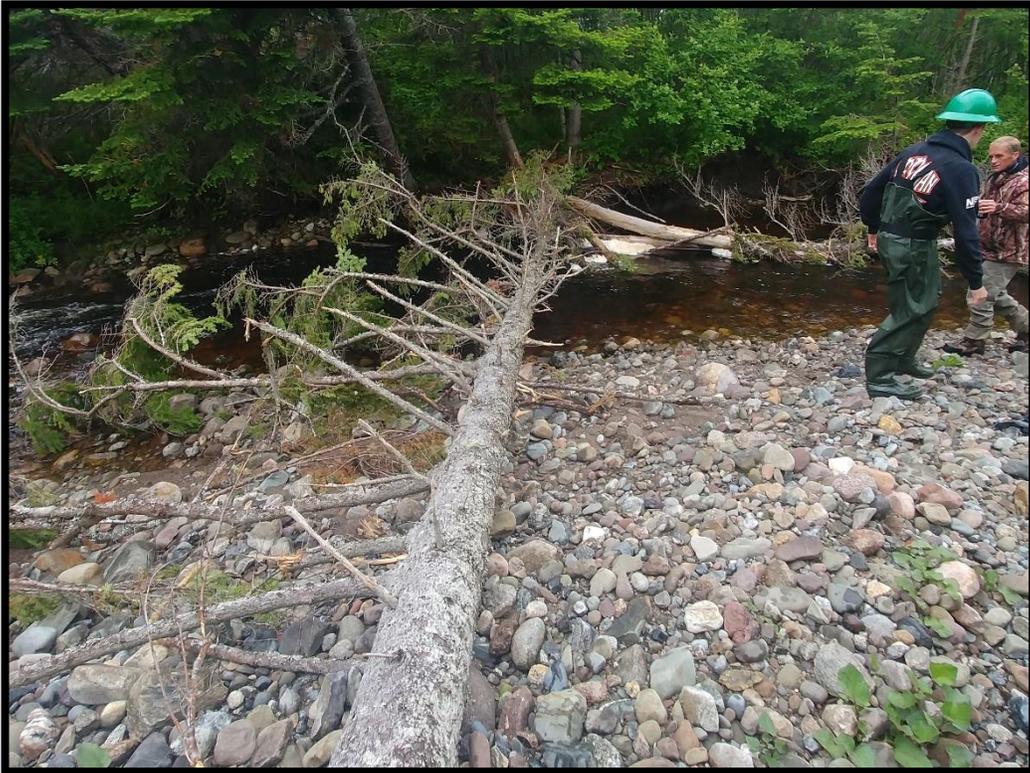
*Figure 58: Sideview of obstruction 3. Tree provides great shelter for salmon, Northern Feeder.*

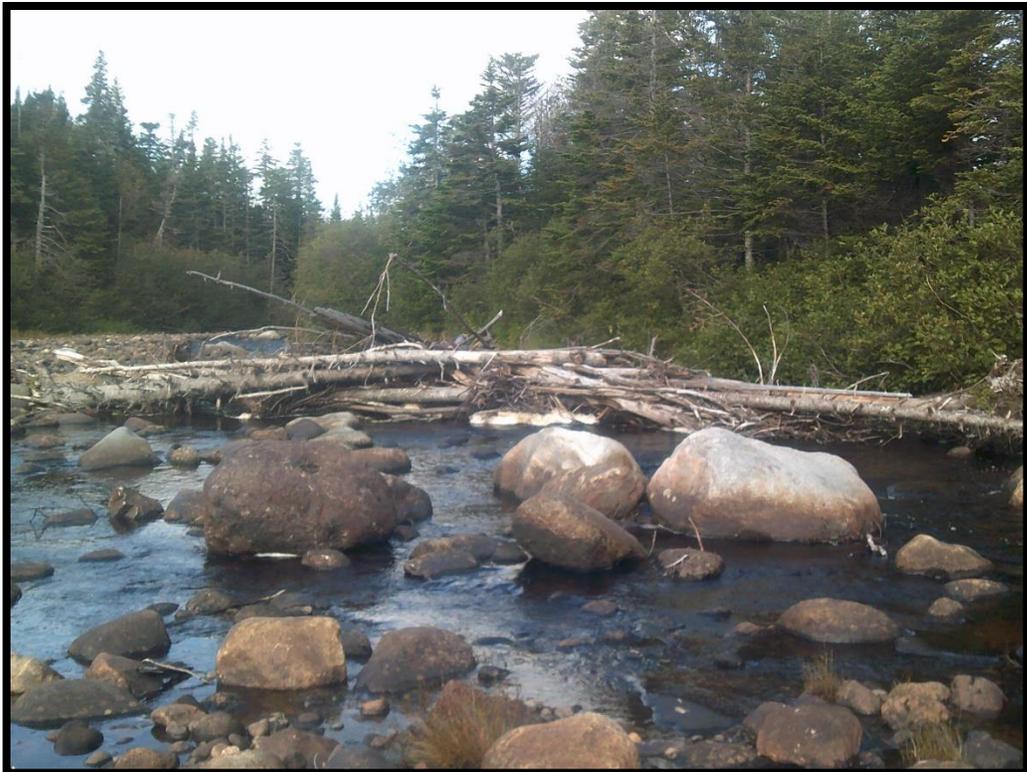
*Figure 59: Downstream view of obstruction 4, Northern Feeder.*

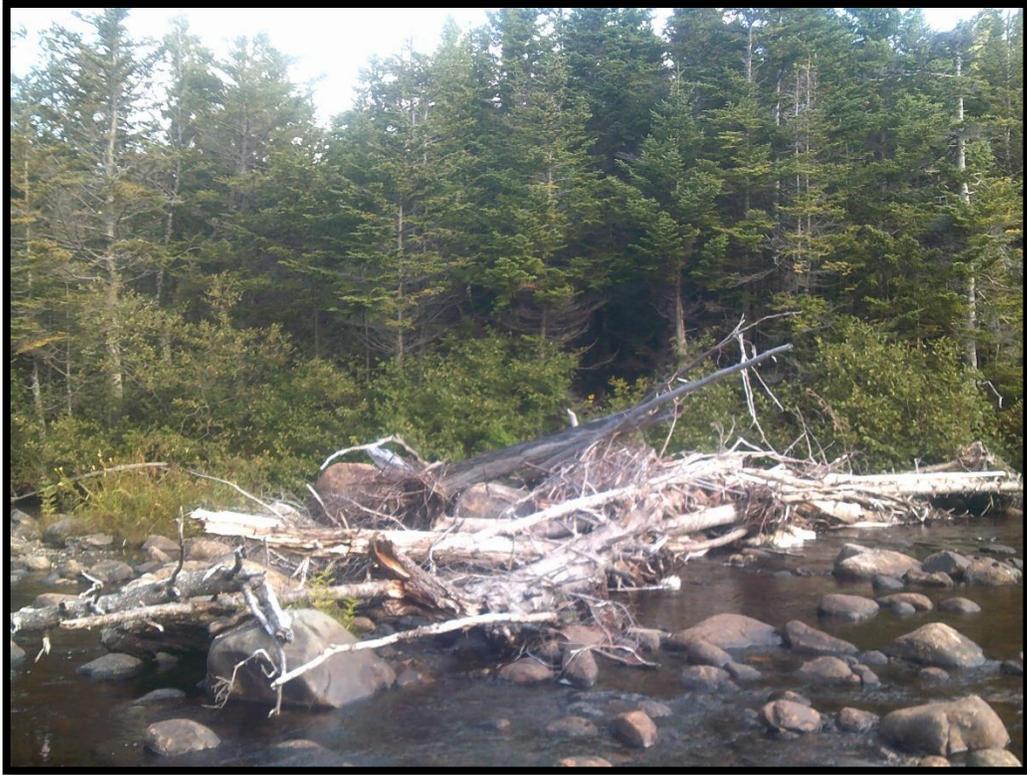
*Figure 60: Sideview of obstruction 4, Northern Feeder.*

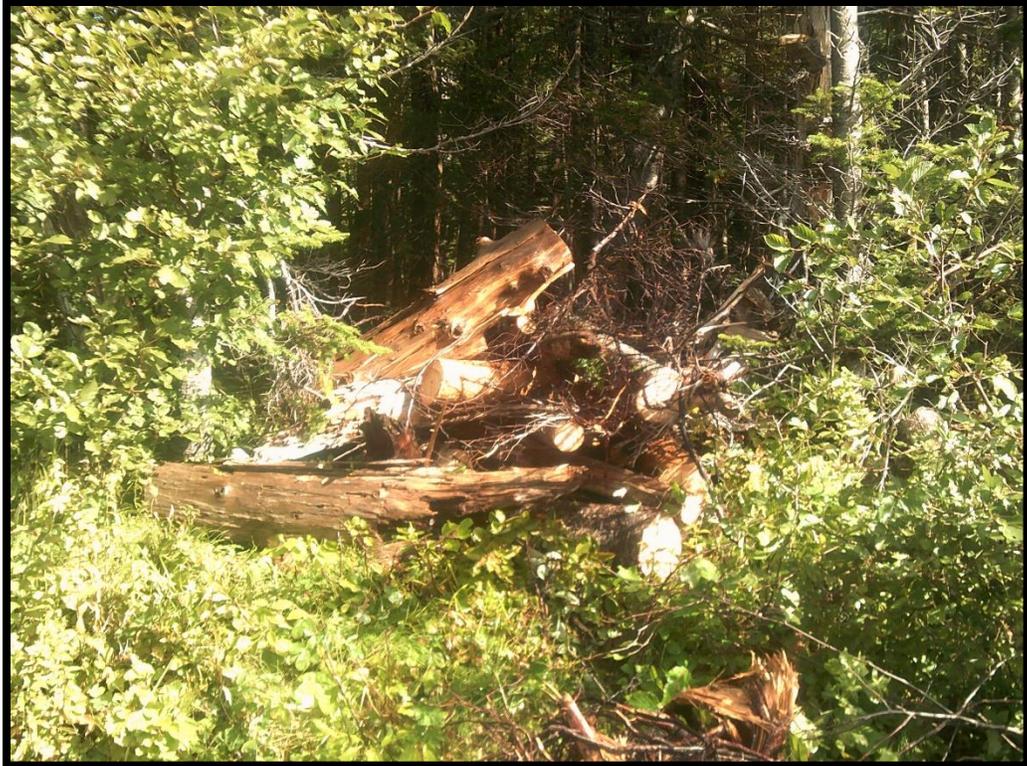
*Figure 61: View of debris removed from obstruction 4, Northern Feeder.*

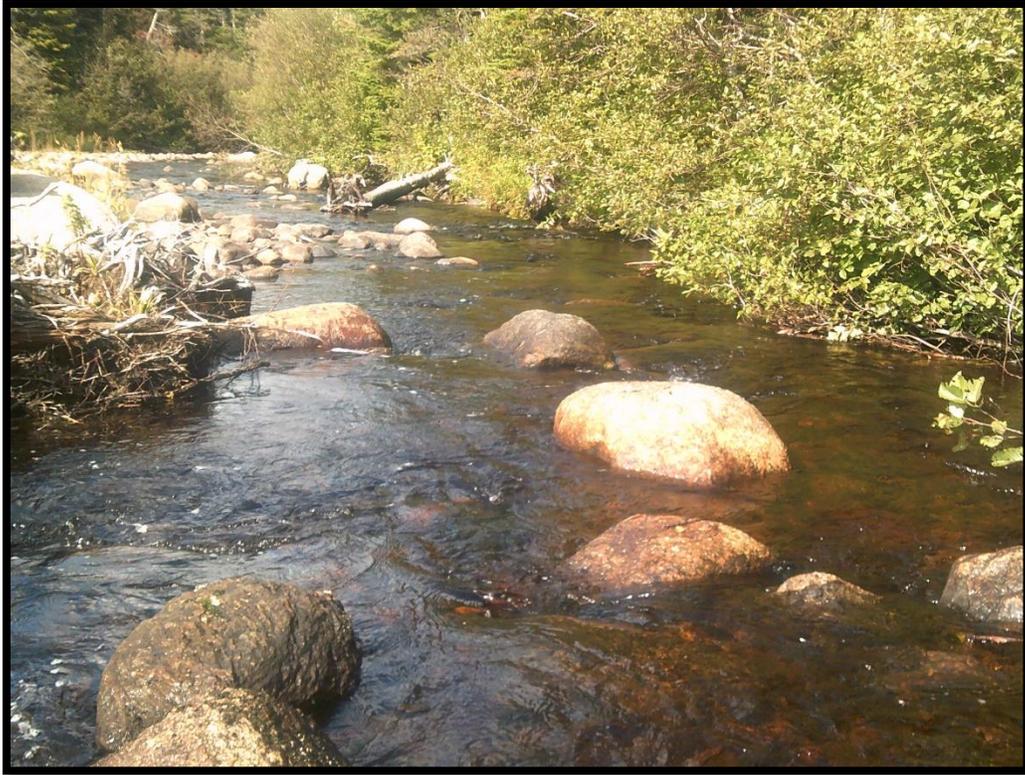
*Figure 62: Downstream view of improved habitat after obstruction 4 removal, Northern Feeder.*

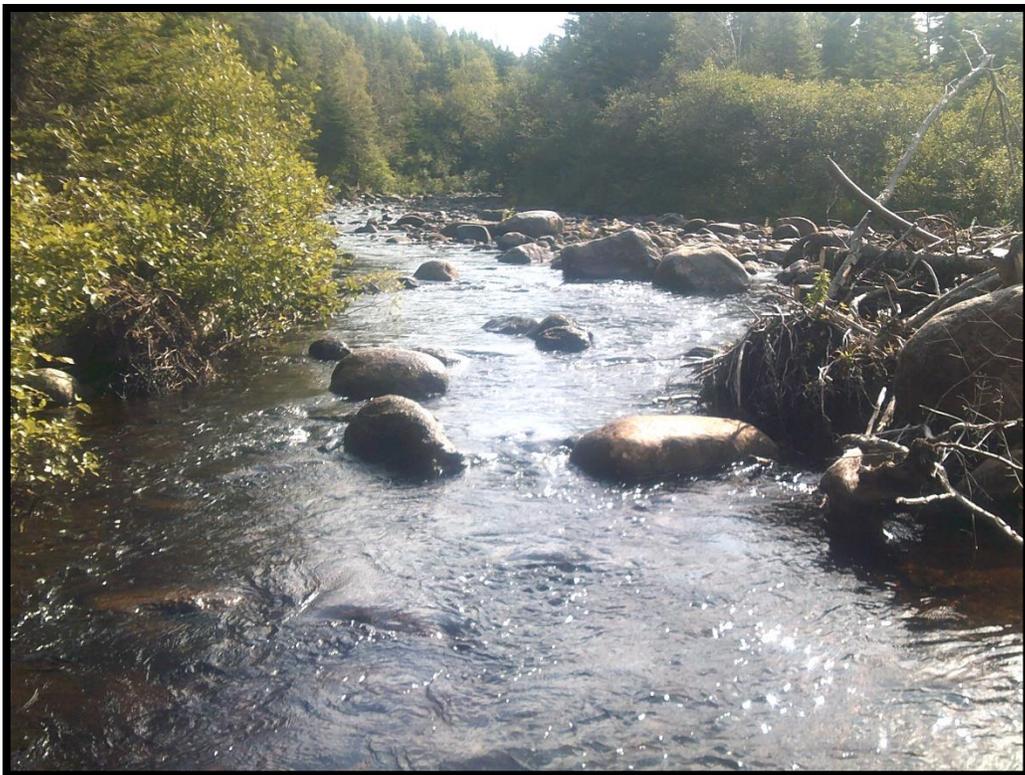
*Figure 63: Upstream view of improved habitat after obstruction 4 removal, Northern Feeder.*

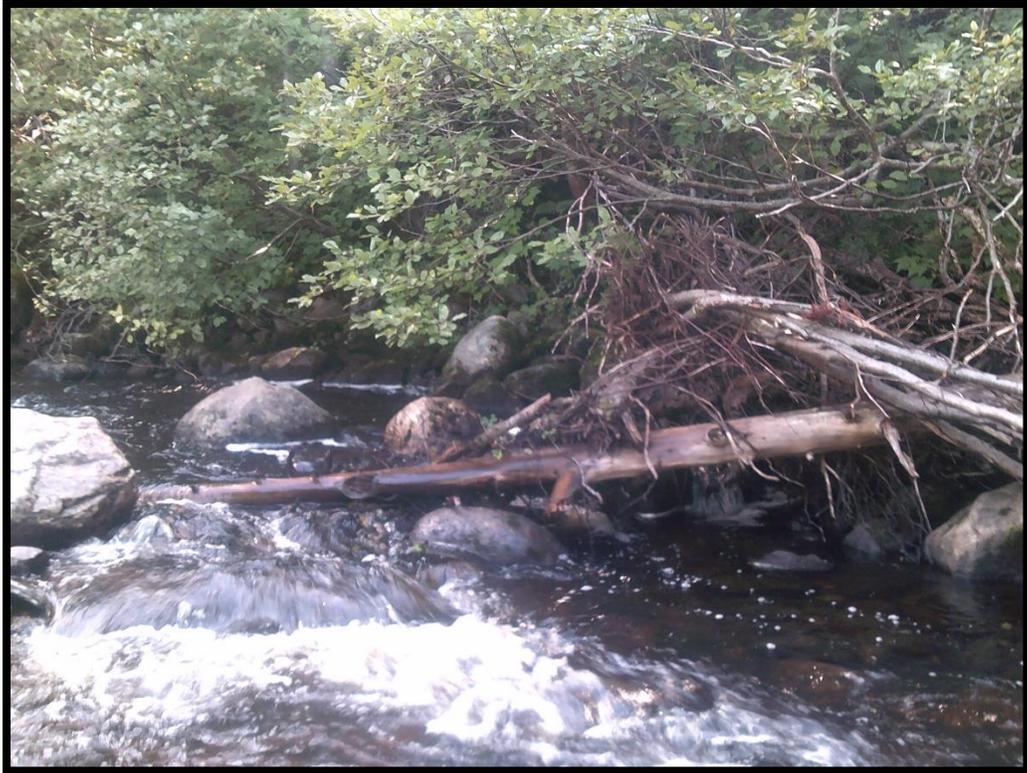
*Figure 64: Looking upstream at obstruction 5, Northern Feeder.*

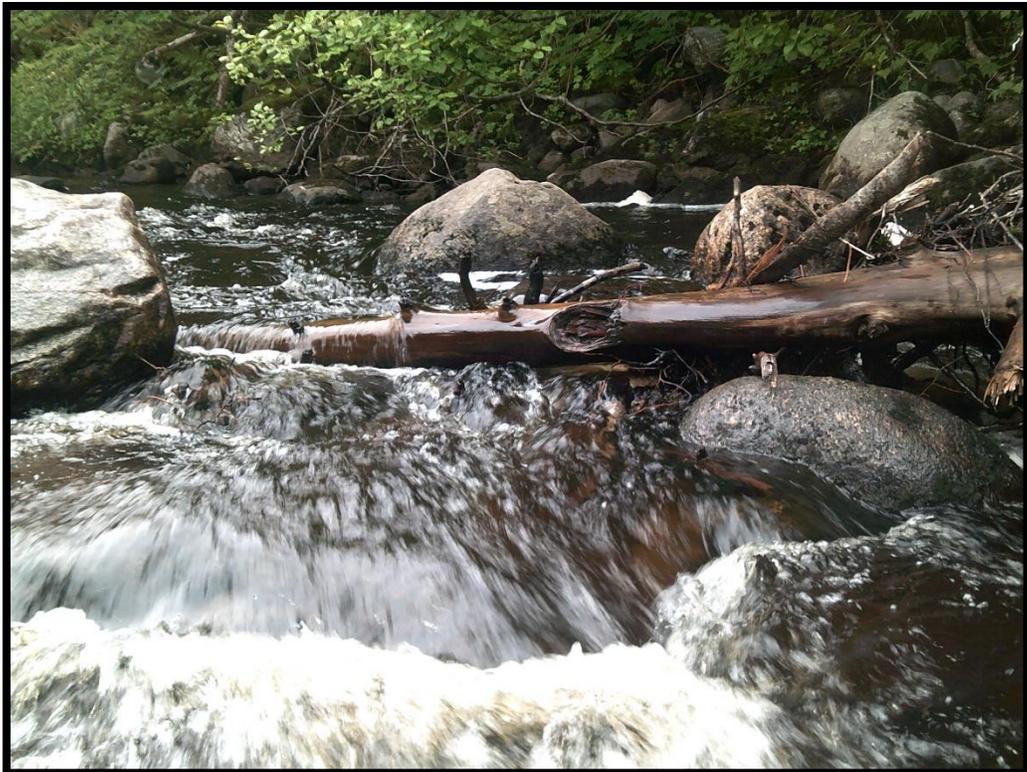
*Figure 65: Closer upstream view of obstruction 5, Northern Feeder.*

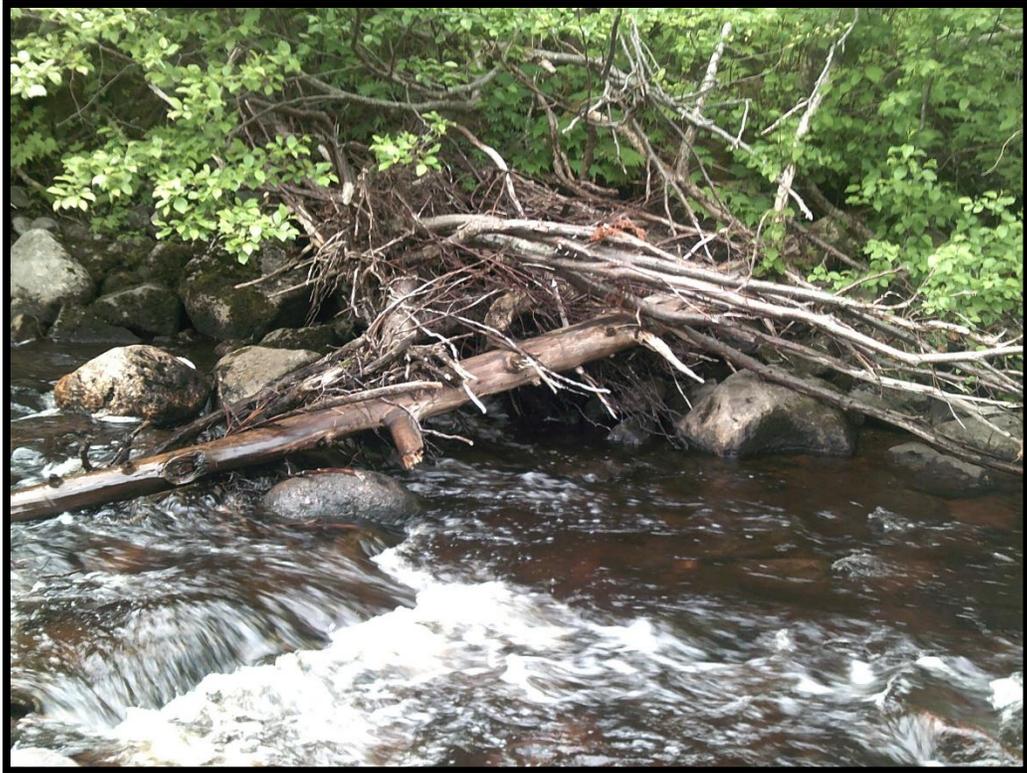
*Figure 66: Sideview of obstruction 5, Northern Feeder.*

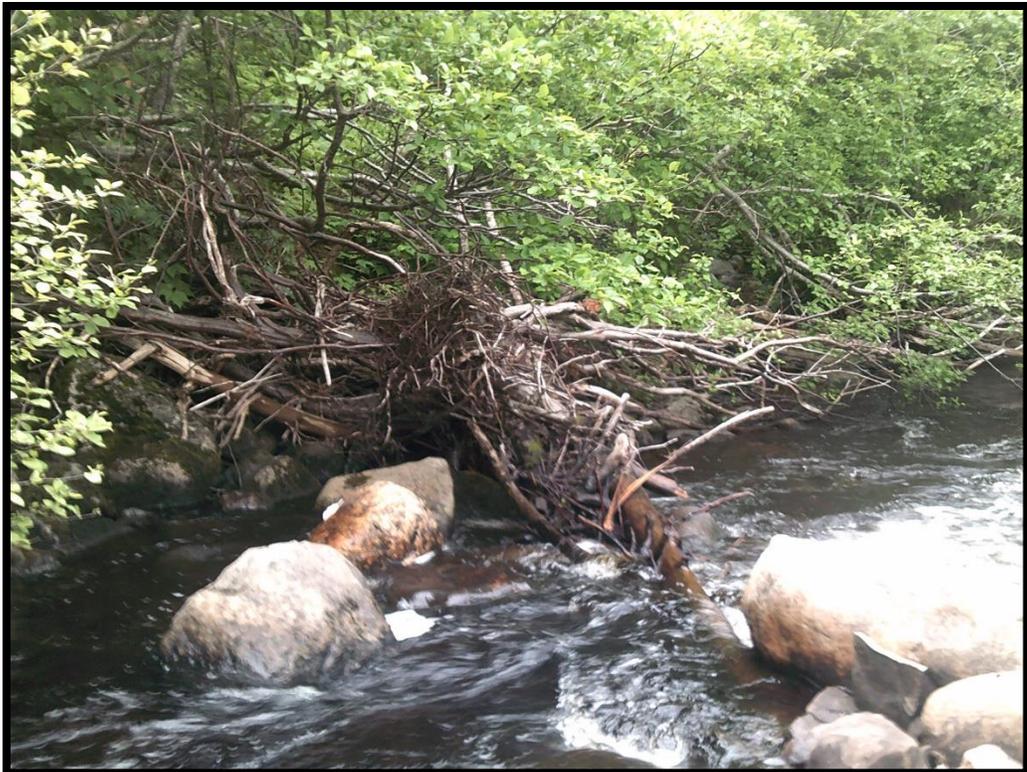
*Figure 67: Downstream view of obstruction 5, Northern Feeder.*

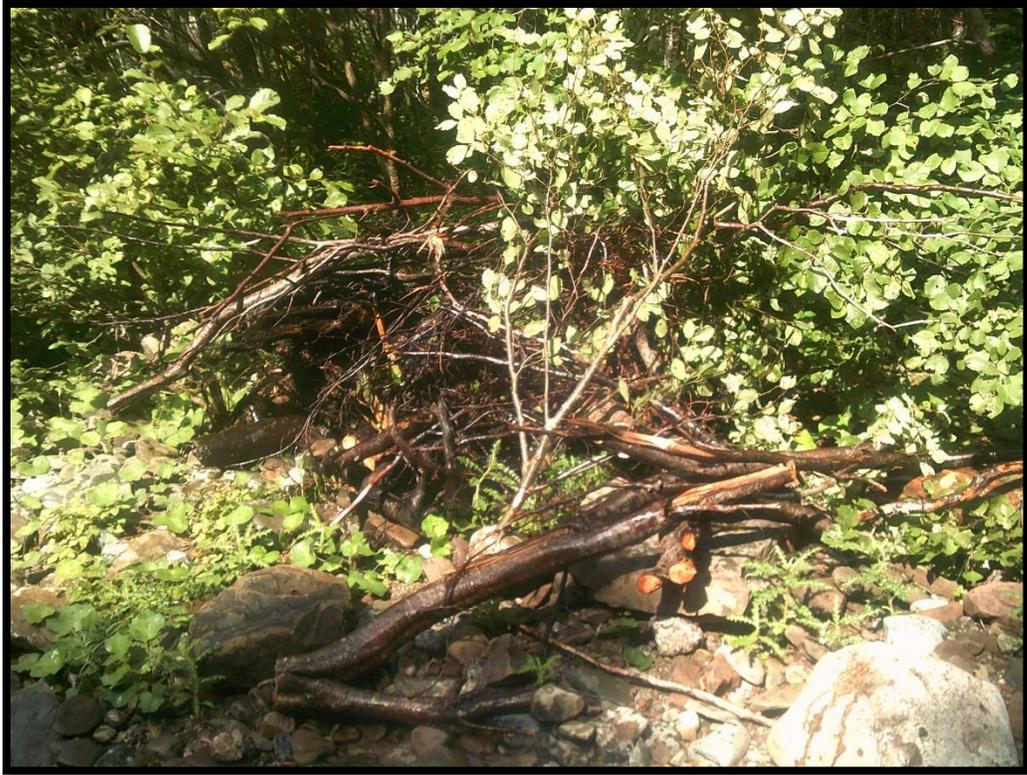
*Figure 68: View of debris removed from obstruction 5, Northern Feeder.*

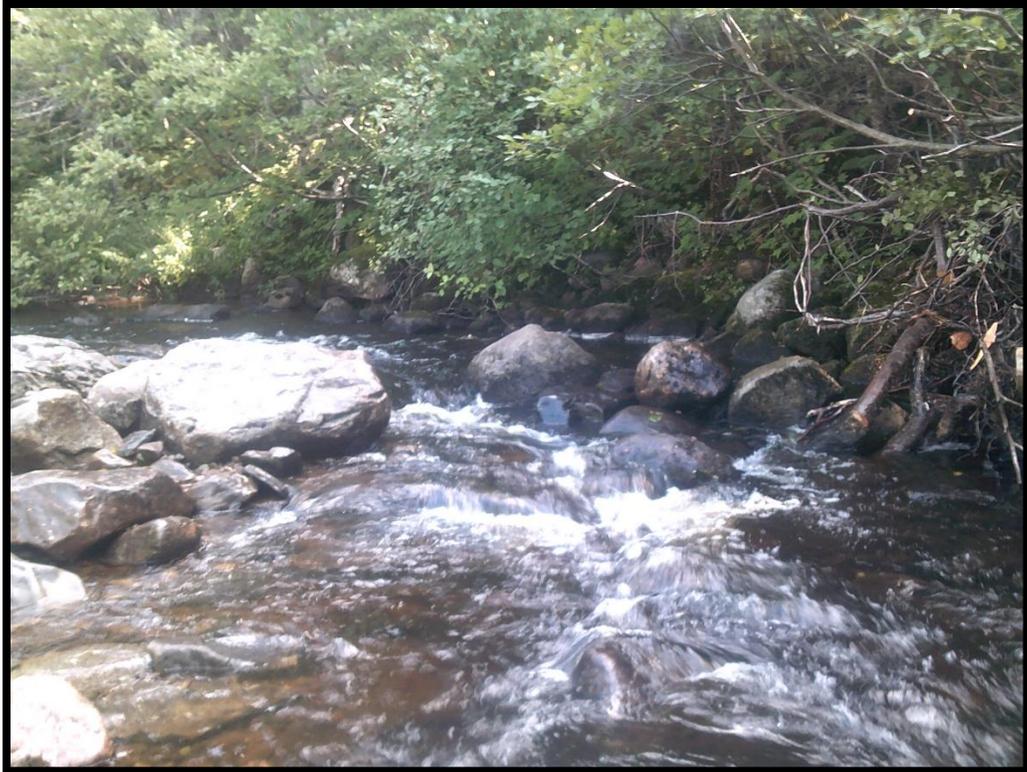
*Figure 69: Upstream view of improved area after removal on obstruction 5, Northern Feeder.*

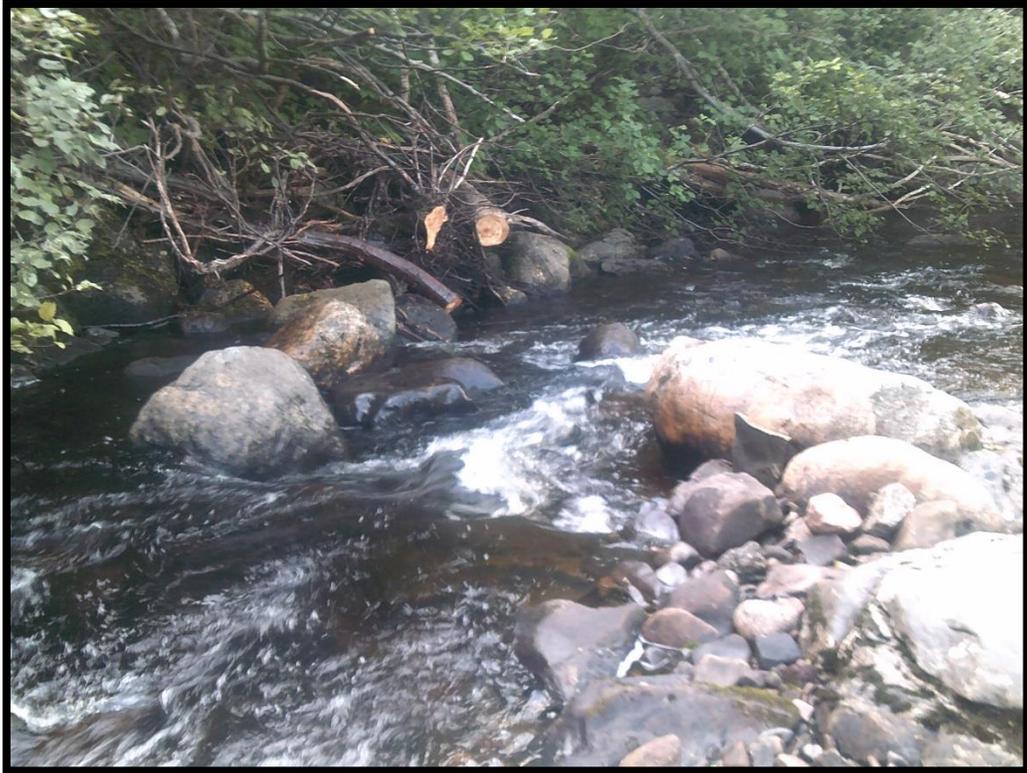
*Figure 70: Downstream view of improved area after removal of obstruction 5, Northern Feeder.*

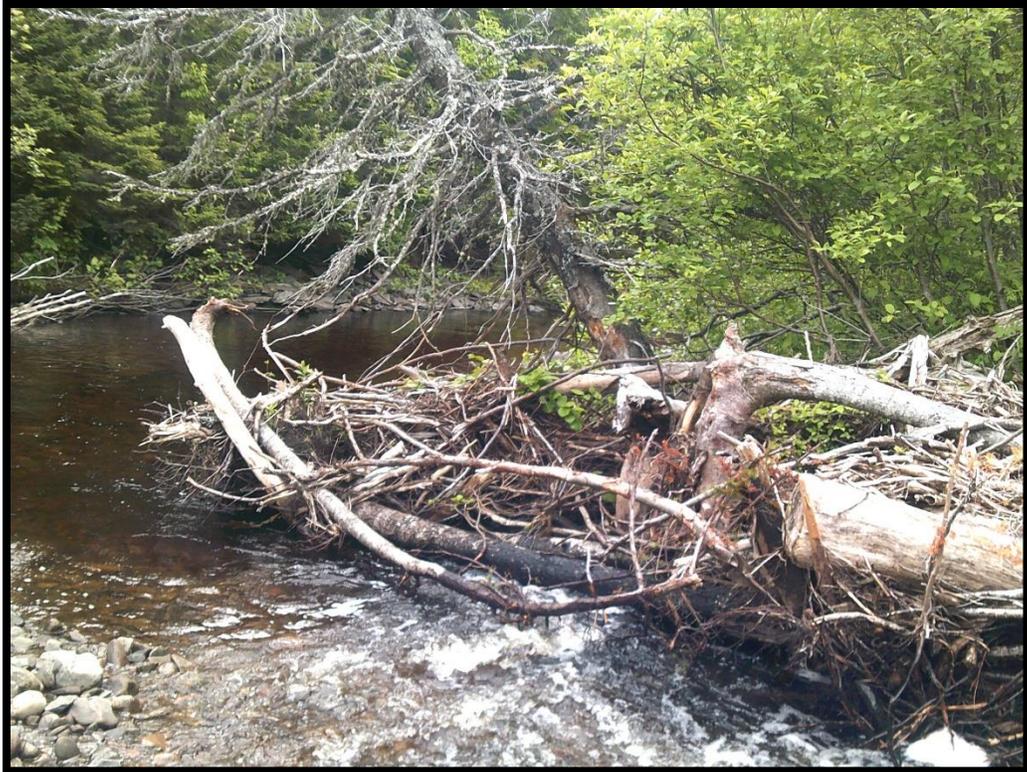
*Figure 71: Downstream view of obstruction 6, Northern Feeder.*

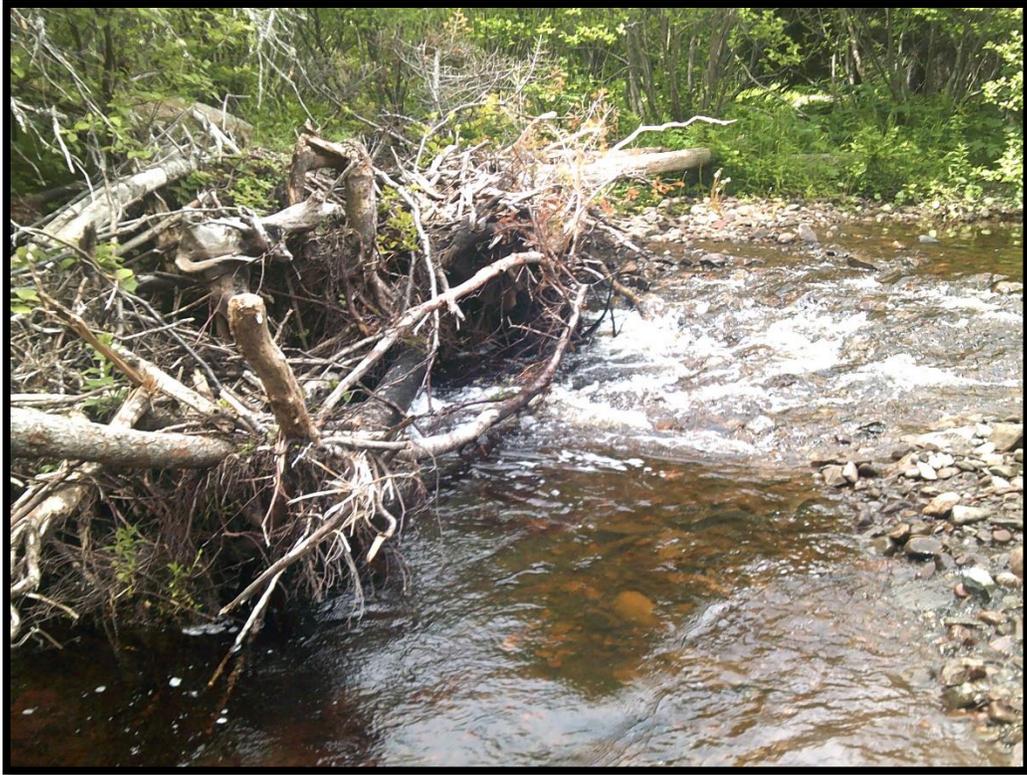
*Figure 72: Looking upstream at obstruction 6, Northern Feeder.*

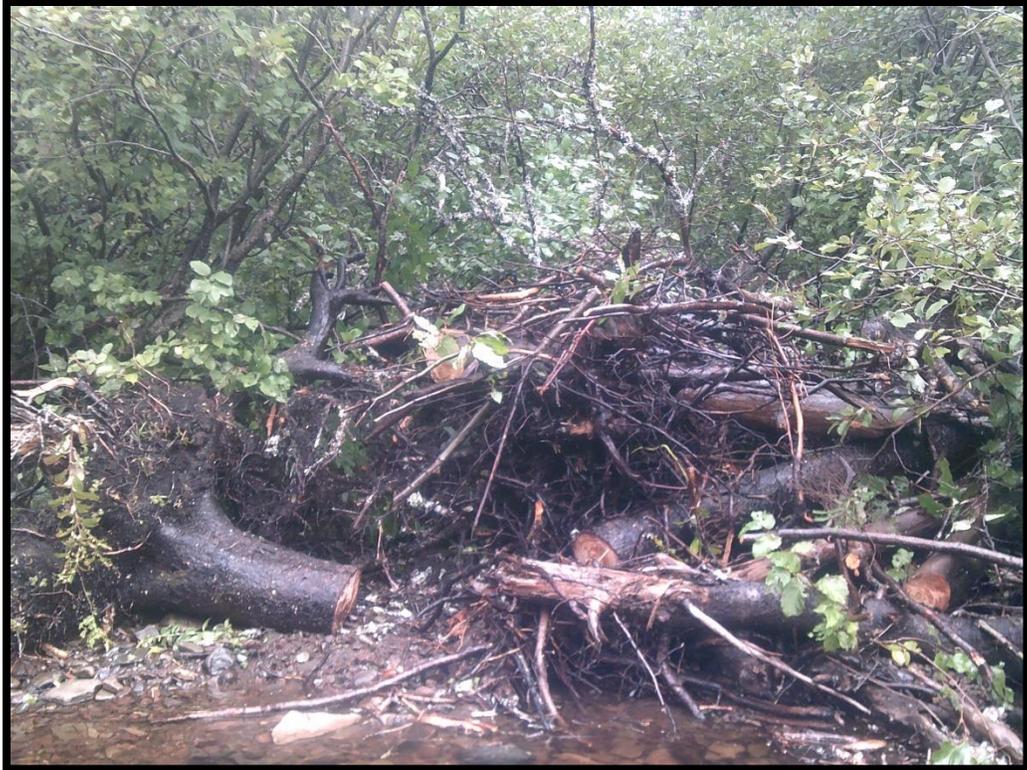
*Figure 73: Debris removed from obstruction 6, out of the flood zone area, Northern Feeder.*
