**DEVELOP HABITAT CONSERVATION PLANS AND RESTORATION FOR RIVERS IN  
BAY ST. GEORGE 2019**

**CRABBES RIVER  
ROBINSONS RIVER**

**BAY ST. GEORGE SOUTH AREA DEVELOPMENT ASSOCIATION**

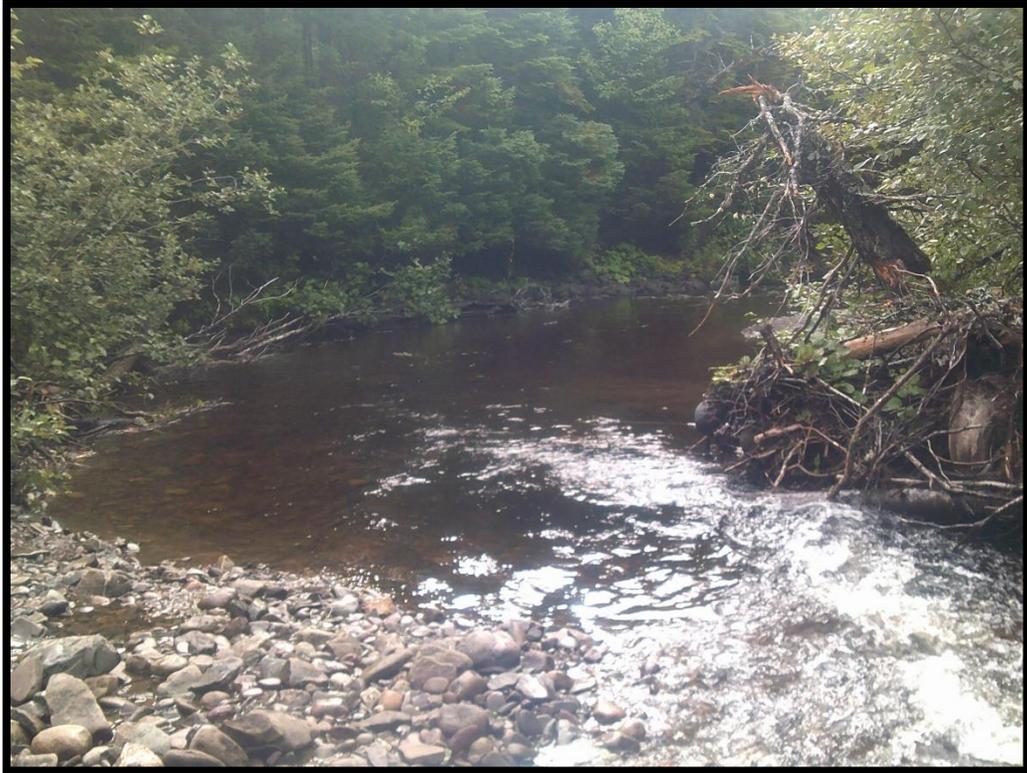
*Figure 74: Looking downstream at improved area on obstruction 6, Northern Feeder.*

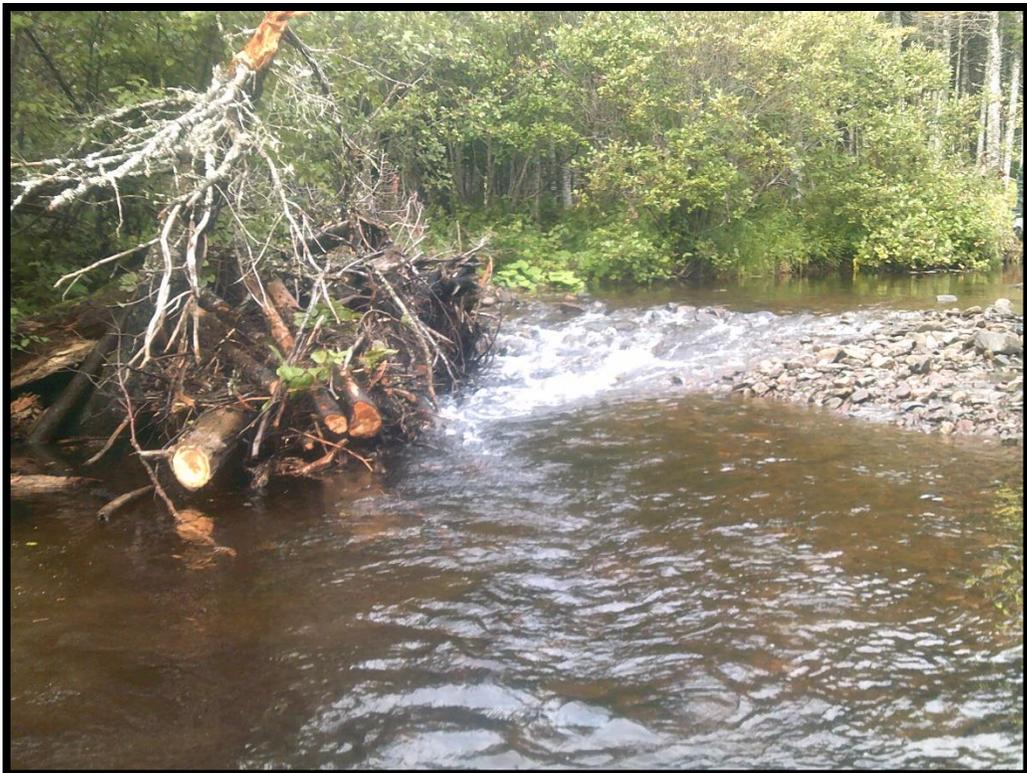
*Figure 75: Upstream view of improved fish passage, Northern Feeder.*

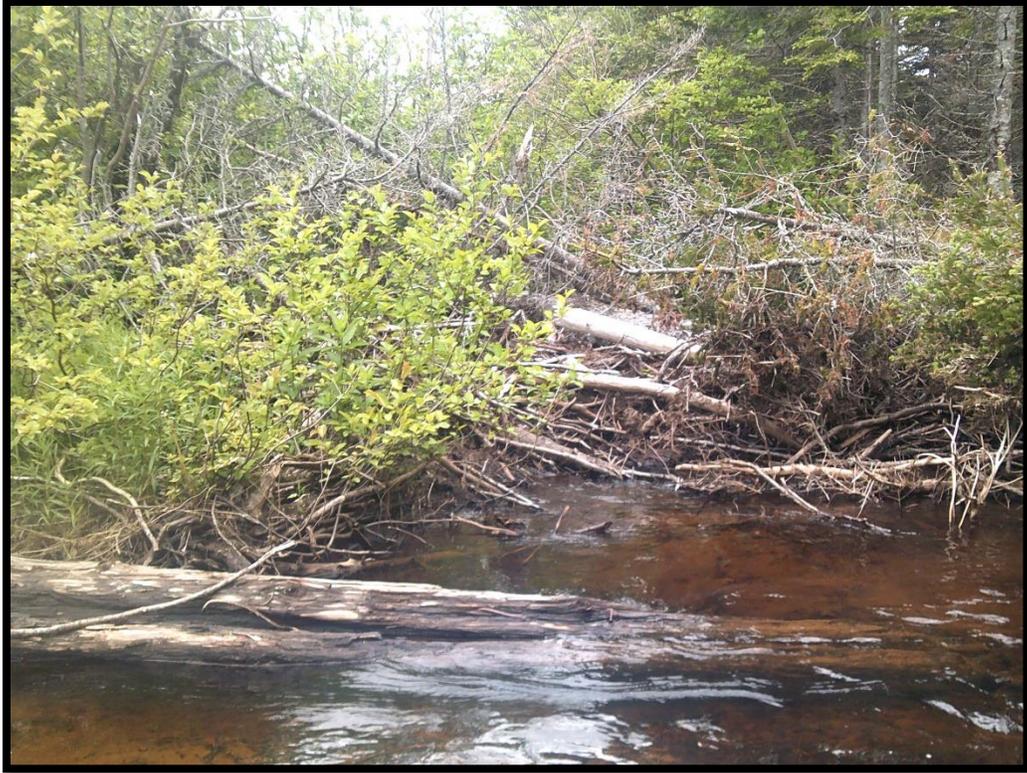
*Figure 76: Downstream view of obstruction 7, Northern Feeder.*

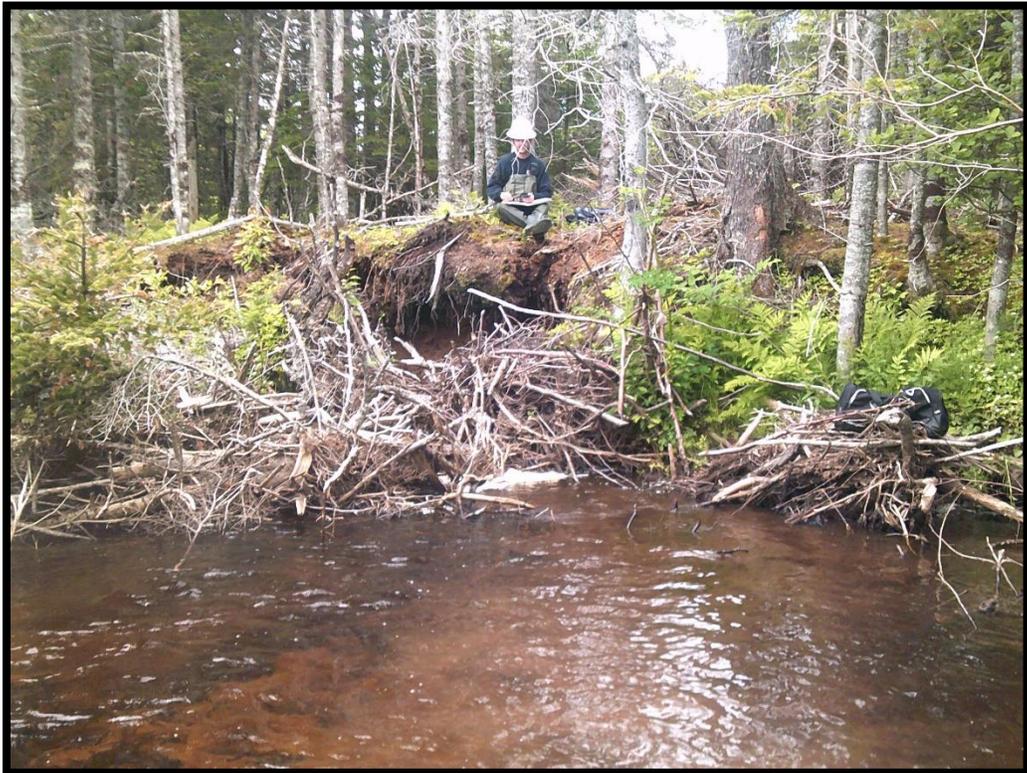
*Figure 77: Sideview of obstruction 7. Water depth is greater here with lots of flow underneath. This is an excellent example of shelter and food source, Northern Feeder.*

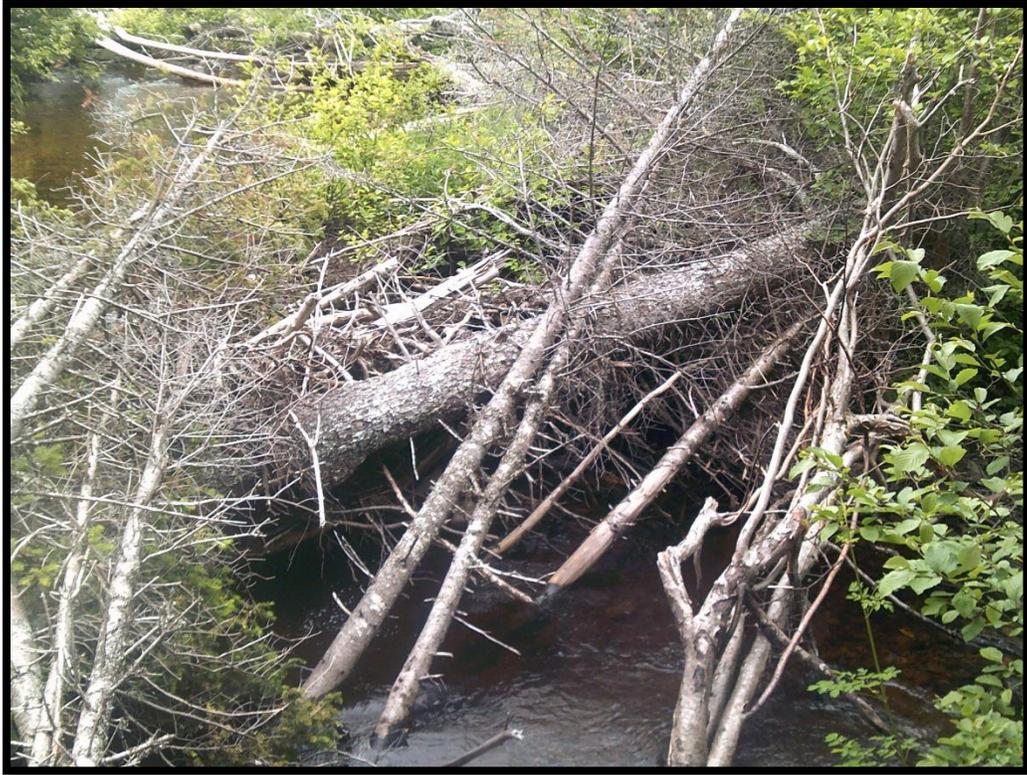
*Figure 78: Overhead view of obstruction 7, Northern Feeder.*

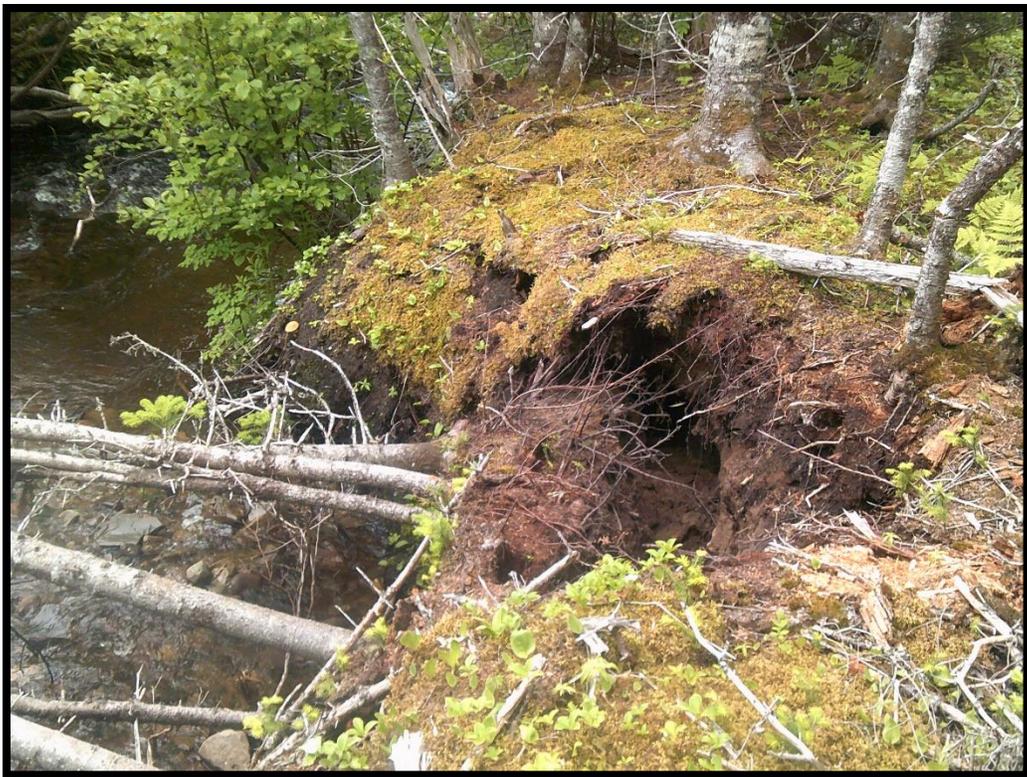
Northern Feeder is a waterbody with minimal debris build up. There were eight (8) obstructions reported with five (5) being removed, most of which were large woody debris. Although most obstructions were removed on Northern Feeder, there was one obstruction that should be monitored due to the high amounts of erosion in the area. Obstruction 7 (N 48.23898°, W -58.60662°) (Fig 76-79) was not removed as there was suffice water flow; however, there is increased risk of higher blockages and siltation due to the higher erosion in the area. One area of higher erosion (N 48.239219°, W -58.606685°) was reported and if left untreated has the potential to cause greater erosion overtime, which would result in increased siltation which can impact salmon and their habitat. It is recommended that seedlings/trees be planted along the eroding banks to give greater bank support to combat the immense erosion in the area.

*Figure 79: Showing the erosion that caused obstruction 7, Northern Feeder.*

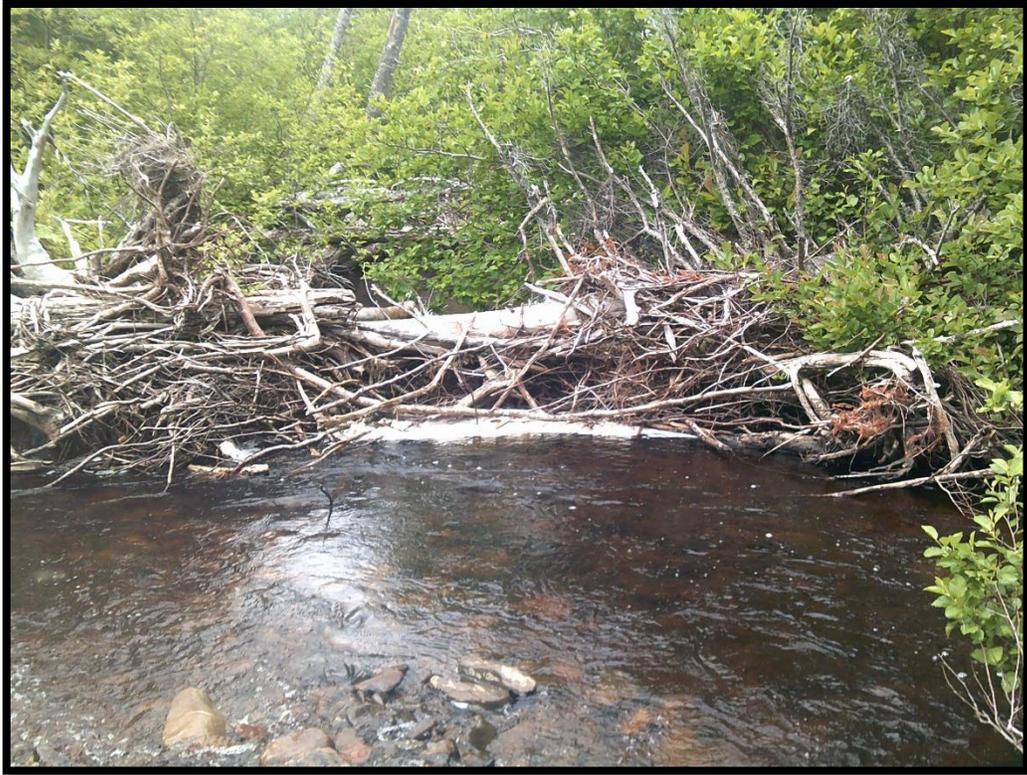
*Figure 80: Looking downstream at obstruction 8, Northern Feeder.*

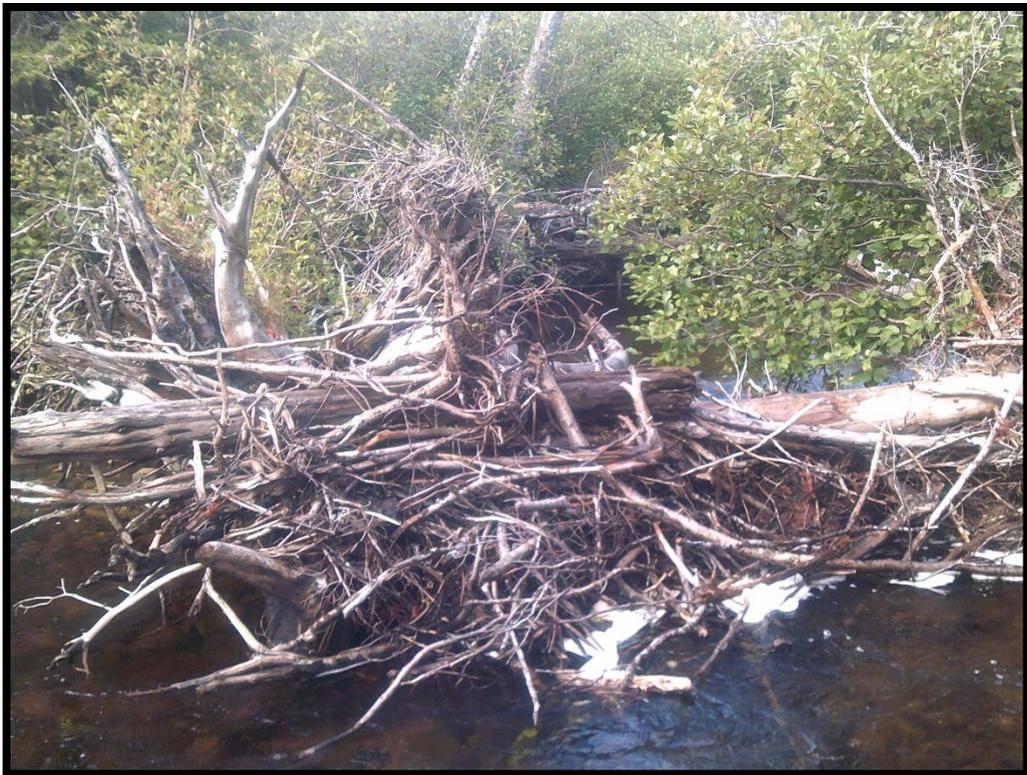
*Figure 81: Closer look at obstruction 8, Northern Feeder.*

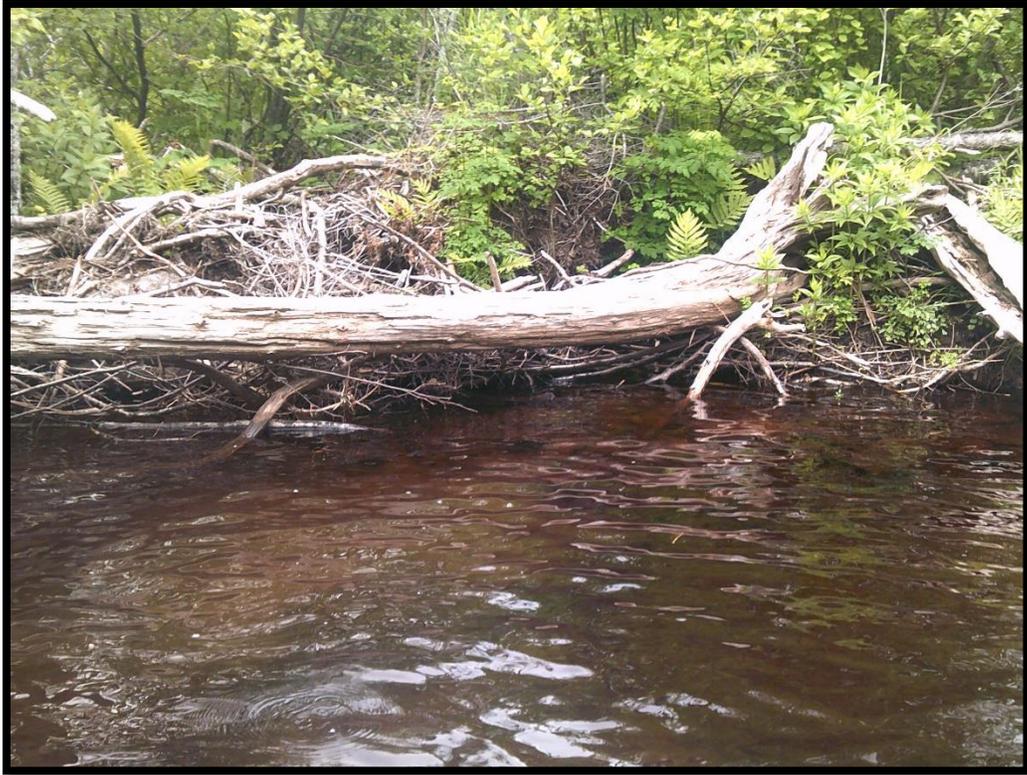
*Figure 82: Upstream view of obstruction 8, Northern Feeder.*

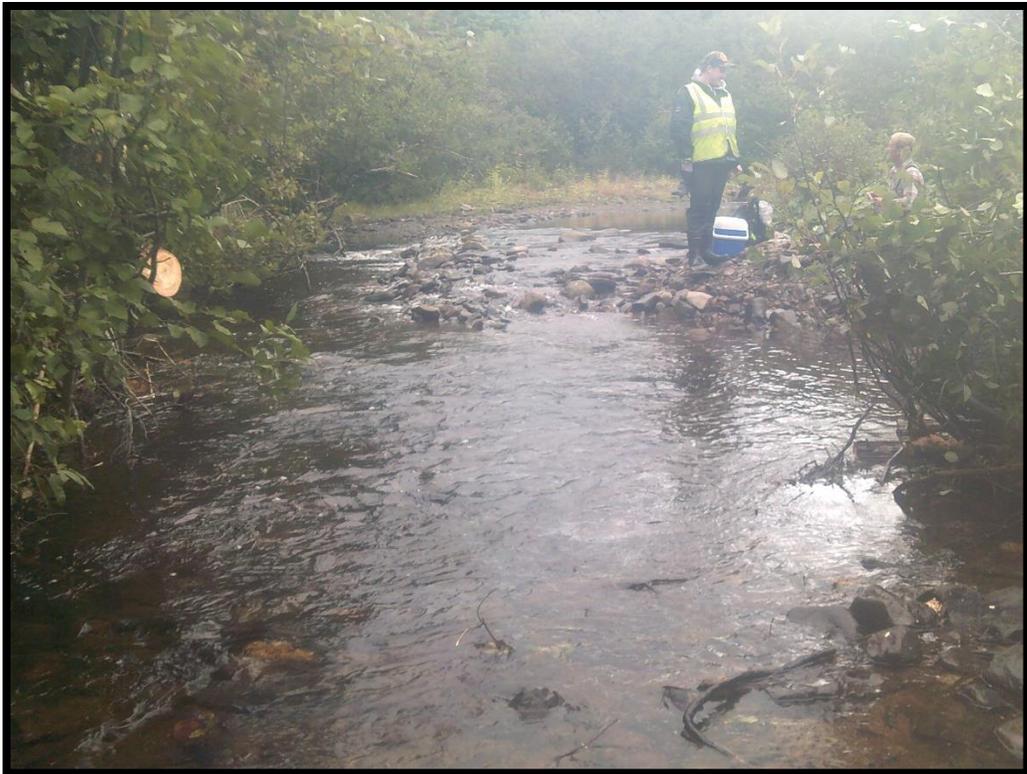
*Figure 83: Looking upstream at improved salmon passage, Northern Feeder.*

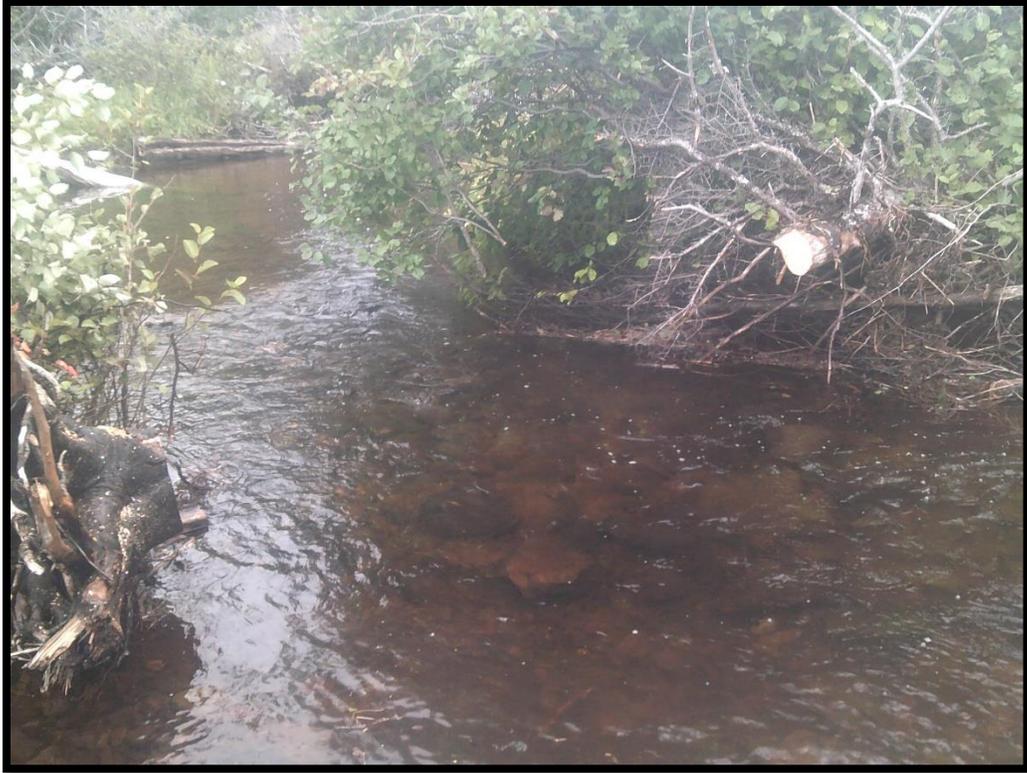
*Figure 84: Downstream view of improved area on obstruction 8, Northern Feeder.*
