A Renewed Conservation Strategy for Atlantic Salmon in Prince Edward Island

April 2019

Daryl Guignon – Oak Meadows Inc.

Connie Gaudet – Central Queens Wildlife Federation

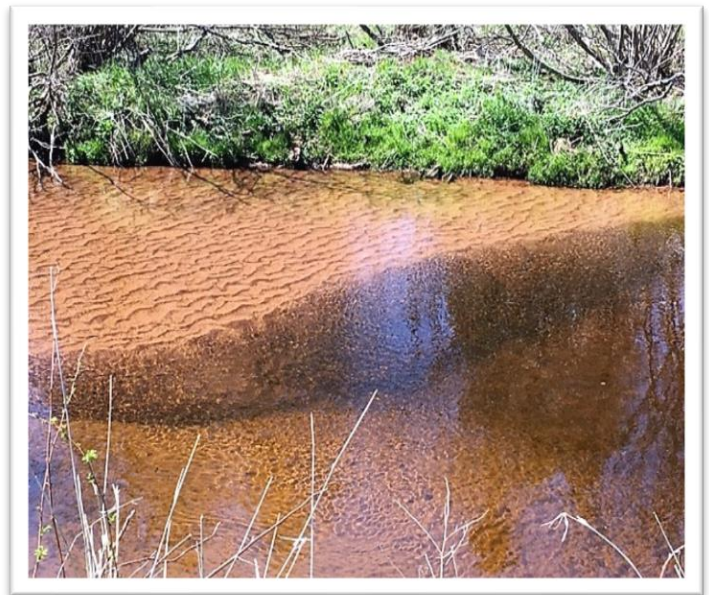
"Wave" of sediment off Dunphy Road in Pisquid River watershed, summer 2018

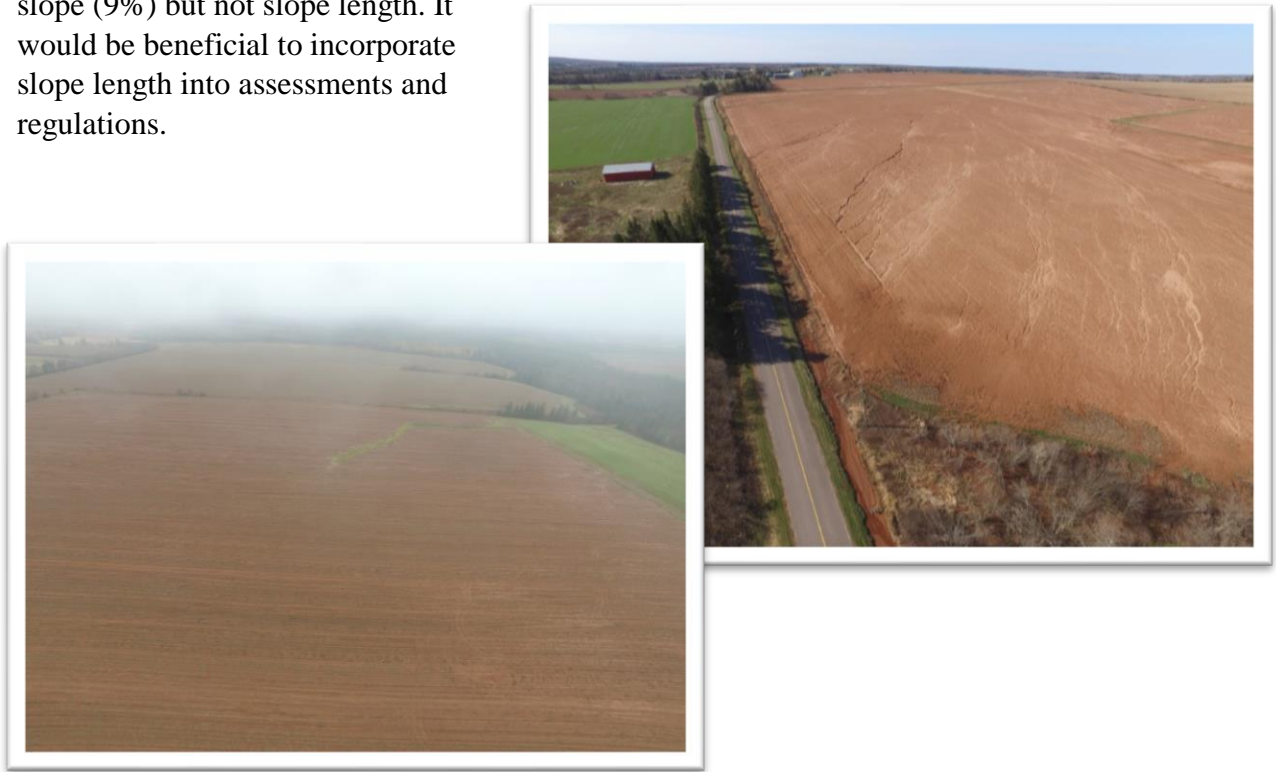
Field consolidation in the Mill River watershed, 2018 (above left) and Fanning Brook in the Hillsborough River watershed, 2018 (above right).

Field consolidation - In November, 2018 Cavendish Farms warned a legislative committee about "significant threats to the long-term sustainability of potato farming on Prince Edward Island," while asking government to double land ownership limits imposed on Island potato farmers. The move towards larger and larger fields is causing greater stress on streams. Depending on topography, consolidation of fields can increase slope length, resulting in significant increase in runoff and soil loss. Generally, if the slope length is doubled, the soil loss is increased 1.5 times. Current regulations and incentives (e.g., for the retiring of sensitive agricultural land) address slope (9%) but not slope length. It would be beneficial to incorporate slope length into assessments and regulations.

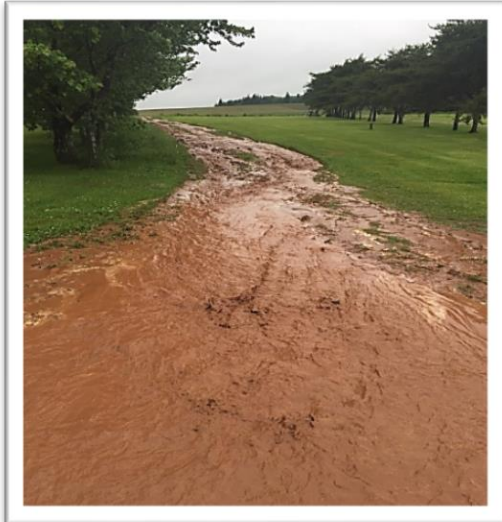
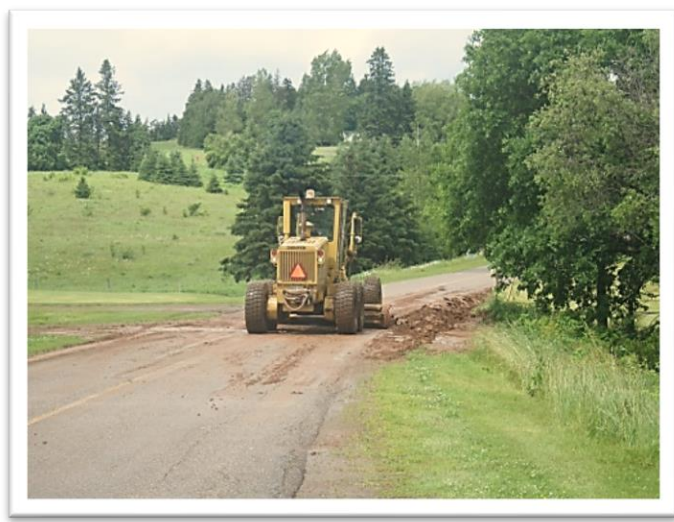
Runoff from potato fields in Grahams Road, July 2018 (above left). A road grader was needed to remove soil from the road (above right)

Exposed Fields - Late harvested potato fields and fields ploughed in the fall can experience major soil erosion during spring runoff. During the winter, cycles of freezing and thawing have a major effect on exposed soil, with the frozen top layer of soil thawing while bottom layers are frozen, making it more susceptible to accelerated runoff through sheet erosion. This is likely to intensify with the increasing frequency of winter rainfall events due to climate change. Exposed winter soil is also subject to sublimation and increased wind erosion. On PEI, there have been several notable “red snow” events – most recently in February 2019 - due to massive topsoil loss in winter as a result of high winds blowing over exposed fields with minimal snow or crop cover.

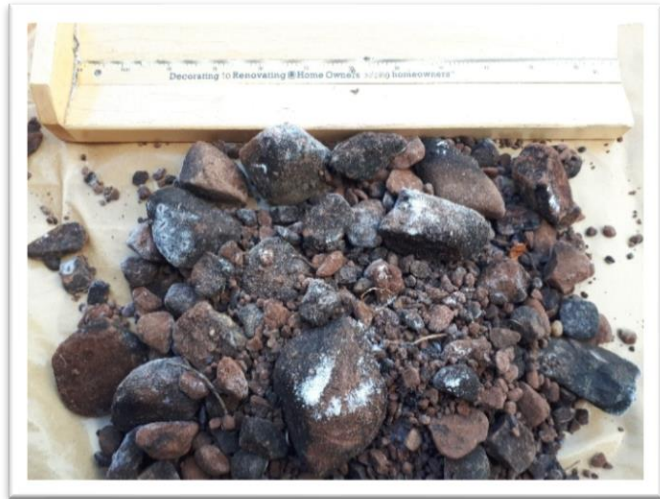
Gravel-cobble substrate taken from North Lake Creek, 2018

Field assessments in 2018 found that the highest density of juvenile salmon, especially for salmon fry, was in well sorted, unembedded, rounded gravel-cobble substrate with adequate interstitial spaces to provide cover. These characteristics are evident in the sample taken from North Lake Creek (right). At this site, high densities of juveniles were found in very shallow water that barely covered the substrate, occupying the interstitial spaces in the gravel. Flatter stones may not provide interstitial spaces for juvenile salmon unless manually manipulated. Several watershed groups have raked existing embedded gravel-cobble substrate or have added cobble to streams to improve salmon habitat.

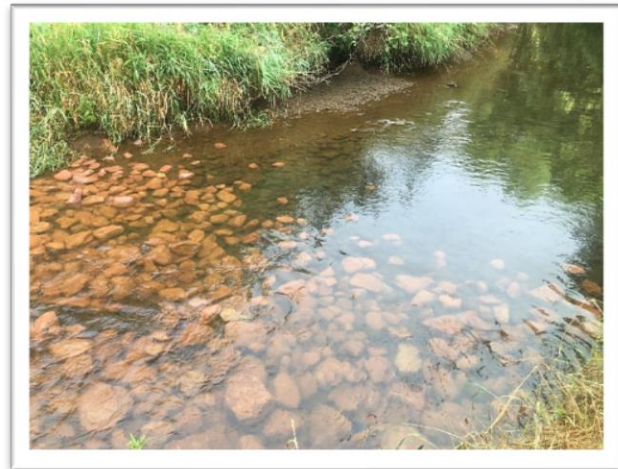
Cobble added to stream bottom in Trout River (Coleman)

- Where suitable gravel-cobble substrate is embedded, raking the stream bottom in late summer can improve juvenile salmon habitat until sedimentation issues are resolved.
- Addition of a mixture of granite gravel and cobble in suitable locations can improve juvenile salmon habitat in rivers with poor quality substrate.
- Crews accessing a site on a regular basis should walk along trails rather than through the stream itself. Many feet walking over gravel beds has potential to kill a large number of juvenile salmon, particularly in sensitive areas where salmon are known to spawn.

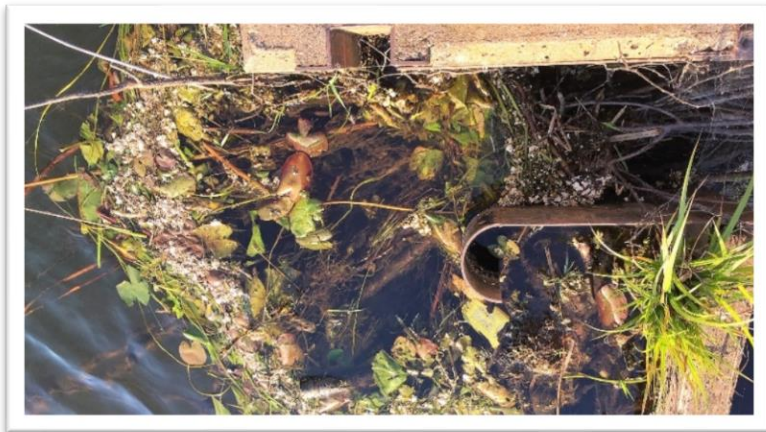
Fish ladder at Robinsons Pond clogged with aquatic vegetation

1. The fish ladder at Robinsons Pond periodically becomes blocked with aquatic vegetation and should be cleared regularly.
2. There appears to be residential runoff near the post office in Tyne Valley.
3. Flood conditions prevented a complete redd count in 2017, suggesting a “flashiness” to the system that could be limiting to Atlantic salmon spawning.
4. Pesticide runoff was a problem in the past (there was a major fish kill in Trout River in 1999).
5. The watershed group is working hard to control beavers and remove blockages.
6. The presence of brown bullhead may be a limiting factor for Atlantic salmon in these streams.

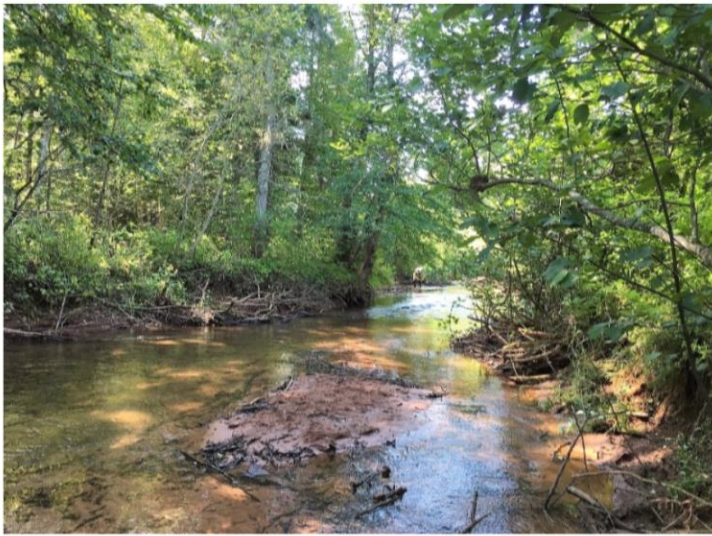
Electrofishing site at Howell Brook below Cudmore's showing some sediment deposits in channel (left)
