**Management Plan for Kouchibouguacis and Kouchibouguac River  
Watersheds**

**2021**

**Published by: The Friends of the Kouchibouguacis Inc.**

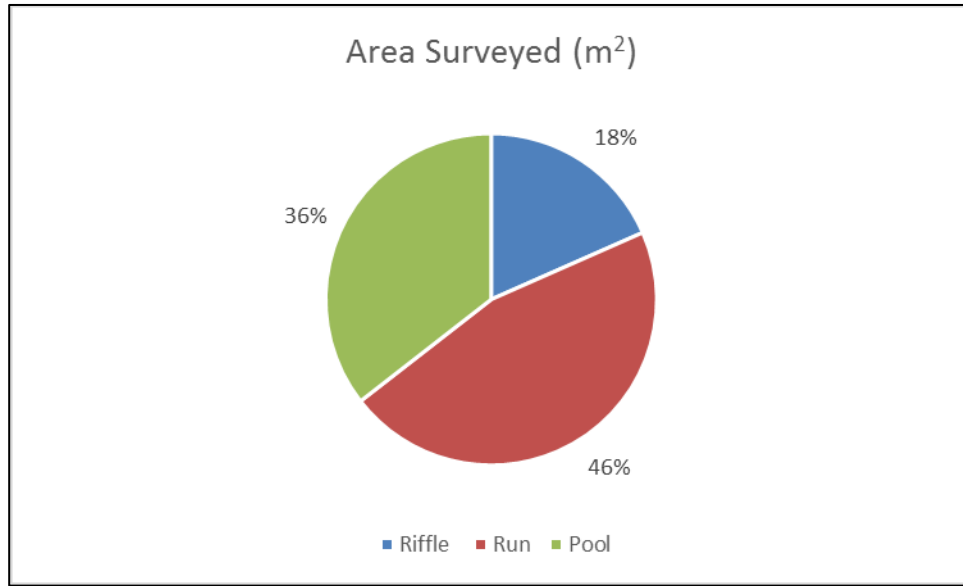
Figure 7: Area surveyed by habitat type Kouchibouguac River

The following data was gathered from stream surveys conducted by TFK in the Kouchibouguac watershed (Kouchibouguac River) from 2019 to 2021, that is to date, and provides a snapshot of the conditions observed. The total linear measured length of stream surveyed in the watershed was 2,5649.4 (m). Starting at the coordinates 46.79262° X 65.05804° Y, and ending at the coordinates 46.71735° X 65.25326° Y. The total area surveyed, obtained by multiplying the wetted width of a section by said sections length and summing all sections was 492,477.80 square meters (m<sup>2</sup>). This can be further broken down by area surveyed per stream habitat type (riffle, run, or pool); as listed in table 8 below and displayed in figure 7 on the following page. As per these charts the habitat type (e.g., run, riffle, pool) making up the largest portion of the area surveyed is runs (46%), followed by pools (36%), and then riffles (18%).

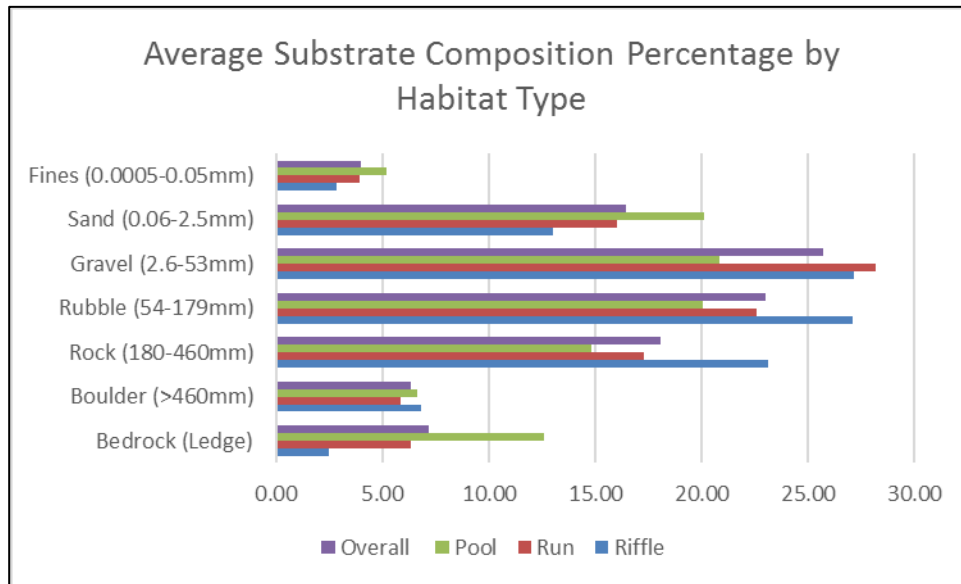
Figure 9: Average substrate composition percentage Kouchibouguac River

Substrate composition and embeddedness of substrate of each section was estimated. The average overall embeddedness of the watershed areas surveyed was approximately 19.63%. The estimated composition of each section was averaged by habitat type and overall. The averaged percentages can be found in table 11 on the following page, along with the category size specifications, and displayed in figure 9 on the following page.

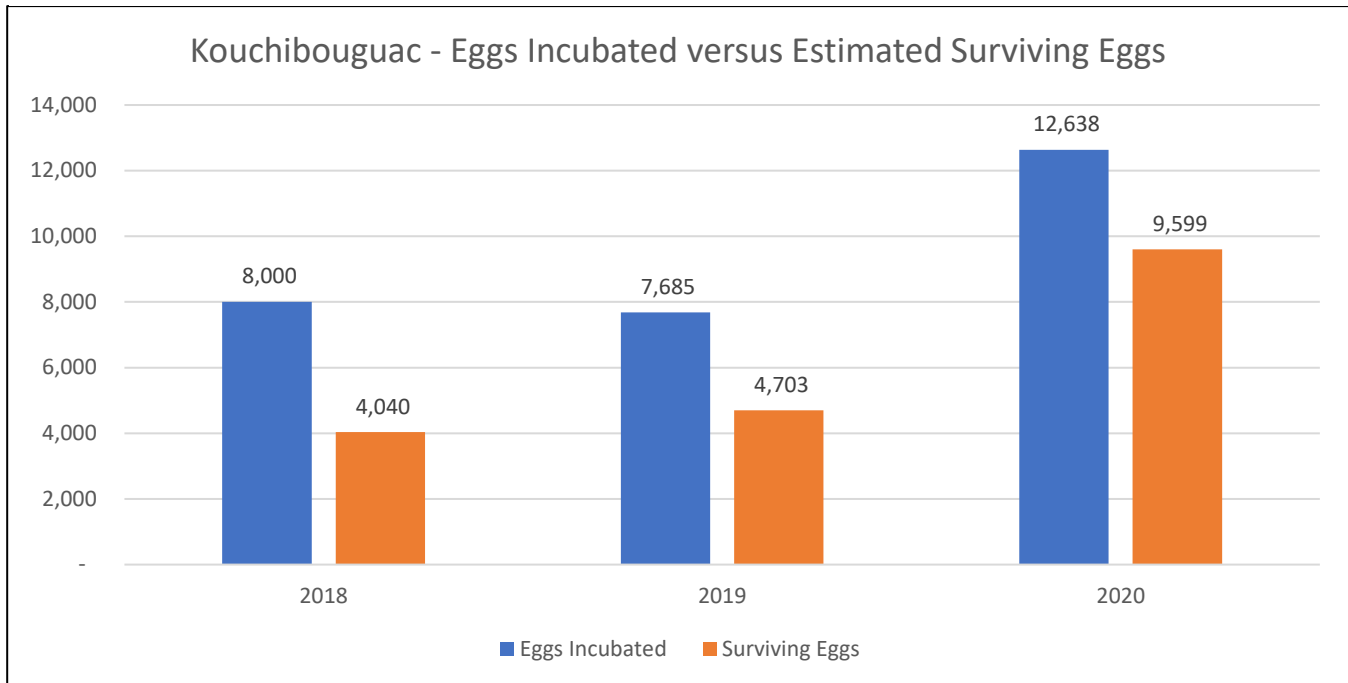
Figure 18: Eggs Incubated versus estimated surviving eggs in the Kouchibouguac watershed

Figure 18 on the following page displays the number of eggs incubated and the estimated number of eggs successfully hatched by year within the Kouchibouguac watershed.

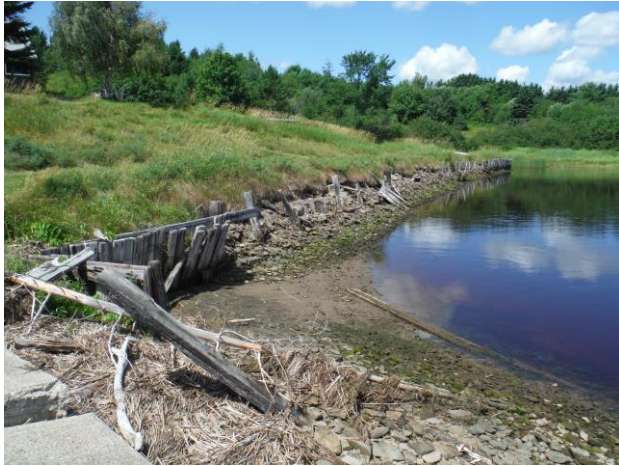
In 2014, an aging creosote wall that was used to support the shoreline located on a private property situated along the main branch of Kouchibouguacis River was removed. This creosote wall was failing, which resulted in a compromised/eroding shoreline as well as a source of pollution (e.g., hydrocarbons, sediment, etc.) into the Kouchibouguacis River. The creosote wall was removed, and the remaining land was regraded with a rock toe being installed to support the shoreline. Various types of native vegetation were also planted to help stabilize the soil using the natural root systems (**see images on the following page for before and after results**).

Pre-restoration photo displaying failing creosote wall (2012)

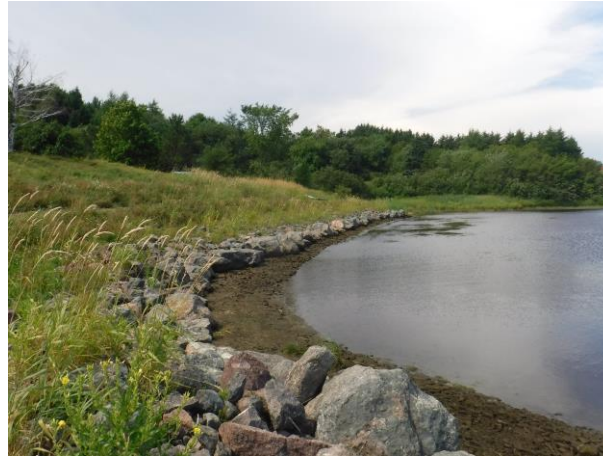
Post-restoration photo during follow-up visit displaying successful shoreline restoration (2016)

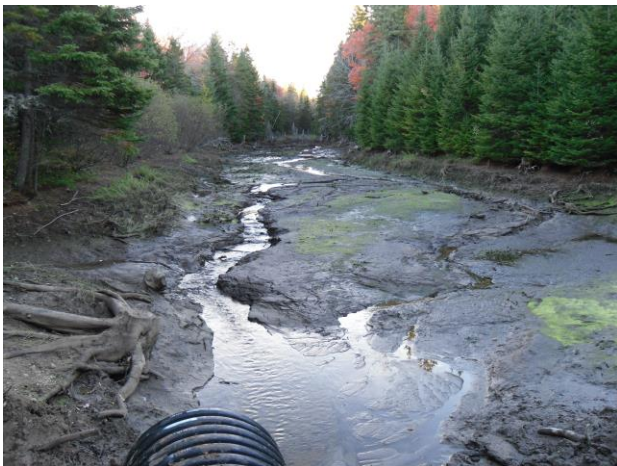
This project consisted of replacing a non-functional culvert that was obstructing flow on the ruisseau sans nom (unnamed brook), a tributary located within the Kouchibouguacis watershed. The obstructed flow was resulting in severe backwatering on the upstream end of the culvert, which converted the stream into a pond temporarily. The replacement of the culvert allowed the reestablishment of appropriate waterflow, and resulted in a restored stream for our watershed (see images below for before and after results).

Before photo displaying effects of severe flow obstruction (2010)

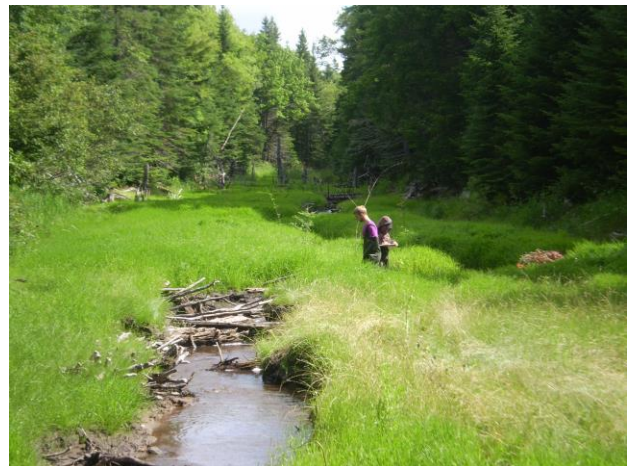
After photo displaying results of flow restoration and revegetation progress (2011)

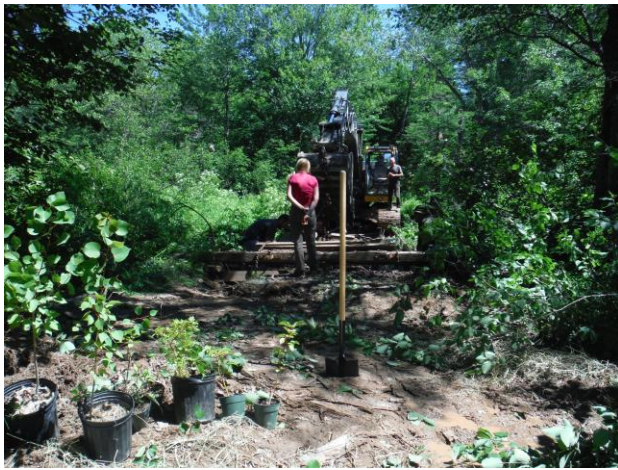
vegetation was planted throughout each side of the trail. Straw and grass seed were placed strategically to help reduce bare soil exposure and rapidly aid in stabilizing each embankment until more dense root systems and vegetation could take hold (see images below).

Before photo displaying bridge removal and exposed trail substrate (2018)

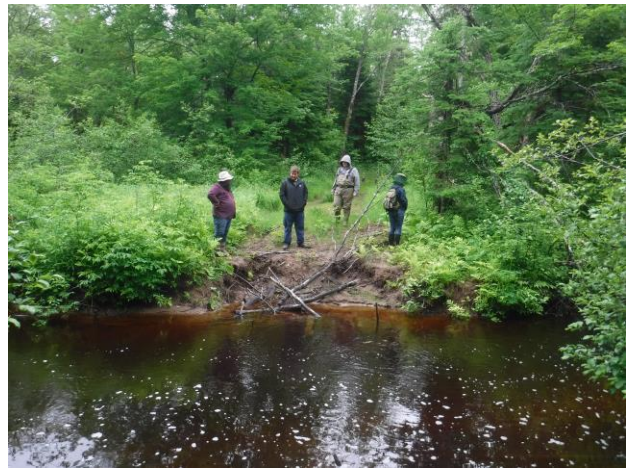
After photo displaying results of restored trail and vegetation (2019)
