Management Plan for Kouchibouguacis and Kouchibouguac River Watersheds

2023

Published by: The Friends of the Kouchibouguacis Inc.

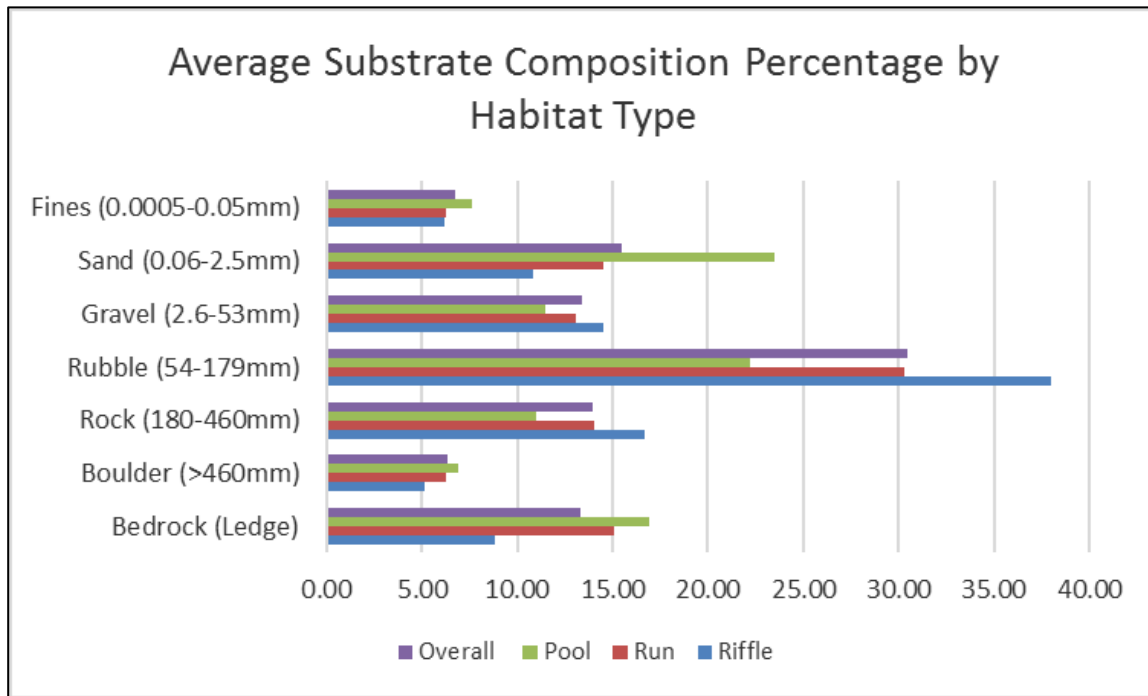
Figure 4: Average substrate composition percentage Kouchibouguacis River

Substrate composition and embeddedness of substrate of each section was estimated. The average overall embeddedness of the watershed areas surveyed was approximately 29.45%. The estimated composition of each section was averaged by habitat type and overall. The averaged percentages can be found in **Table 5 below**, along with the category size specifications, and displayed in **Figure 4 on the following page**.

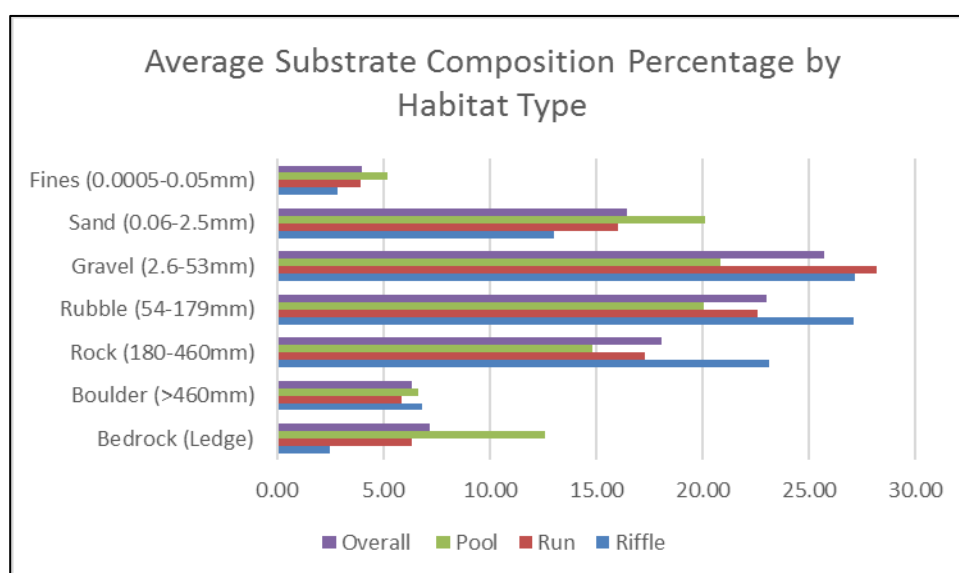
Figure 9: Average substrate composition percentage Kouchibouguac River

Substrate composition and embeddedness of substrate of each section was estimated. The average overall embeddedness of the watershed areas surveyed was approximately 19.63%. The estimated composition of each section was averaged by habitat type and overall. The averaged percentages can be found in **Table 11 on the following page**, along with the category size specifications, and displayed in **Figure 9 on the following page**.

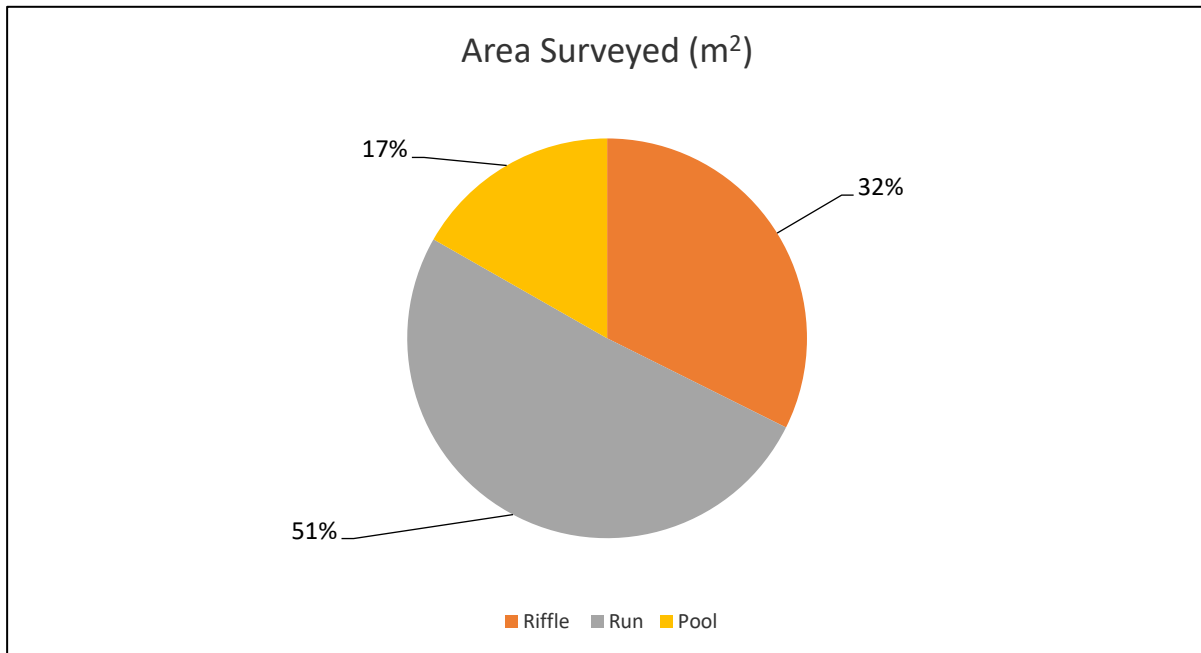
Figure 21 : Area surveyed (m²) (Kouchibouguac)

The total flat area of stream survey was calculated in order give an idea of area of available habitat. The total was then further broken-down by habitat, accounting for both the area of the main section and the smaller “sub habitats” found within each section. Area was calculated using the measured length of each section and multiplying that by the averaged “wetted width” of each section. The total cumulative area of each habitat type and total area surveyed can be found in **Table 27 below** and the breakdown by habitat is visualized in **Figure 21 on the following page**.

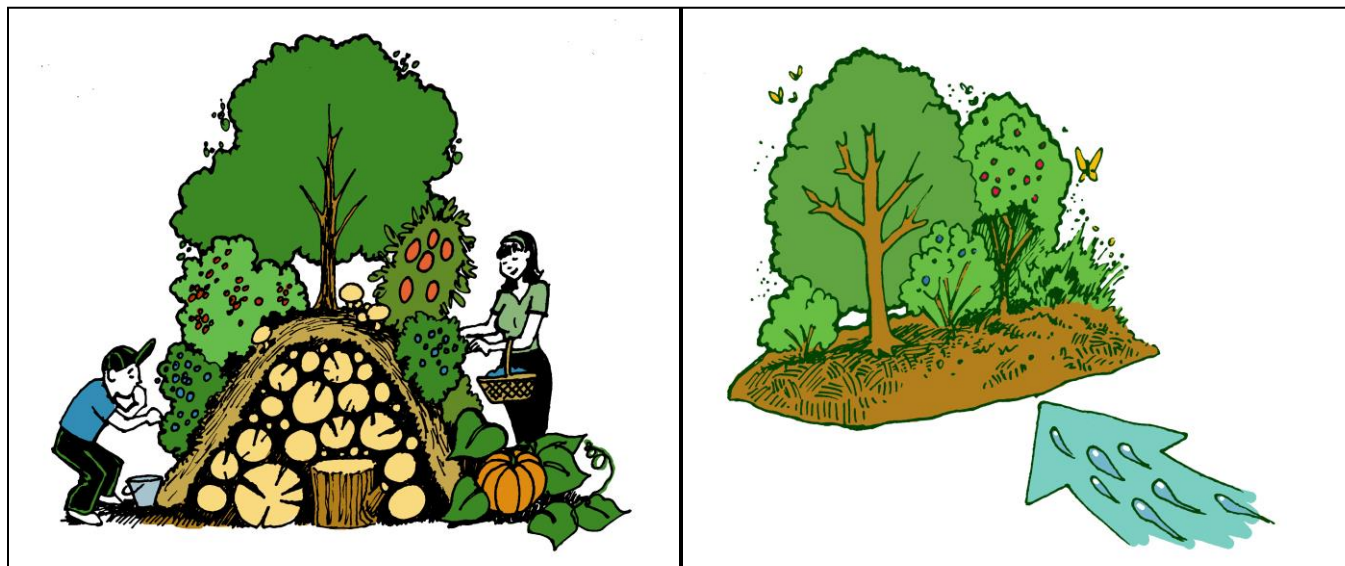
- On a smaller scale (e.g., private residences, community areas, etc.), various gardening techniques can be implemented to utilize and control excess surface water; one great example is hügelkultur (see images below).

Hügelkultur is a Germanic-traditional permaculture method that utilizes organic debris (e.g., sticks, logs, compost, etc.) along with soil to form berm-like structures that can be shaped to divert or slow surface water. The action of diverting surface water can slow down the speed and assist in directing the runoff to an area more capable of handling it. This technique can be implemented in private or public settings, vegetation such as produce and/or aesthetic plants can be planted very successfully; as each hügelkultur bed absorbs water and feeds plants adequately – this stored water also allows for a more consistent water-supply during periods of drought. Hügelkultur also produces heat as a by-product of the natural composting processes taking place within the soil, which can extend growing seasons in areas like ours (provides heat when cold weather comes).

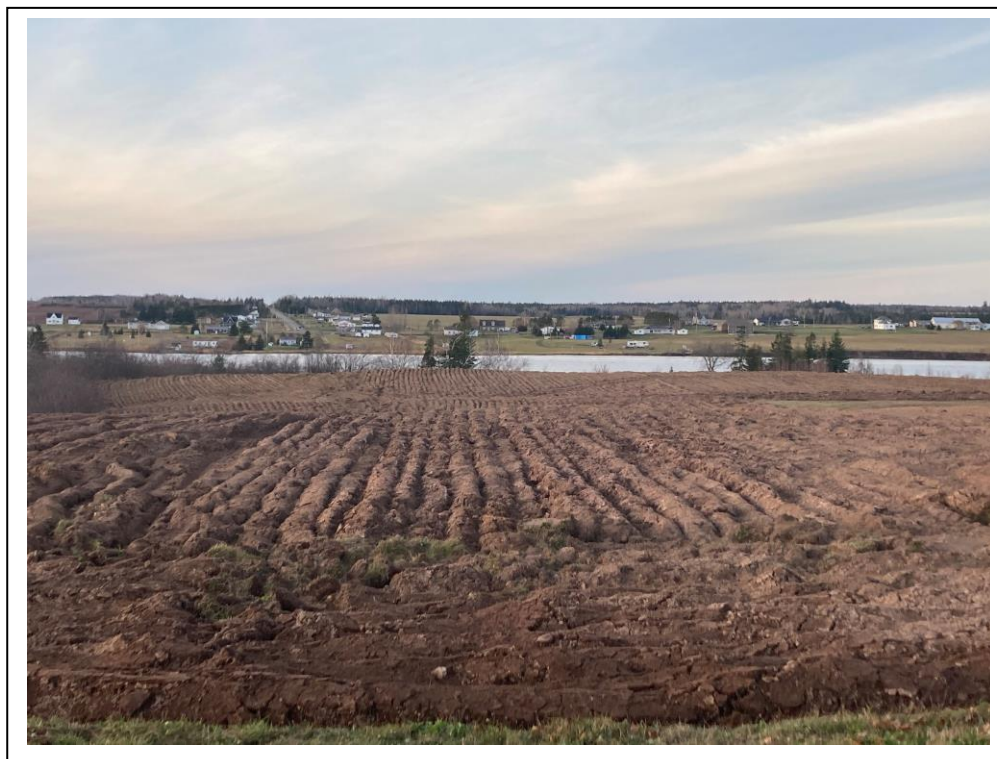
Agriculture is a very necessary and important aspect of any community, especially a rural one like ours. However, there are various common agricultural practices that are beginning to be revealed as detrimental to the ecosystem. Nature does not like bare soil - though it may happen naturally at times - it either gets covered by new vegetation, or it gets washed away by surface water and/or wind. Many agricultural facilities leave enormous amounts of bare soil exposed to the elements, through tilling and/or harvesting processes (**see image below**).

Every particle of dust/soil and molecule of water will likely make its way into the nearby waterways. This illustrates the importance of using methods that reduce the amount of bare soil exposure. Regenerative agriculture is comprised of practices that utilize: crop rotation, livestock rotation, and the elimination of tilling. Implementing these practices allows for the maintenance and/or restoration of soil organic matter (SOM) and the natural soil composition; which in turn absorbs and stores carbon from the atmosphere, while also improving crop/land resiliency and the water cycle (e.g., increased water retention, reduced evaporation, increased nutrient retention, reduced soil loss, etc.). It should be noted that some crops or instances do not allow for no-till practices (e.g., deep planted crops such as potatoes, etc.) though minimally disturbing practices and/or measures that mitigate sedimentation and runoff (e.g., ditching, sedimentation ponds, etc.) from entering nearby waterways can still be implemented around these areas (**see on the following page**).

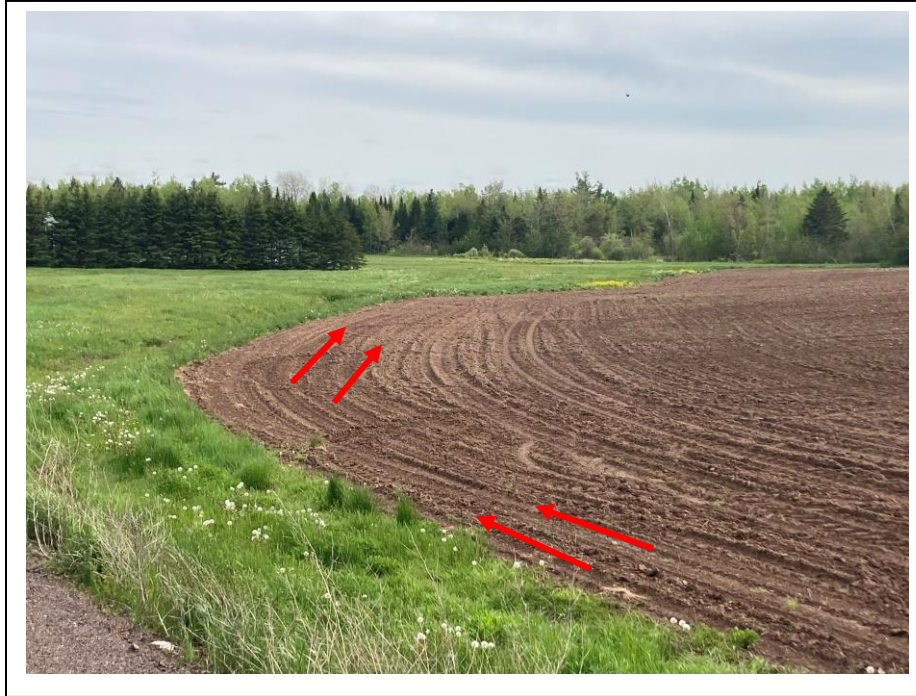
This image shows a ditching process that uses a minimum of three trenches dug in a parallel direction in relation to drainage ditches, these act as a final catchment for any debris/sediment that may otherwise wash away with surface water runoff. The following recommendations can be used individually, or collectively to achieve greater results.

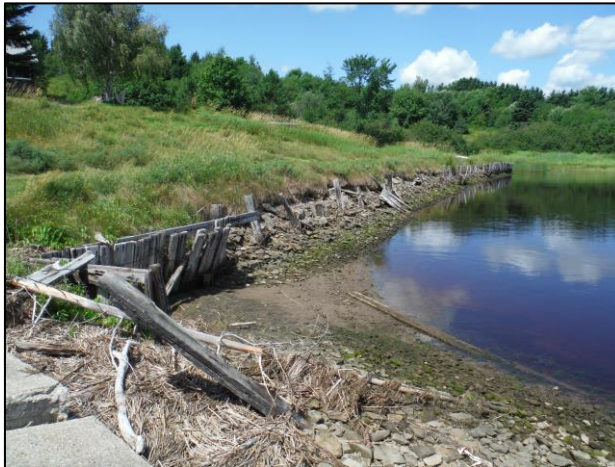
Pre-restoration photo displaying failing creosote wall (2012)

In 2014, an aging creosote wall that was used to support the shoreline located on a private property situated along the main branch of Kouchibouguacis River was removed. This creosote wall was failing, which resulted in a compromised/eroding shoreline as well as a source of pollution (e.g., hydrocarbons, sediment, etc.) into the Kouchibouguacis River. The creosote wall was removed, and the remaining land was regraded with a rock toe being installed to support the shoreline. Various types of native vegetation were also planted to help stabilize the soil using the natural root systems (**see image on the following page**).

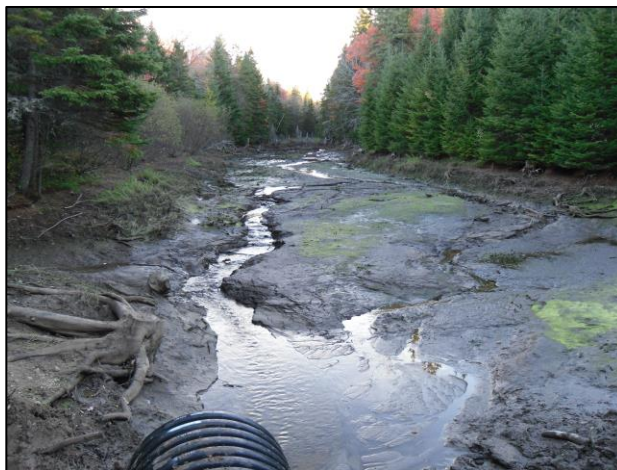
Before photo displaying effects of severe flow obstruction (2010)

This project consisted of replacing a non-functional culvert that was obstructing flow on the ruisseau sans nom (unnamed brook), a tributary located within the Kouchibouguacis watershed. The obstructed flow was resulting in severe backwatering on the upstream end of the culvert, which converted the stream into a pond temporarily. The replacement of the culvert allowed the reestablishment of appropriate waterflow, and resulted in a restored stream for our watershed (see images below for before and after results).

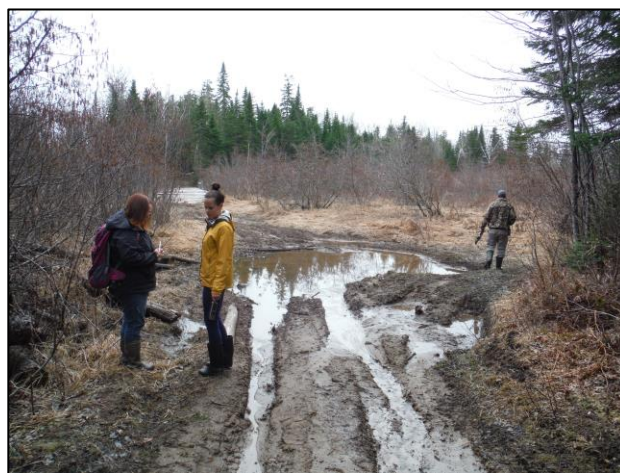
Before photo displaying large puddle interrupting trail flow (2017)

This project consisted of the restoration of a dilapidated ATV bridge and trail. The degraded trail resulted in large puddles which encouraged ATV riders to drive around into the surrounding wetland (see images below).

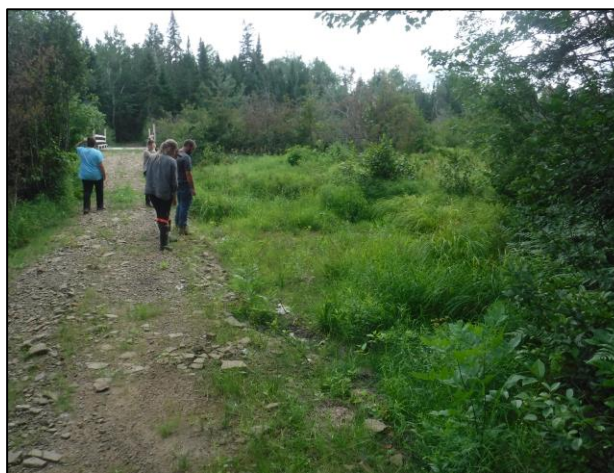
After photo displaying results of restored trail, bridge and vegetation (2018)

This off-roading into the surrounding wetland resulted in significant damage to vegetation critical to protecting the nearby ruisseau de la truite as well as habitat to any wildlife that relied upon it. A new bridge was constructed, and the trail was built back up to grade to allow for normal ATV trail usage to occur. Vegetation was also planted along the sides of the trail to help encourage ATV riders to stay on the designated trail, and to help restore and protect the nearby wetland and waterway.

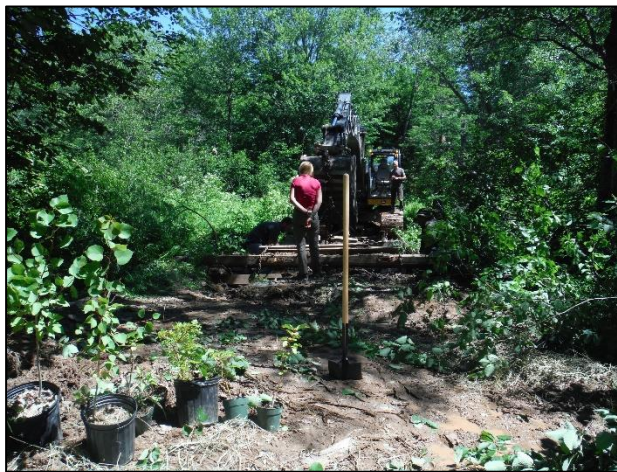
Before photo displaying bridge removal and exposed trail substrate (2018)

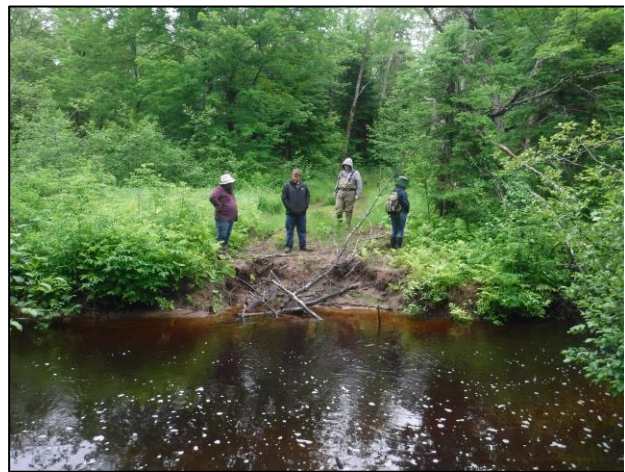
After photo displaying results of restored trail and vegetation (2019)

This project was considered mostly successful, though due to an off-roading incident in which a truck attempted to continue to use the trail and ended up getting stuck in the stream after our efforts, the embankment incurred significant damage. TFK revisited the site afterwards and planted additional vegetation and applied further remedial efforts to restabilize the embankment. Follow-up visits have displayed encouraging results and it appears the trail is well on its way to being restored to its natural conditions.

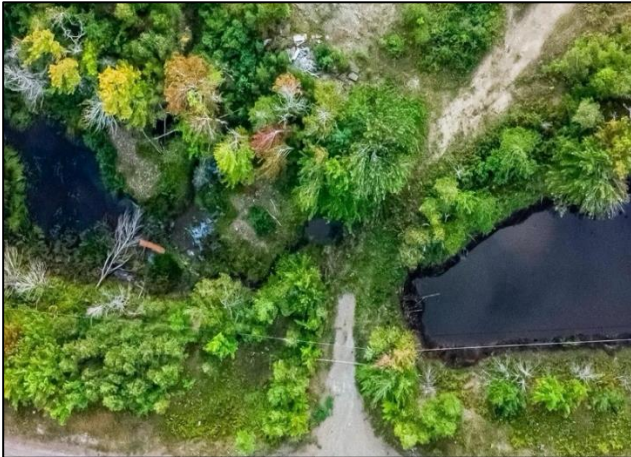
Before photo displaying the D/S culvert restricted water flow and flooding.

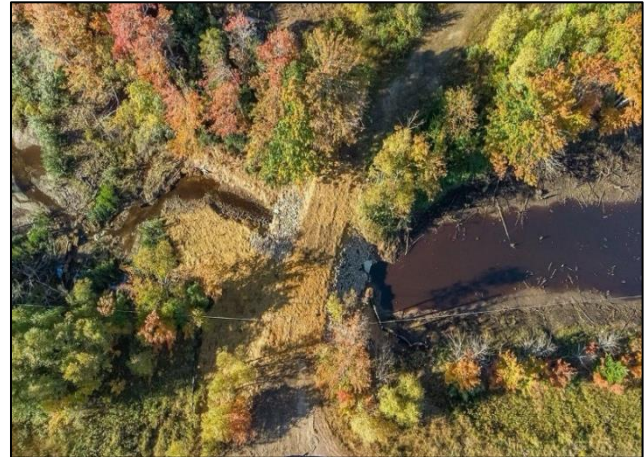
After photo displaying the D/S culvert with a restored water flow.

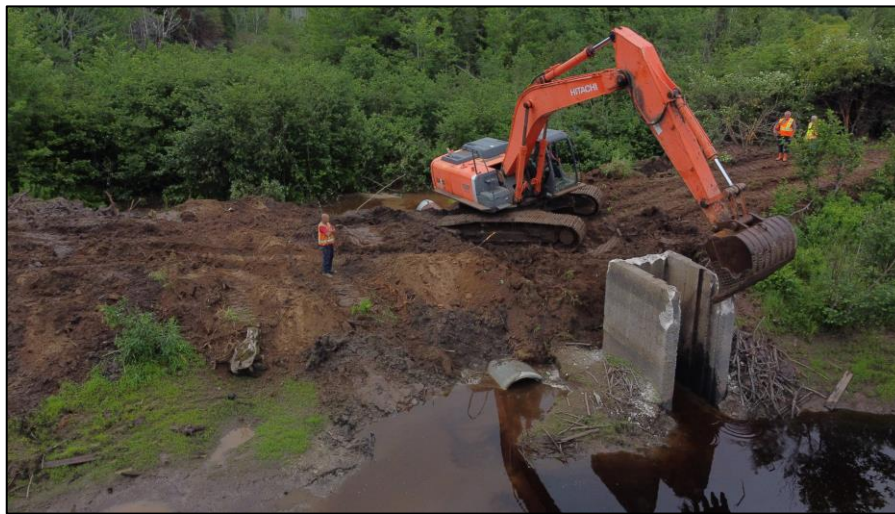
Before photo displaying manmade dam prior to removal.

TFK continued restoration efforts on ruisseau baptiste in 2023-24 with the removal of a concrete manmade dam (see image below) that had obstructed fish and water passage for years.

This dam was clogged with debris after neglect and resulted in the stream flanking approximately 10 meters to the true left and blowing out the driveway. This resulted in an unstable site which continuously introduced sediment to the waterway. This flanked channel was eventually blocked by beaver activity which stopped fish and water passage for many years. TFK removed the beaver dam to lower the pond to allow contractors to work in the dry. After lowering the pond, the manmade dam was removed, and a new 1200 mm concrete culvert was installed to maintain fish/water passage and land access for the landowners. (See before and after images of the site on the following page).

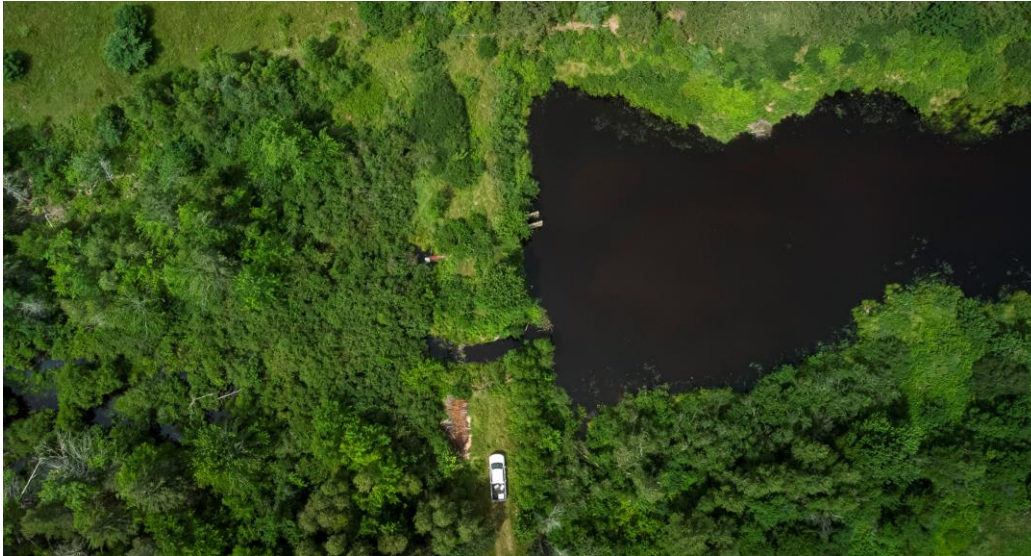
Image displaying restoration site prior to dam removal from above

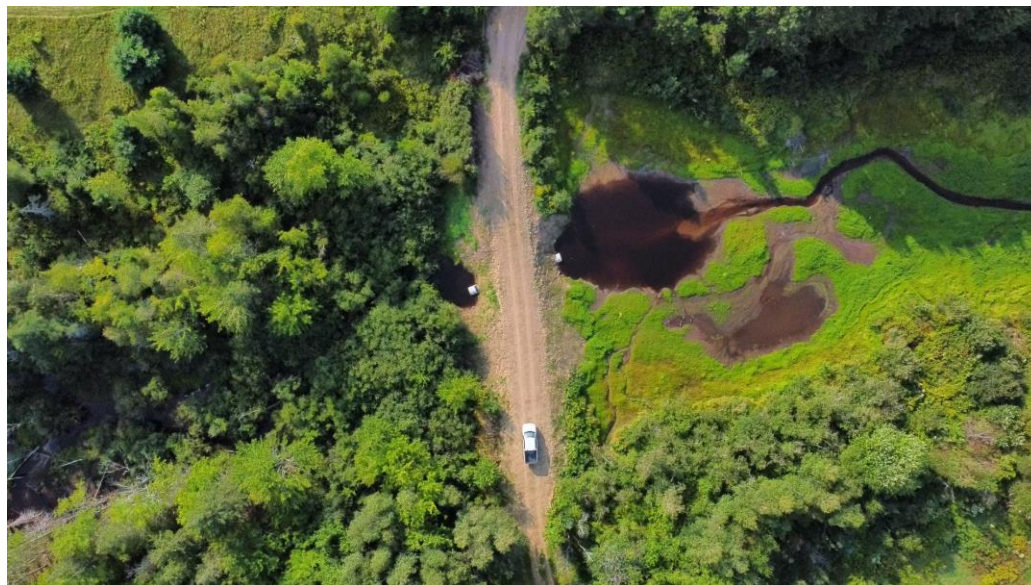
Image displaying restoration site after dam removal from above

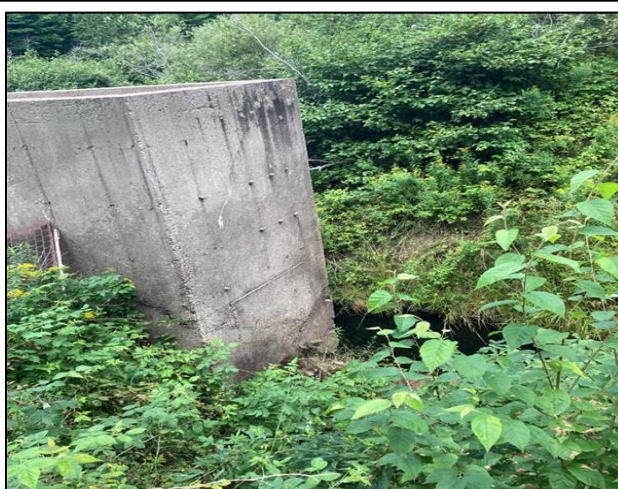
Image above displays significant flow alteration caused by dam structure at site 2 (middle dam) on ruisseau baptiste.

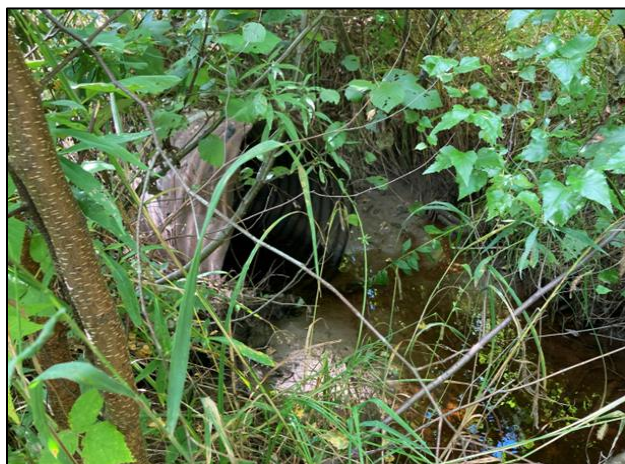
Image above displays inlet of culvert 1 on Little Beaver Brook along with significant sedimentation

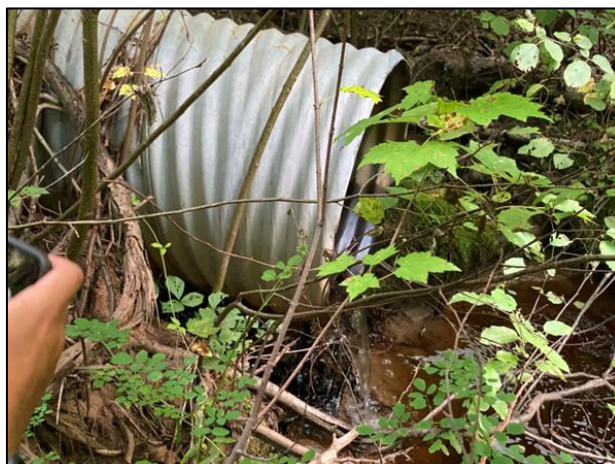
Image above displays outlet of culvert 1 on Little Beaver Brook. Culvert is perched and significant sedimentation is observed downstream

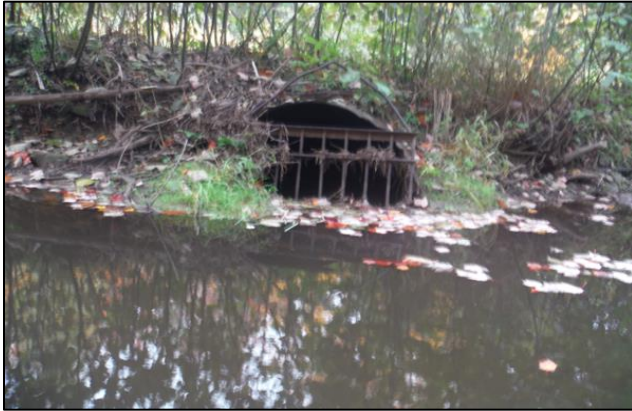
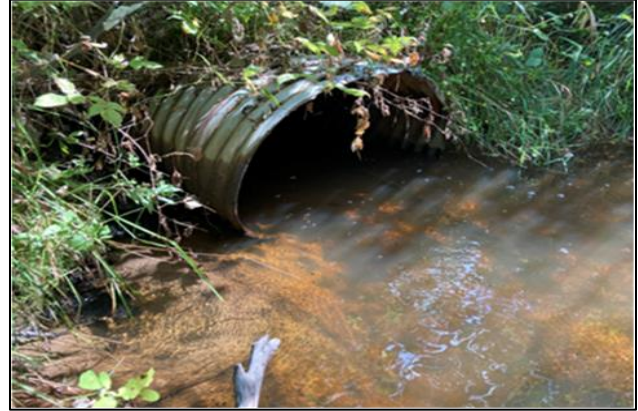
Image above displays Little Beaver Brook flanking culverts and establishing new channel on ch. Desherbiers. This is a significant source of sedimentation into the watercourse

watercourse. TFK has already performed some pre-remediation monitoring/evaluation of Little Beaver Brook which includes: electrofishing, and stream survey assessments (e.g., stream widths, velocities, substrate evaluation, vegetation assessments, etc.). Post-remediation monitoring and maintenance will also be performed as part of this project to help TFK monitor the effectiveness of the remediation and to allow TFK to adapt to any potential issues that may arise quickly and efficiently to ensure a successful restoration. (See images below and on following page).

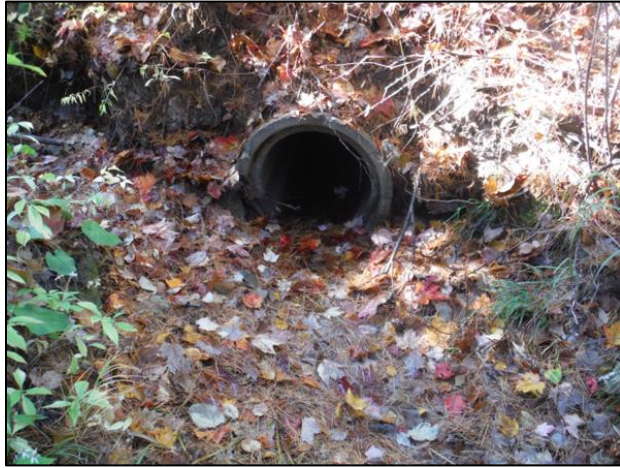
Image above displays inlet of culvert #1 on Beaver Brook. This channel of the stream is usually flowing during high precipitation events. Significant erosion and sedimentation is present due to washouts from roadway.

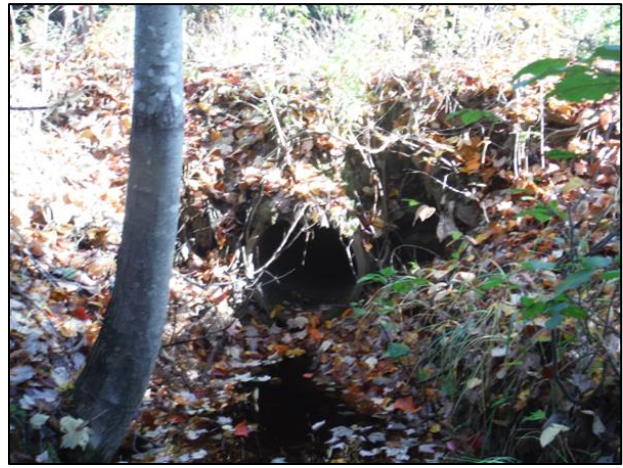
Image above displays outlet of culvert #1 on Beaver Brook. Severe erosion occurring on surrounding culvert, culvert is too short (~10 meters) and should be extended to ~15 meters to allow for proper grading.

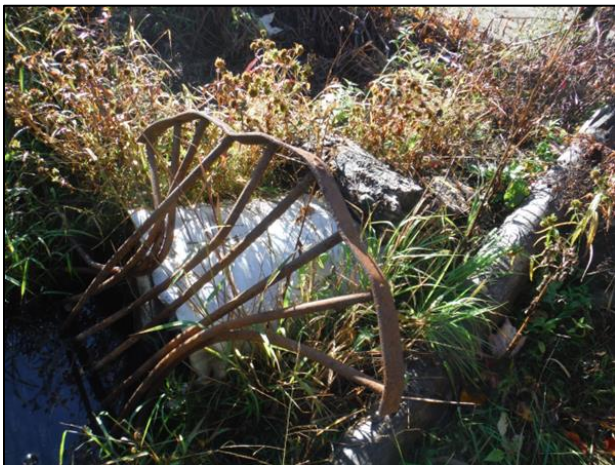
Image above displays inlet of culvert #2 on Beaver Brook. Significant backwatering is observed.

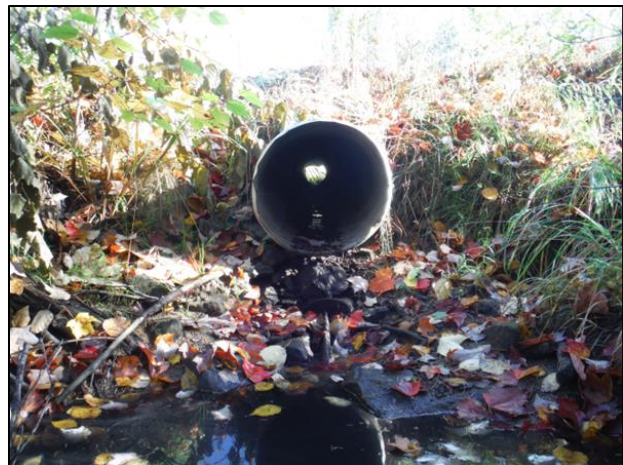
Image above displays outlet of culvert #2 on Beaver Brook. Culvert is perched and broken in middle.
