The Friends of the Kouchibouguacis

2023-2024 Activity Report

This report presents an overview of all activities performed by TFK during the 2023-24 season. Recommendations and needed adjustments for next year will be discussed also. This report has been created for the stakeholders and partners involved in this project, and for future reference of the organization.

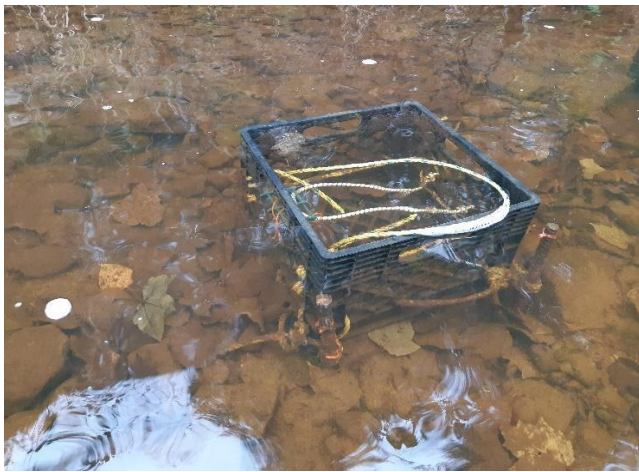
Photo of empty milk crate design in stream

All empty milk crates were previously installed in the stream with rebar earlier in the season. This allowed for better scouting of prime locations within the waterway that ensured the incubators would remain submerged during low flow. This new setup allowed for installation time on incubation day to be decreased, which aided in the safety and efficiency of the technicians as less effort is spent attempting to tie incubators within the stream in near freezing temperatures.

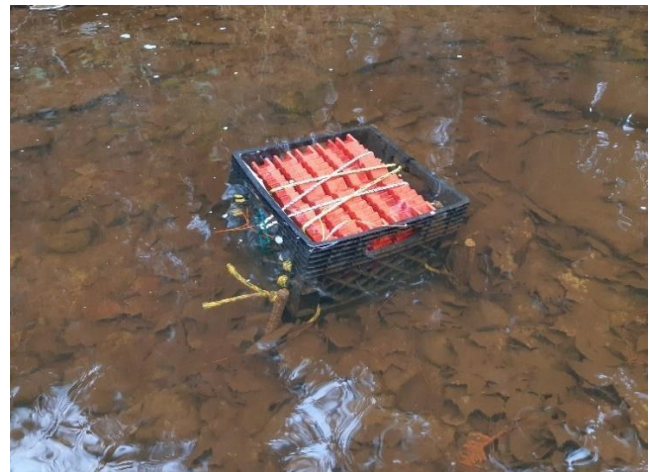
Photo of milk crate design with loaded incubator installed

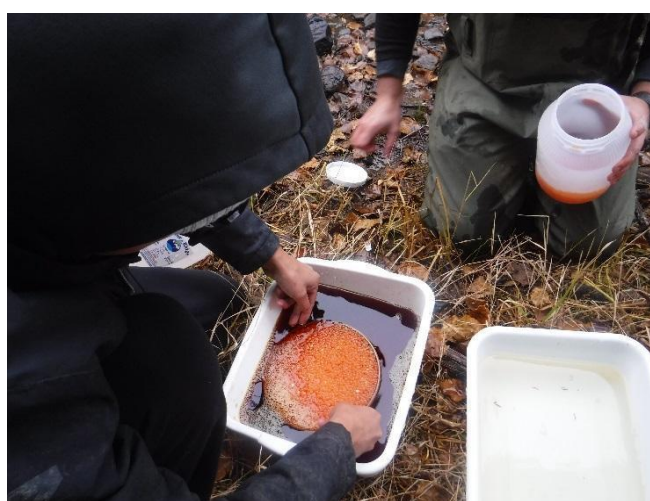
TFK and Kopit Lodge staff transferring hardened eggs to Ovadine solution

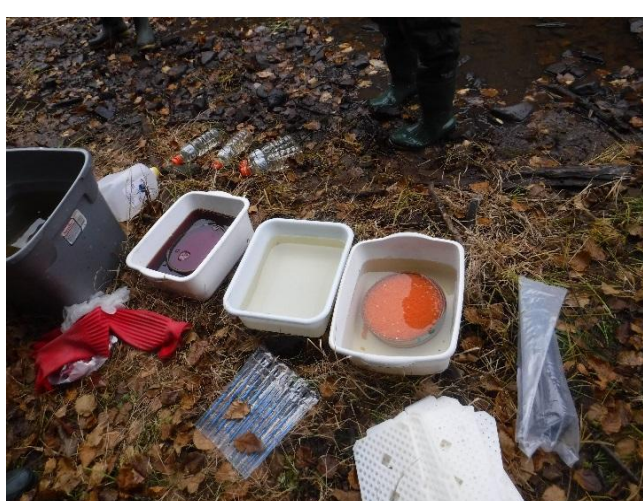
Photo illustrating three stages of disinfection; Ovadine solution, rinse bin, fresh brook water

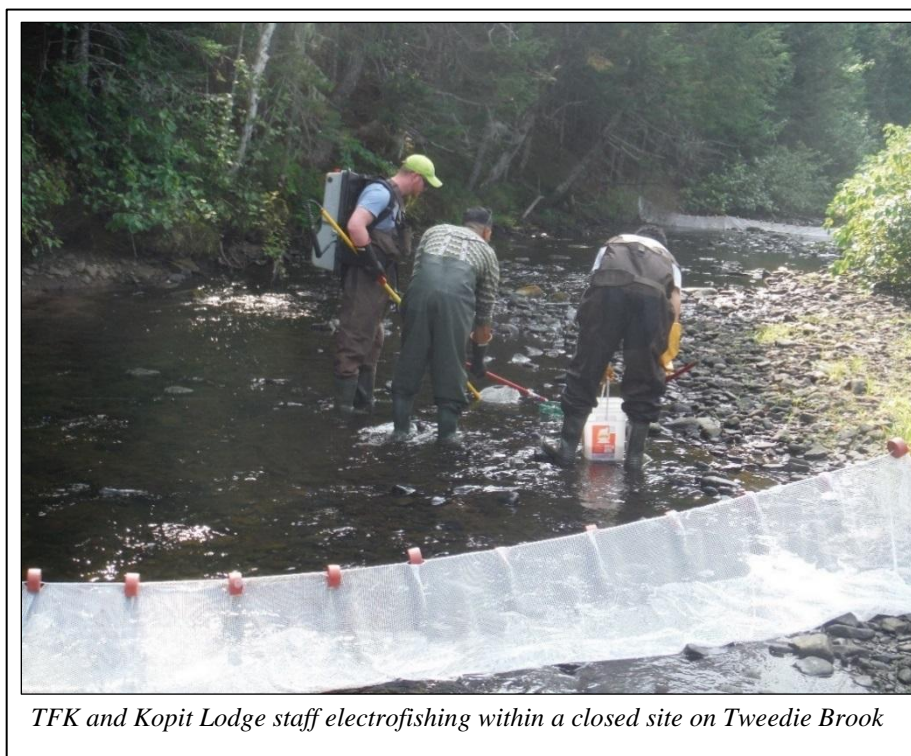
TFK and Kopit Lodge staff electrofishing within a closed site on Tweedie Brook

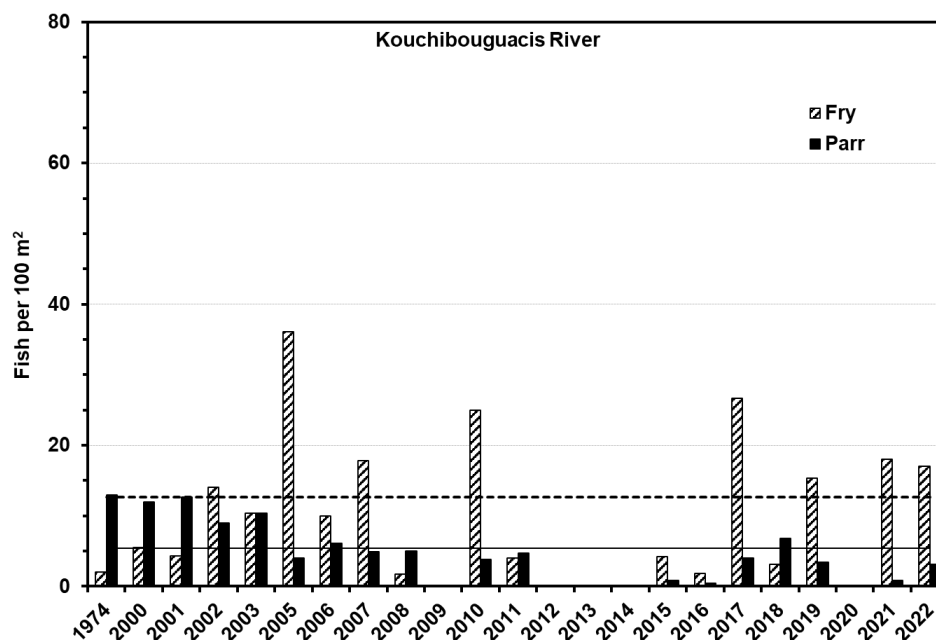
Figure 4 : Densities of Atlantic salmon fry and parr expressed as number of fish per 100 m² in the Kouchibouguacis River between 1974 and 2022. The horizontal dashed line represents the average fry

density over the time series while the solid horizontal line represents the average parr density over the time series.

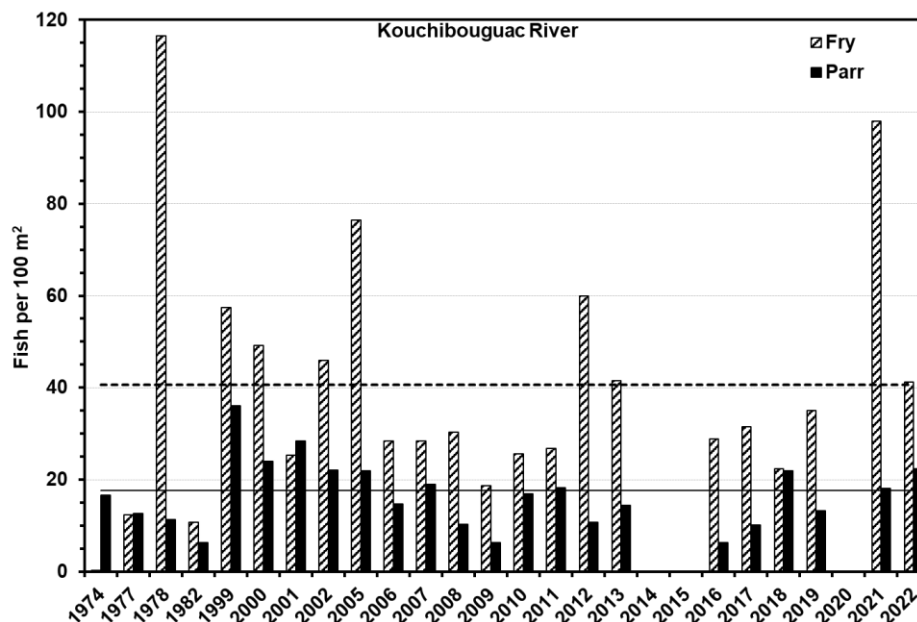
Figure 5 : Densities of Atlantic salmon fry and parr expressed as number of fish per 100 m² in the Kouchibouguac River between 1974 and 2022. The horizontal dashed line represents the average fry density over the time series while the solid horizontal line represents the average parr density over the time series

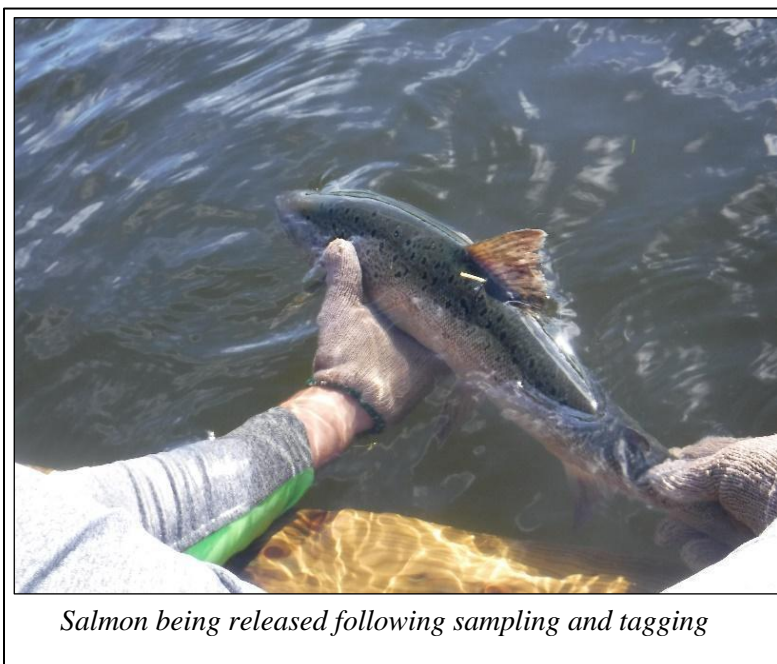
Salmon being released following sampling and tagging

TFK used Carlin tags provided by DFO staff that were installed with a hypodermic needle that was disinfected between every individual in an alcohol-filled sponge to reduce the risk of infection.

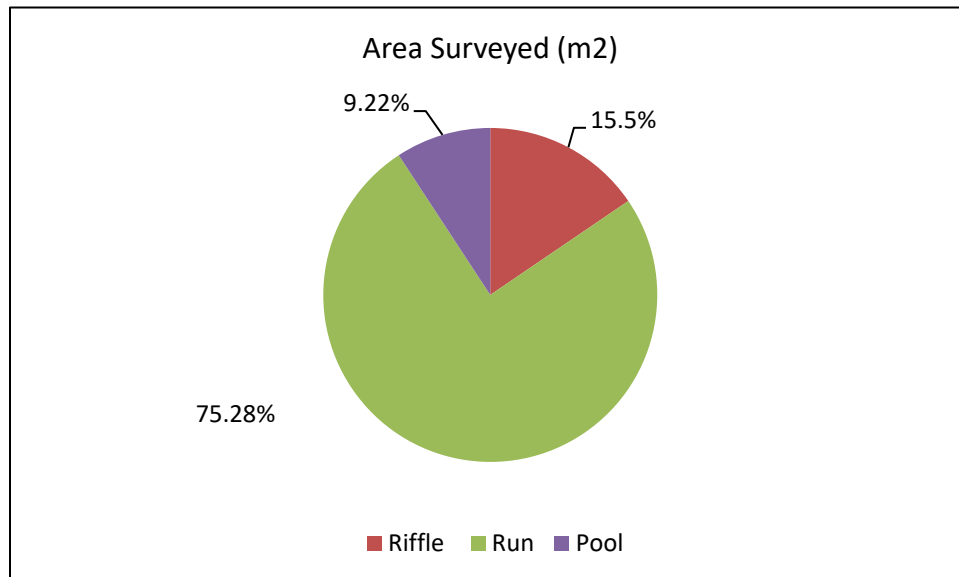
Figure 14 : Area surveyed (m²) (Kouchibouguacis)

The total flat area of stream survey was calculated in order give an idea of area of available habitat. The total was then further broken-down by habitat, accounting for both the area of the main section and the smaller “sub habitats” found within each section. Area was calculated using the measured length of each section and multiplying that by the averaged “wetted width” of each section. The total cumulative area of each habitat type and total area surveyed can be found in **Table 25 below**, the breakdown by habitat is visualized in **Figure 14 below**.

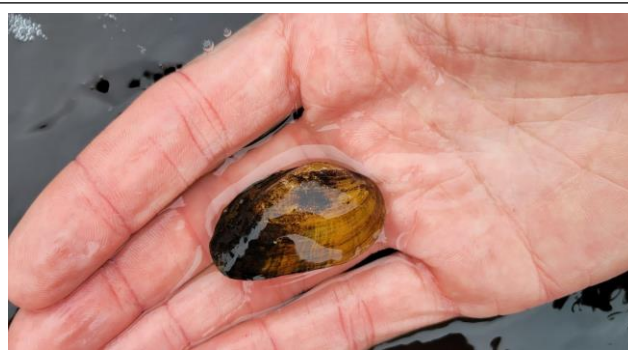
Brook floater found during survey

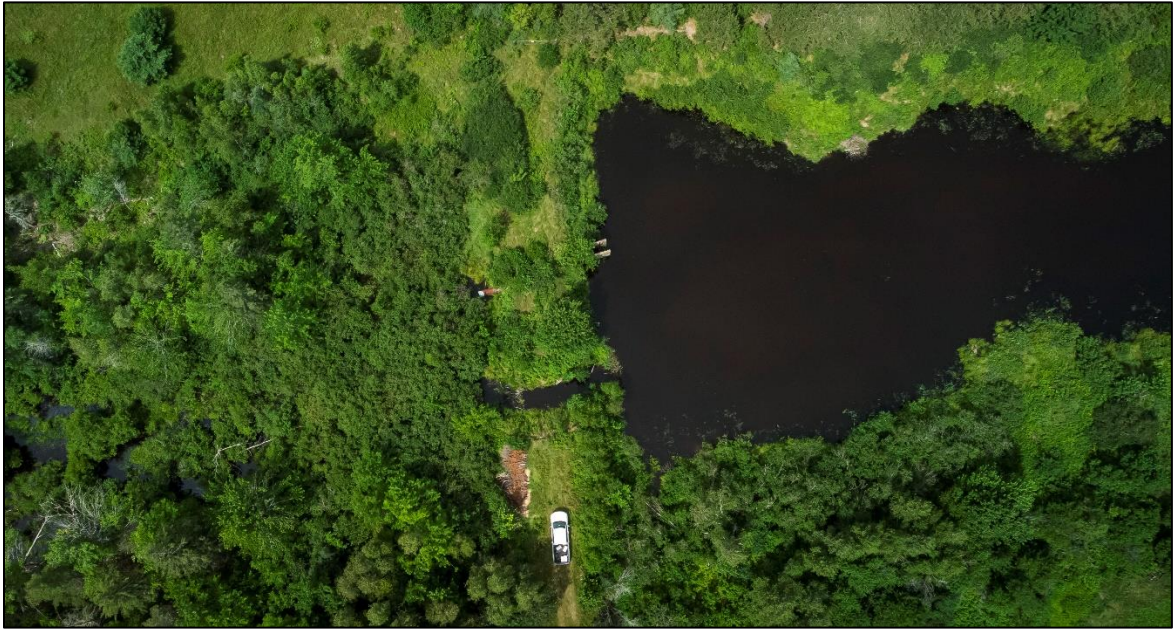
Before dam removal and culvert replacement – ruisseau a baptiste

species can now access these sites and other habitats within the stream. A more detailed stream restoration report will be generated as this initiative progresses over the years.

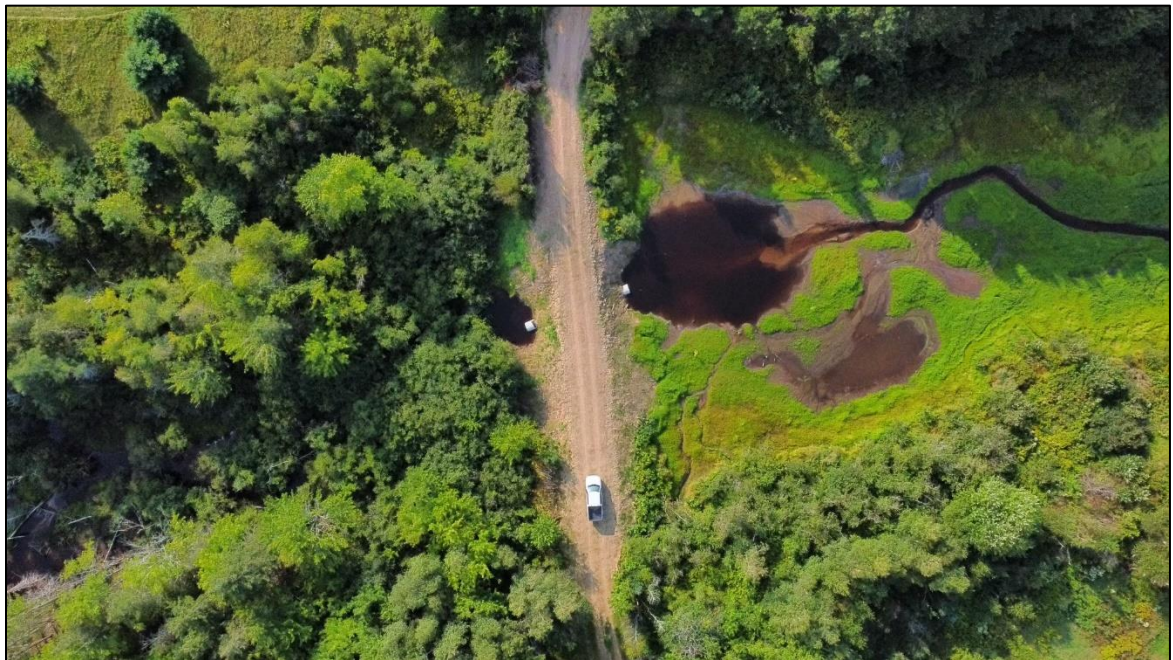
After dam removal and culvert replacement – ruisseau a baptiste

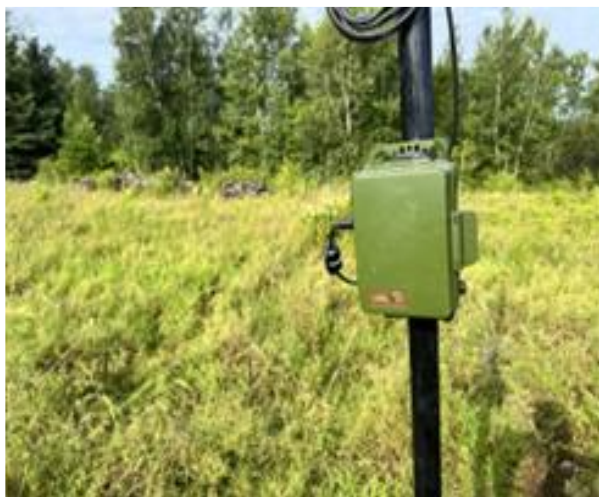
Vocal monitor secured on PVC pipe after installation.

On august 4th, 2023 an ultrasonic vocal monitor provided by Kouchibouguac National park (KNP) (see photos on the following page) was installed to try and capture activity from the bats to be able to identify the species based on their vocals. TFK assisted KNP with installing the monitors at 5 other sites within the Kouchibouguacis and Kouchibouguac watershed (see map in Figure 22 on page 53). The vocal monitors were secured on long PVC pipe and installed on rebar in a clear area at least 6m away from nearest clutter. The vocal monitors were typically removed from the sites a week or two after installment depending on the weather, the stored data was sent to KNP for analyses of which species (if any) were detected.

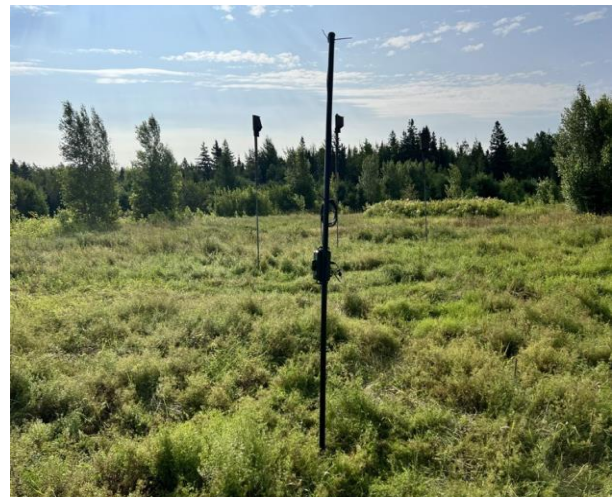
Vocal monitor installed near bat boxes.

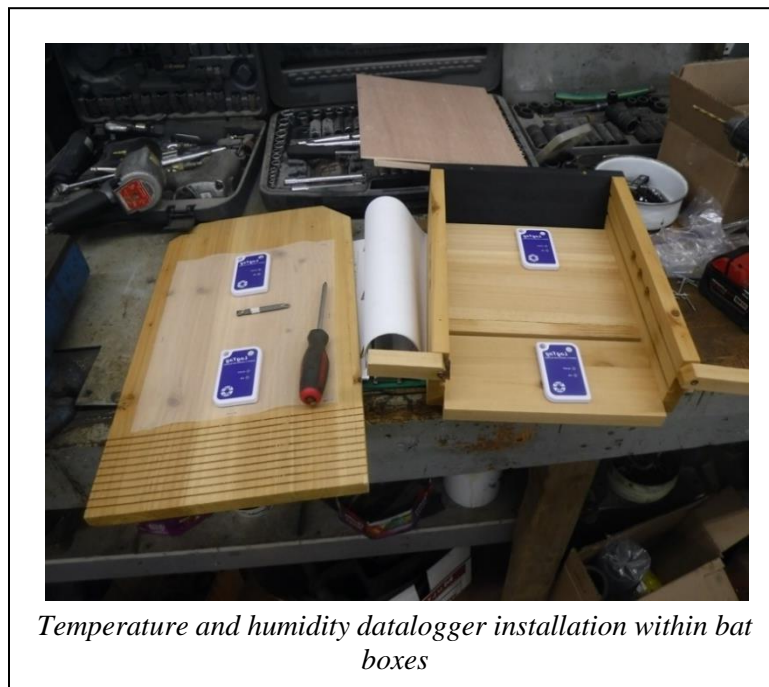
<p>Box #1</p> <p>Dataloggers: Upper bottom S/N 1010187129 Lower bottom S/N 1010193974 Upper front S/N 1010193966 Lower front S/N 1010187131</p>

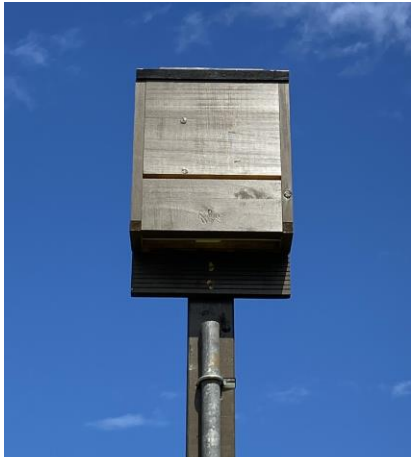
<p>Box 4</p> <p>Comments: (Box #4 was installed on July 22nd and replaced box #2 which was student-made and lacked appropriate grip/mesh features for bats)</p> <p>Dataloggers: Upper back S/N 7106 Lower back S/N 7130 Upper front S/N 3970 Lower front S/N 3963</p>

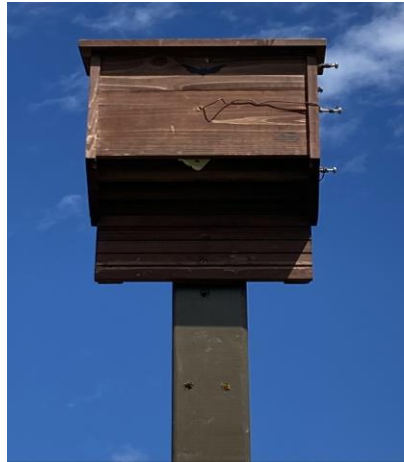
<p>Box #3 (Black Box)</p> <p>Comments: Could only fit 2 dataloggers in box #3, 1 on each side of box</p> <p>Dataloggers: Right S/N 3973 Left S/N 3972</p>
