# **SALMON HABITAT CONSERVATION**

## **SOUTH BROOK, NEWFOUNDLAND AND LABRADOR**

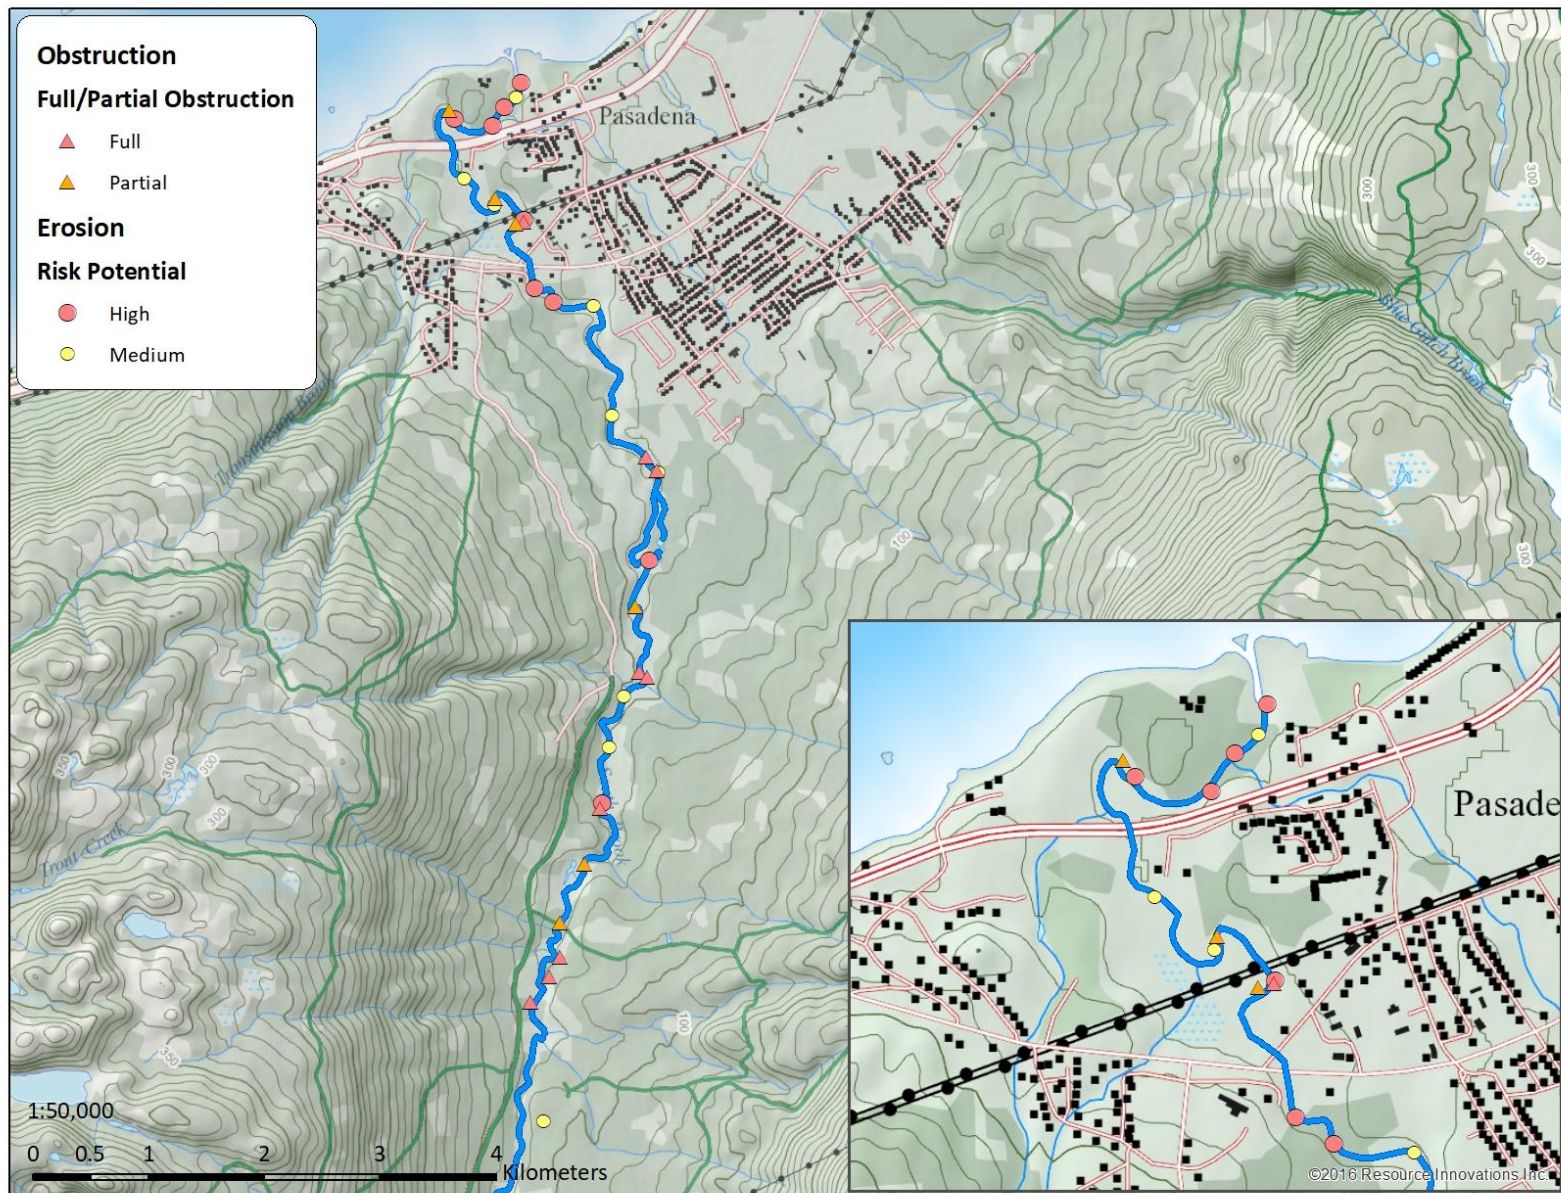
Low risk reaches had values between 0-30, medium risk between 31-61 and high risk reaches included and value equal or greater than 62.

EROSION POTENTIAL				
Latitude	Longitude	U/S Length (m)	D/S Length (m)	Risk Potential
49.02122	-57.6118	20	50	High
49.02046	-57.61216	25	10	Medium
49.01999	-57.61306	10	10	High
49.01903	-57.61398	35	40	High
49.0194	-57.61691	20	20	High
49.01632	-57.61616	60	70	Medium
49.015	-57.61386	10	10	Medium
49.01423	-57.61151	20	30	High
49.01073	-57.61069	20	40	High
49.01007	-57.60923	50	40	High
49.00984	-57.60613	30	35	Medium
49.00424	-57.60471	75	50	Medium
49.00135	-57.6011	15	15	Medium
48.99685	-57.6018	30	60	High
48.98992	-57.60379	40	40	Medium
48.98731	-57.6649	40	50	Medium
48.98449	-57.60545	10	20	Medium
48.98449	-57.60545	50	30	High
48.96827	-57.61	10	50	Medium
