Inverness South Anglers Association

Mull River Habitat Restoration Plan

Assessment of instream habitat and recommendations for Atlantic Salmon
Recovery

MacInnis Natural Resource Services Inc.
12/1/2020

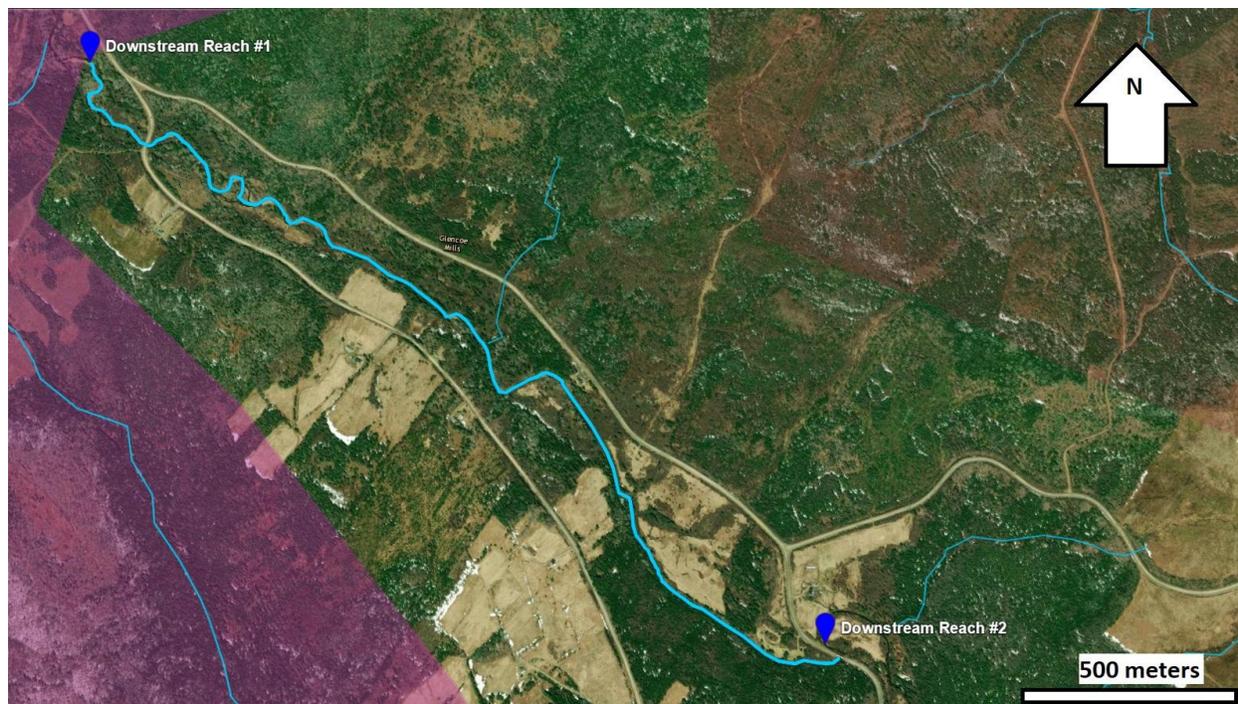
**Figure 11**

Reach #1 is the lowest downstream reach in the headwaters section of the Mull River and the quality of habitat has been negatively impacted by historic land use and resource extraction related activities (e.g. sawmills and grist mills). Instream surveys found that much of the channel through this section was over-widened (10-12 meter wide) and lacked sufficient pool habitat.

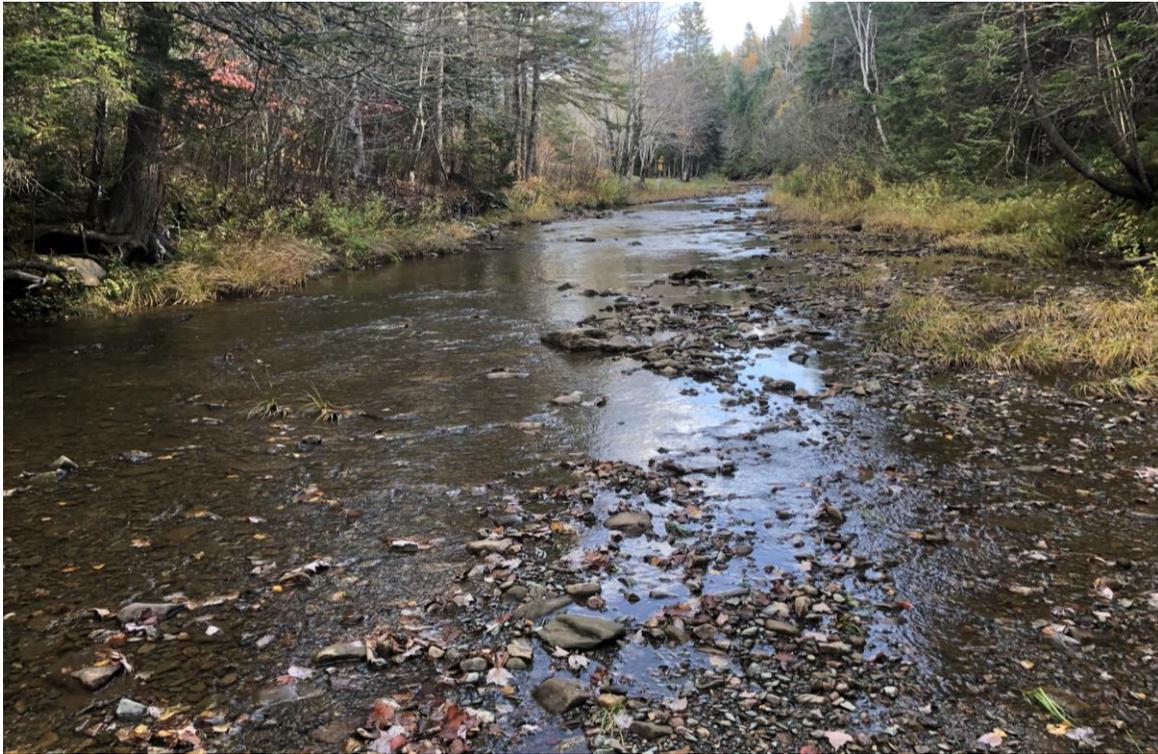
outcropping. Beginning 50 meters downstream the habitat substrate becomes conducive to instream restoration techniques such as deflectors and possibly digger logs. The channel below the bedrock outcropping is straight and lacks a meander pattern (visible in figures 13 and 14).

Figure 13: Looking upstream towards the bedrock outcropping. As the river moves away from the steep embankment the channel is allowed to dissipate energy and deposit instream materials.

Restoration through this reach can be completed using digger logs and deflectors for the first 2200 meters of stream. The construction of bank cribbing using logs and instream material should be completed at two sites (61°20'17.4"W, 45°58'39"N) identified in figure 16 below.

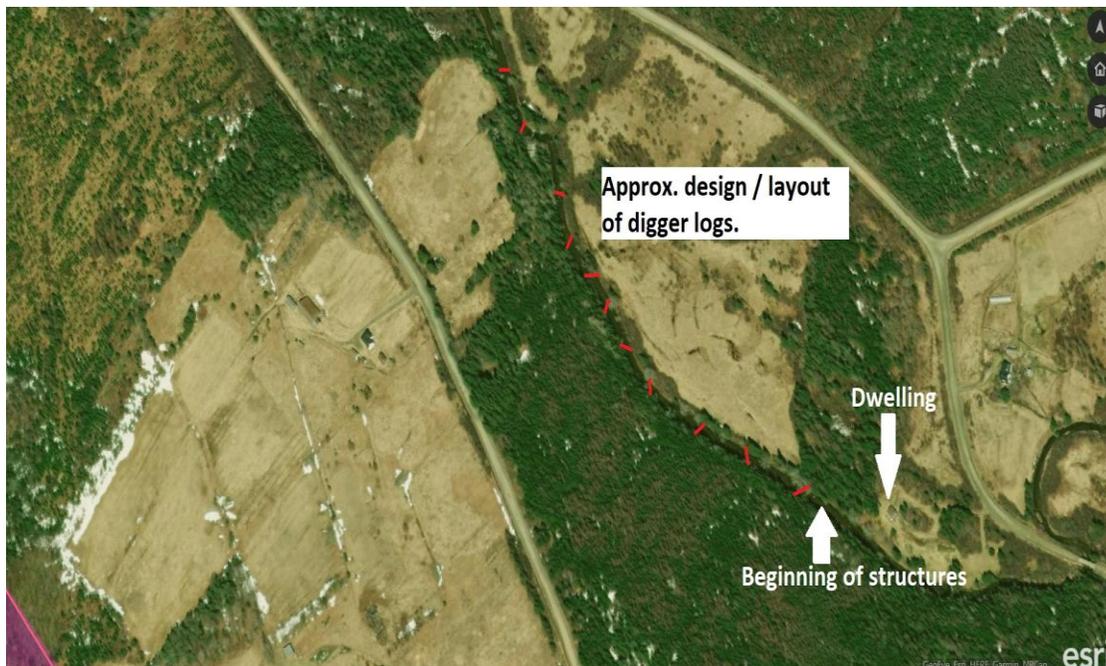
Figure 15: Red lines denote approximate location and design of digger log structures.

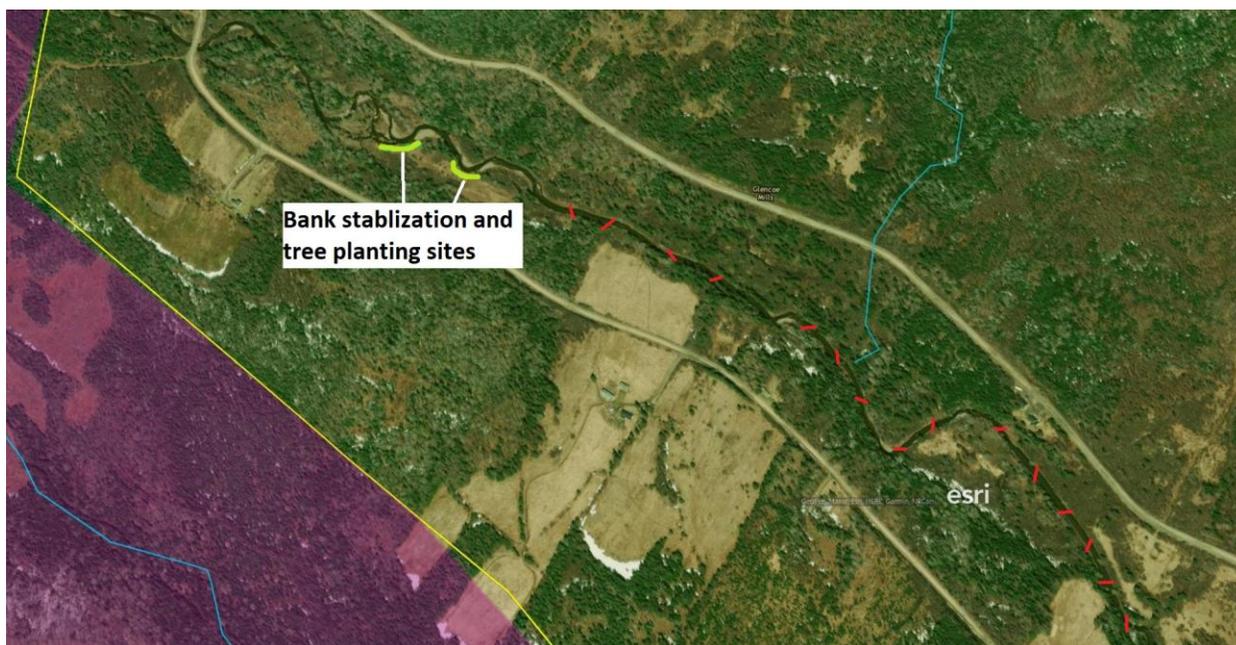
Figure 16: Approximate layout of instream restoration structures. Digger logs denoting in red.

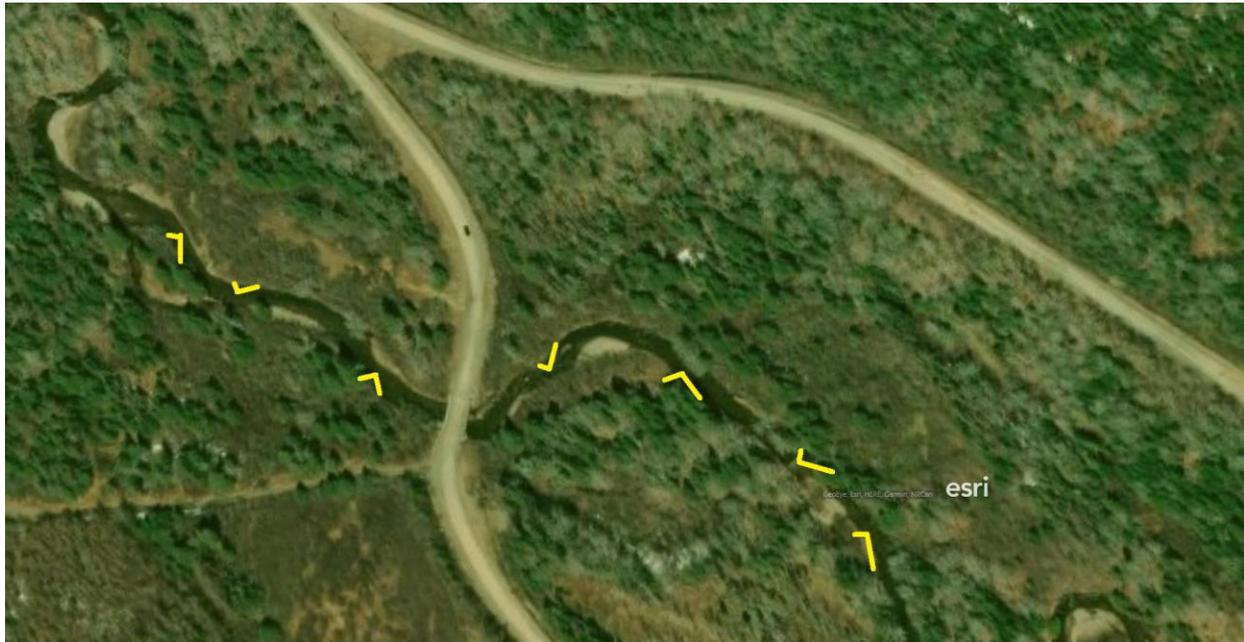
The floodplain topography surrounding the lower 800 meters is much wider and has a much greater degree of sinuosity and contains a major debris complex that has divided the channel into multiple threads. As this section of channel may further migrate within the floodplain, the most suitable technique for restoration would be alternating deflectors.

Figure 17: Lower sites on reach #1. Deflectors are most appropriate technique.

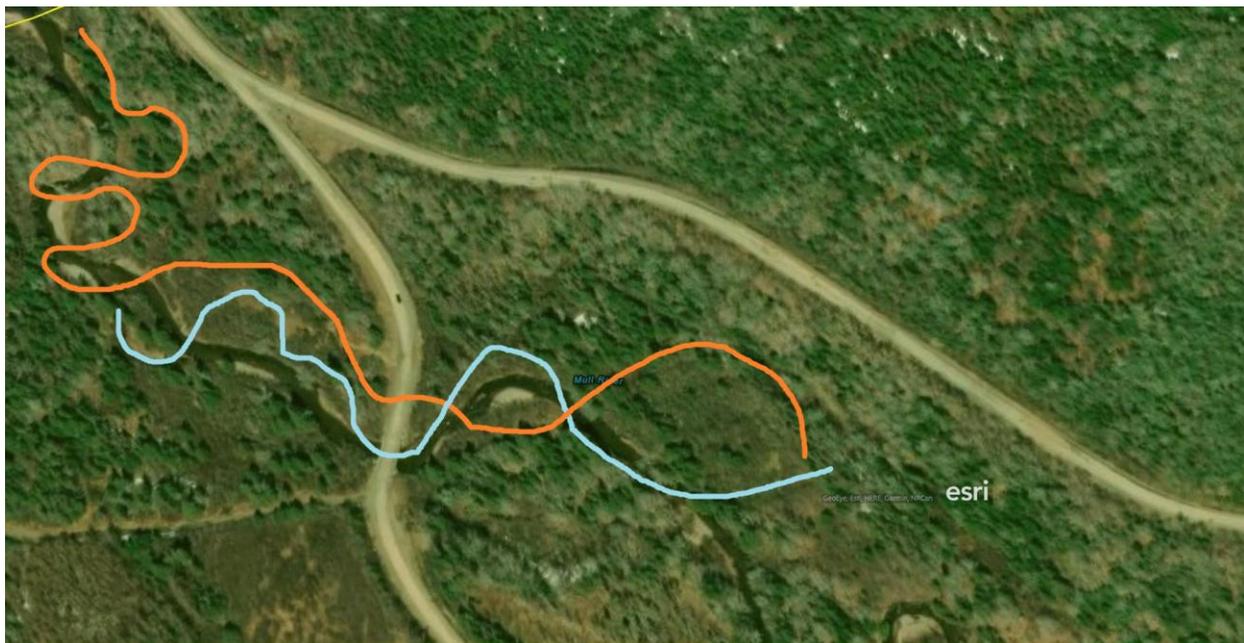
Figure 18: Orange and blue markings denote locations of historic channels, signifying a great degree of changes over time.

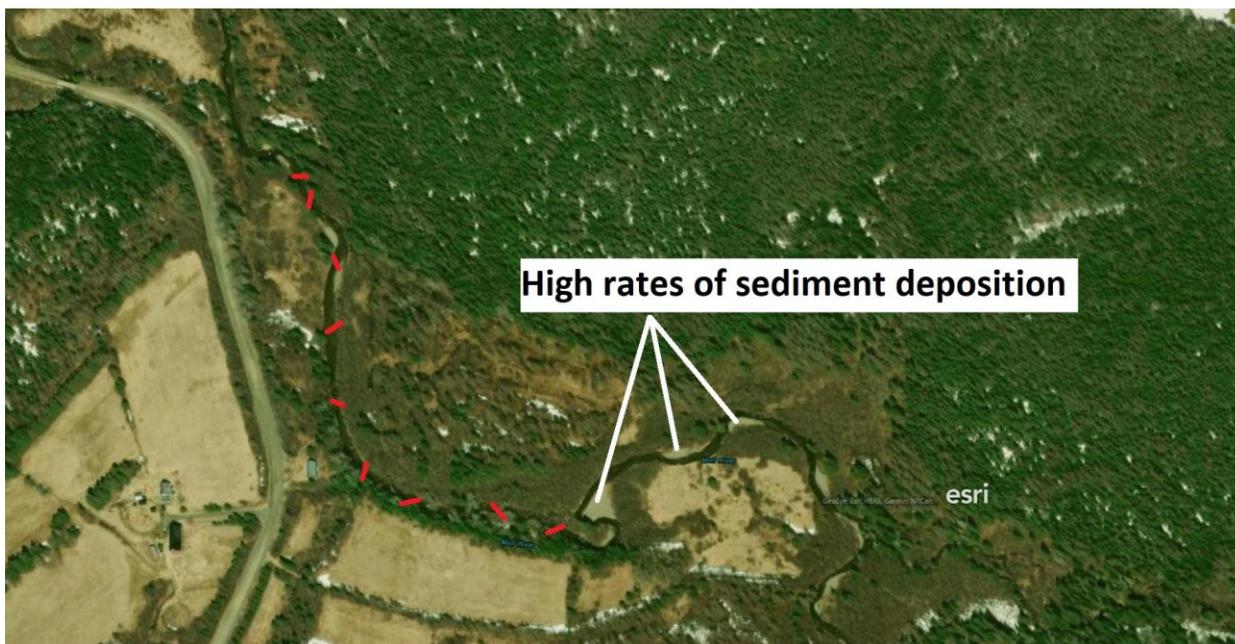
Figure 25: Red lines indicate approximate location of digger logs.

Reach #2 begins below the confluence of the upper branches ($61^{\circ}18'34.6''W$, $45^{\circ}57'57.6''N$) and ends at the bridge on Upper Glencoe Rd. The majority of this reach flows through abandoned and semi active pasture land. A combination of digger logs, deflectors and bank logs can be used to improve instream habitat conditions through this reach. Tree planting should accompany any bank stabilization work if an intact riparian zone doesn't exist. The potential for restoration in this reach is 10,218 square meters and can be completed using primarily crew work. The lower-most turn in this reach, located just upstream from the Upper Glencoe Bridge may benefit from armour rocking. There appears to be machine access to this site, therefore bank stabilization can be completed using armour stone. There is beaver activity scattered throughout this reach with an established dam (Figure 24) about 300 meters above the Upper Glencoe Rd bridge. Where naturally occurring features such as debris jams and beaver dams exist, those structures should be left intact whenever possible. Landowner education on the benefits of natural structures could be a worthwhile expenditure of effort.

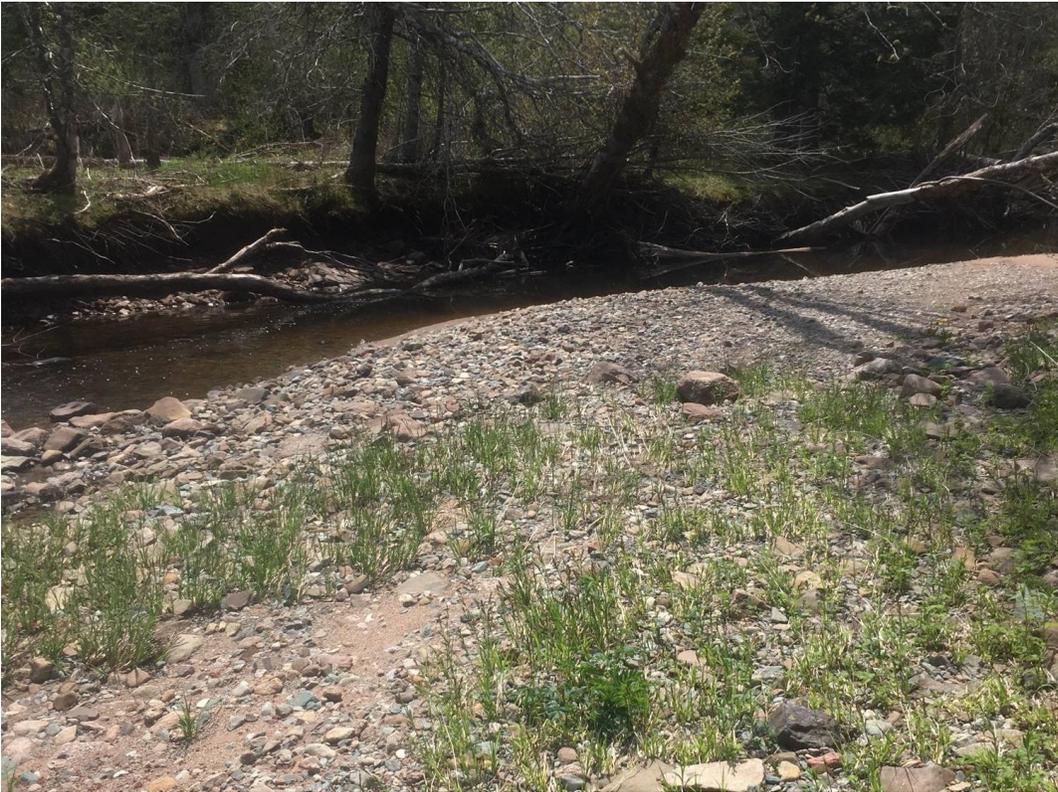
Figure 26: Showing deposition of gravels and fines along inside of meander.

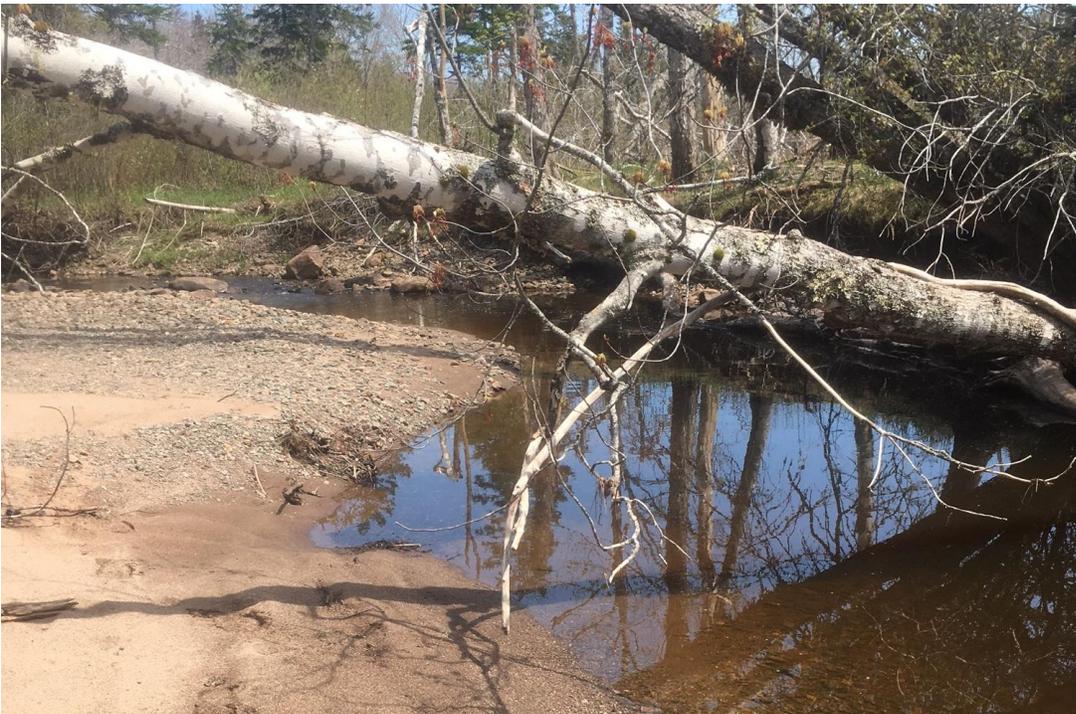
Figure 27: Showing accumulation of fines. Large woody debris providing overhead cover.

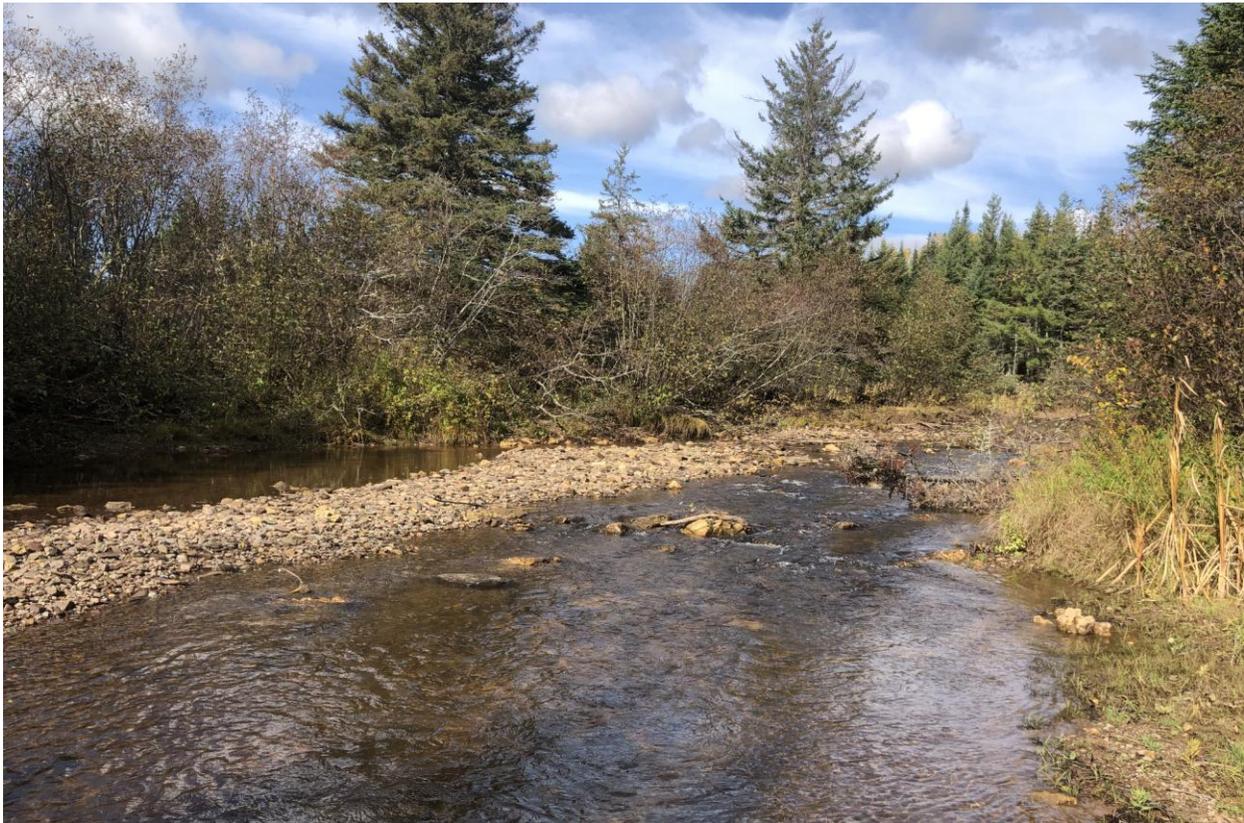
Figure 31: Typical channel condition in reach #4 of the headwaters.

Restoration of this reach will be done using digger logs and deflectors spaced at approximately 40 meters between structures. There is potentially enough stream length through this reach to require the installation of 35 digger log structures.

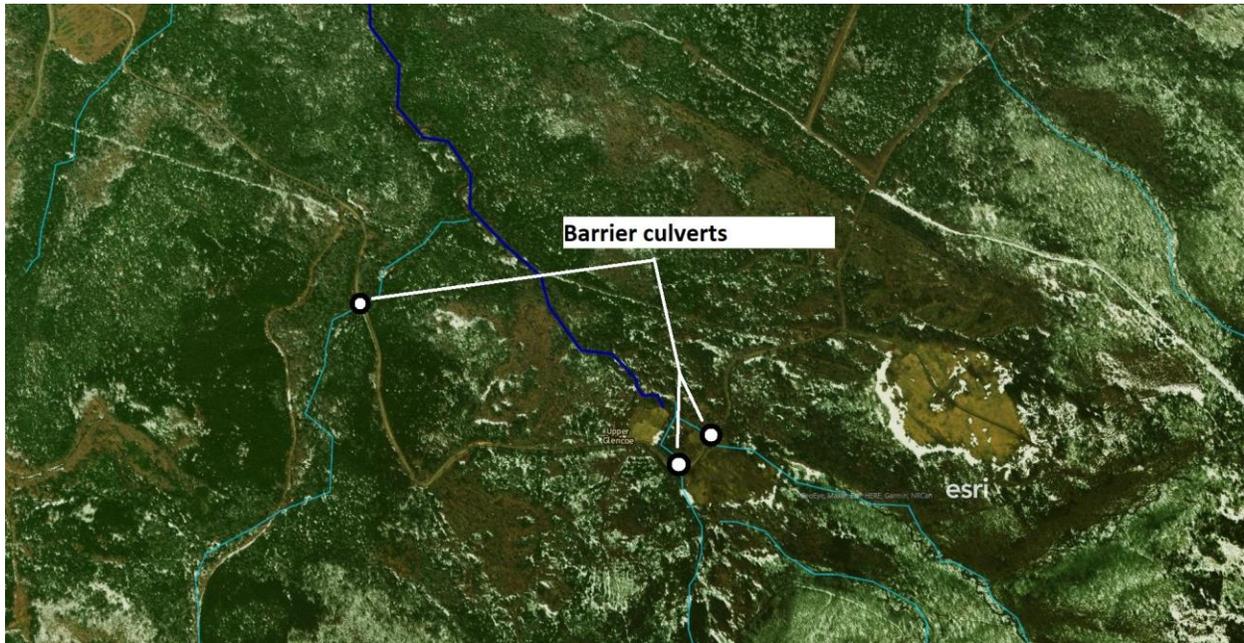
Reach 5 and Reach six are similar in watershed size, stream gradient and restoration potential. Reach six splits into two smaller watercourses that both contain trout and salmon habitat. The productivity of both reaches has been diminished by habitat fragmentation caused by improperly installed highway culverts (figures 33 – 36). The habitat in both reaches has been impacted to some extent by historical land use practices such as farming, clear-cutting and road construction. The installation of digger logs at approximately 32 meter structure spacing should facilitate the recovery of spawning habitat and pool habitat.

Figure33: Satellite map showing the locations of the three barrier culverts in the headwaters section.

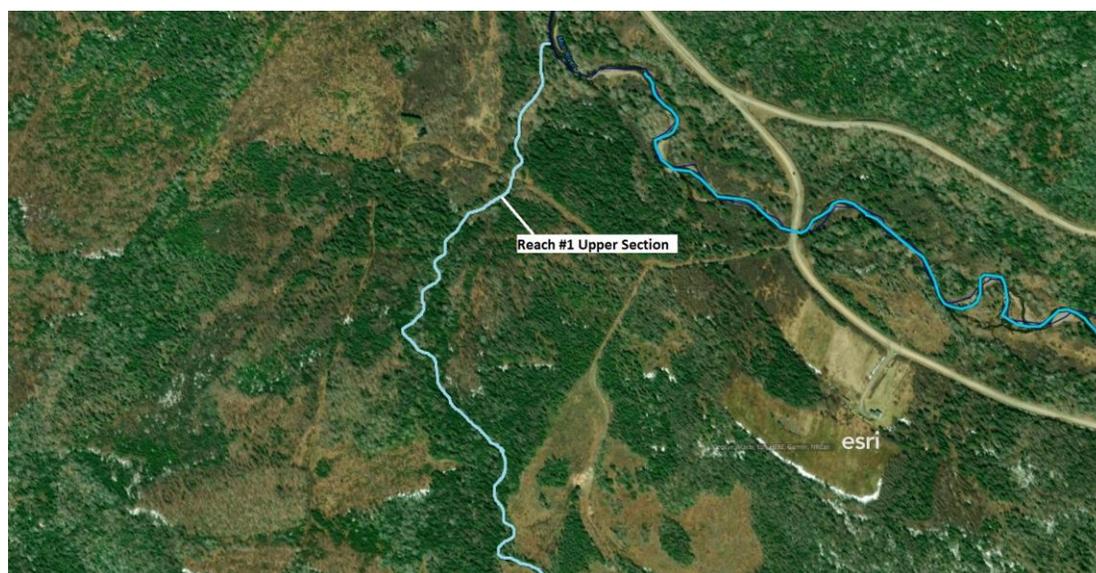
The upper section of the Mull River begins with a tributary that enters on the south side of the watershed and meets the Mull River at 61°20'53.8"W, 45°58'52.9"N. This stream drains a 4.9 square kilometer watershed and contains 300 meters of stream that would be suitable for instream restoration. Moving further upstream on this watercourse the potential for restoration is limited due to inaccessibility and steep gradient stream bed.

Figure 39: Small tributary with a 4.9 square kilometer watershed.

The lower 300 meters of channel could be restored by installing digger logs every 32.6 meters. The logs will be installed at alternating angles to create a series of left and right side pools.

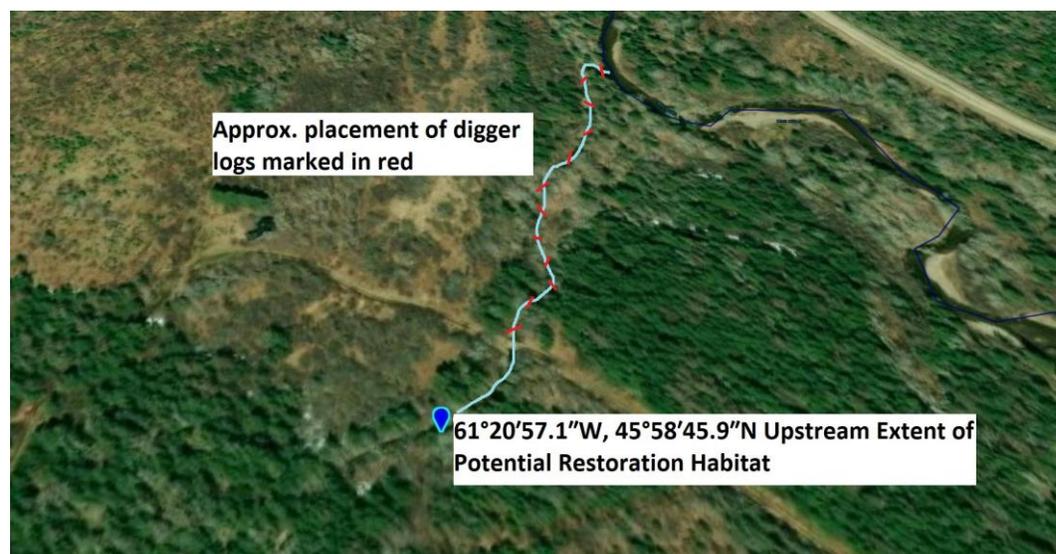
Figure 41: Satellite image showing approximate location and sequence of digger logs.

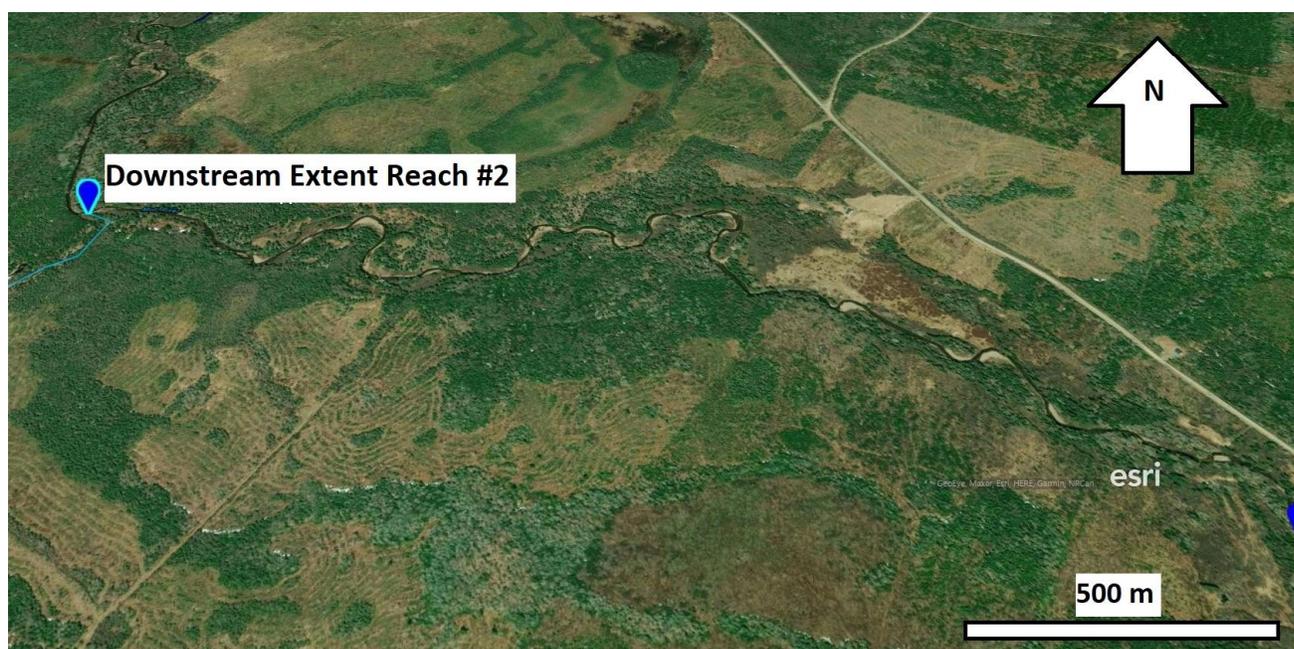
The second reach in the upper section covers approximately 3700 meters of channel making it the longest reach in the upper section. The channel within this reach should have a calculated bankfull width of 9.19 meters, however surveys of this reach during the fall of 2019 and 2020 found that the channel was over-widened (10-14 meters wide) and that in recent years the meanders have begun to widen out (e.g. greater sinuosity). This is evident by the accumulation of large gravel bars forming on the inside of all meanders (Figure X). Historical accounts of the land-use surrounding this reach describe a functioning grist mill at the location of the current bridge on Upper Glencoe Rd. The riparian vegetation was also cleared in the 1860s and the ground cover was converted to pasture land. This changes to the hydrology in this reach caused severe habitat degradation, primarily through the straightening of the channel and removal of organic materials and streamside vegetation. Satellite imagery on this reach clearly shows where had been straightened, following the abandonment of the pasture land sometime in the last century, this reach has begun to recover its meander pattern.

Figure 42: Satellite image of reach #2 in the upper section.

Restoration of fish habitat in this reach can be achieved by installing log deflectors to encourage meander formation and pool creation. Deflectors that are installed upstream from the newly forming gravel bars will reduce flood and ice scouring by pushing the flow towards the thalweg of the channel. Reducing the pressure on these newly formed bars will promote the establishment of permanent vegetation. Gravel bars that are allowed to vegetate help retain groundwater, reduce the transport of fine sediments and eventually provide shade as pioneer tree species such

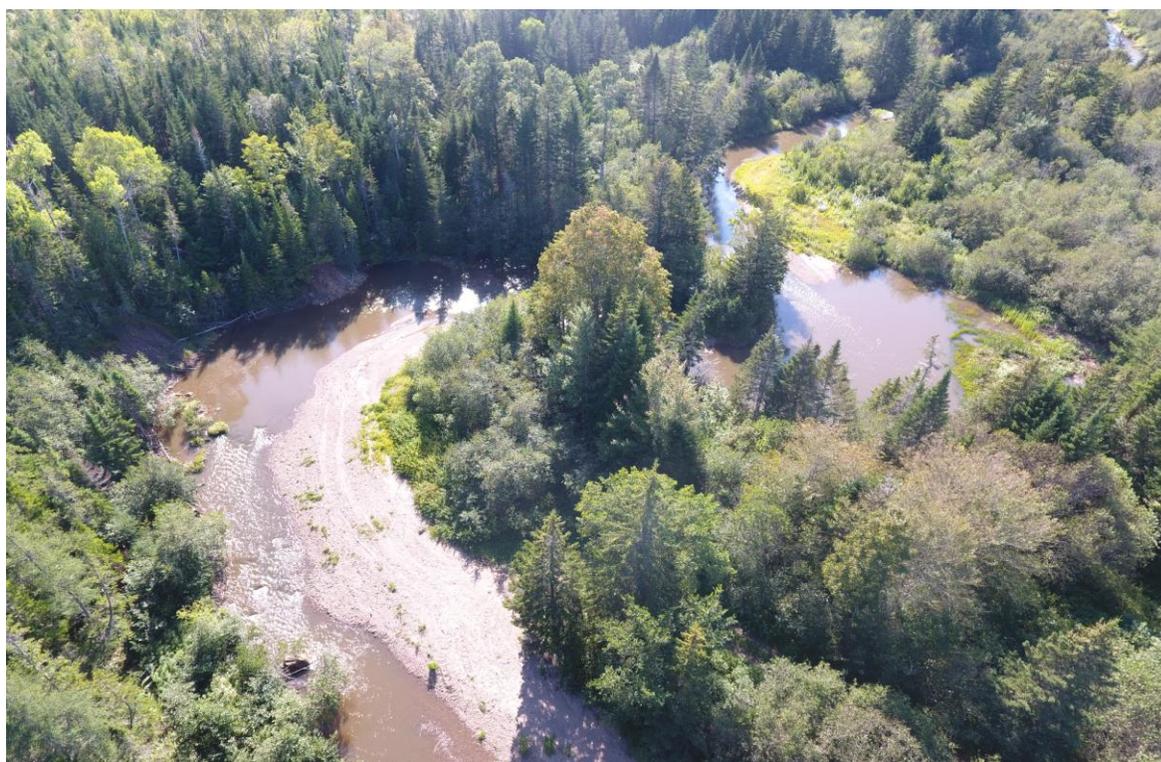
Figure 43: Aerial photo from reach #2 below the Upper Glencoe Bridge showing the accumulation of gravel on the inside of the meander.

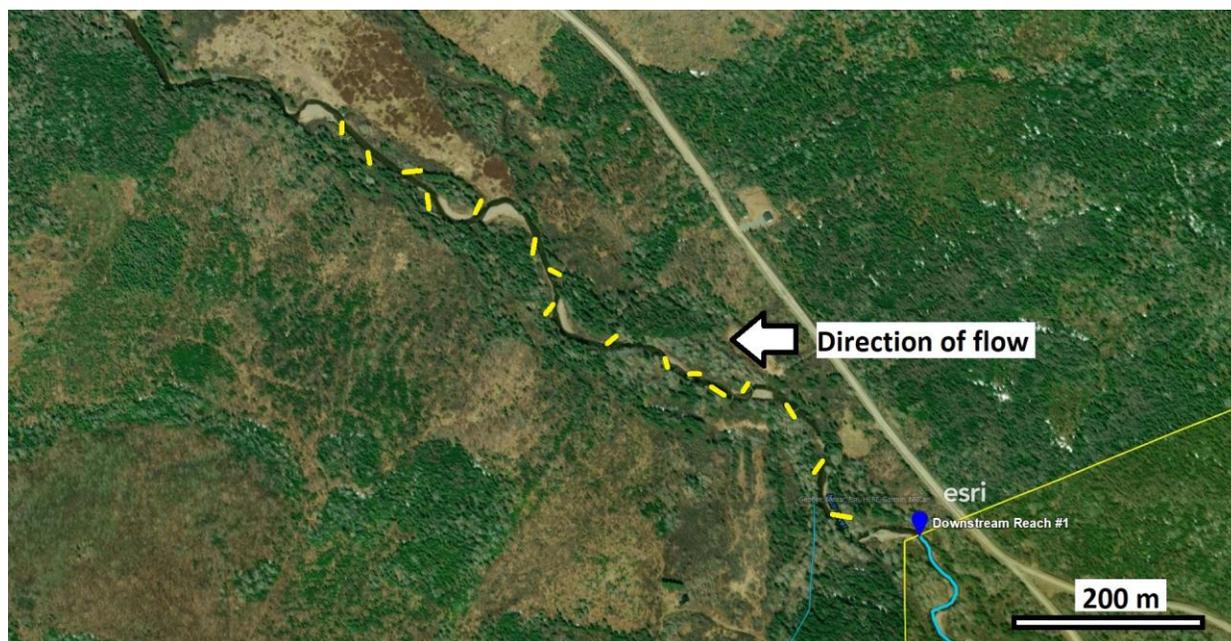
Figure 44: Approximate placement of deflector structures in upper section reach #2.

Log deflectors will be built to encourage channel habitat recovering, primarily through the deepening of pools, narrowing of channel width and by allowing gravel bars to develop. Deflectors will be spaced out at approximately 50 to 65 meter intervals in alternating directions. Two sites were identified for tree planting (see figure 45) and two sites were identified for bank stabilization through the construction of log framed cribs. Depending on site conditions during the time of structure installation, the log cribs could be constructed to include an artificial overhanging bank.

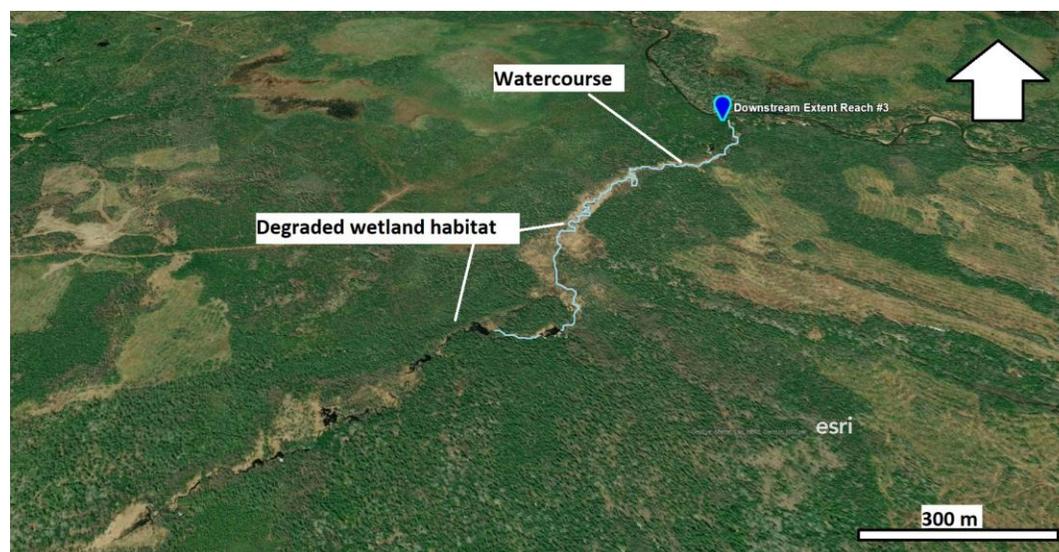
Figure 46: Upper Reach #3

The third reach in the upper section is a highly degraded tributary that flows south to north, emptying into the Mull River at the downstream extent of reach #2. This 4.9 square kilometer sub-watershed has been fragmented by forestry activities and historical land clearing for farming. The upper portion of this reach is a series of wetland ponds connected by 2-3 meter wide channels. As a result of the historical land-uses in this reach, the headwater wetlands are disconnected during summer months due to low water. Options for remediation include digger logs in the lower 300 meters of stream, however addressing the disappearance of surface water will require the installation of gradient controls which could include the installation of log sills or artificial beaver dams. The potential impact of restoration on this reach will depend on the landowner's willingness to restore connectivity throughout this reach by restoring the wetlands and increasing water retention. There a number of logging roads that intersect the channel throughout this section, assessing these crossing for fish passage is recommended in 2021. Recent forest harvesting activity was observed in the upper portion of these reach. Meeting with the landowner to discuss their plans and willingness to allow restoration is required before starting any restoration.

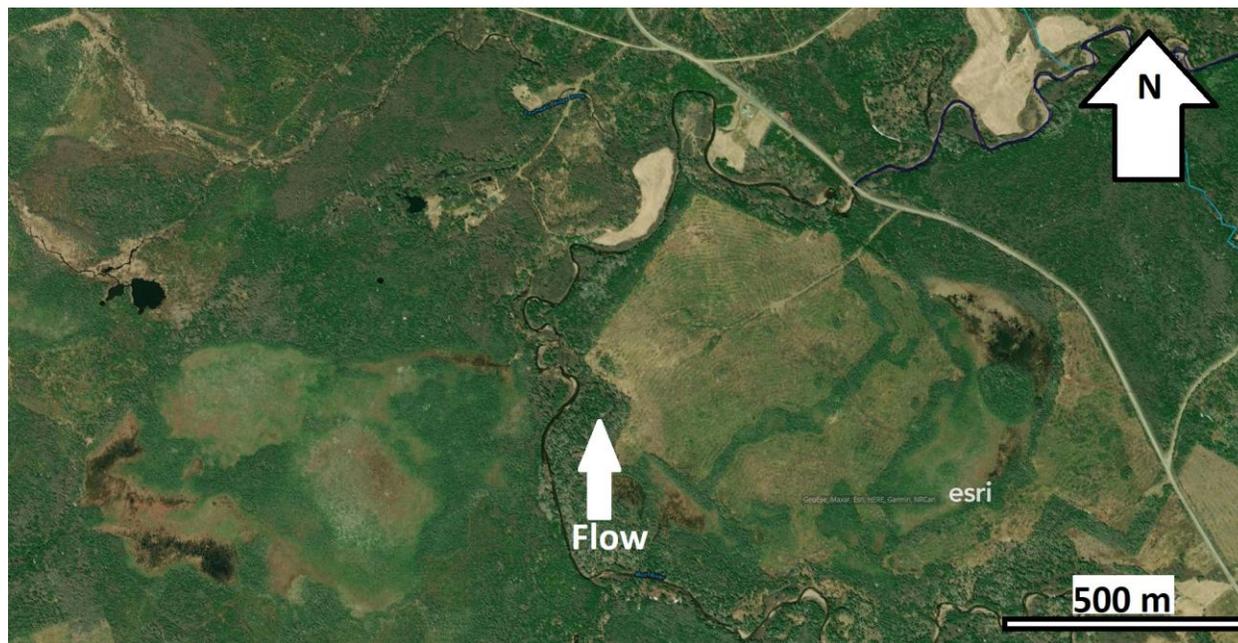
Reach #4 in the upper section begins at the confluence of reach #3 and the Mull River and continues for about one kilometer to the confluence of Southwest Ridge Brook and the Mull River. The adjacent floodplain in reach #4 contains both active and abandoned farmland as a couple of dwellings. Streambed sediment was observed throughout much of this section and the distance between pools (e.g. the meander length) was greater than the hydrological data would suggest. Both these issues can be addressed by installing deflectors which will help to sort substrate and promote the delivery of fines and silts into the floodplain. To the east of this reach a 110 hectare plot of land was clearcut around the year 2000, this could be a contributor to the siltation observed throughout reach #4. After reviewing both drone footage and satellite images it appears that all environmental guidelines (e.g. buffer zones) were adhered to. Regardless, clearcutting can negatively affect adjacent streams by reducing the capacity of soils to retain water, thus decreasing baseflow conditions during the summer months.

Figure 47: Satellite image showing reach #4 upper section.

Restoration through this section will be completed by installing alternating series of log deflectors. This reach can be divided into two sections, beginning upstream this reach flows through a channelized section of stream and has been completely straightened. Installing deflectors will help recover the natural meander pattern. Approximate location of each deflector is marked with a yellow dash in figures 49-52.

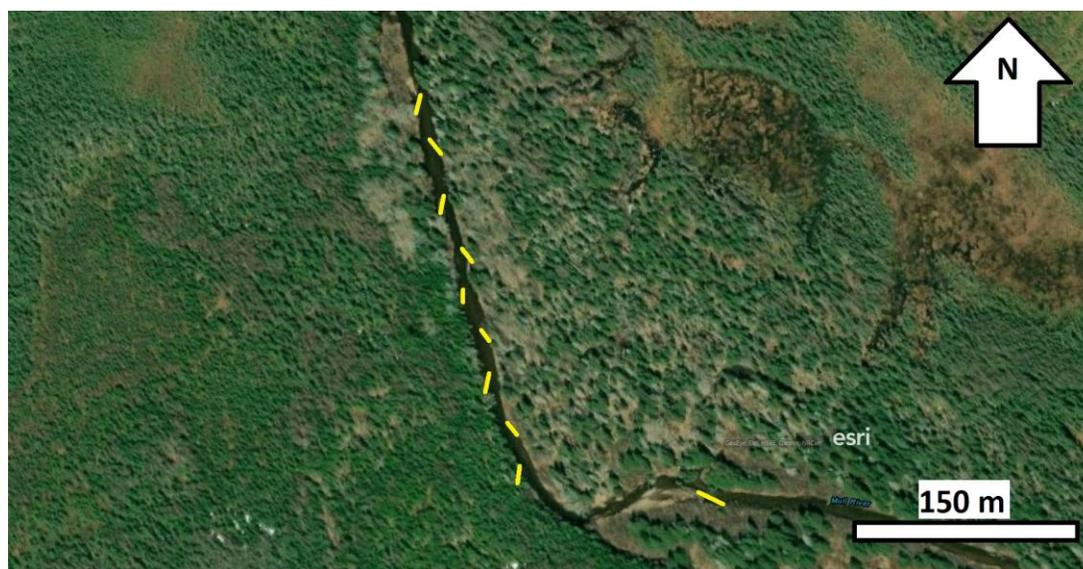
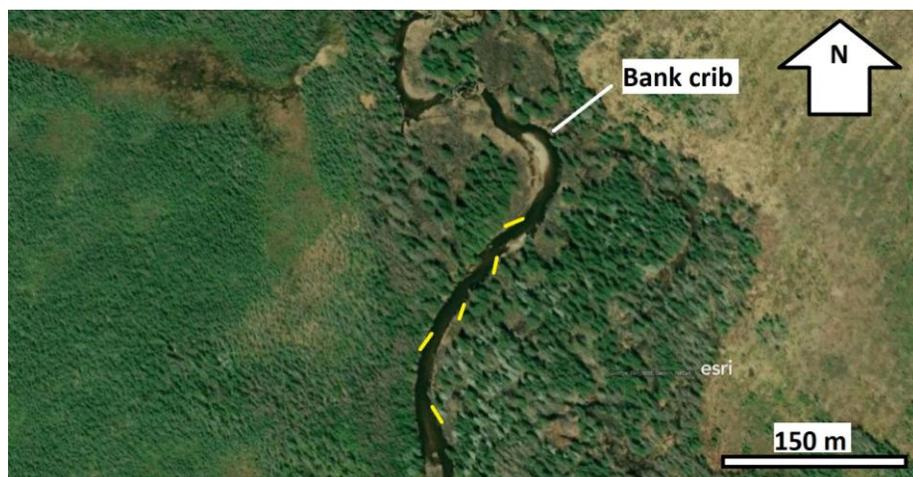
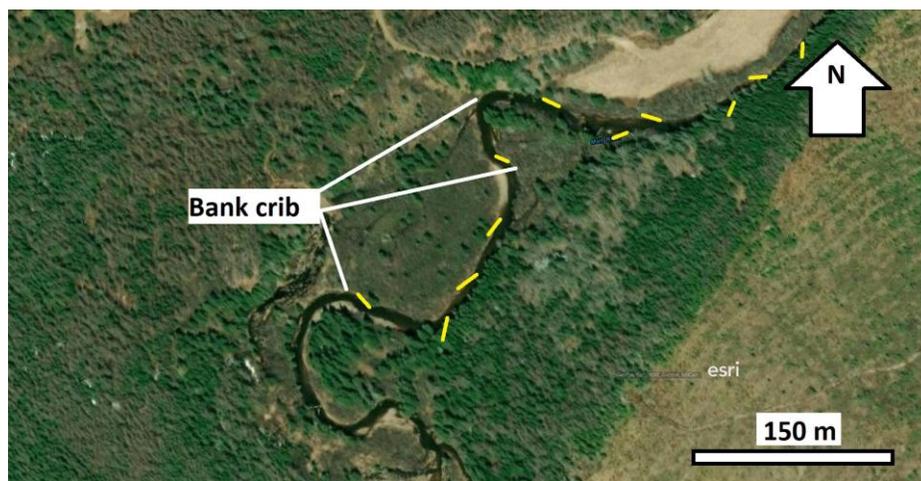
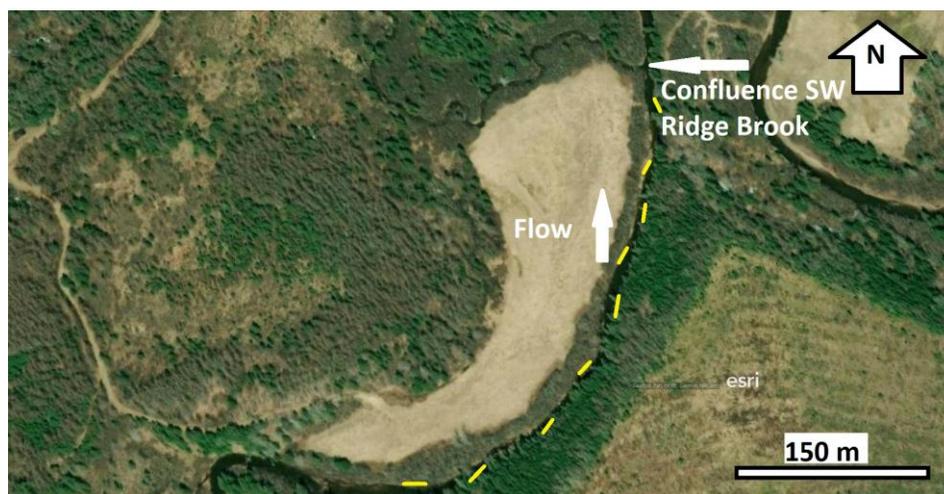
Figure 49: Approximate location of log deflectors.

Figure 50: Approximate location of deflectors.

Figure 51: Approximate location of deflectors and bank cribbing.

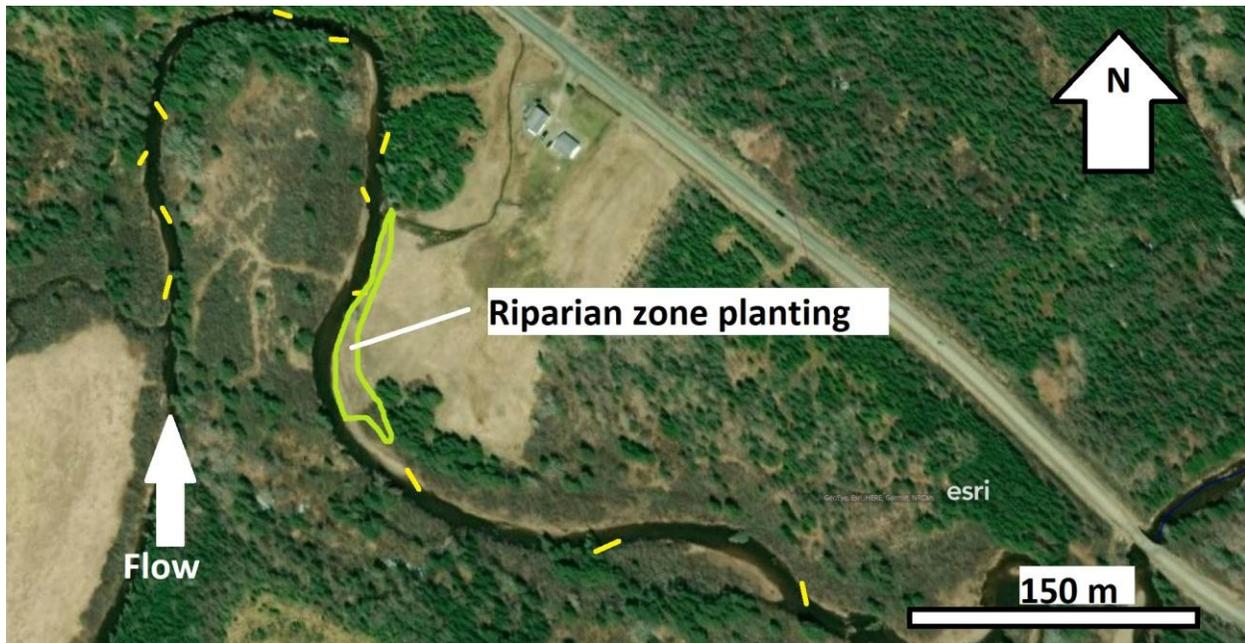
Figure 54: Approximate location of deflectors marked with yellow dash.

Reach #5 in the upper section of the Mull River begins at the confluence of the Southwest Ridge Brook and the Mull River and ends at the Whycogomah-Port Hood Rd crossing. The total watershed area above this bridge is 53.5 square kilometers. This reach contains several holding pools and an active beaver dam (figure 53) approximately 100 meters upstream from the bridge. It appears the beaver dam is creating habitat for fish and mitigating flood water damage so restoration work will begin upstream from the dam. Measurements of the channel in 2020 indicate that the channel is over-widened by 30% and could benefit from the installation of deflectors. By narrowing the channel the deflectors will enhance the depth of the holding pools. Tree planting should also be completed along a 110 meter section of bank that currently lacks a riparian zone (figure 54 and 55).

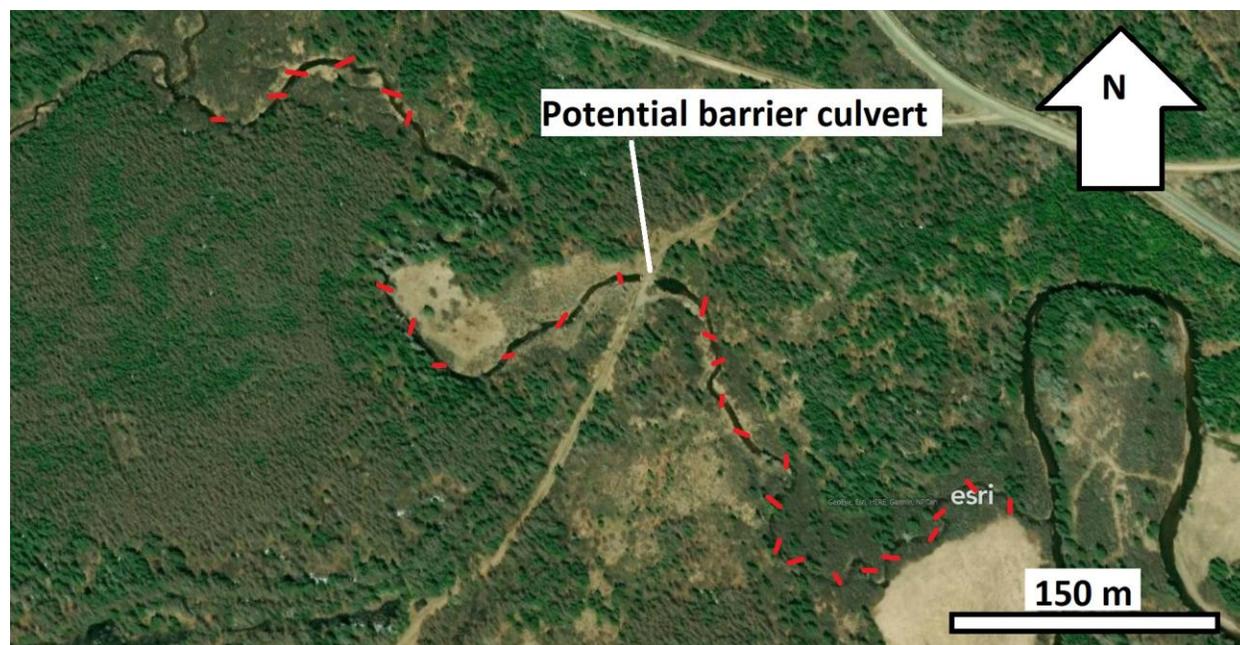
Reach #6 consists of the lower 700 meters of Southwest Ridge Brook, a tributary that enters the Mull River from the north side of the river. Southwest Ridge Brook drains a watershed of 14.1 kilometers and should have an average channel width of 7.39 meters. Instream surveys were conducted in the fall of 2020 and found that the channel was over-widened and it lacked pools and instream cover. Improving the quality of fish habitat in this reach can be accomplished by installing a series of digger logs and deflectors. The digger logs will dig pools on the downstream side of the structure which will improve the downstream meander pattern as well as providing important instream cover for trout and juvenile salmon. On the upstream side of the digger log the formation of spawning habitat will occur as cobble and gravel substrate deposit above the log.

Figure 56: Approximate location of digger logs marked in red.

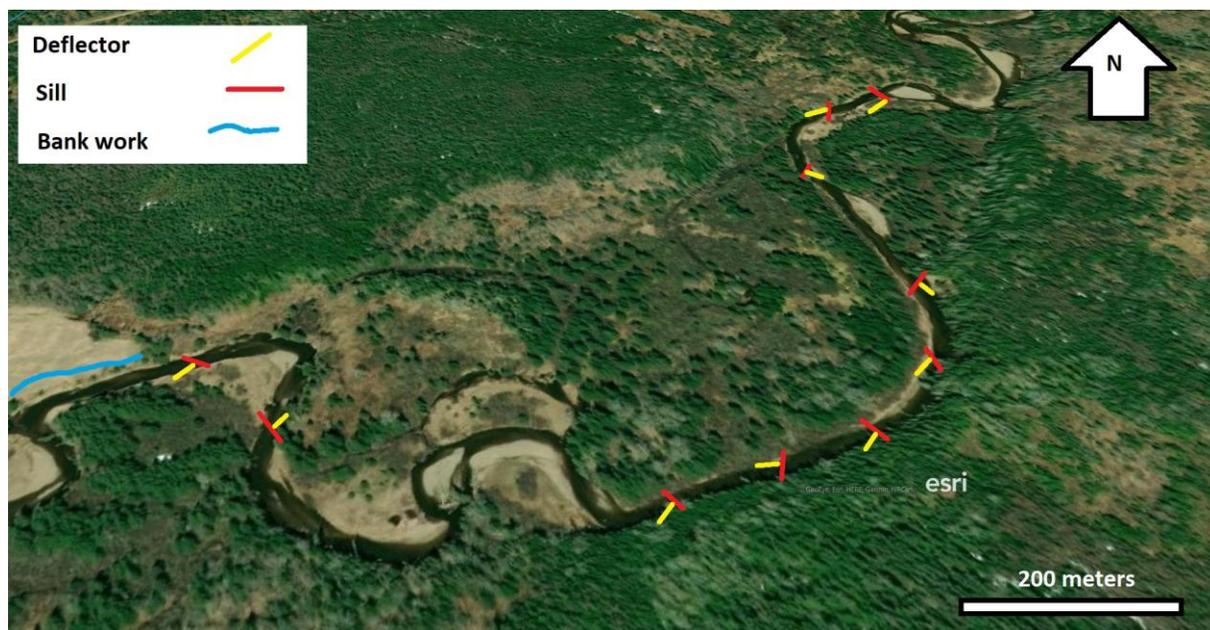
The removal of “the bend in the river” around the year 1900 resulted in the loss of 1 kilometer of channel and over 11,000 square meters in fish habitat. It is quite likely that similar projects were completed by farmers during that area of settlement and as a result the channel has been forced to adjust to an entirely different flow regime. Evidence of this can be seen in figure 63 below.

Figure 63: Lower half of reach #1 mid section Mull River.

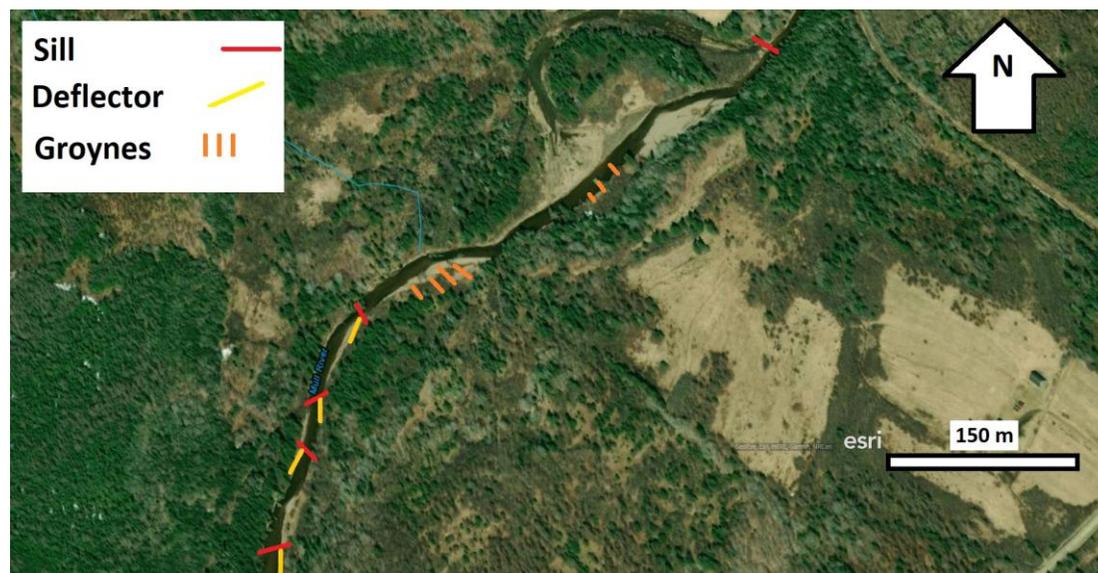
Figure 65: Approximate structure layout for reach #2 mid section Mull River.
