Inverness South Anglers Association

Mull River Habitat Restoration Plan

Assessment of instream habitat and recommendations for Atlantic Salmon
Recovery

MacInnis Natural Resource Services Inc.
12/1/2020

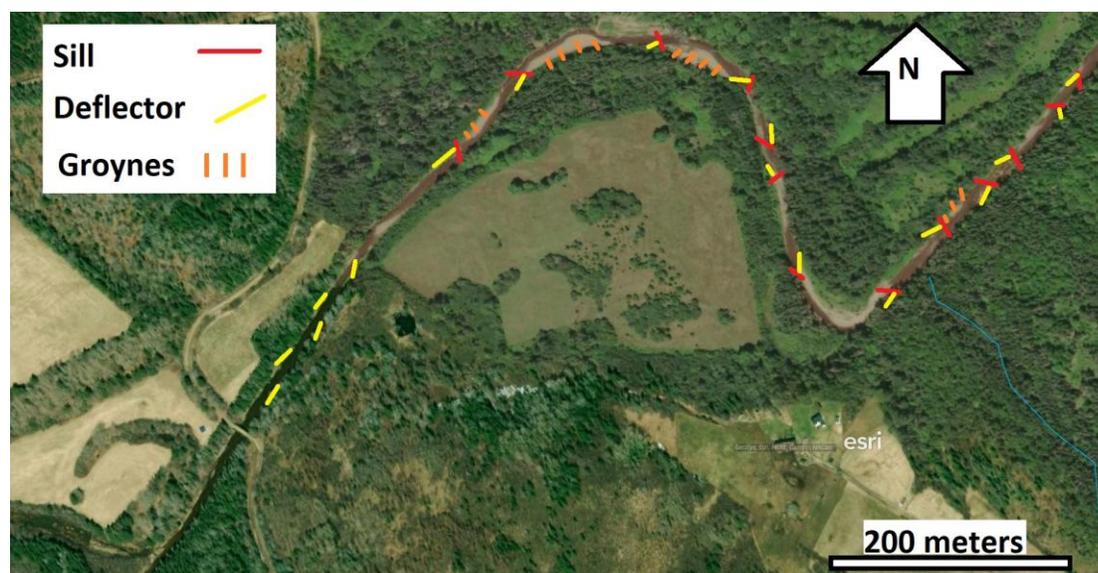
Figure 66: Approximate structure layout for reach #3 mid section Mull River.

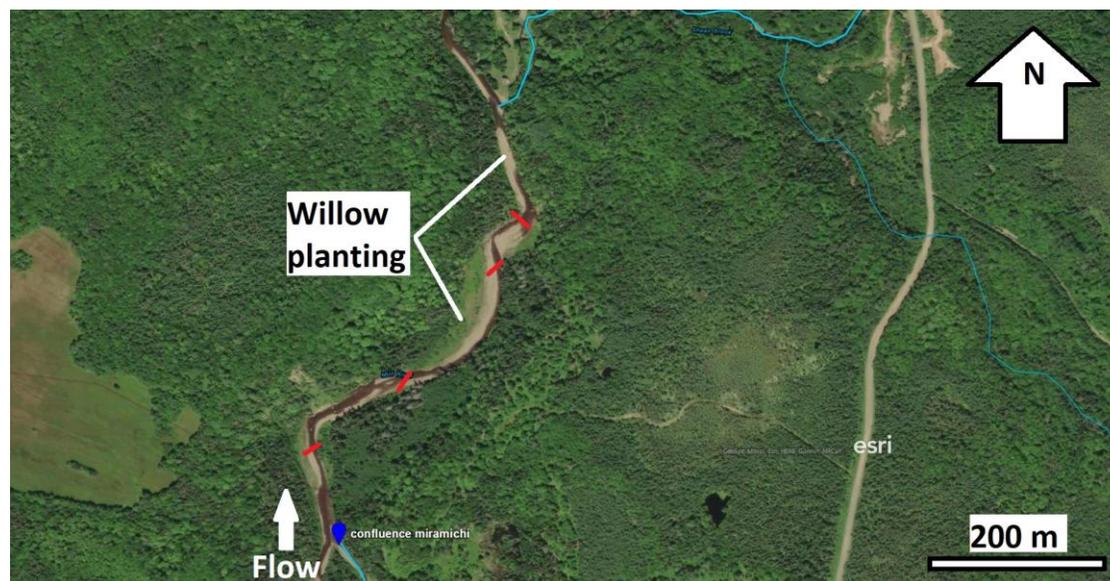
Figure 67: Approximate structure layout in reach 1 of the lower section.

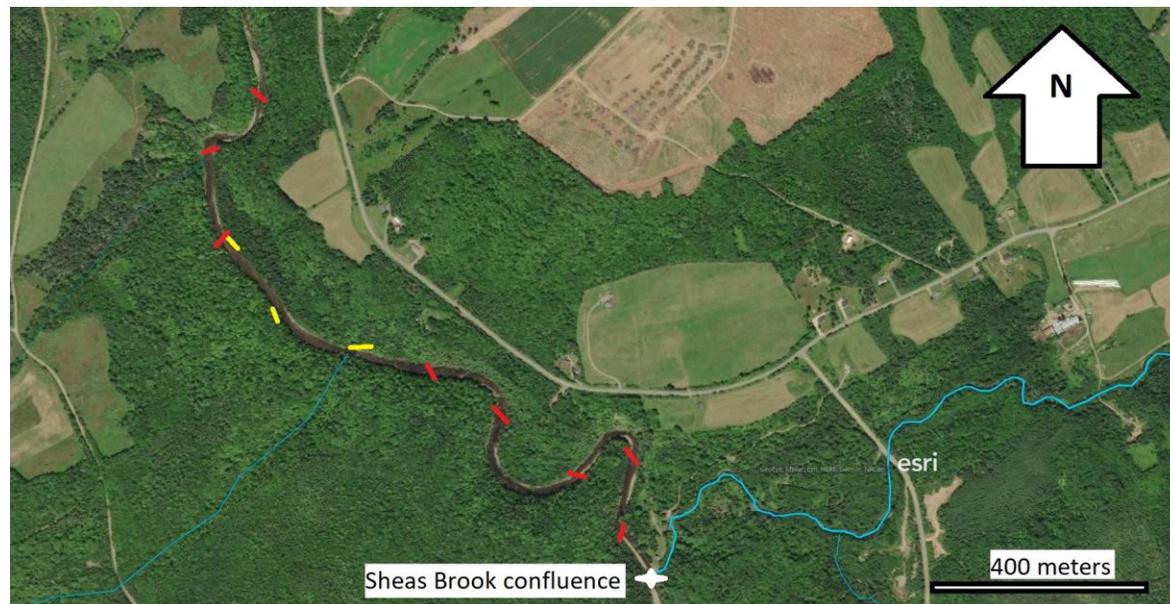
Figure 69: Approximate structure layout for the upstream half of reach #2 in the lower section of Mull River.

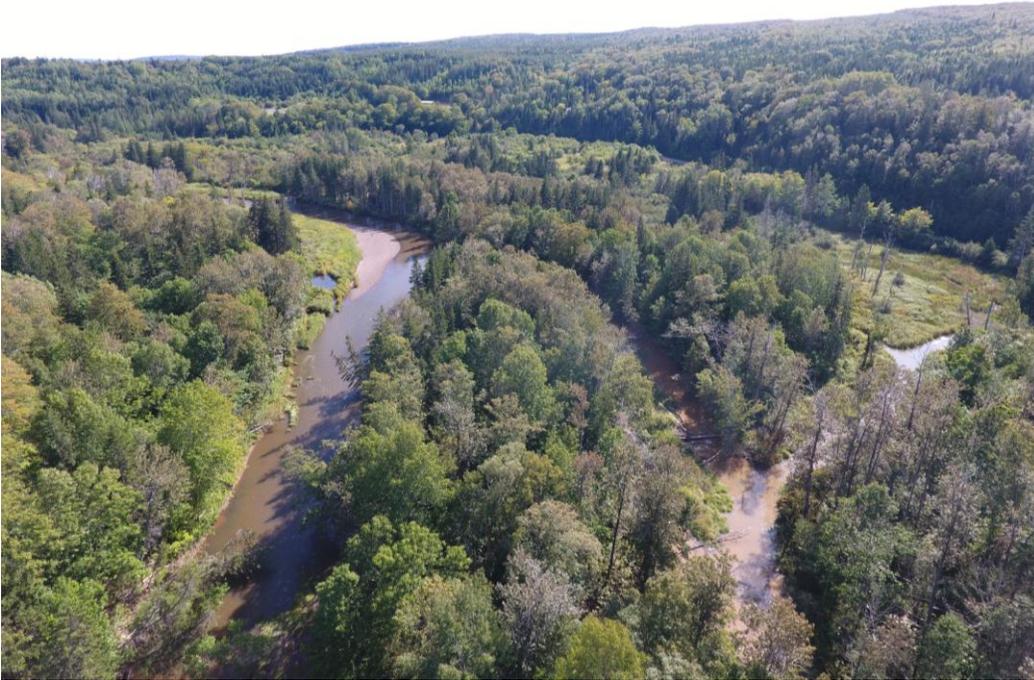
Figure 74: Aerial photo looking upstream from Murray Hill Bridge. Historic channels are visible to the right.

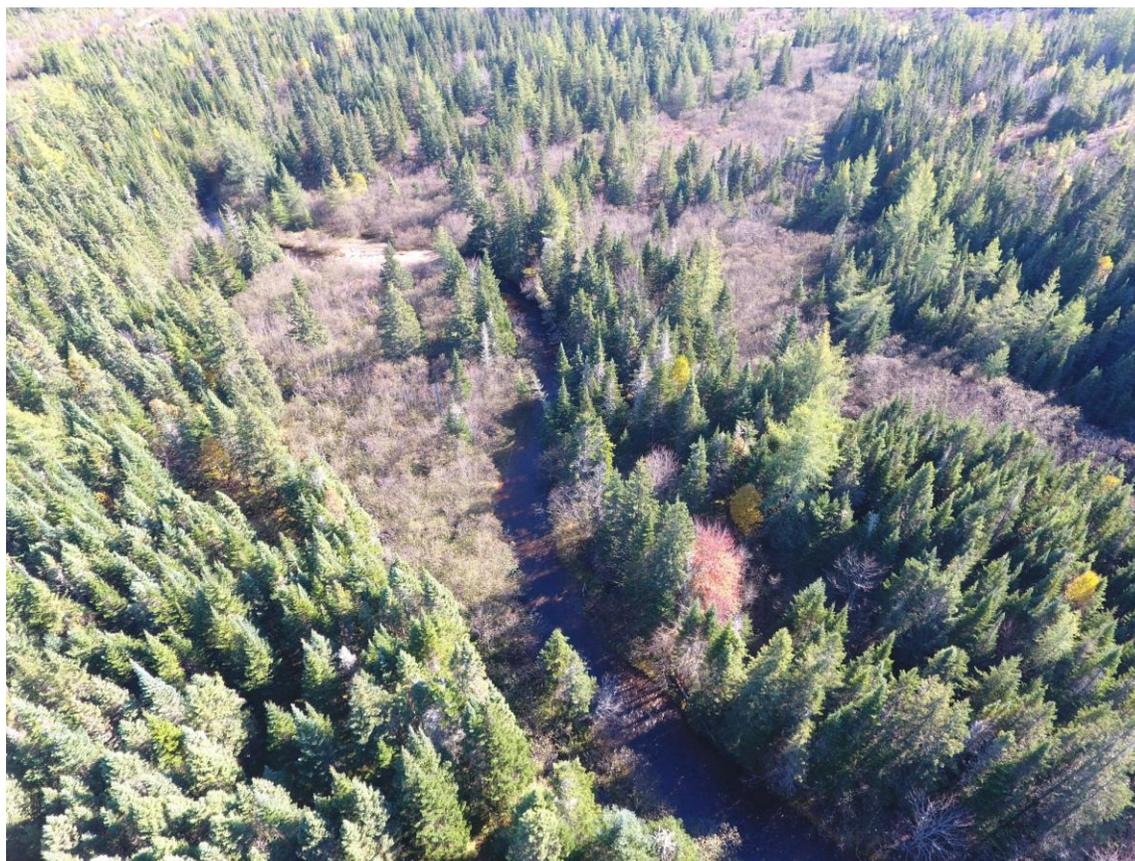
Figure 80: Potential restoration site #2 in Miramichi Brook.

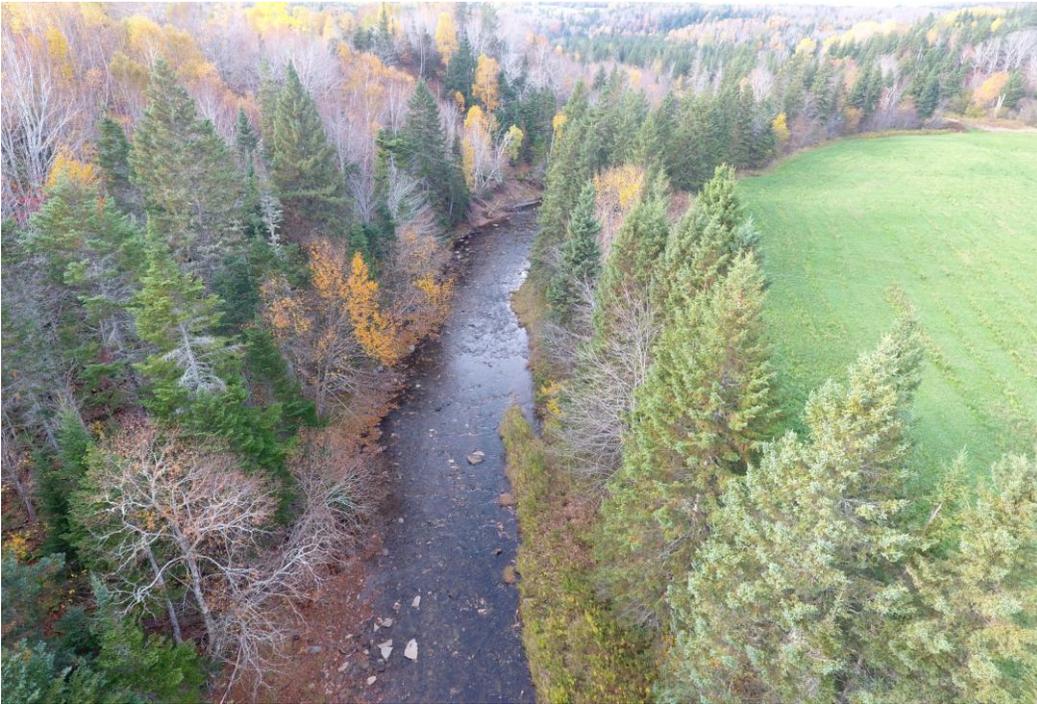
Figure 82: Looking downstream on Sheas Brook approximately 1 kilometer from Mull River confluence.

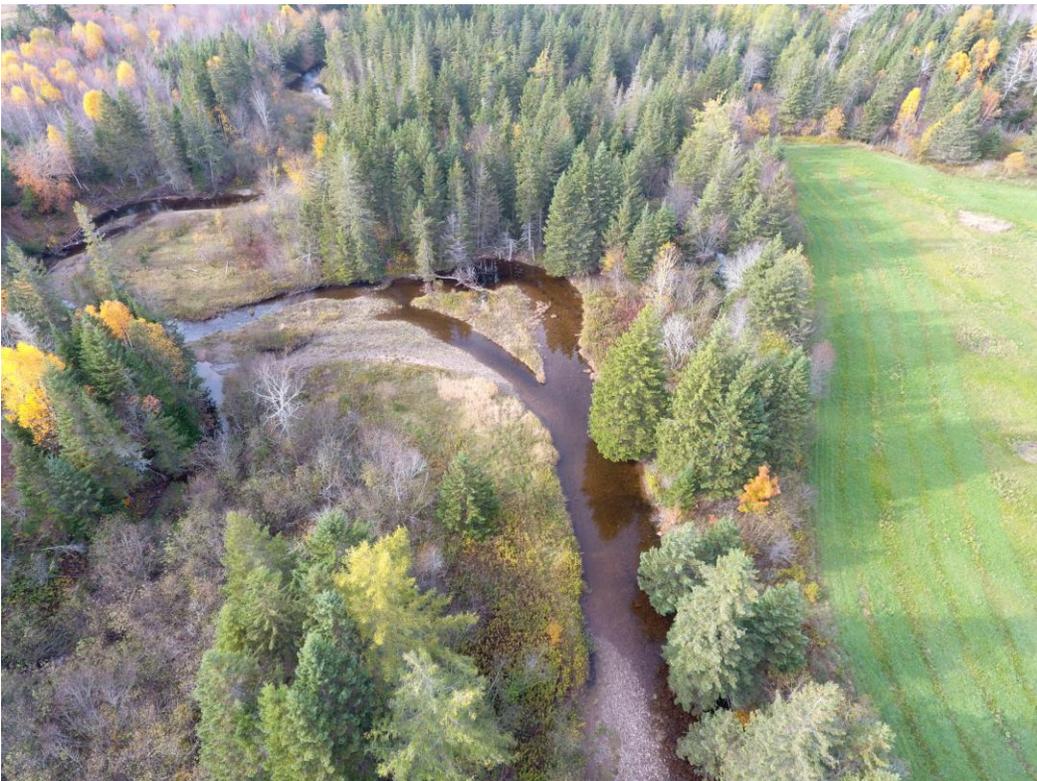
Figure 83: Looking downstream on Sheas Brook approximately 500 meters above Mull River confluence.

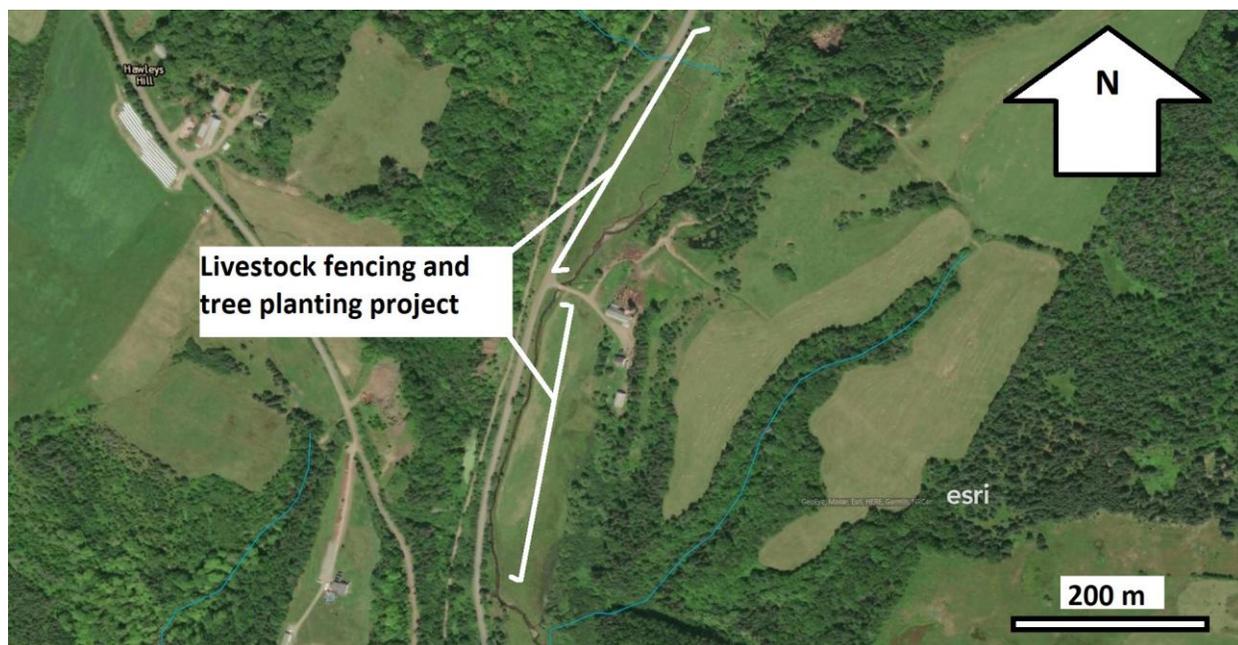
Figure 85: Lower Glendyer Brook - potential for riparian zone project with landowner permission.

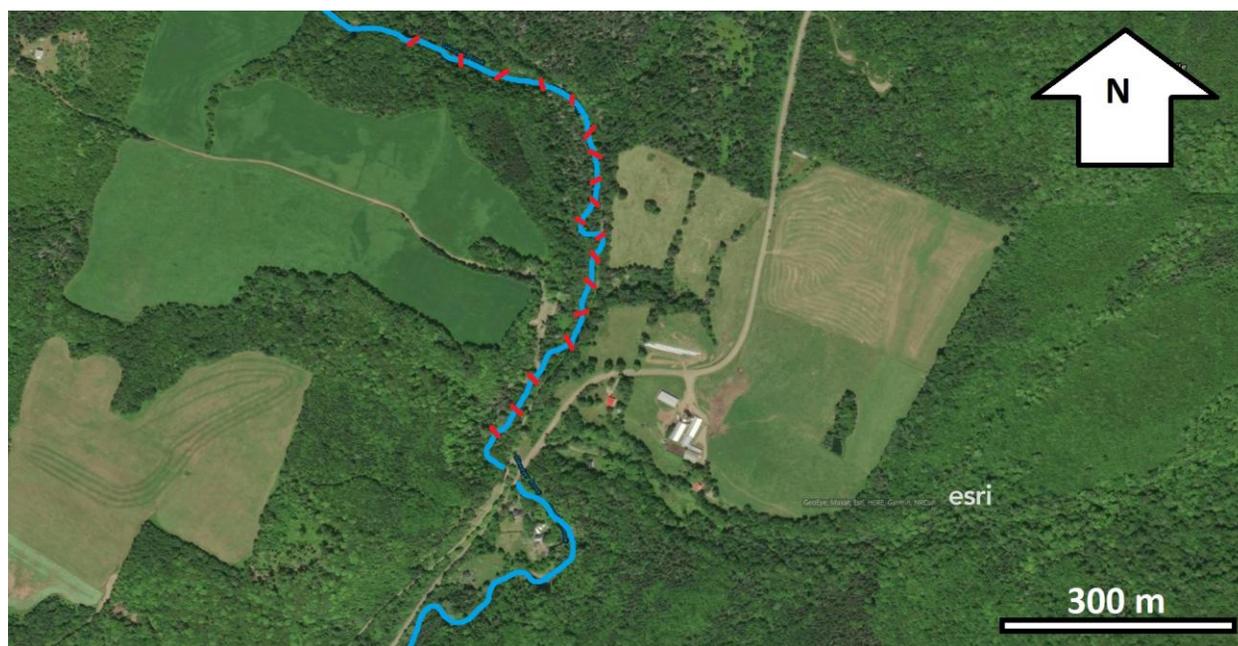
Figure 86: Approximate location of digger logs marked in red.
