Stephen Rose
Natural Resources Technician
Qalipu First Nation
1 Church Street, Corner Brook, NL
A2H 2Z4

Background

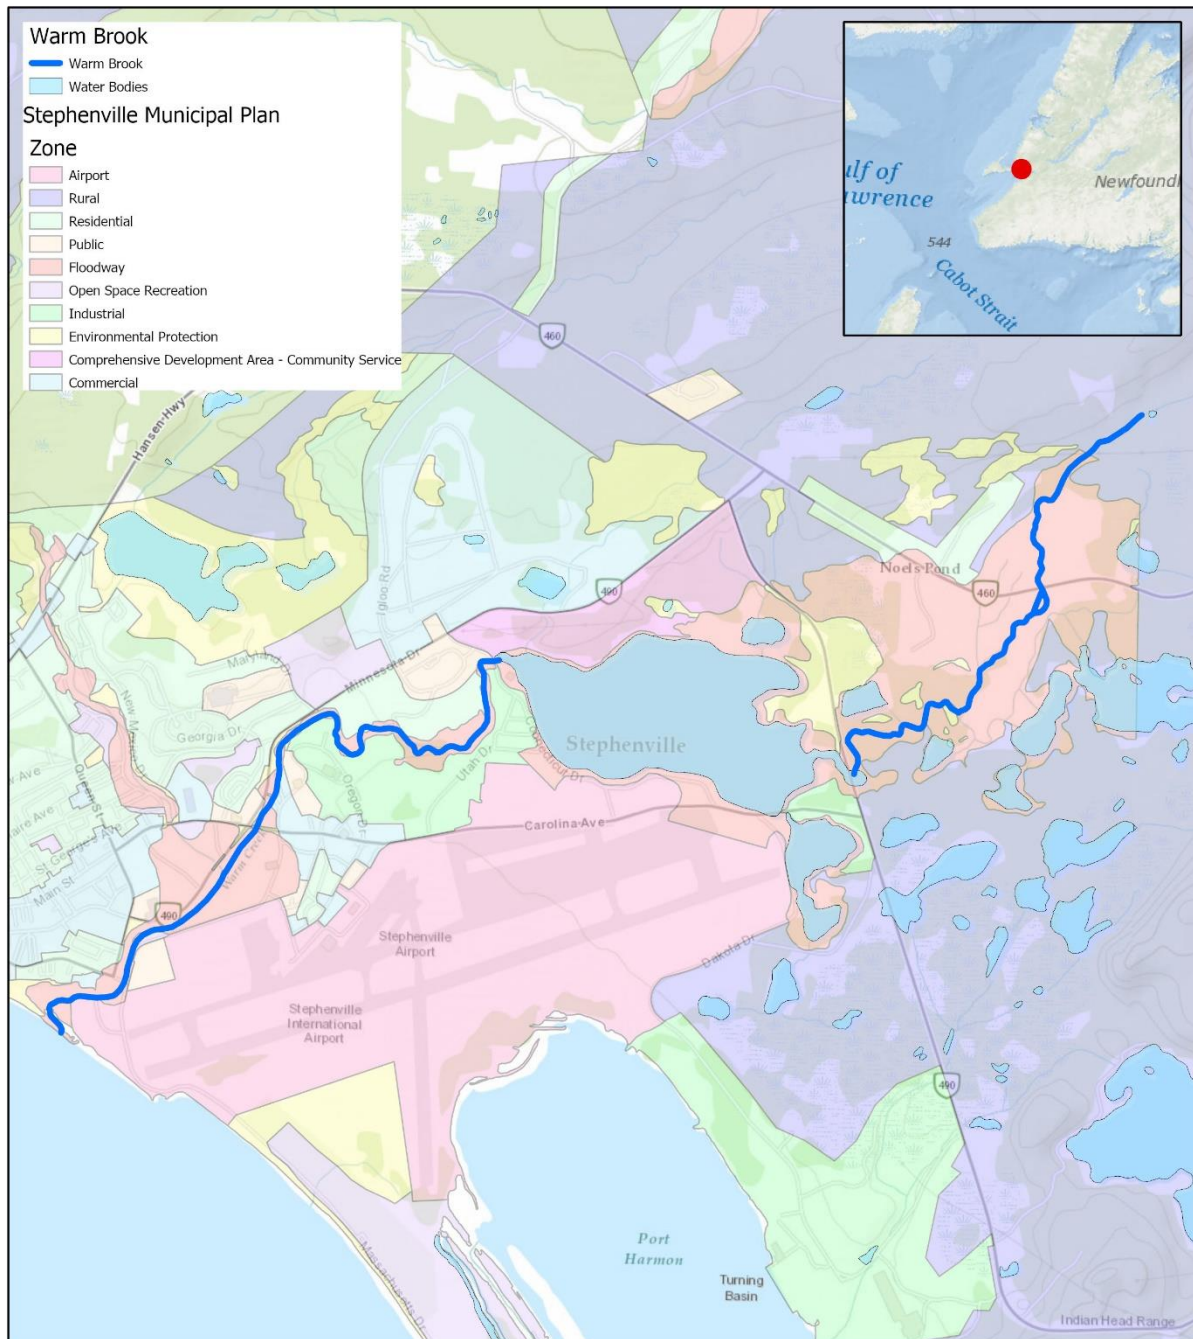
2019
Map No. 1 of 3

Table 1.1: Land Use Zones adjacent to Warm Brook by distance and percentage (see Appendix I, Map 1 of 3)

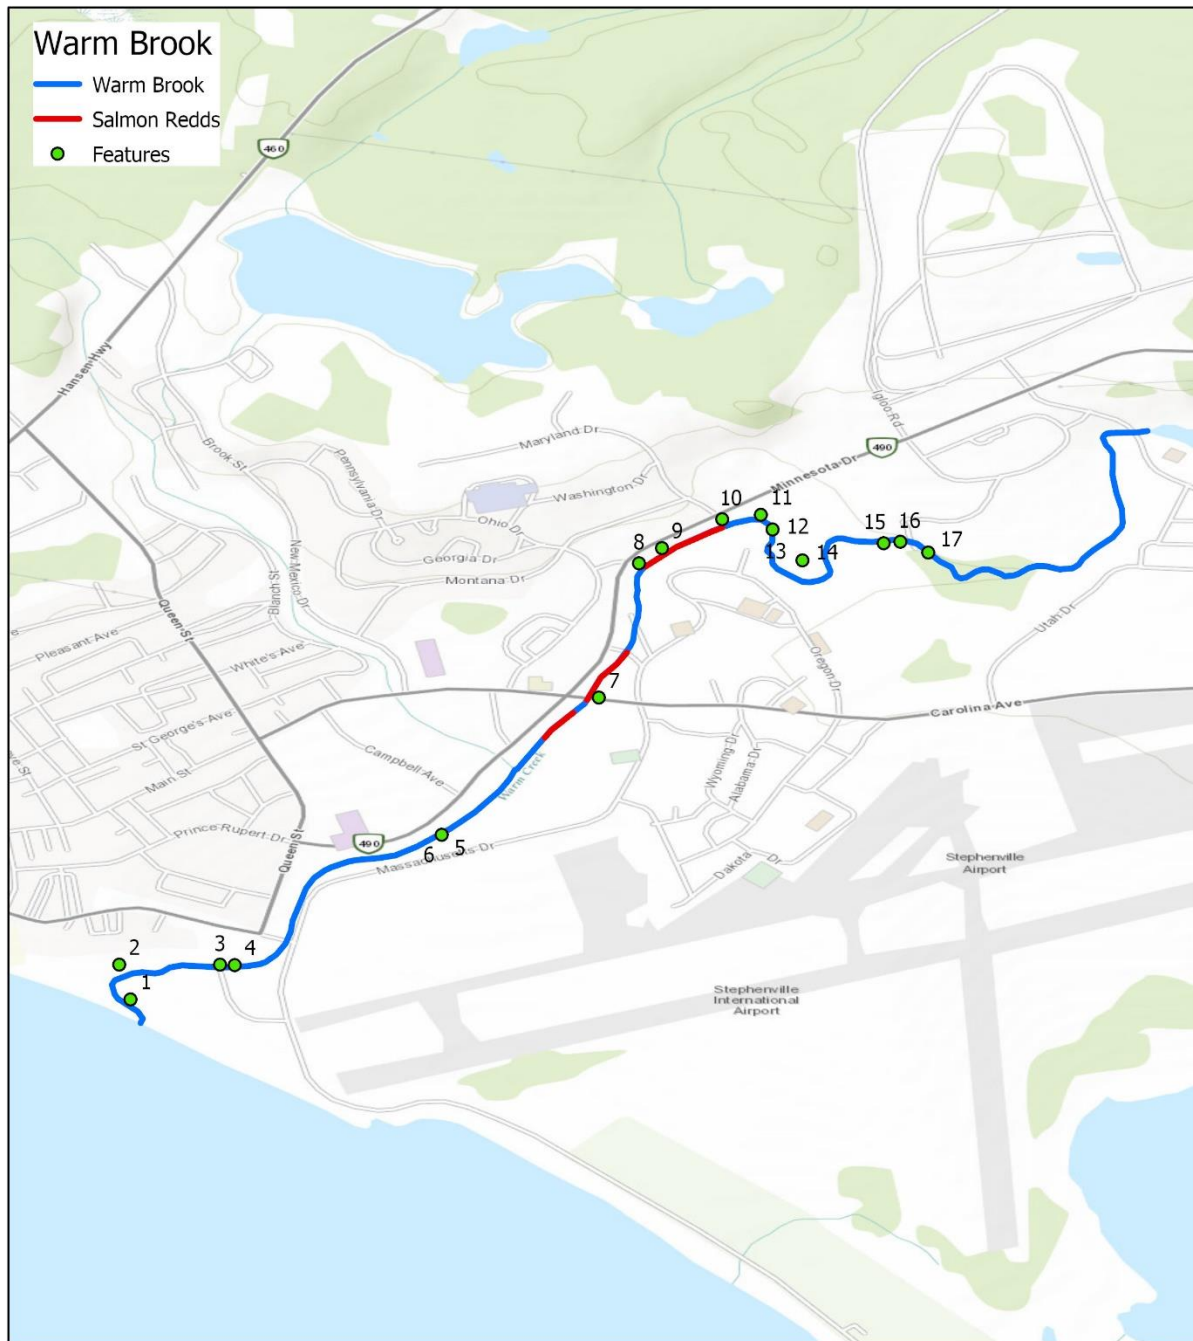
2020
Map No. 2 of 3

Table 1.2: Identified features in Warm Brook, NL while conducting field surveys. (See Map 2 of 3 and 3 of 3 in Appendix I; photos in Appendix II)
