## WOLASTOQEY NATION IN NEW BRUNSWICK

### **Wolastoq Watershed barrier analysis**

#### **Executive summary**

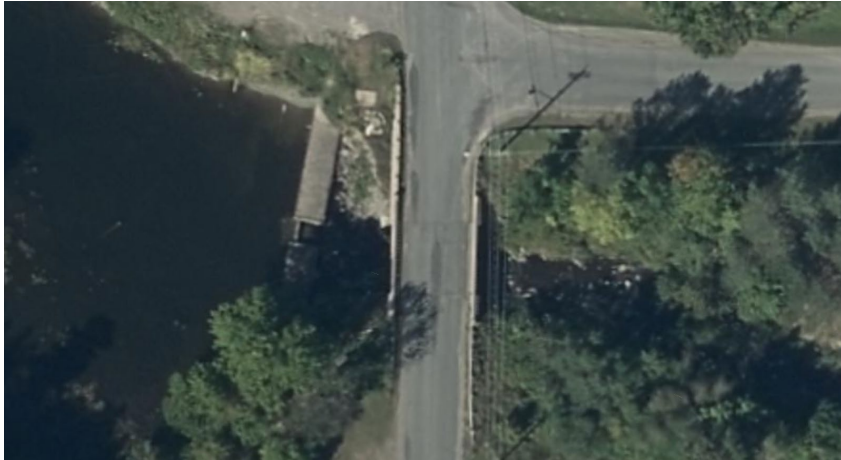
### Crossing 3

| Coordinates | 67.6859913°W, 46.3370867°N | Notes | Structure appears to be a weir from orthophotography, large elevation changes over the 3-meter-wide structure from the LiDAR DEM confirms that it is. While weirs can provide fish passage during high flow events when the structure is not retaining water, the high slope, channelization of 80% results in high velocity flows with a steep slope would not allow fish passage at any point. Solution could be complete removal of the structure. If it is needed for water retention, a fish ladder could be installed. |

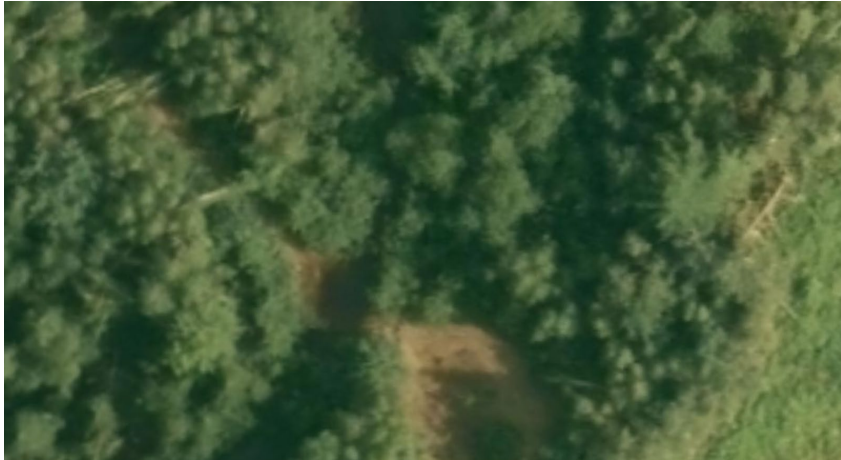
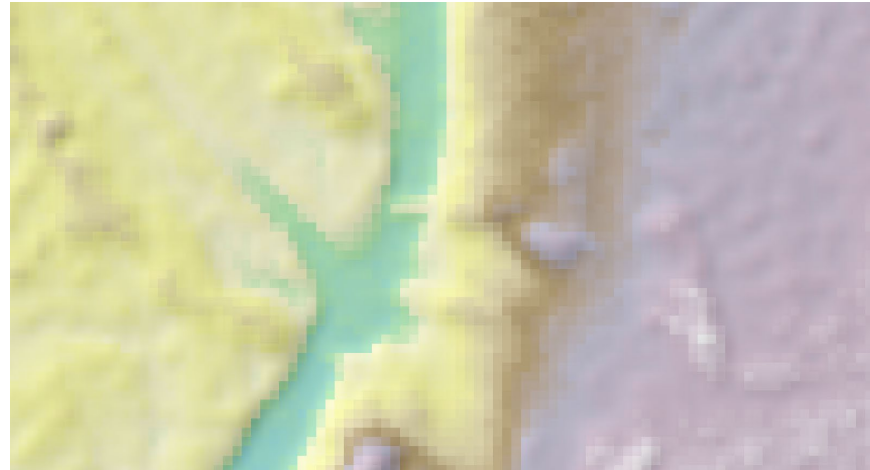
### Crossing 4

| <b>Coordinates</b> | 66.4414438°W, 45.7154392°N | <b>Notes</b> | The ford lacks any natural or artificial bank reinforcement. This could result in increased erosion and sedimentation. Evidence of erosion is already present, increased stream width at crossing. Bank reinforcement to maintain the average stream width and prevent erosion would result in water depth increase, protecting downstream habitat from sedimentation. |

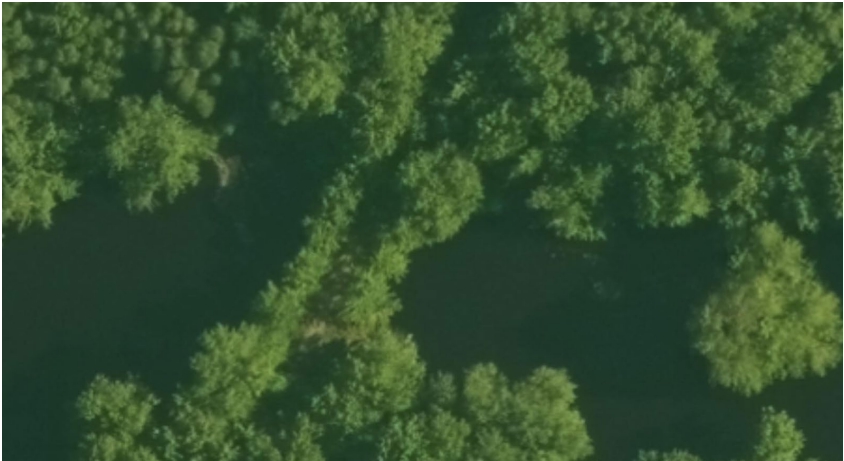
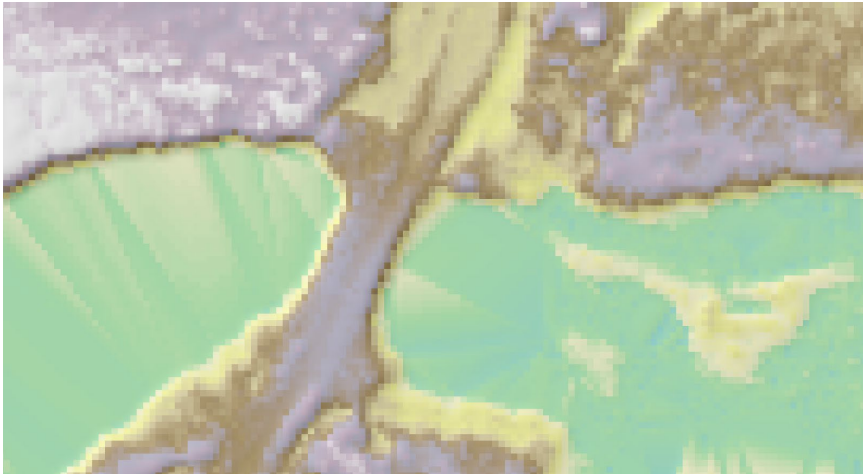
| Crossing 5 | | | |

| Crossing 5 | | | |
|---|---|--|---|
| Coordinates | 66.4278025°W, 45.8988082°N | Notes | <p>Impoundment has no structure. The road appears to be an old forestry road that was not properly decommissioned. Solution would be to remove the impoundment fully and reinforce the underlying substrate to prevent erosion.</p> |

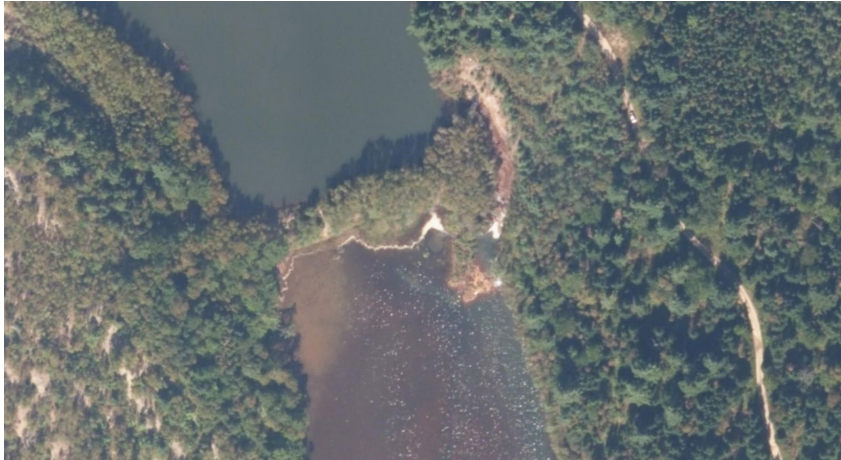
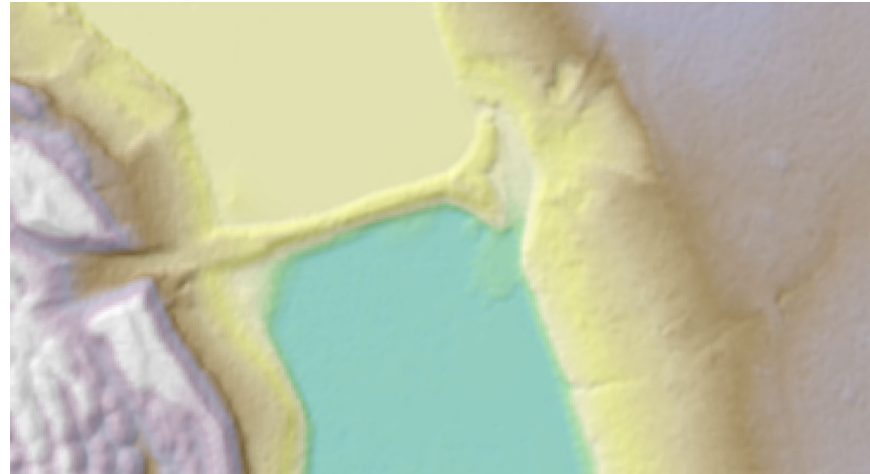
## Crossing 6

| <b>Coordinates</b> | 65.9485715°W, 46.1407914°N | <b>Notes</b> | Impoundment has no crossing structure installed, the only viable crossing passage is to the East edge where there appears to be a natural spillway. The slope of the spillway averages 8% slope, making it impassable to any fish species present in New Brunswick. Solution is to either remove the impoundment and restore natural passage or if that's not viable, remediate the spillway to the East at a maximum slope of 2% to ensure all fish can pass upstream. |

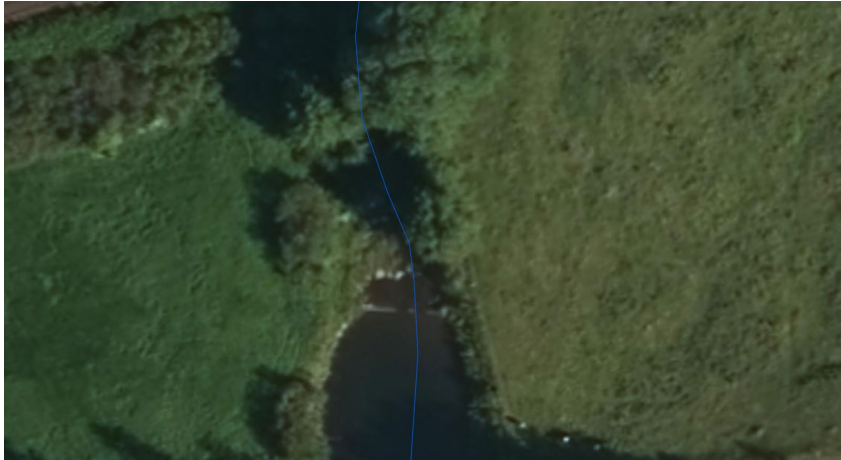
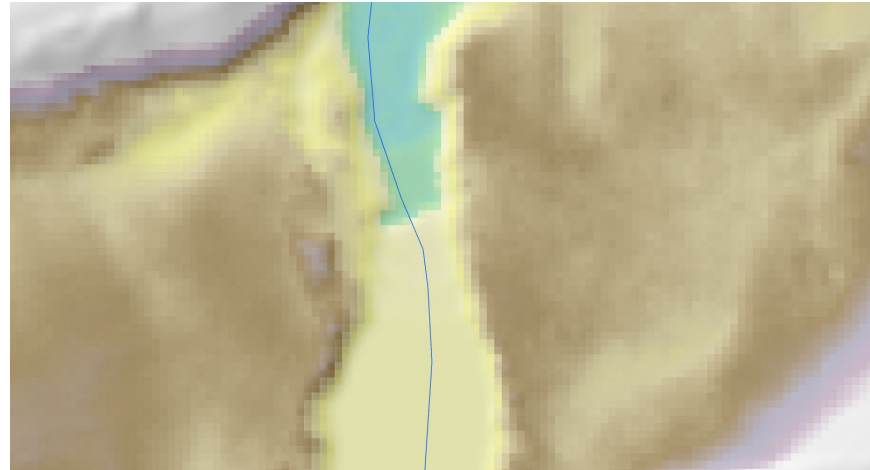
## Crossing 7

| <b>Coordinates</b> | 65.5676446°W, 45.7087957°N | <b>Notes</b> | <p>From remotely accessed data, there is no evidence to identify what structure the impoundment is. From the LiDAR DEM, it shows a sharp level of elevation gain, (0.8 meters) over a 1 meter distance. There is a culvert upstream and this could be installed to raise the water level on the downstream end of the culvert; upstream side of the impoundment. Further investigation is needed to have a conclusive solution.</p> |

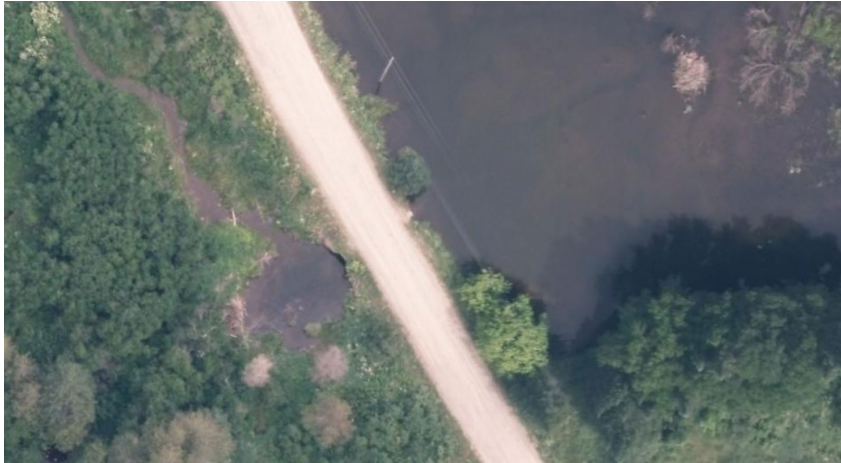
## Crossing 8

| <b>Coordinates</b> | 67.5077527°W, 46.6137278°N | <b>Notes</b> | <p>Culvert slope exceeds slope threshold.</p> <p>Need to remove two barriers: There is a bridge on another branch of the stream that allows upstream passage. Can be low priority if habitat is not adequate for target species.</p> |

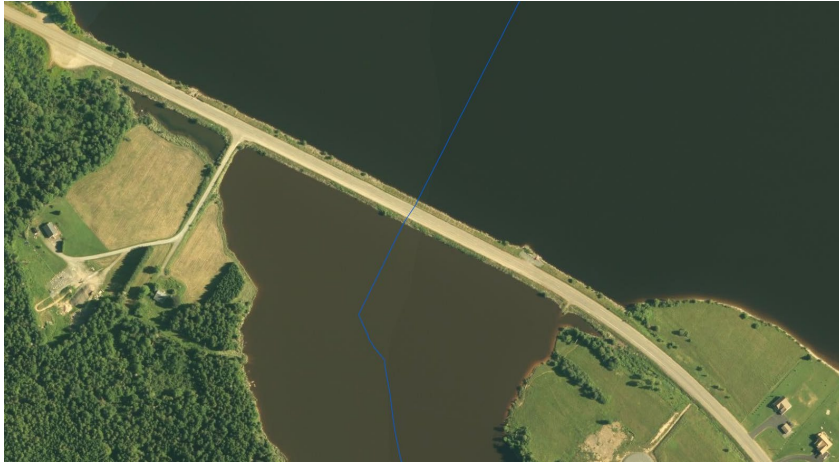
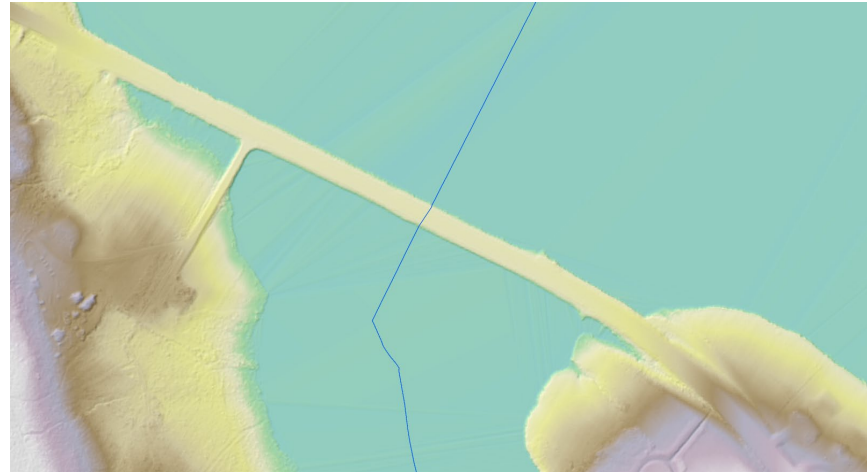
## Crossing 9

| <b>Coordinates</b> | 67.0204065°W, 45.9005610°N | <b>Notes</b> | <p>Impoundment length is 700m in length with no visible crossing structure. If there is a crossing structure present, it would be too small for a in-stream structure for such a long impoundment. An open bottom culvert installed at the highest velocity point in the thalweg would open passage through and reduce erosion on the embankment of the impoundment.</p> |

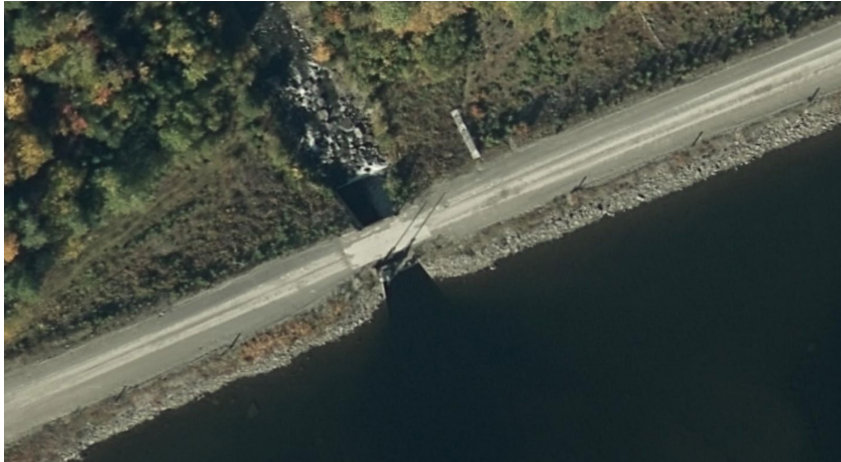
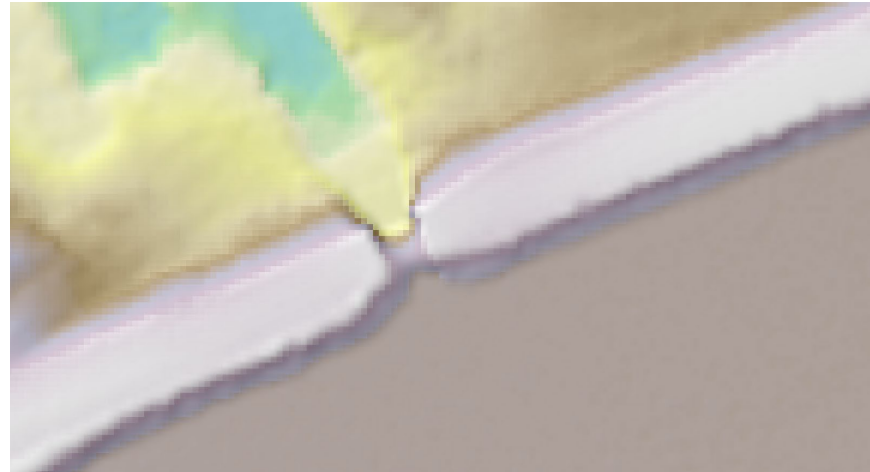
## Crossing 10

| <b>Coordinates</b> | 66.9229512°W, 47.0600975°N | <b>Notes</b><br><br>Crossing appears to be a bridge with a water retention/artificial riffle structure. DEM and LiDAR confirm that the water characteristics and water level dramatically change over the 8m barrier and again at the riffle structure 15m downstream. Elevation drops by 4 meters under the bridge, indicating there might be a structure below. The elevation drops by another 0.5m of the riffle structure. The elevation values in the DEM could be altered depending on the method used to remove the pits. Regardless the slope from the upstream bridge side to the downstream end of the riffle structure (18m in length) still has a slope of 24.4%, which fish cannot pass. Due to the intricate nature of the structure, the crossing should be modified within the existing structure; install natural boulder habitat to create a series of pool/riffle habitat at low slope. |

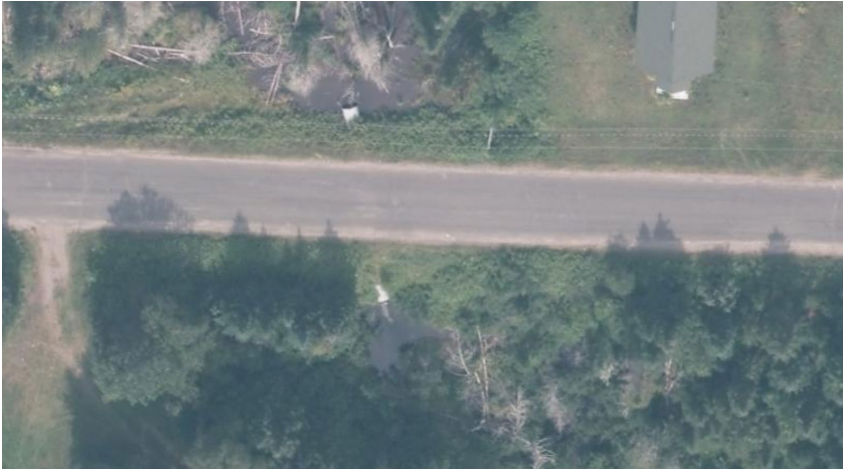
| Crossing 15 | | | |

| Crossing 15 | | | |
|---|---|--|--|
| Coordinates | 67.6117368°W, 46.8140493°N | Notes | Culvert slope exceeds slope threshold. |

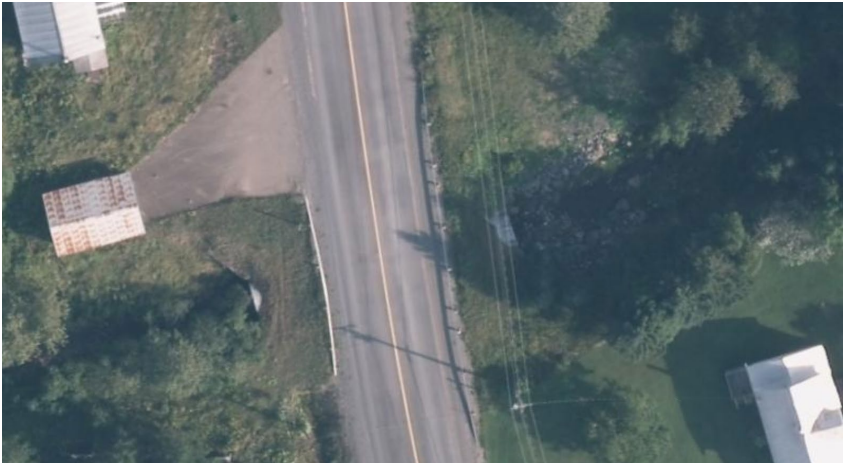
| Crossing 16 | | | |

| Crossing 16 | | | |
|---|---|--|--|
| Coordinates | 67.3016939°W, 47.0290785°N | Notes | Culvert slope exceeds slope threshold. |

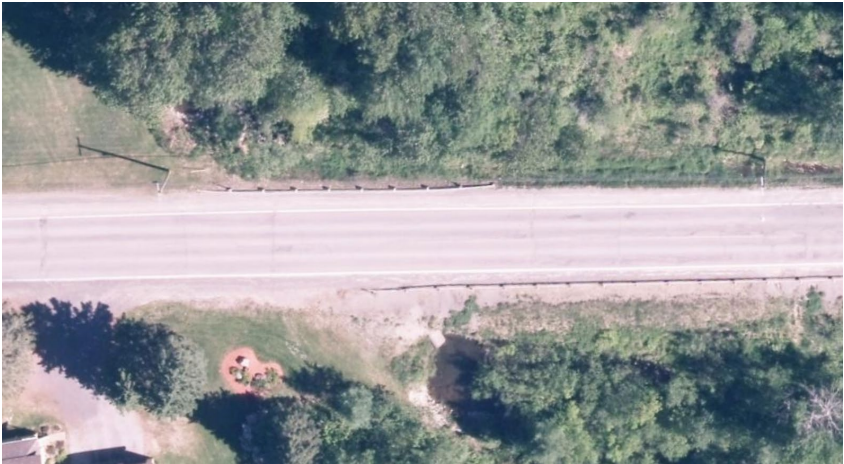
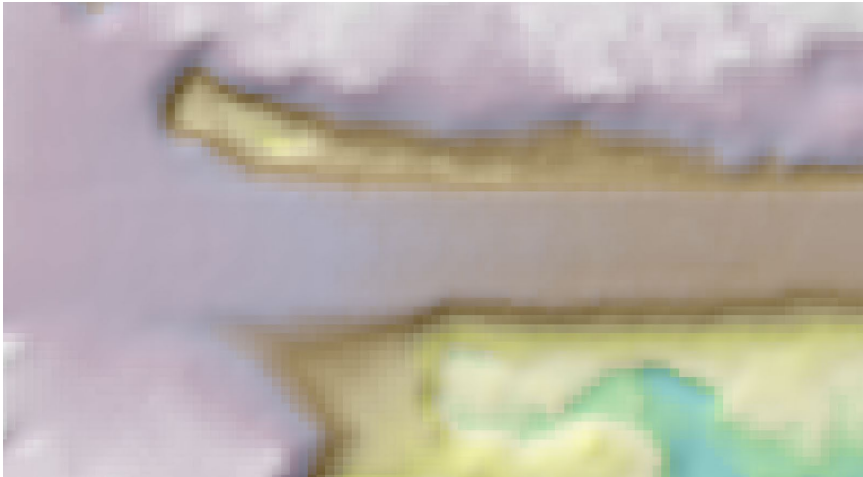
| Crossing 17 | | | |

| Crossing 17 | | | |
|---|---|--|--|
| Coordinates | 68.4117716°W, 47.2902511°N | Notes | Culvert slope exceeds slope threshold. |

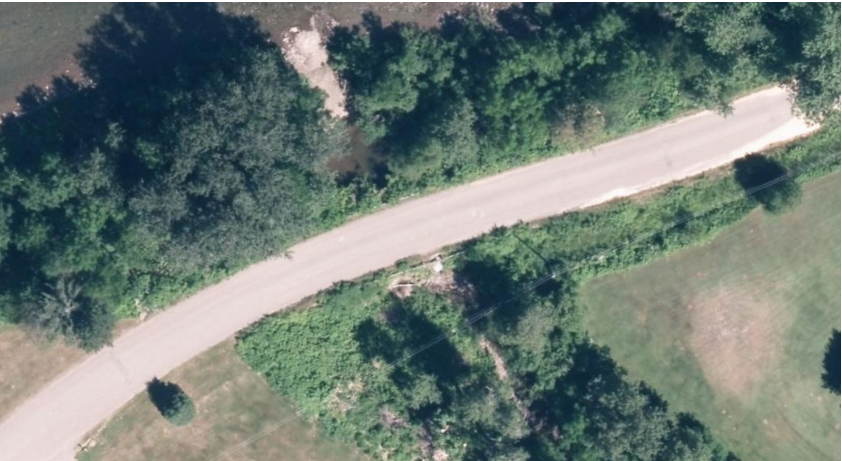
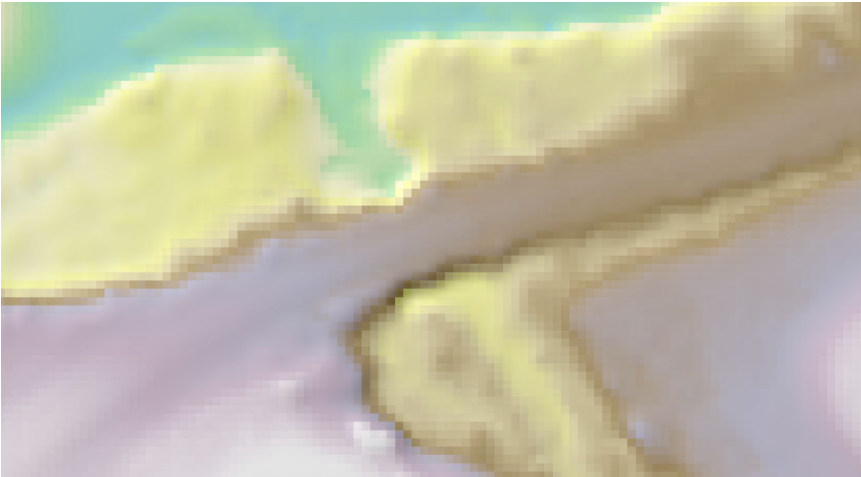
| Crossing 18 | | | |

| Crossing 18 | | | |
|---|---|--|--|
| Coordinates | 67.5638751°W, 47.0556402°N | Notes | Culvert slope exceeds slope threshold. |

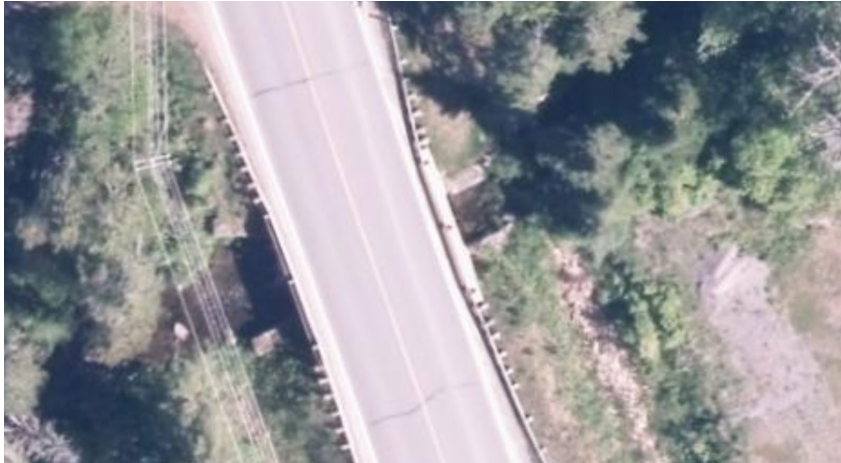
### Crossing 19

| <b>Coordinates</b> | 68.5860539°W, 47.2911587°N | <b>Notes</b> | Crossing appears to be a bridge culvert, it is assumed to not have a concrete bottom due to the design. The slope exceeds the threshold. If the slope is naturally of a higher slope or it is a DEM error due to pit removal methods, then no remediation should take place unless its anthropogenic or was a result of intervention. |

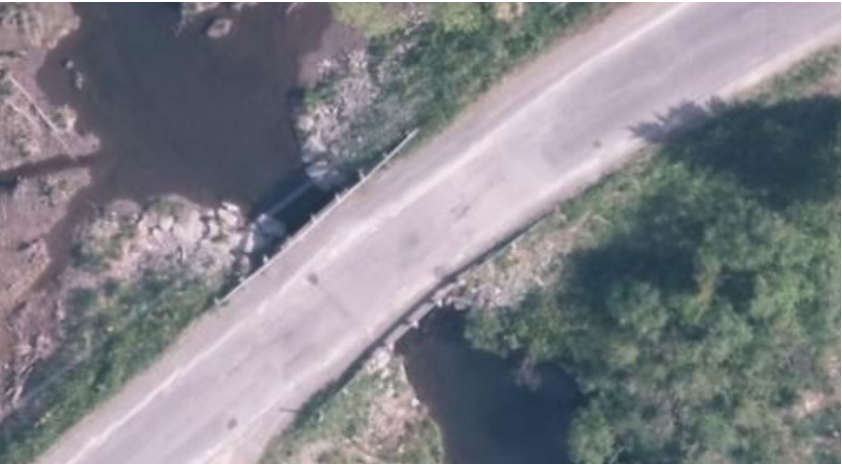
| Crossing 20 | | | |

| Crossing 20 | | | |
|---|---|--|--|
| Coordinates | 68.5037588°W, 47.4001740°N | Notes | Culvert slope exceeds slope threshold. |

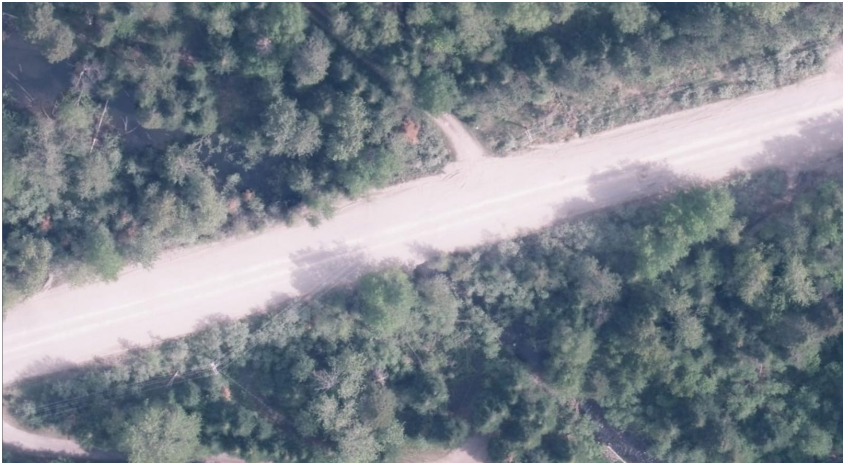
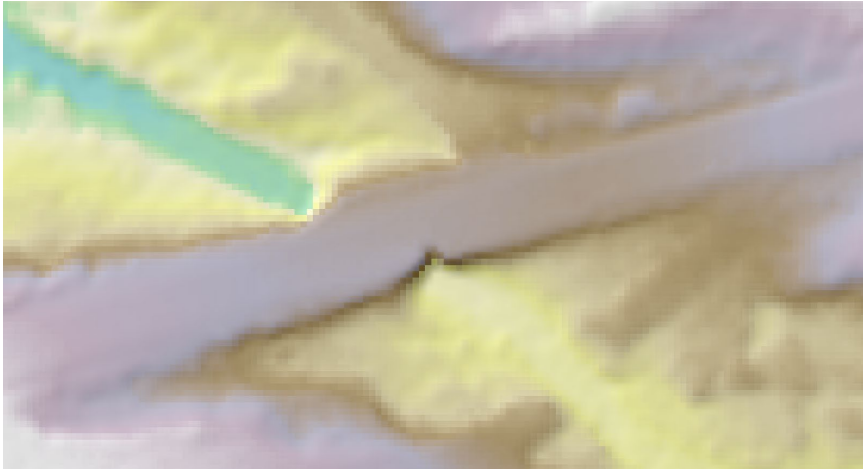
| Crossing 22 | | | |

| Crossing 22 | | | |
|---|---|--|--|
| Coordinates | 68.1872518°W, 47.4758987°N | Notes | Culvert slope exceeds slope threshold. |

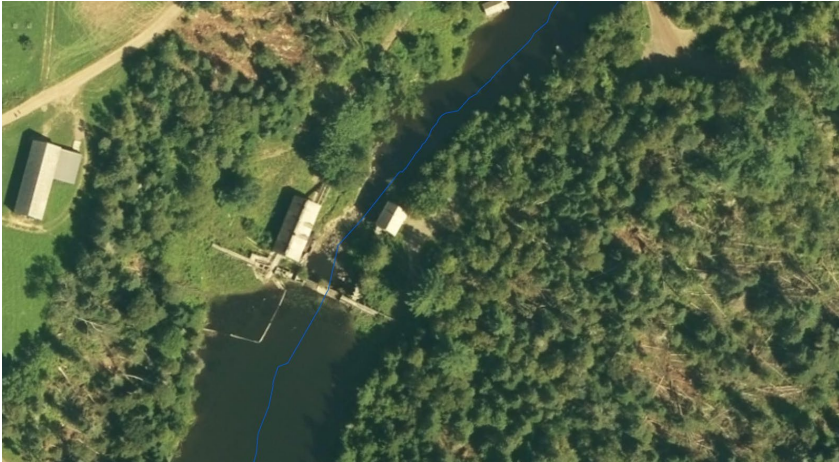
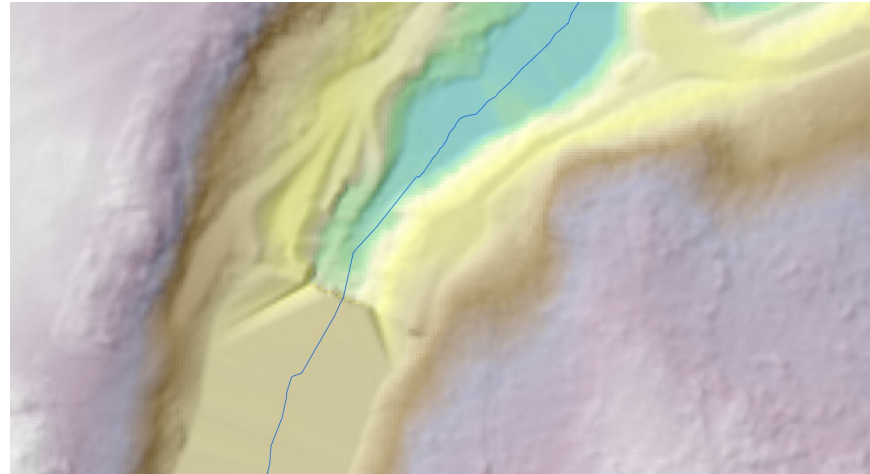
## Crossing 26

| <b>Coordinates</b> | 66.9749724°W, 45.8753000°N | <b>Notes</b> <p>Unknown structure, it could be a grain mill or some water diversion system for the nearby fields. The removal of this structure would be optimal, but if it is vital to existing infrastructure, a fish ladder can be installed or a fishway. The height of the dam is estimated to be 6.5 meters based on LiDAR DEM values.</p> <p>Need to remove two barriers: The barrier upstream (Crossing 25) would need to be removed for the upstream kilometers to be restored.</p> |

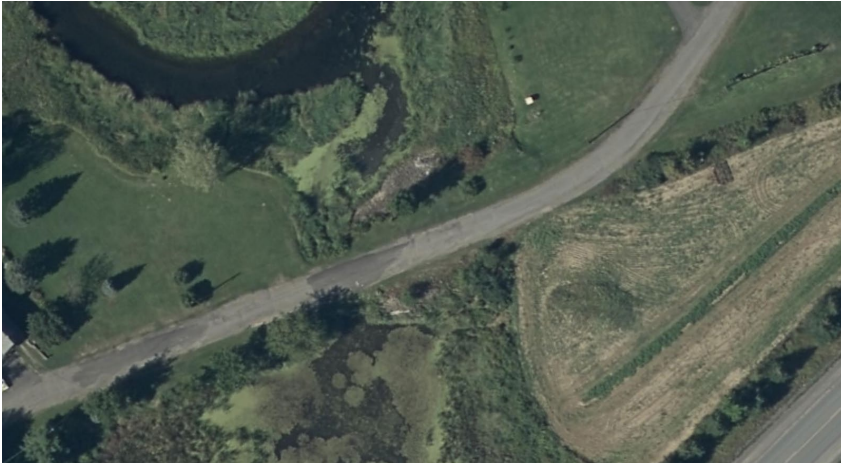
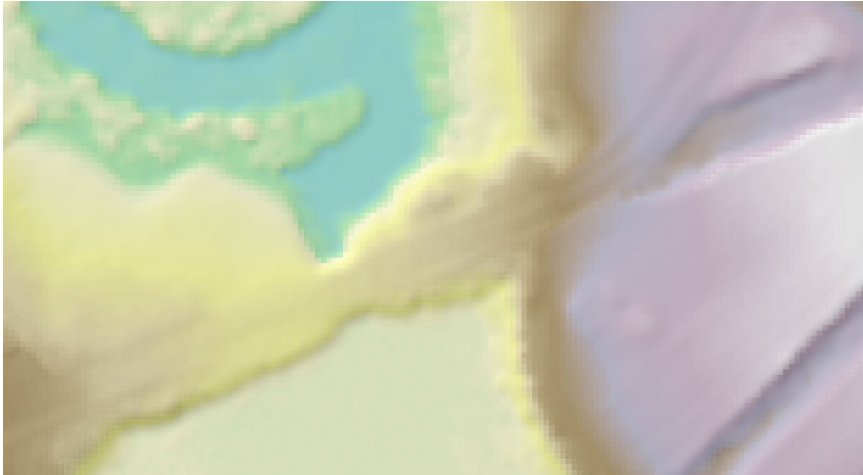
| Crossing 27 | | | |

| Crossing 27 | | | |
|---|---|--|--|
| Coordinates | 67.5788892°W, 46.2707830°N | Notes | Culvert slope exceeds slope threshold. |

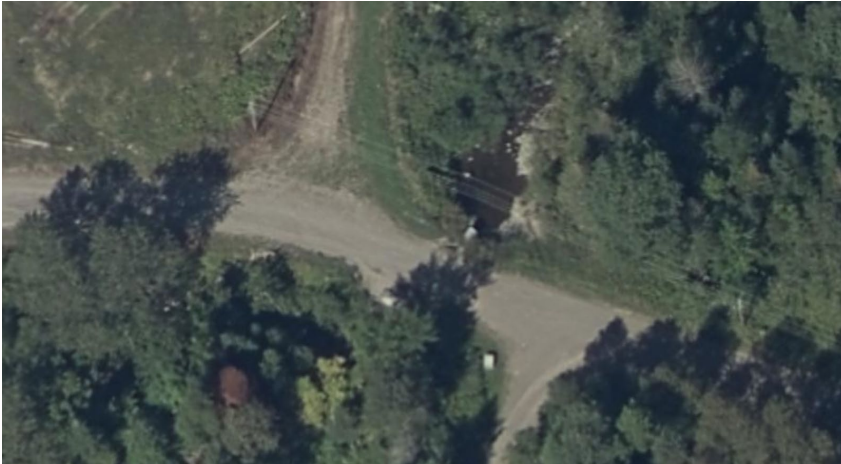
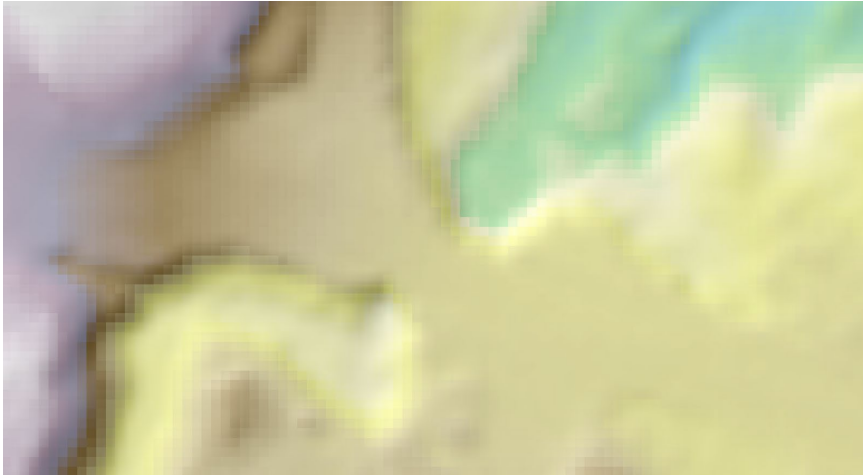
| Crossing 28 | | | |

| Crossing 28 | | | |
|---|---|--|--|
| Coordinates | 67.7611115°W, 46.4333473°N | Notes | Culvert slope exceeds slope threshold. |

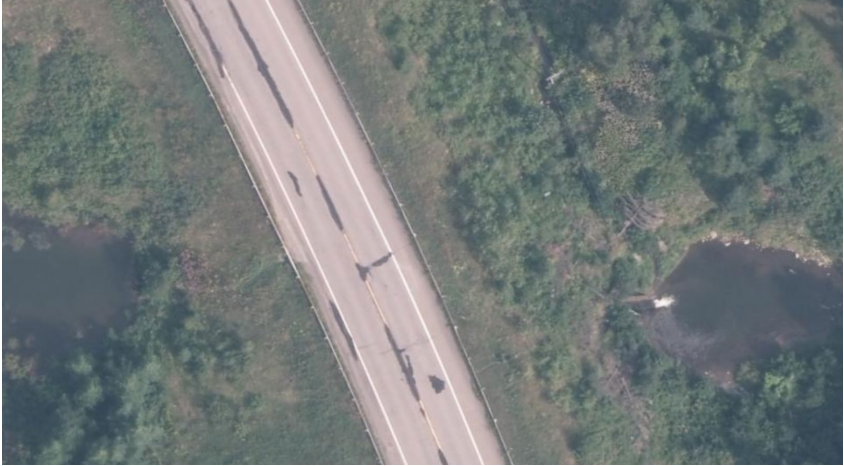
| Crossing 31 | | | |

| Crossing 31 | | | |
|---|---|--|--|
| Coordinates | 67.7264555°W, 46.9731048°N | Notes | Culvert slope exceeds slope threshold. |

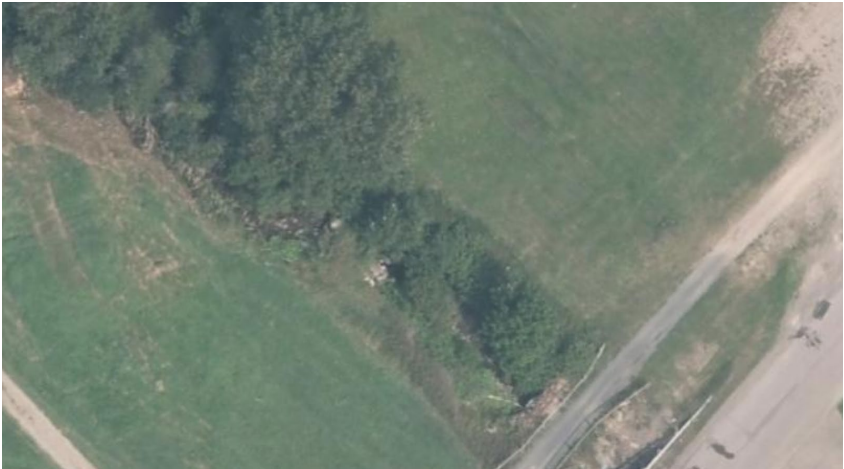
| Crossing 32 | | | |

| Crossing 32 | | | |
|---|---|--|--|
| Coordinates | 67.7003661°W, 46.9340917°N | Notes | <p>Culvert slope exceeds slope threshold.</p> <p>Need to remove two barriers: Crossing 32 (located 100m downstream) will need to be remediated as well to restore the upstream kilometers.</p> |

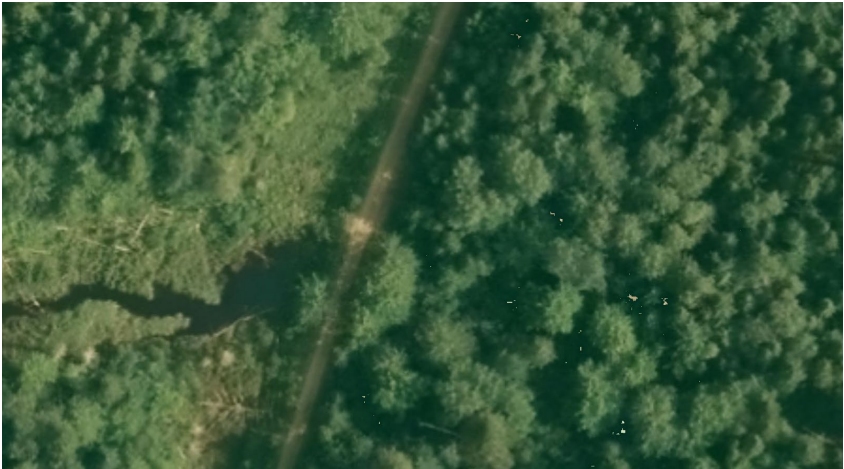
| Crossing 35 | | | |

| Crossing 35 | | | |
|---|---|--|--|
| Coordinates | 66.5960094°W, 45.7370292°N | Notes | Culvert slope exceeds slope threshold. |
| Slope % | 18.8% | | |

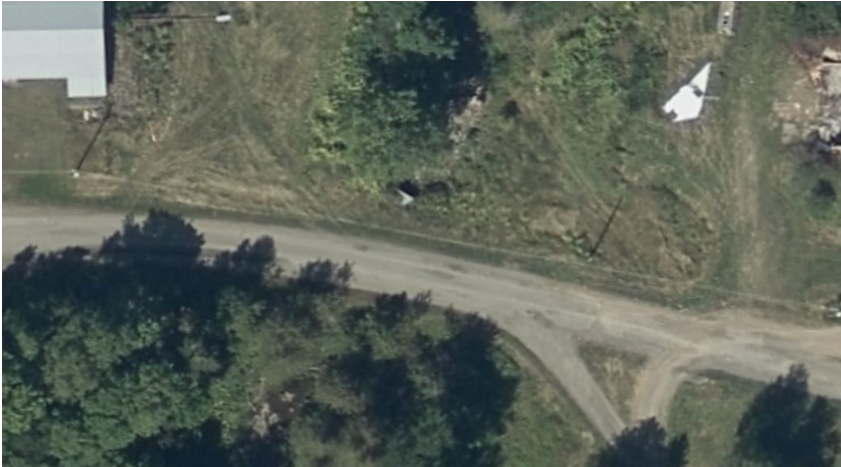
| Crossing 36 | | | |

| Crossing 36 | | | |
|---|---|--|--|
| Coordinates | 67.6864184°W, 46.4221726°N | Notes | Culvert slope exceeds slope threshold. |
| Slope % | 11.3% | | |

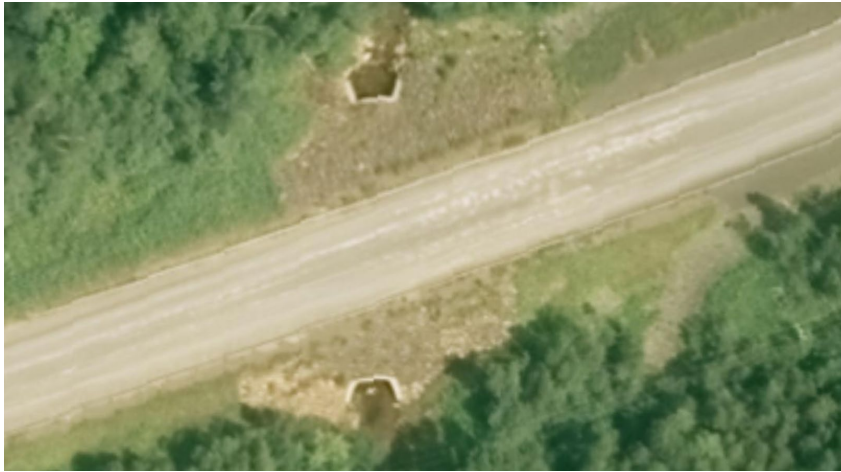
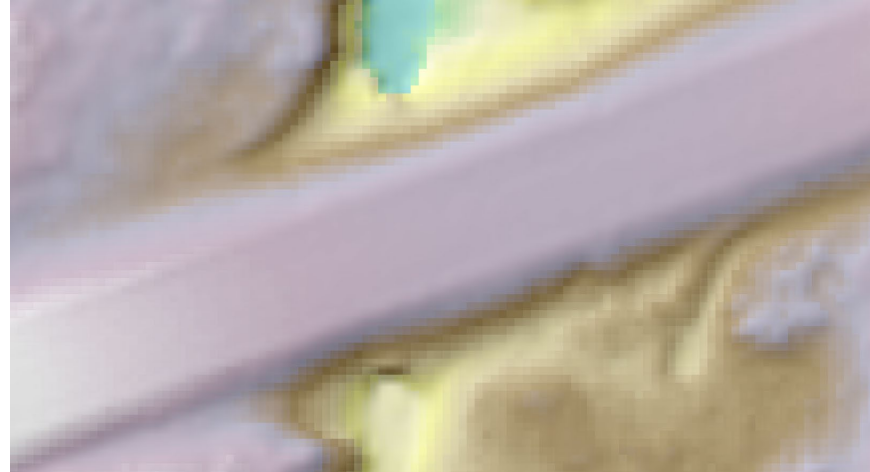
### Crossing 38

| Coordinates | 66.3408822°W, 45.5836366°N | Notes | Since the structure is open bottom, the slope is calculated from the natural stream bed. Further investigation is needed to determine if the slope was from anthropogenic impacts altering the stream slope or it has maintained natural stream state throughout construction. |

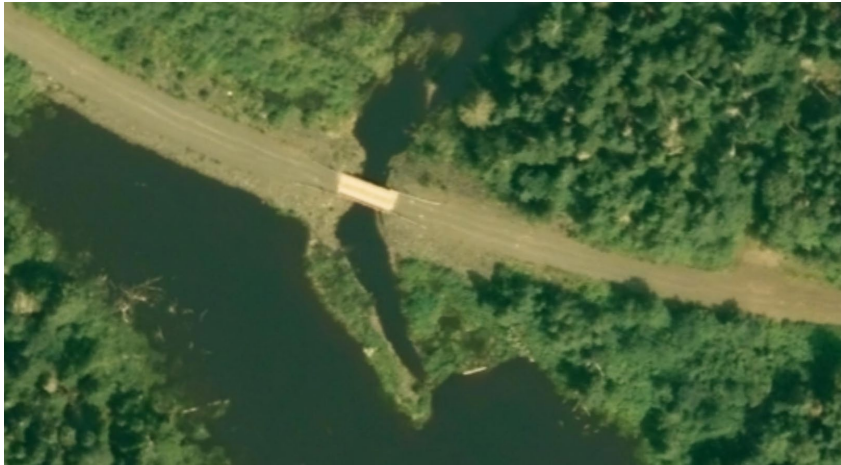
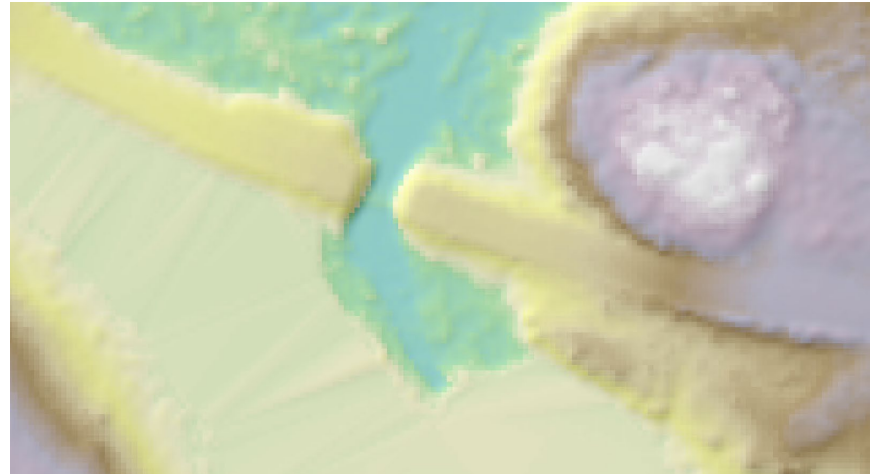
### Crossing 39

| Coordinates | 66.1723001°W, 45.5717696°N | Notes | Downstream of the bridge is a breakwater, unsure if it is natural or installed during bridge construction. There is evidence from the Ortho and DEM that the impoundment is a complete barrier and is 1.5m berm separating the up and downstream ends. It should be breached if still present. |

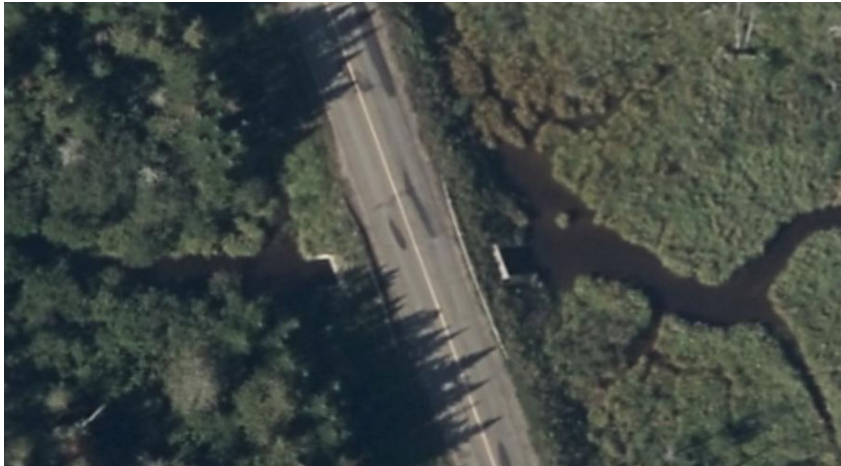
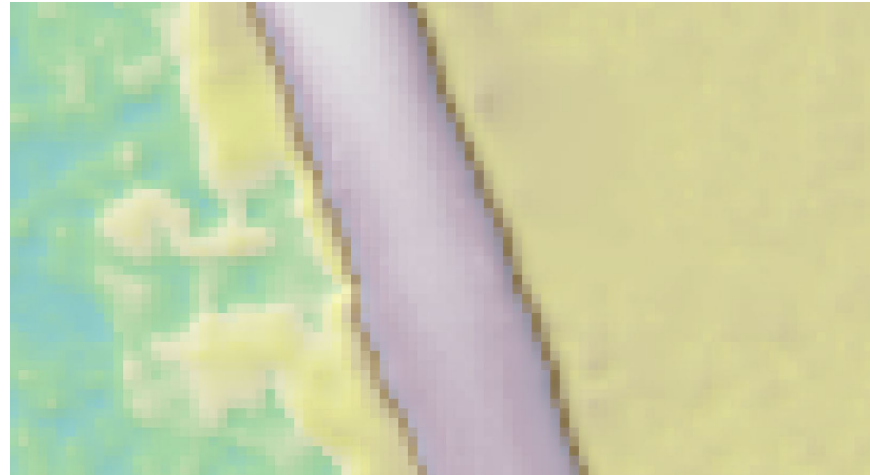
### Crossing 40

| <b>Coordinates</b> | 67.2912440°W, 46.2225714°N | <b>Notes</b> | Since the structure is open bottom, the slope is calculated from the natural stream bed. Further investigation is needed to determine if the slope was from anthropogenic impacts altering the stream slope or it has maintained natural stream state throughout construction. |

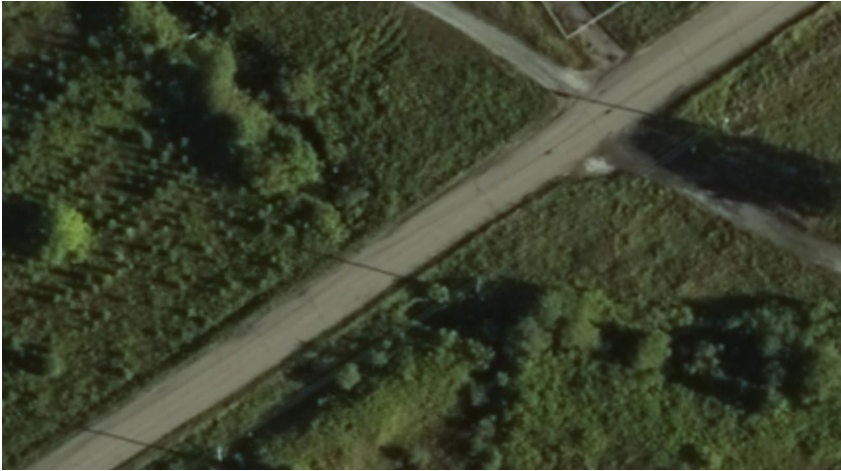
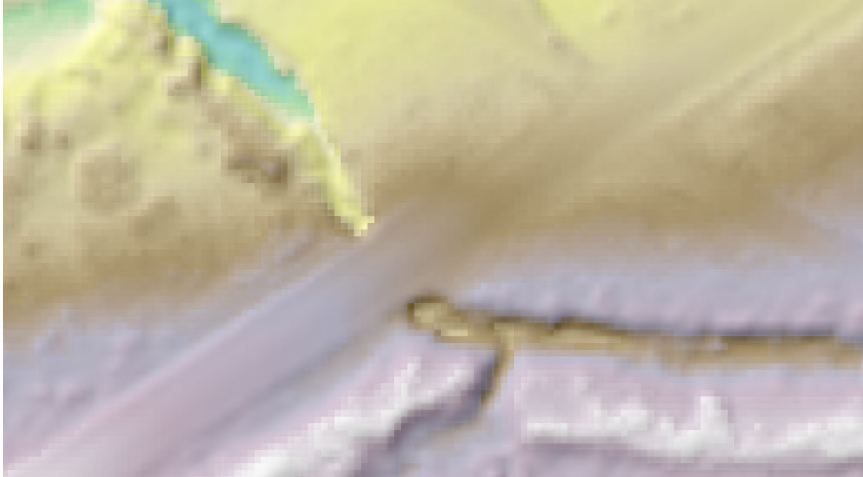
| Crossing 41 | | | |

| Crossing 41 | | | |
|---|---|--|---|
| Coordinates | 65.2913929°W, 46.0117647°N | Notes | <p>Culvert slope exceeds slope threshold.</p> <p>Need to remove two barriers: Crossing 42 (located 1km upstream) will need to be remediated as well to restore the upstream kilometers.</p> |

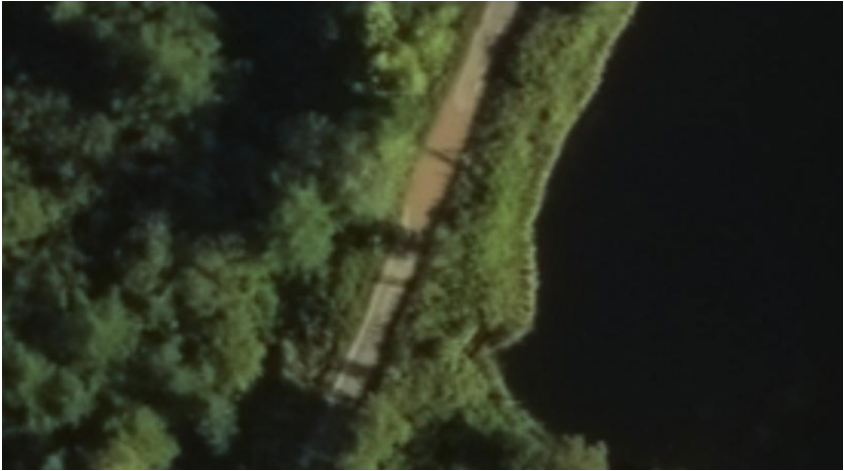
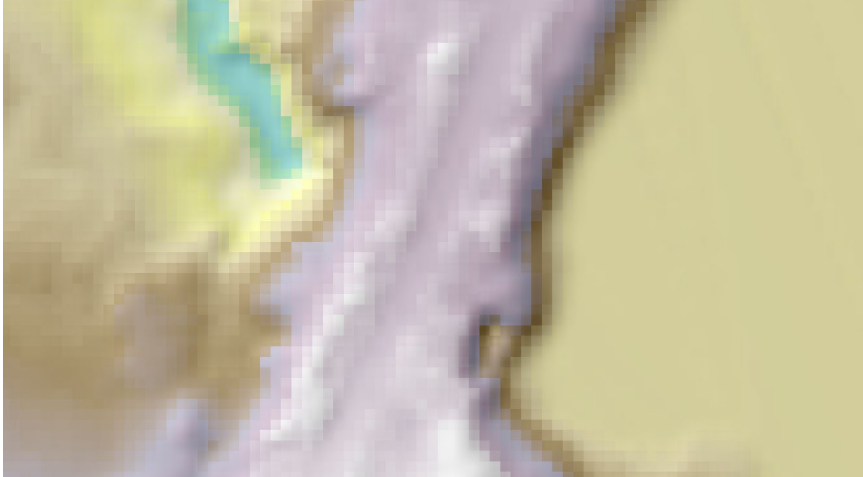
| Crossing 42 | | | |

| Crossing 42 | | | |
|---|---|--|---|
| Coordinates | 65.2855161°W, 46.0104251°N | Notes | <p>Culvert slope exceeds slope threshold.</p> <p>Need to remove two barriers: Crossing 41 (located 1km downstream) will need to be remediated as well to restore the upstream kilometers.</p> |

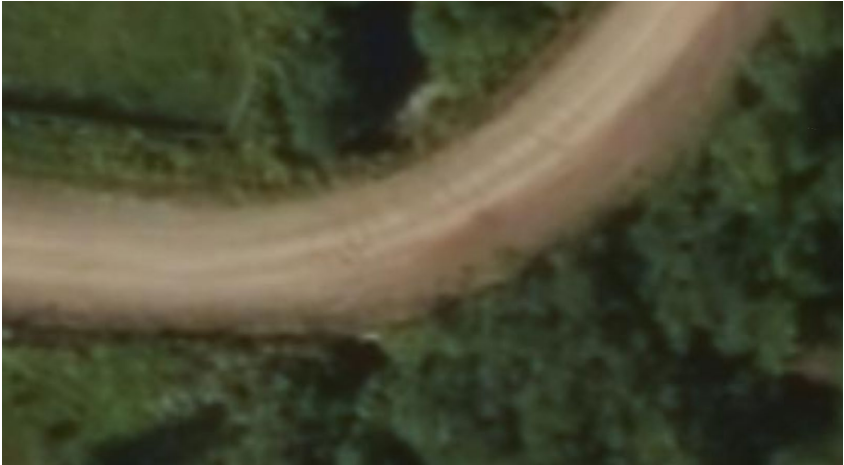
| Crossing 43 | | | |

| Crossing 43 | | | |
|---|---|--|--|
| Coordinates | 65.2534161°W, 46.5435251°N | Notes | Culvert slope exceeds slope threshold. |

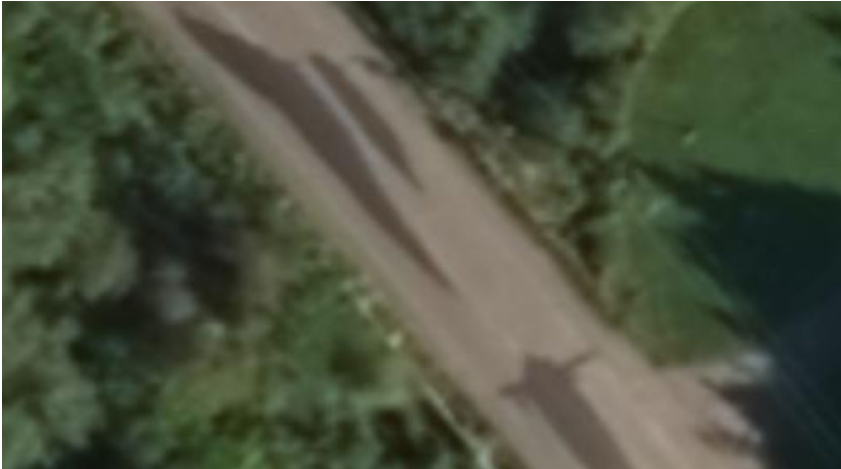
| Crossing 44 | | | |

| Crossing 44 | | | |
|---|---|--|--|
| Coordinates | 65.9212526°W, 45.7039002°N | Notes | Culvert slope exceeds slope threshold. |

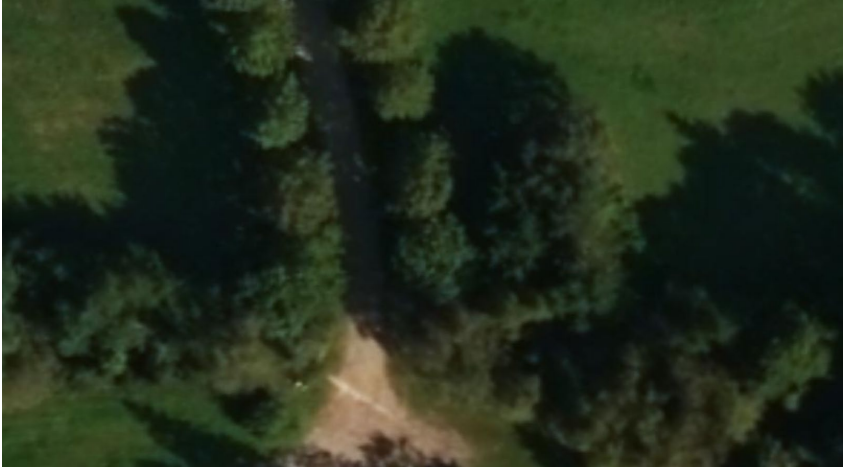
| Crossing 45 | | | |

| Crossing 45 | | | |
|---|---|--|--|
| Coordinates | 65.3444217°W, 45.7218550°N | Notes | Culvert slope exceeds slope threshold. |

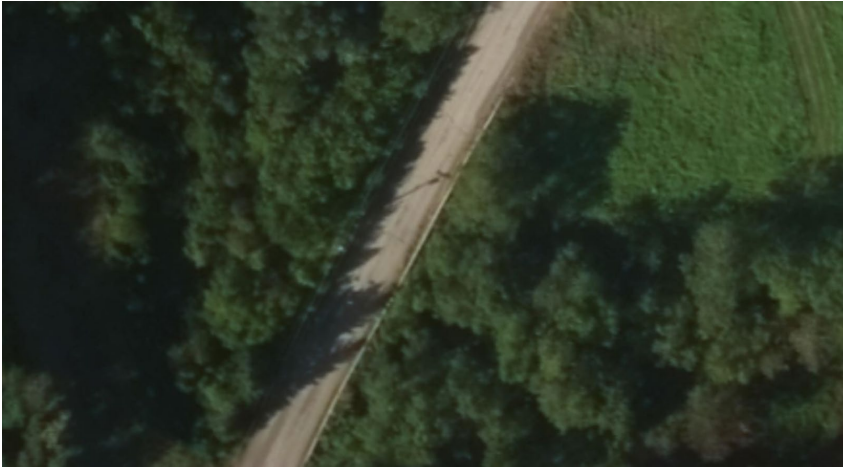
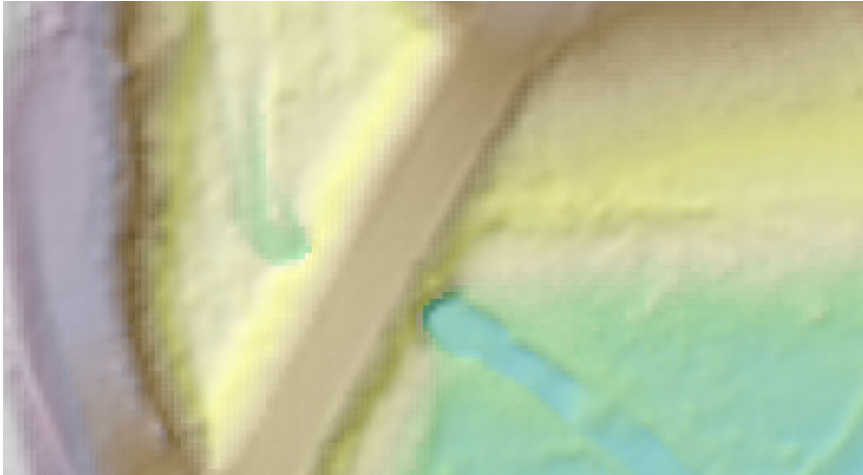
| Crossing 46 | | | |

| Crossing 46 | | | |
|---|---|--|---|
| Coordinates | 65.8822266°W, 45.6401328°N | Notes | <p>Culvert slope exceeds slope threshold.</p> <p>Need to remove two barriers: Crossing 47 (located 100 m upstream) will need to be remediated as well to restore the upstream kilometers.</p> |

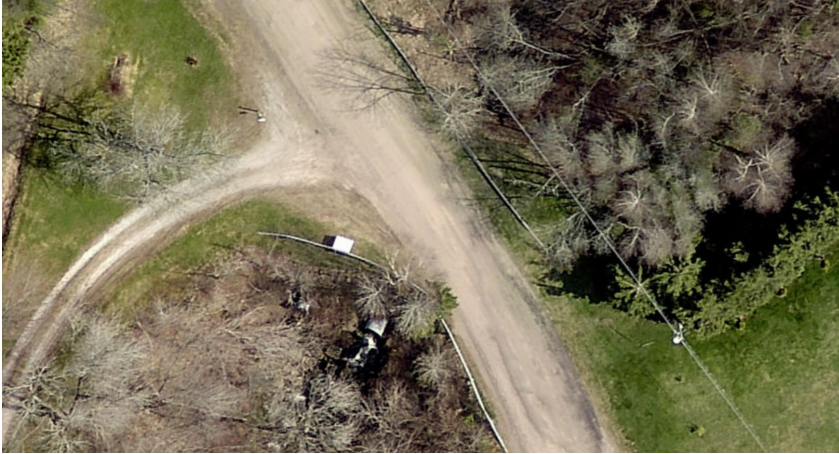
### Crossing 47

| Coordinates | 65.8824408°W, 45.6412808°N | Notes | <p>Culvert slope exceeds slope threshold. Evidence from Ortho and DEM show that it could be a hanging culvert.</p> <p>Need to remove two barriers: Crossing 46 (located 100 m downstream) will need to be remediated as well to restore the upstream kilometers.</p> |

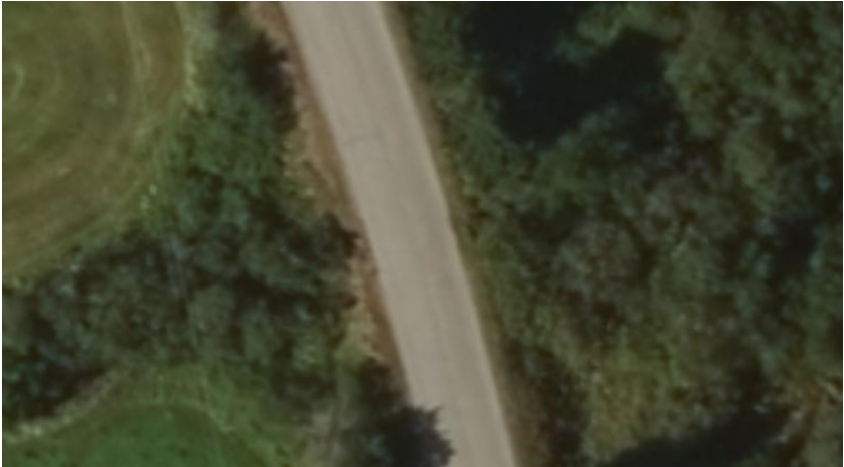
| Crossing 48 | | | |

| Crossing 48 | | | |
|---|---|--|--|
| Coordinates | 65.4904891°W, 45.6501638°N | Notes | Culvert slope exceeds slope threshold. |
