## WOLASTOQEY NATION IN NEW BRUNSWICK

### **Wolastoq Watershed barrier analysis**

#### **Executive summary**

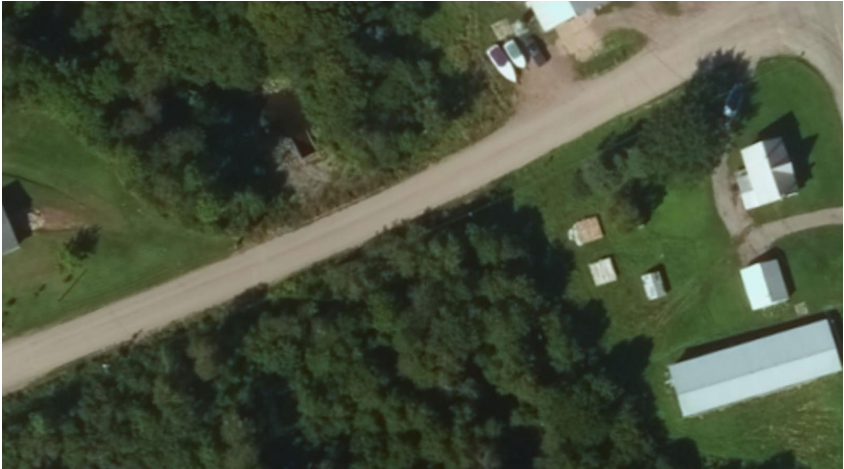
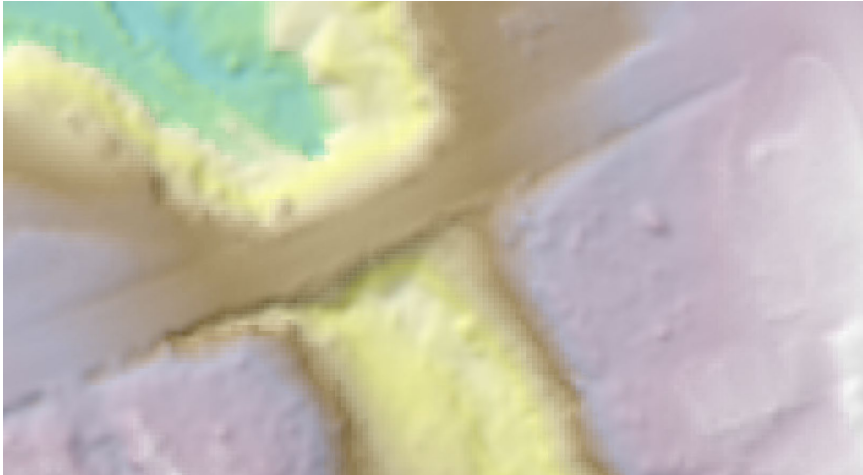
| Crossing 49 | | | |

| Crossing 49 | | | |
|---|---|--|--|
| Coordinates | 65.9144018°W, 45.5929071°N | Notes | Culvert slope exceeds slope threshold. |

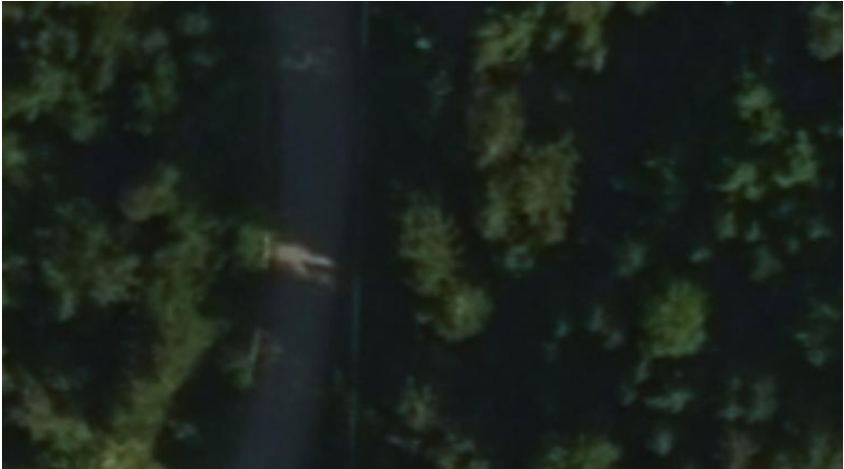
| Crossing 50 | | | |

| Crossing 50 | | | |
|---|---|--|--|
| Coordinates | 65.4591384°W, 45.6798873°N | Notes | Culvert slope exceeds slope threshold. |

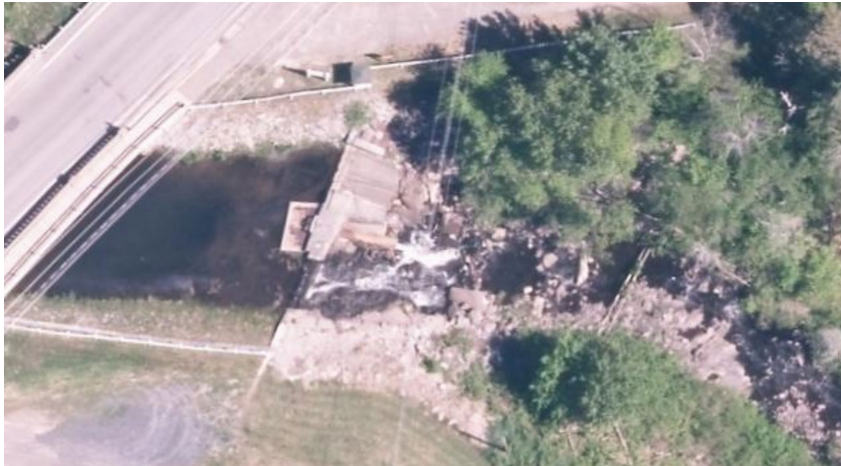
## Crossing 51

| <b>Coordinates</b> | 68.6989288°W, 47.2442763°N | <b>Notes</b> | Ortho shows evidence of a decommissioned dam or water retaining structure. Further investigation is needed to determine if the steep slope is a result of the deconstruction or it being natural rapids. |

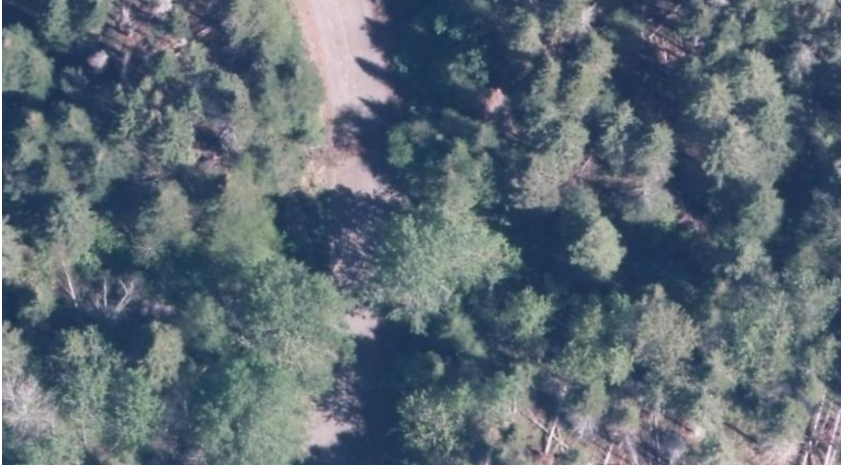
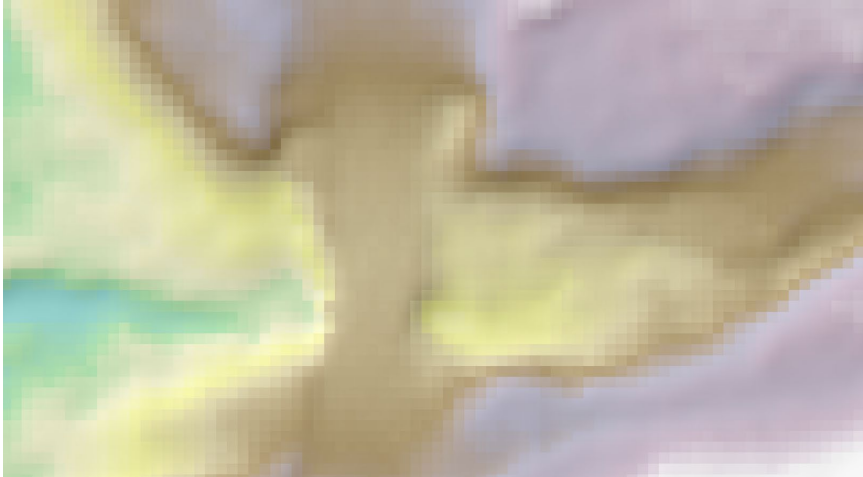
| Crossing 52 | | | |

| Crossing 52 | | | |
|---|---|--|--|
| Coordinates | 68.2472987°W, 47.7317075°N | Notes | Culvert slope exceeds slope threshold. |

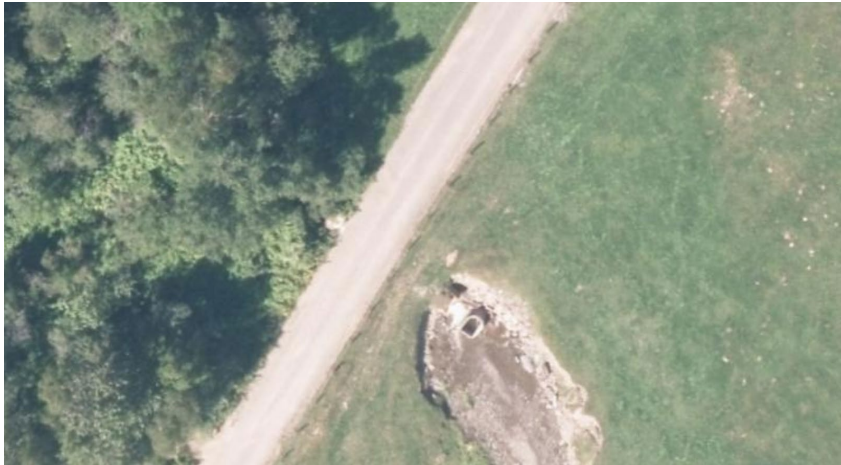
### Crossing 55

| Coordinates | 68.1954018°W, 47.3546768°N | Notes | <p>Culvert slope exceeds slope threshold.</p> <p>Need to remove two barriers: Crossing 56 (located 700 m upstream) will need to be remediated as well to restore the upstream kilometers</p> |

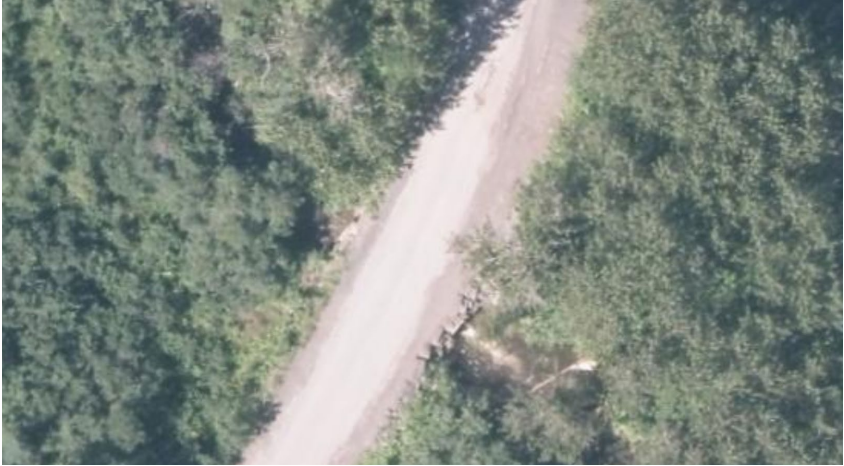
| Crossing 56 | | | |

| Crossing 56 | | | |
|---|---|--|--|
| Coordinates | 68.1997066°W, 47.3594587°N | Notes | <p>Culvert slope exceeds slope threshold.</p> <p>Need to remove two barriers: Crossing 55 (located 700 m downstream) will need to be remediated as well to restore the upstream kilometers</p> |

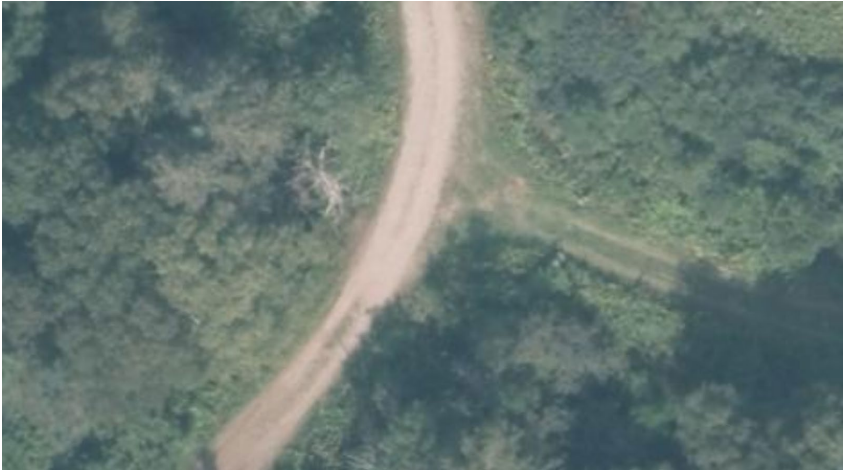
| Crossing 57 | | | |

| Crossing 57 | | | |
|---|---|--|--|
| Coordinates | 67.7055345°W, 46.8307689°N | Notes | Culvert slope exceeds slope threshold. |

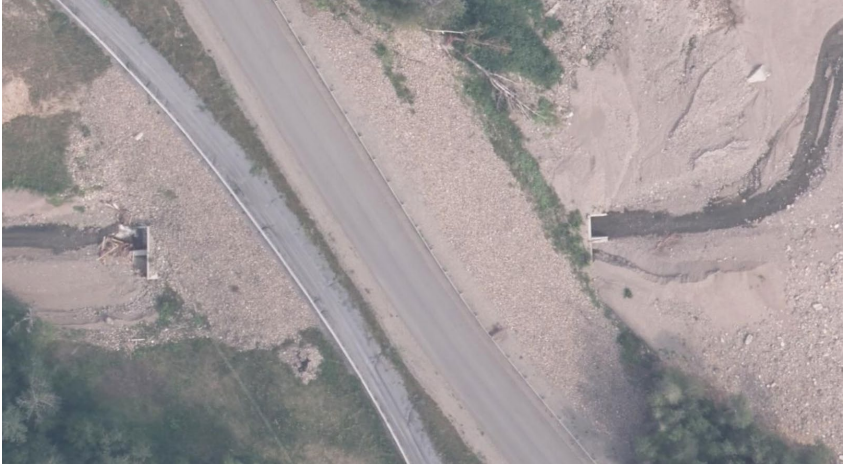
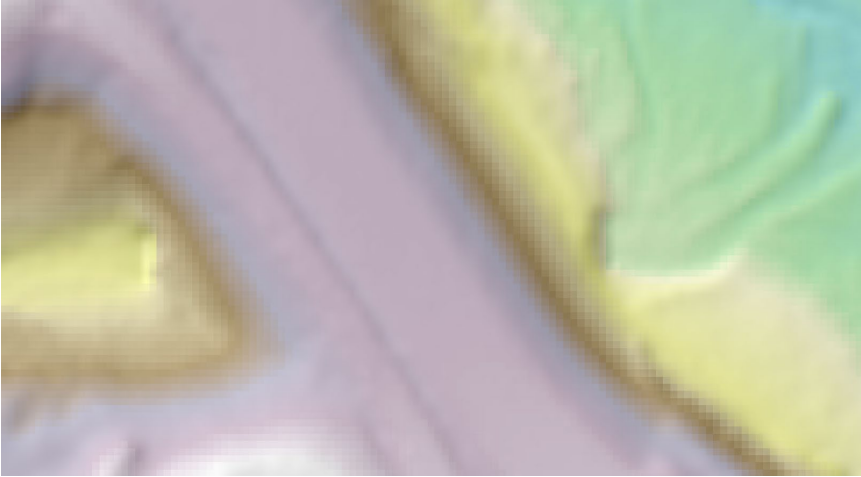
| Crossing 58 | | | |

| Crossing 58 | | | |
|---|---|--|---|
| Coordinates | 67.706539°W, 46.98114800°N | Notes | <p>Ortho shows heavy sedimentation and erosion prone substrate. In Ortho from 2018, one of the two barrel culverts was completely blocked by sand/silt. Bank reinforcement and a culvert design that can encompass the width of the stream is needed.</p> |

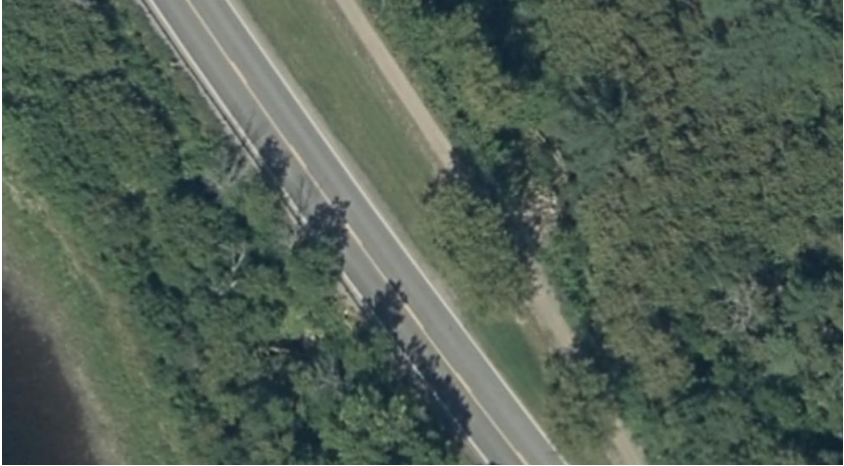
| Crossing 59 | | | |

| Crossing 59 | | | |
|---|---|--|--|
| Coordinates | 67.5762056°W, 46.4957055°N | Notes | Culvert slope exceeds slope threshold. |

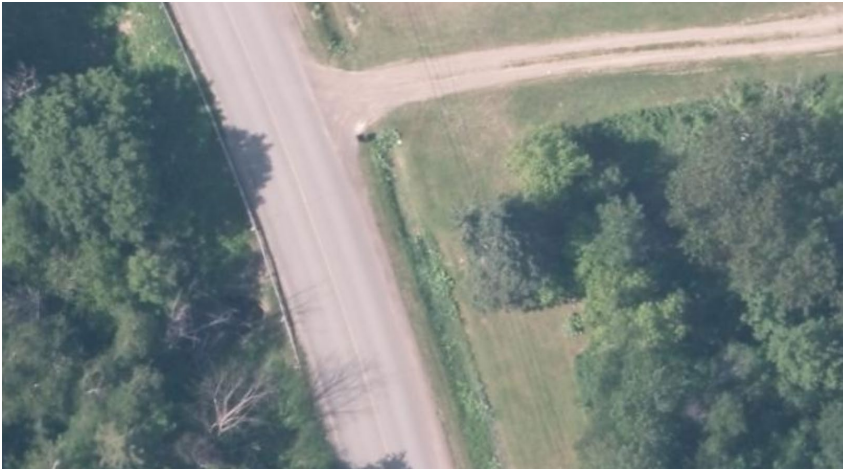
| Crossing 60 | | | |

| Crossing 60 | | | |
|---|---|--|--|
| Coordinates | 67.7155876°W, 46.6594798°N | Notes | Culvert slope exceeds slope threshold. |

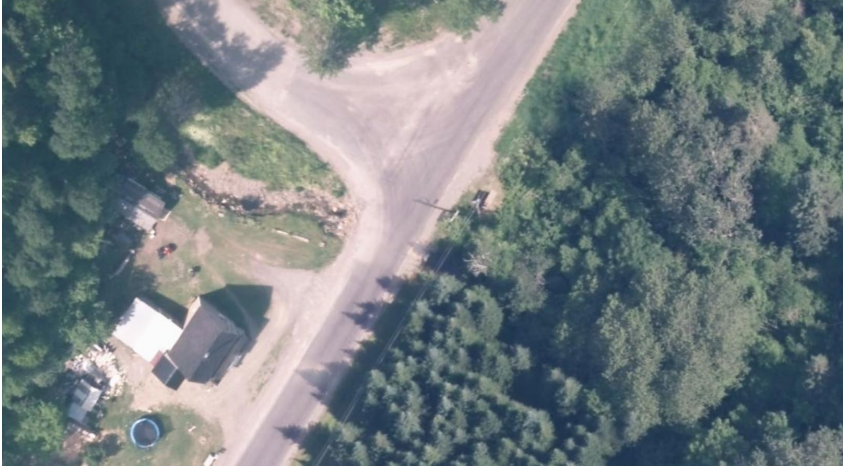
| Crossing 61 | | | |

| Crossing 61 | | | |
|---|---|--|--|
| Coordinates | 67.6430403°W, 46.6821694°N | Notes | Culvert slope exceeds slope threshold. |

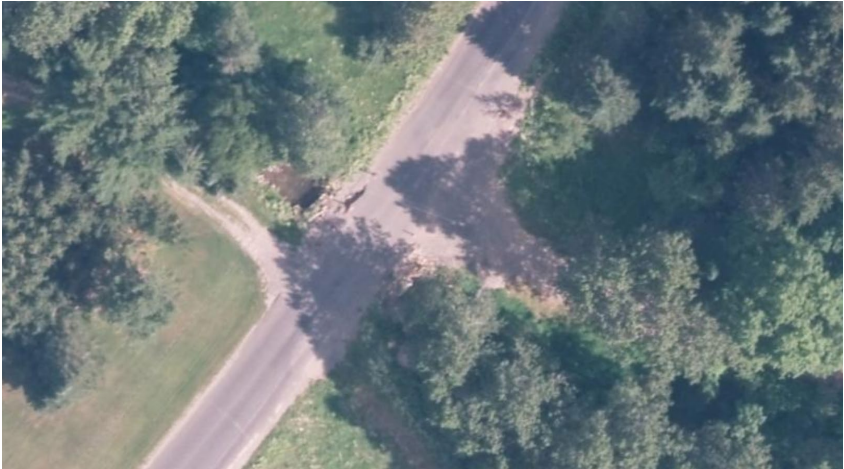
| Crossing 62 | | | |

| Crossing 62 | | | |
|---|---|--|--|
| Coordinates | 67.6499599°W, 46.6724106°N | Notes | Culvert slope exceeds slope threshold. |

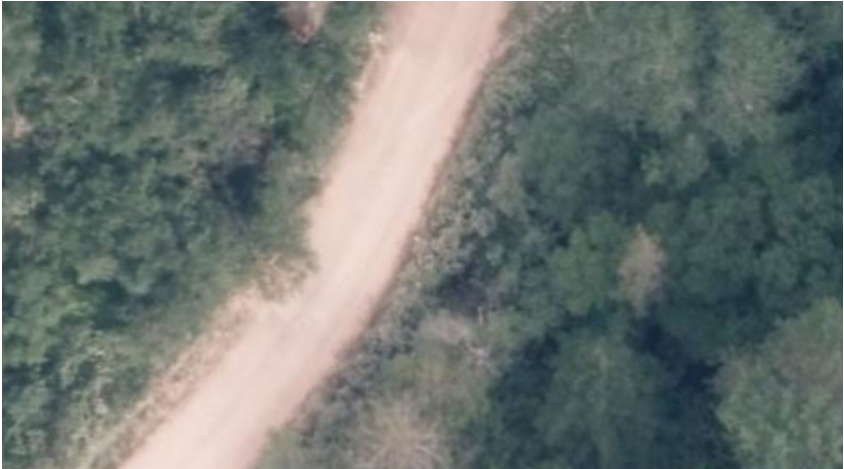
| Crossing 64 | | | |

| Crossing 64 | | | |
|---|---|--|--|
| Coordinates | 67.5062534°W, 46.6138827°N | Notes | Culvert slope exceeds slope threshold. |
| Slope % | 5% | | |

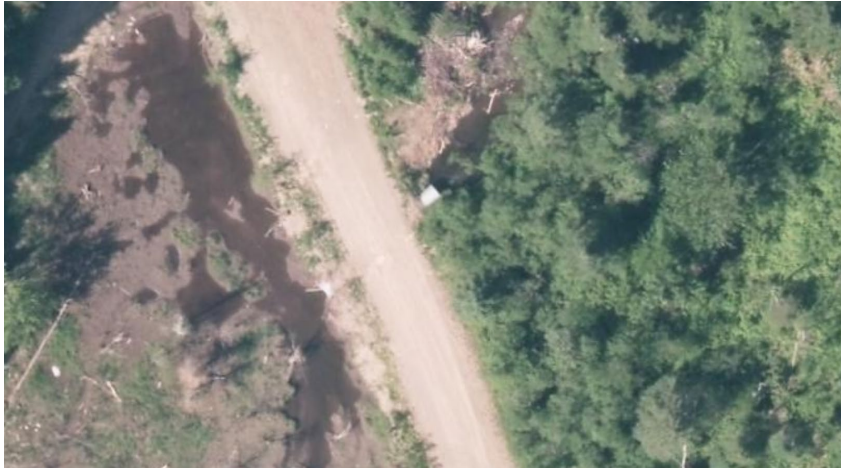
## Crossing 65

| <b>Coordinates</b> | 67.5882924°W, 46.6856340°N | <b>Notes</b> | Culvert slope exceeds slope threshold. Upstream side of culvert appears to have concrete wings from the Ortho. Slow moving, wetted land, with no evidence of a channel. Downstream is more channelized due to the slope of the culvert increasing the velocity of water resulting in scouring downstream. The upstream wetted land should be investigated to see if the stream morphology is natural or anthropogenic from the road. The crossing should be removed for a larger diameter culvert to prevent pooling on the upstream side and establish a channel. |
| <b>Slope %</b> | 12.5% | | |

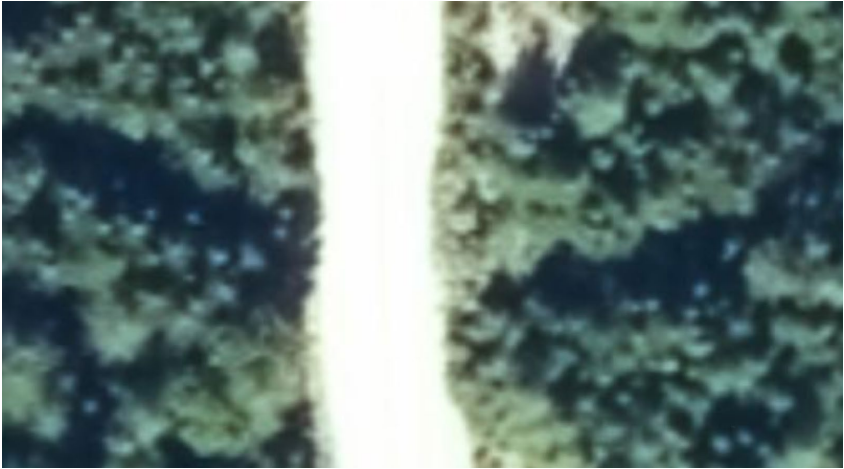
| Crossing 66 | | | |

| Crossing 66 | | | |
|---|---|--|--|
| Coordinates | 66.815595°W, 47.1059359°N | Notes | Culvert slope exceeds slope threshold. |
| Slope % | 9.2% | | |

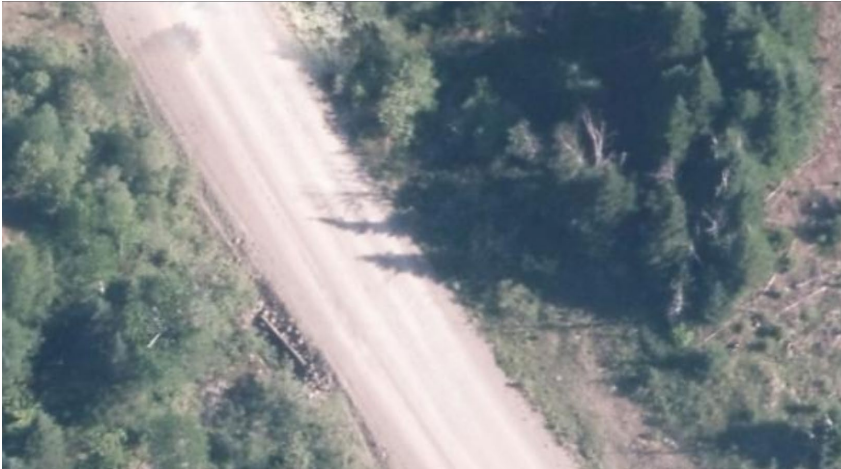
| Crossing 67 | | | |

| Crossing 67 | | | |
|---|---|--|--|
| Coordinates | 67.1768676°W, 47.2867639°N | Notes | Culvert slope exceeds slope threshold. |

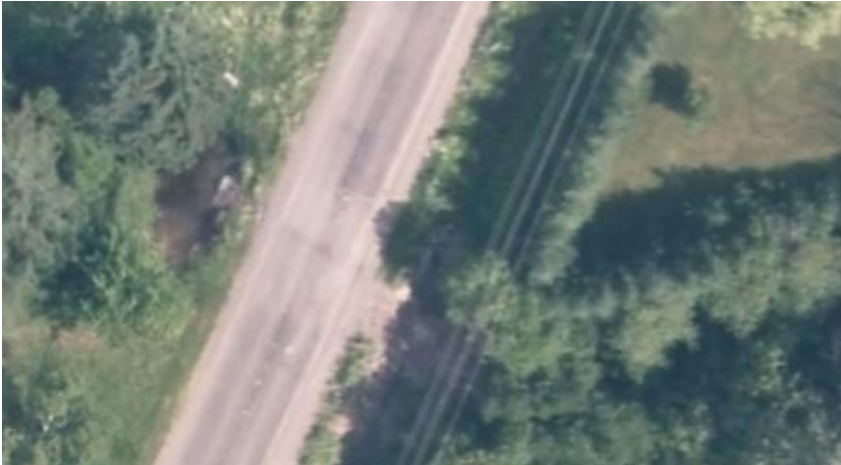
| Crossing 68 | | | |

| Crossing 68 | | | |
|---|---|--|--|
| Coordinates | 67.6545964°W, 46.6375832°N | Notes | Culvert slope exceeds slope threshold. |

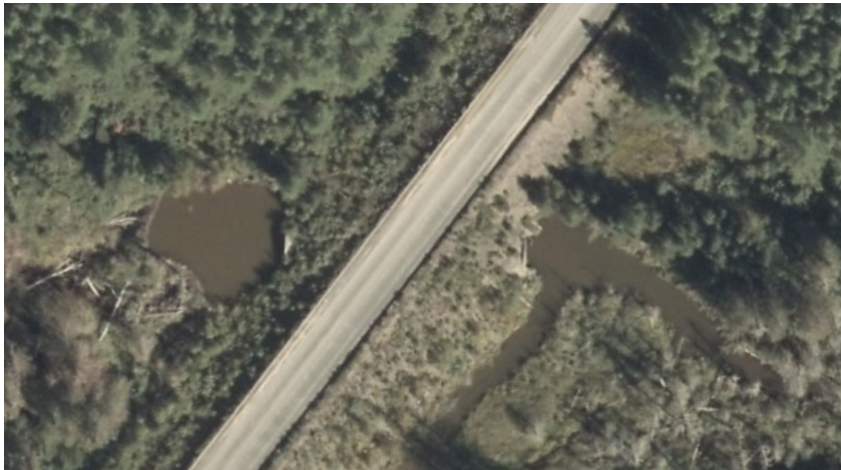
### Crossing 69

| Coordinates | 67.0276874°W, 47.3153825°N | Notes | Significant pooling on the upstream side of the culvert, indicating water is slow moving and not channelized. 20 meters downstream either fresh beaver or logging activity that has allowed a large pool to form. More channelization is needed on the upstream side and for the downstream side to be free of structures to allow fish passage |

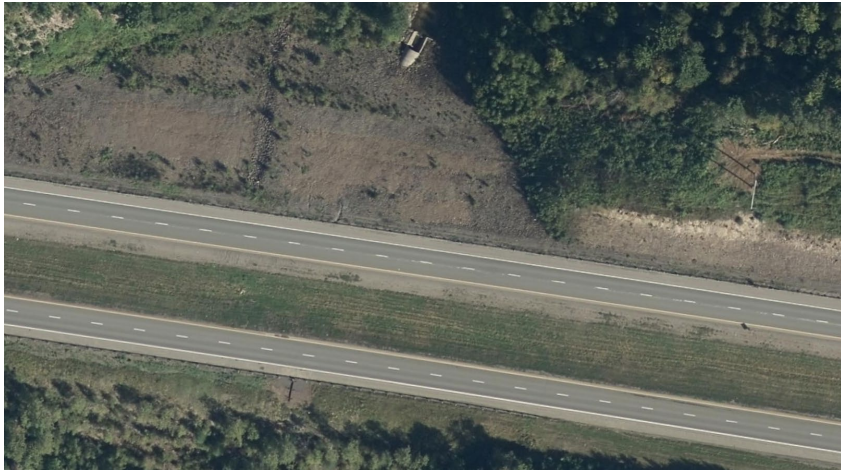
## Crossing 70

| <b>Coordinates</b> | 67.6436100°W, 46.159610°N | <b>Notes</b> | While culvert slope does not exceed the 4% threshold for strong swimming fish, the length of the culvert at a 2.5% slope could pose a problem for burst swimmers. Additionally, this would be a barrier for any non-trout species that could inhabit the area. Due to the culvert being below 20 meters of road embankment, modifying the existing structure would be most viable. From LiDAR and Ortho measurements, the diameter (taken from the outside shell of the culvert) is roughly 4 m. This could provide enough space to place baffles and resting pools within the culvert, given the water level can be high enough. Another concern is that the stream is being restricted by about 50% on the lead up to the culvert causing further increases in velocity which would make it even more unlikely to pass weaker swimmers. |

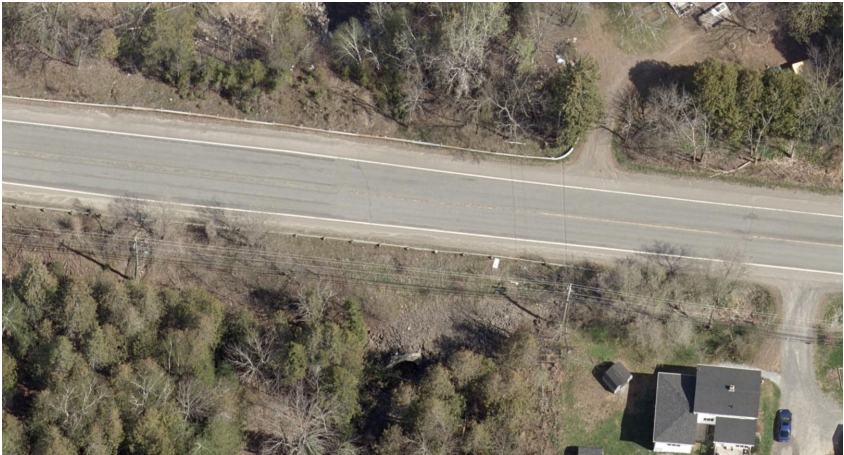
| Crossing 71 | | | |

| Crossing 71 | | | |
|---|---|--|--|
| Coordinates | 66.7800439°W, 45.9674094°N | Notes | Culvert slope exceeds slope threshold. |

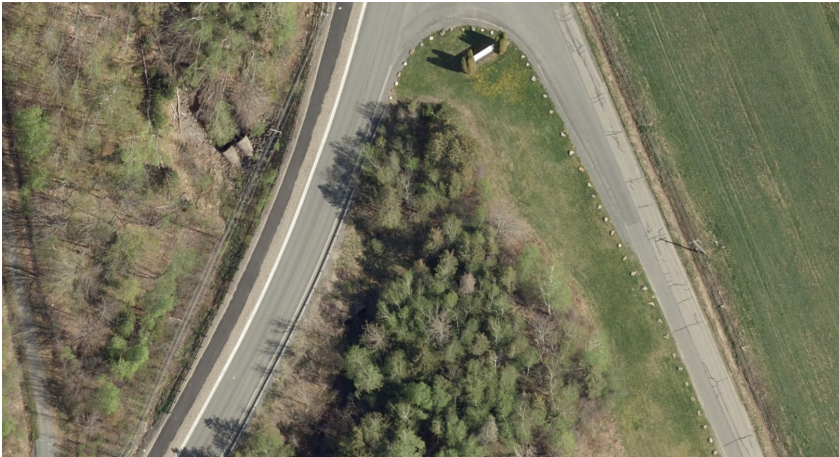
## Crossing 72

| <b>Coordinates</b> | 66.6188212°W, 45.9238103°N | <b>Notes</b> | Culvert slope exceeds slope threshold. |

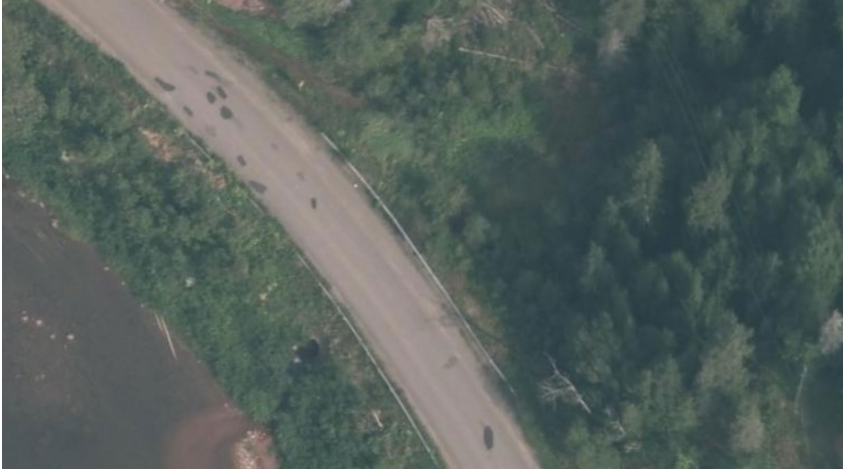
| Crossing 73 | | | |

| Crossing 73 | | | |
|---|---|--|--|
| Coordinates | 67.3890064°W, 46.9185546°N | Notes | Culvert slope exceeds slope threshold. |

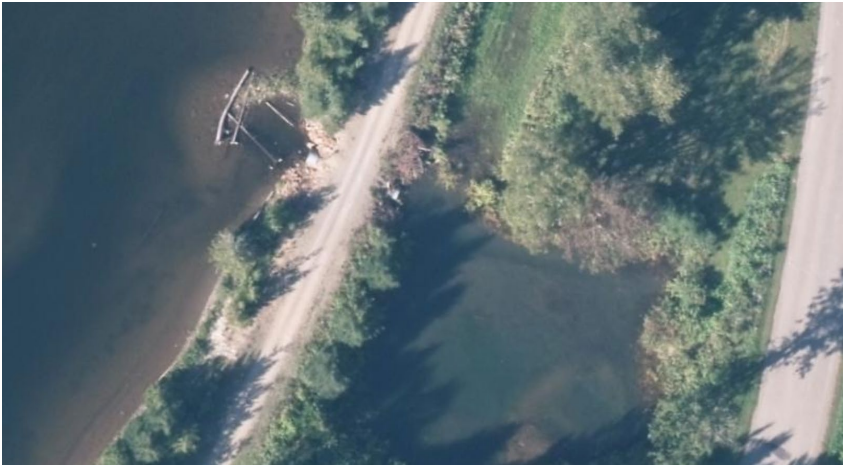
| Crossing 74 | | | |

| Crossing 74 | | | |
|---|---|--|--|
| Coordinates | 67.6907237°W, 46.7841622°N | Notes | Culvert slope exceeds slope threshold. |

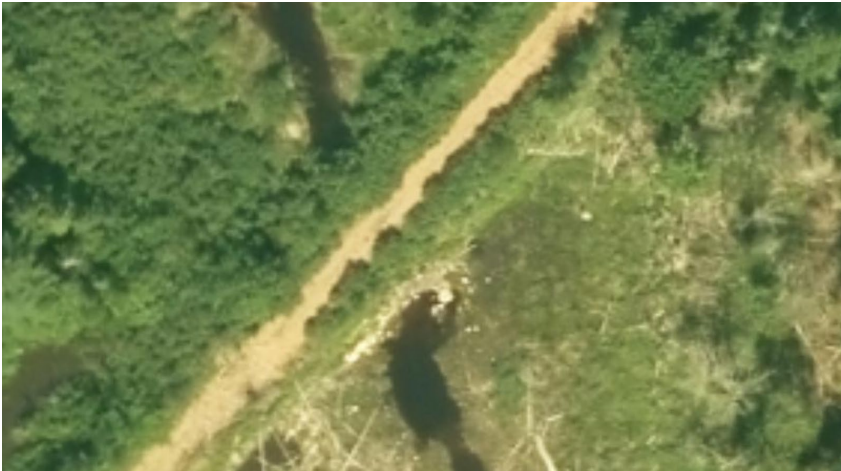
| Crossing 77 | | | |

| Crossing 77 | | | |
|---|---|--|--|
| Coordinates | 66.7293031°W, 45.5532472°N | Notes | Culvert slope exceeds slope threshold. |

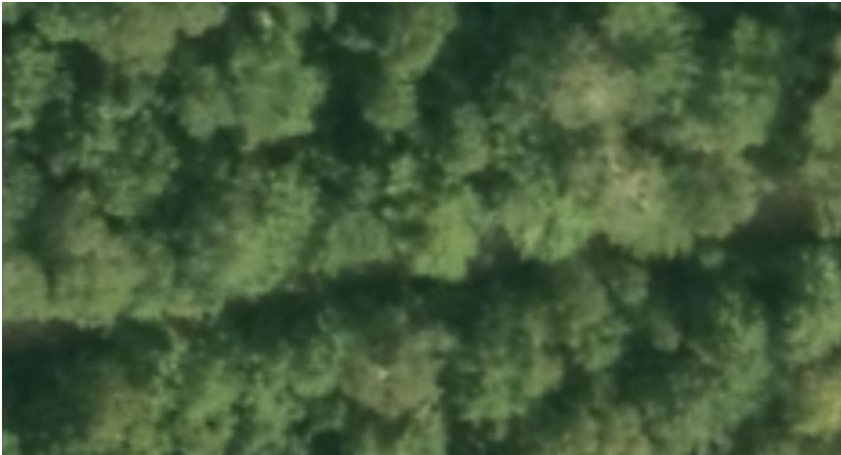
| Crossing 78 | | | |

| Crossing 78 | | | |
|---|---|--|--|
| Coordinates | 66.7468757°W, 45.7858299°N | Notes | Culvert slope exceeds slope threshold. |

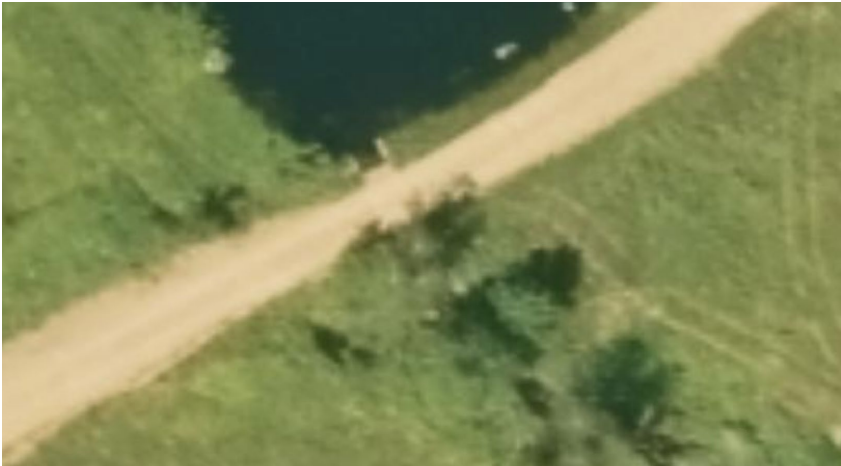
| Crossing 79 | | | |

| Crossing 79 | | | |
|---|---|--|--|
| Coordinates | 66.6858961°W, 45.6981587°N | Notes | Culvert slope exceeds slope threshold. |

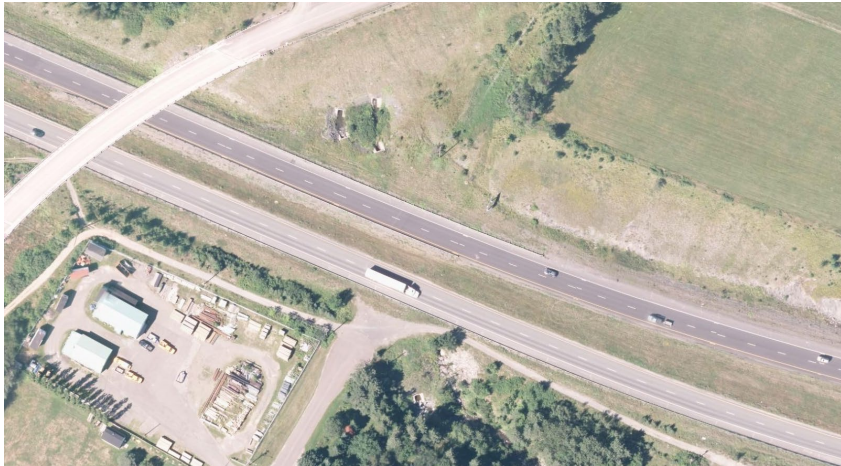
## Crossing 80

| <b>Coordinates</b> | 68.2529868°W, 47.3628336°N | <b>Notes</b> | <p>Culvert slope exceeds slope threshold. The downstream side has too many boulders where there is no unimpeded flow to the actual downstream end.</p> <p>1 km upstream (Crossing 81 or 82) need to be removed to restore upstream habitat.</p> |

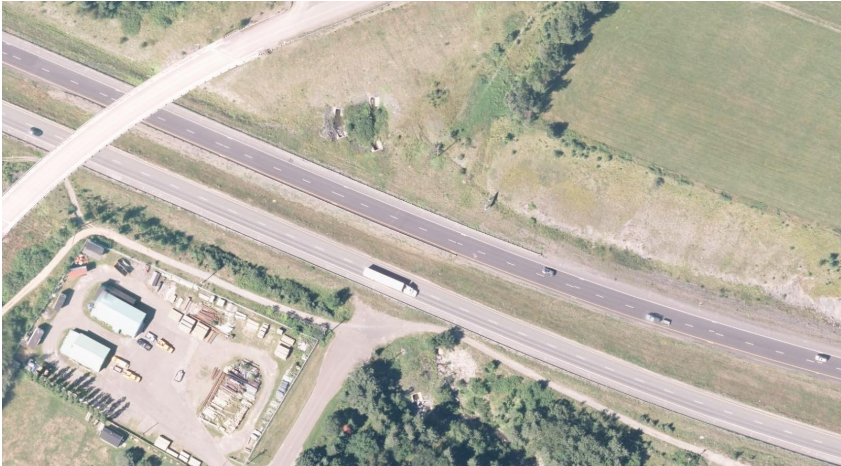
| Crossing 81 | | | |

| Crossing 81 | | | |
|---|---|--|--|
| Coordinates | 68.2529868°W, 47.3628336°N | Notes | <p>Culvert slope exceeds slope threshold.</p> <p>1 km upstream (Crossing 80 or 82) need to be removed to restore upstream habitat.</p> |

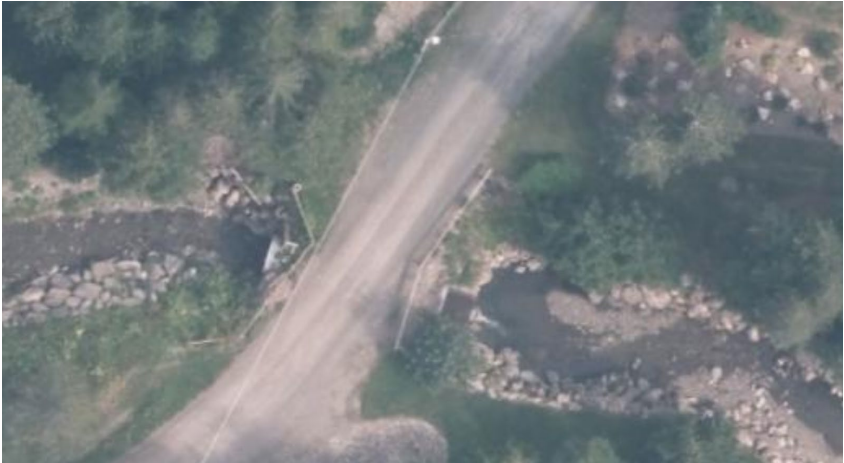
| Crossing 82 | | | |

| Crossing 82 | | | |
|---|---|--|--|
| Coordinates | 67.6319020°W, 46.9936756°N | Notes | <p>Culvert slope exceeds slope threshold. Downstream end appears to be hanging based on Ortho.</p> <p>Need to remove two barriers: 1 km downstream (Crossing 80 or 81) need to be removed to restore upstream habitat.</p> |

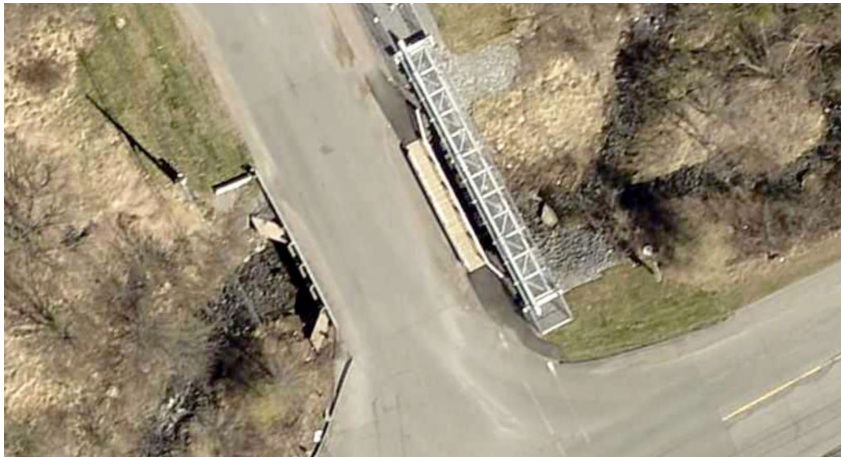
### Crossing 83

| Coordinates | 66.0085262°W, 45.3187327°N | Notes | Since the structure is open bottom, the slope is calculated from the natural stream bed. Further investigation is needed to determine if the slope was from anthropogenic impacts altering the stream slope or it has maintained natural stream state throughout construction. |

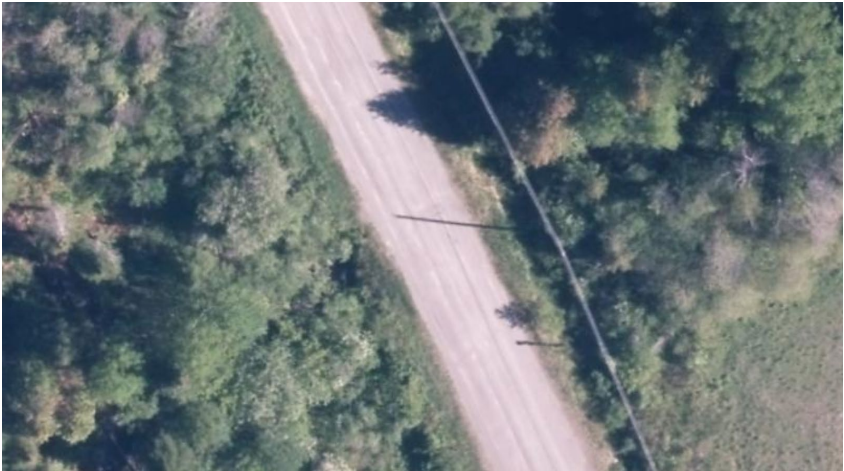
| Crossing 84 | | | |

| Crossing 84 | | | |
|---|---|--|--|
| Coordinates | 68.6064814°W, 47.3353702°N | Notes | Culvert slope exceeds slope threshold. |

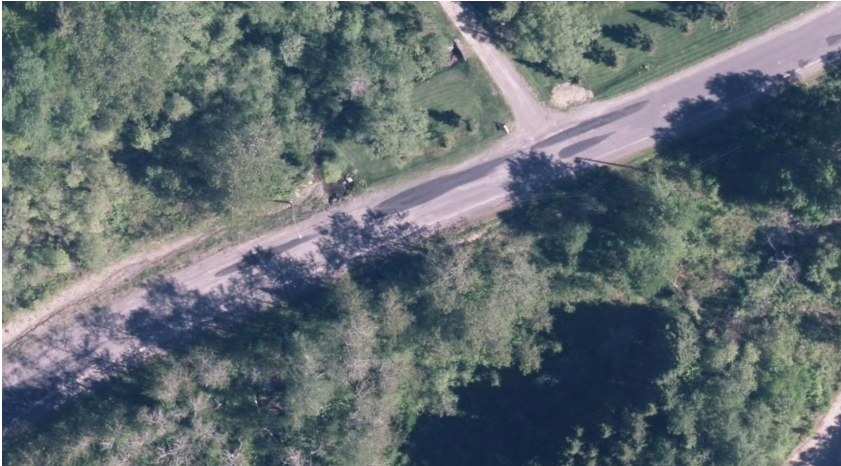
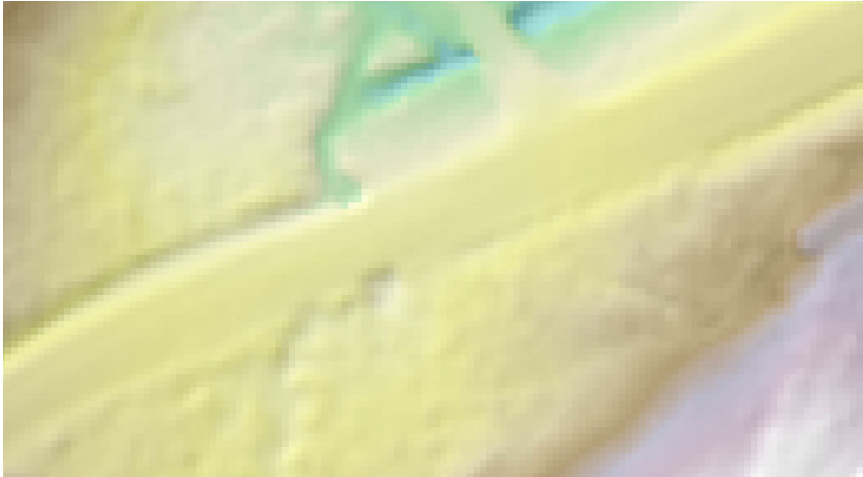
| Crossing 85 | | | |

| Crossing 85 | | | |
|---|---|--|--|
| Coordinates | 68.4140582°W, 47.3556283°N | Notes | Culvert slope exceeds slope threshold. |

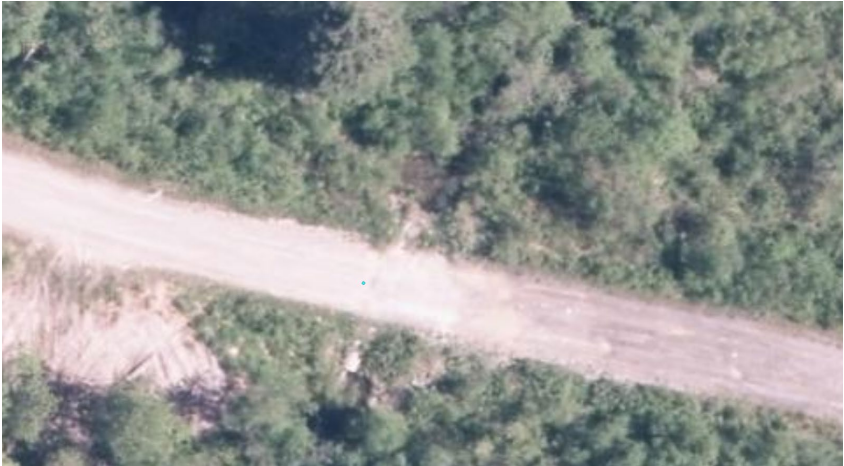
| Crossing 86 | | | |

| Crossing 86 | | | |
|---|---|--|--|
| Coordinates | 68.4756997°W, 47.3724718°N | Notes | Culvert slope exceeds slope threshold. |

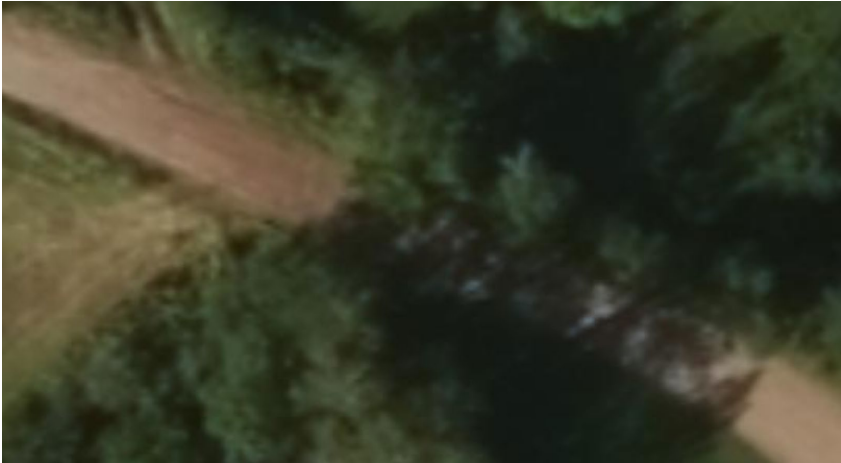
| Crossing 89 | | | |

| Crossing 89 | | | |
|---|--|--|--|
| | | Notes | Culvert slope exceeds slope threshold. |

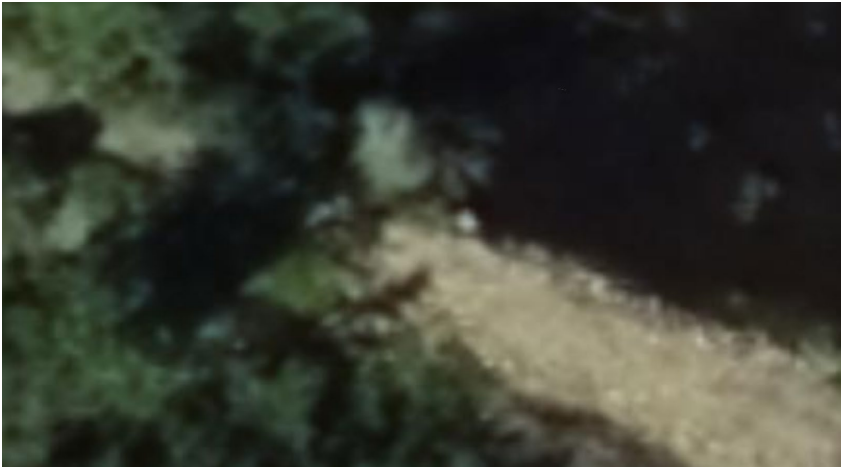
| Crossing 90 | | | |

| Crossing 90 | | | |
|---|---|--|--|
| Coordinates | 65.6847531°W, 45.7814214°N | Notes | Culvert slope exceeds slope threshold. |

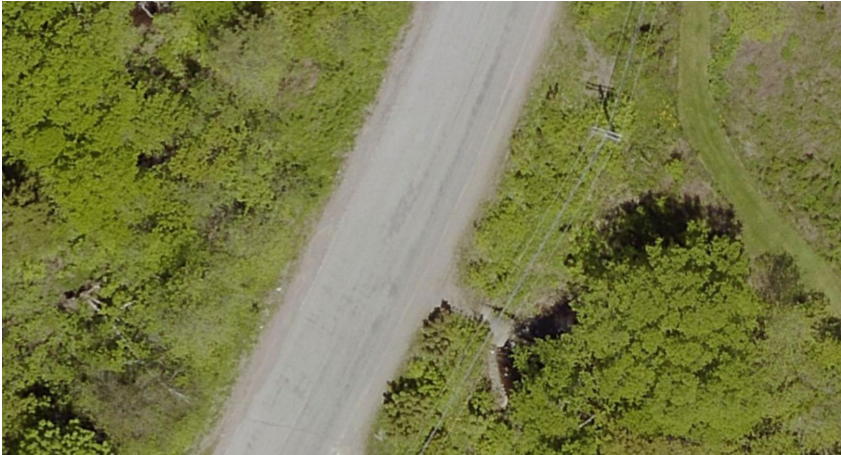
| Crossing 91 | | | |

| Crossing 91 | | | |
|---|---|--|--|
| Coordinates | 66.0789023°W, 45.3850063°N | Notes | Culvert slope exceeds slope threshold. |

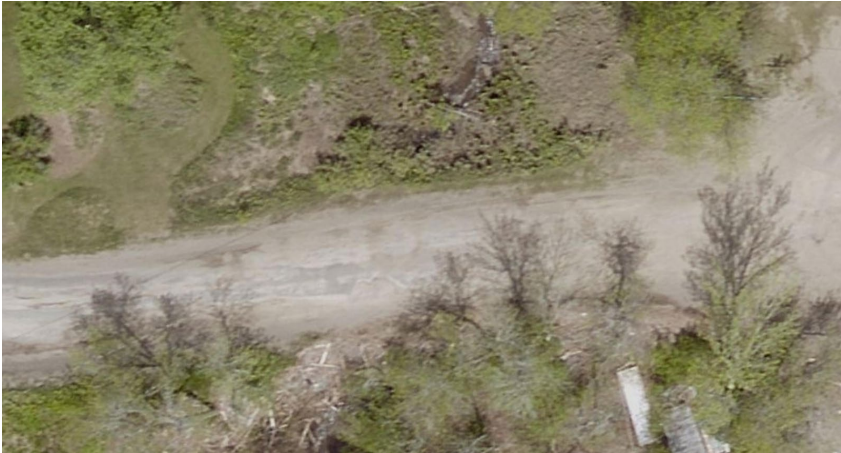
| Crossing 92 | | | |

| Crossing 92 | | | |
|---|---|--|--|
| Coordinates | 66.0657481°W, 45.3918538°N | Notes | Culvert slope exceeds slope threshold. |

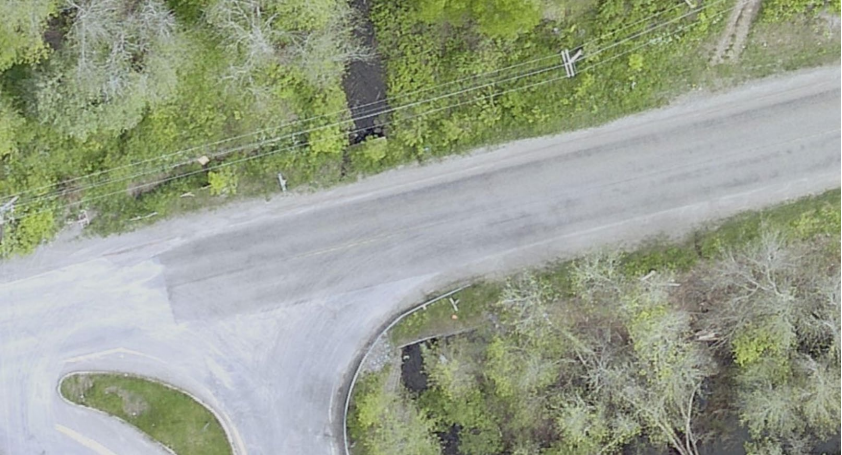
| Crossing 94 | | | |

| Crossing 93 | | | |
|---|---|--|--|
| Upstream kilometers restricted | 8 km | | |

| Crossing 94 | | | |
|---|---|--|--|
| Coordinates | 65.9841253°W, 45.4587568°N | Notes | Culvert slope exceeds slope threshold. |

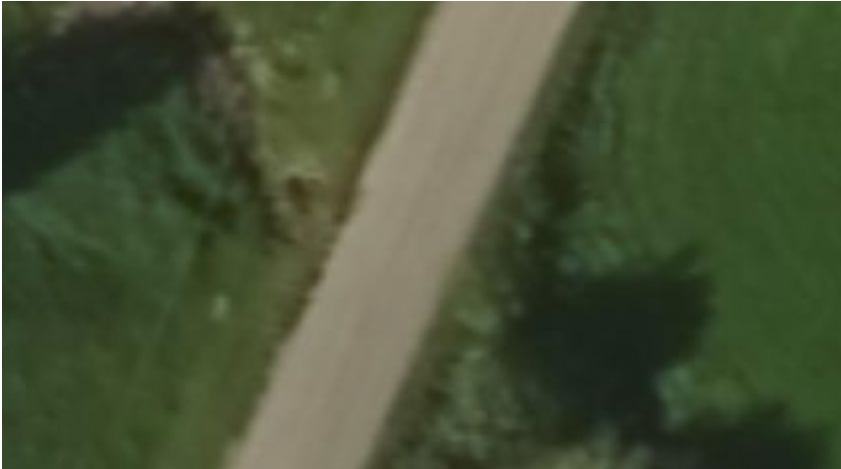
| Crossing 95 | | | |

| Crossing 94 | | | |
|---|---|--|--|
| Upstream kilometers restricted | 12.5 km | | |

| Crossing 95 | | | |
|---|---|--|--|
| Coordinates | 65.8087248°W, 45.6431503°N | Notes | Culvert slope exceeds slope threshold. |

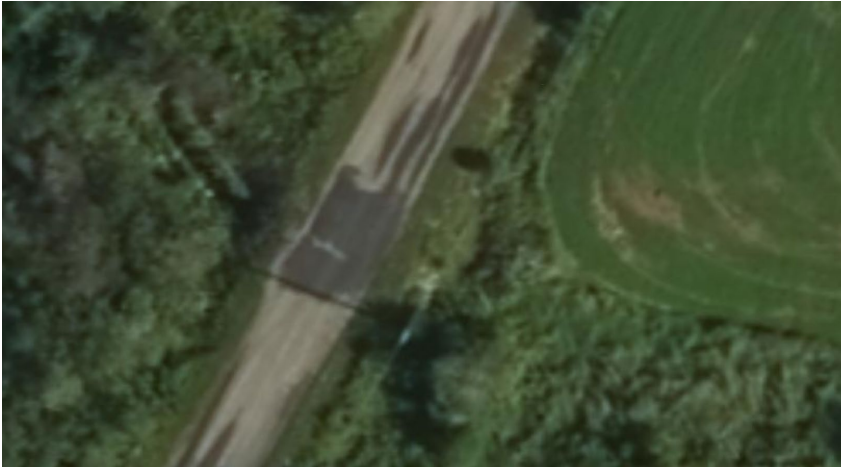
| Crossing 96 | | | |

| Crossing 95 | | | |
|---|---|--|--|
| Upstream kilometers restricted | 5 km | | |

| Crossing 96 | | | |
|---|---|--|--|
| Coordinates | 65.6929005°W, 45.6862085°N | Notes | Culvert slope exceeds slope threshold. |

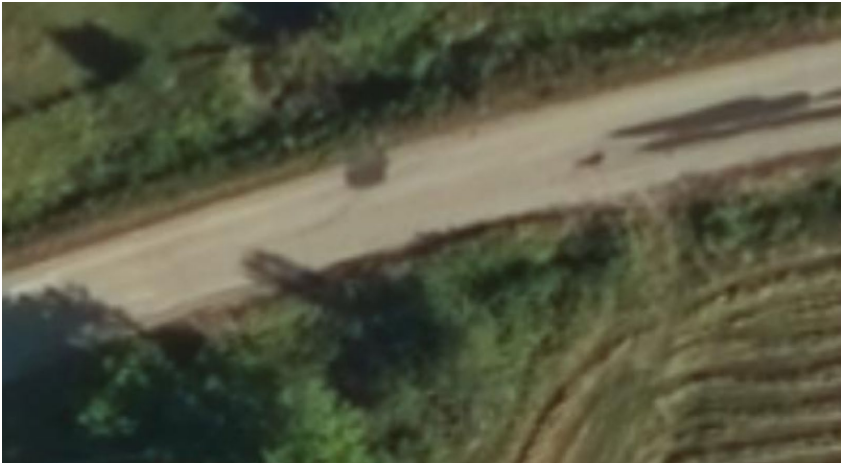
| Crossing 98 | | | |

| Crossing 97 | | | |
|---|---|--|--|
| Upstream kilometers restricted | 3 km | | |

| Crossing 98 | | | |
|---|---|--|--|
| Coordinates | 65.7142991°W, 45.6904984°N | Notes | Culvert slope exceeds slope threshold. |

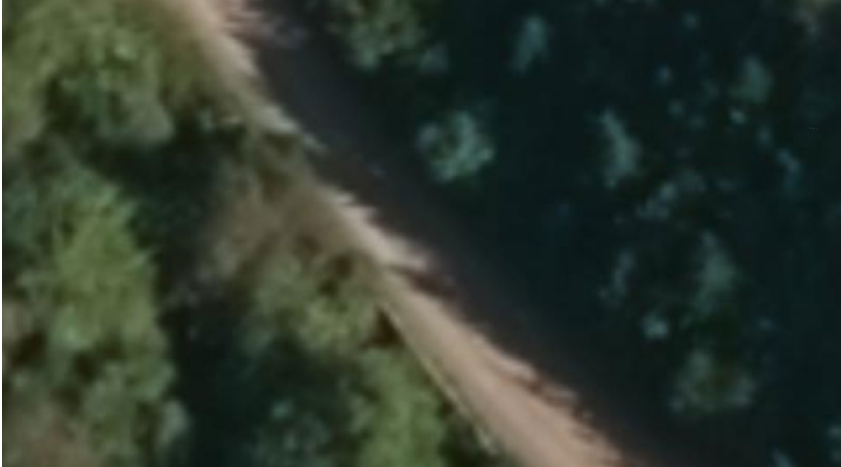
| Crossing 99 | | | |

| Crossing 98 | | | |
|---|---|--|--|
| Upstream kilometers restricted | 3 km | | |

| Crossing 99 | | | |
|---|---|--|--|
| Coordinates | 65.9689026°W, 45.6950132°N | Notes | Culvert slope exceeds slope threshold. |

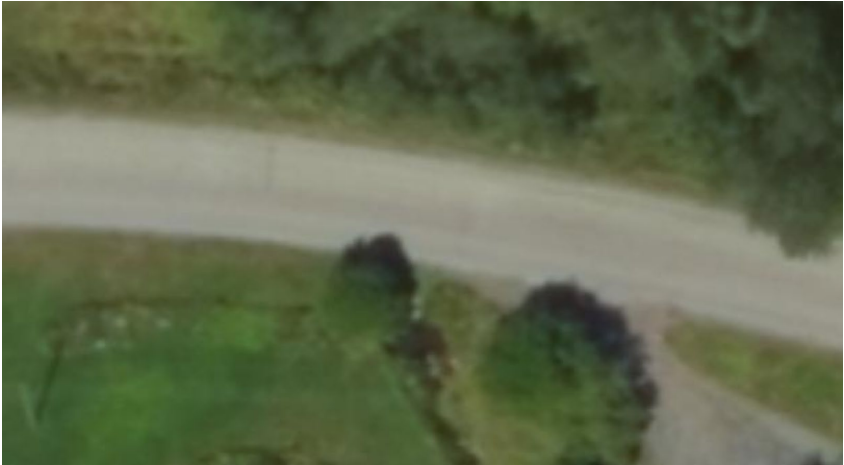
| Crossing 100 | | | |

| Crossing 99 | | | |
|---|---|--|--|
| Upstream kilometers restricted | 15 km | | |

| Crossing 100 | | | |
|---|---|--|--|
| Coordinates | 65.6868364°W, 45.5399354°N | Notes | Culvert slope exceeds slope threshold. |
