# Main Branch LaHave

**Sub-watershed**

## **Fish Habitat**

## **Restoration Plan**

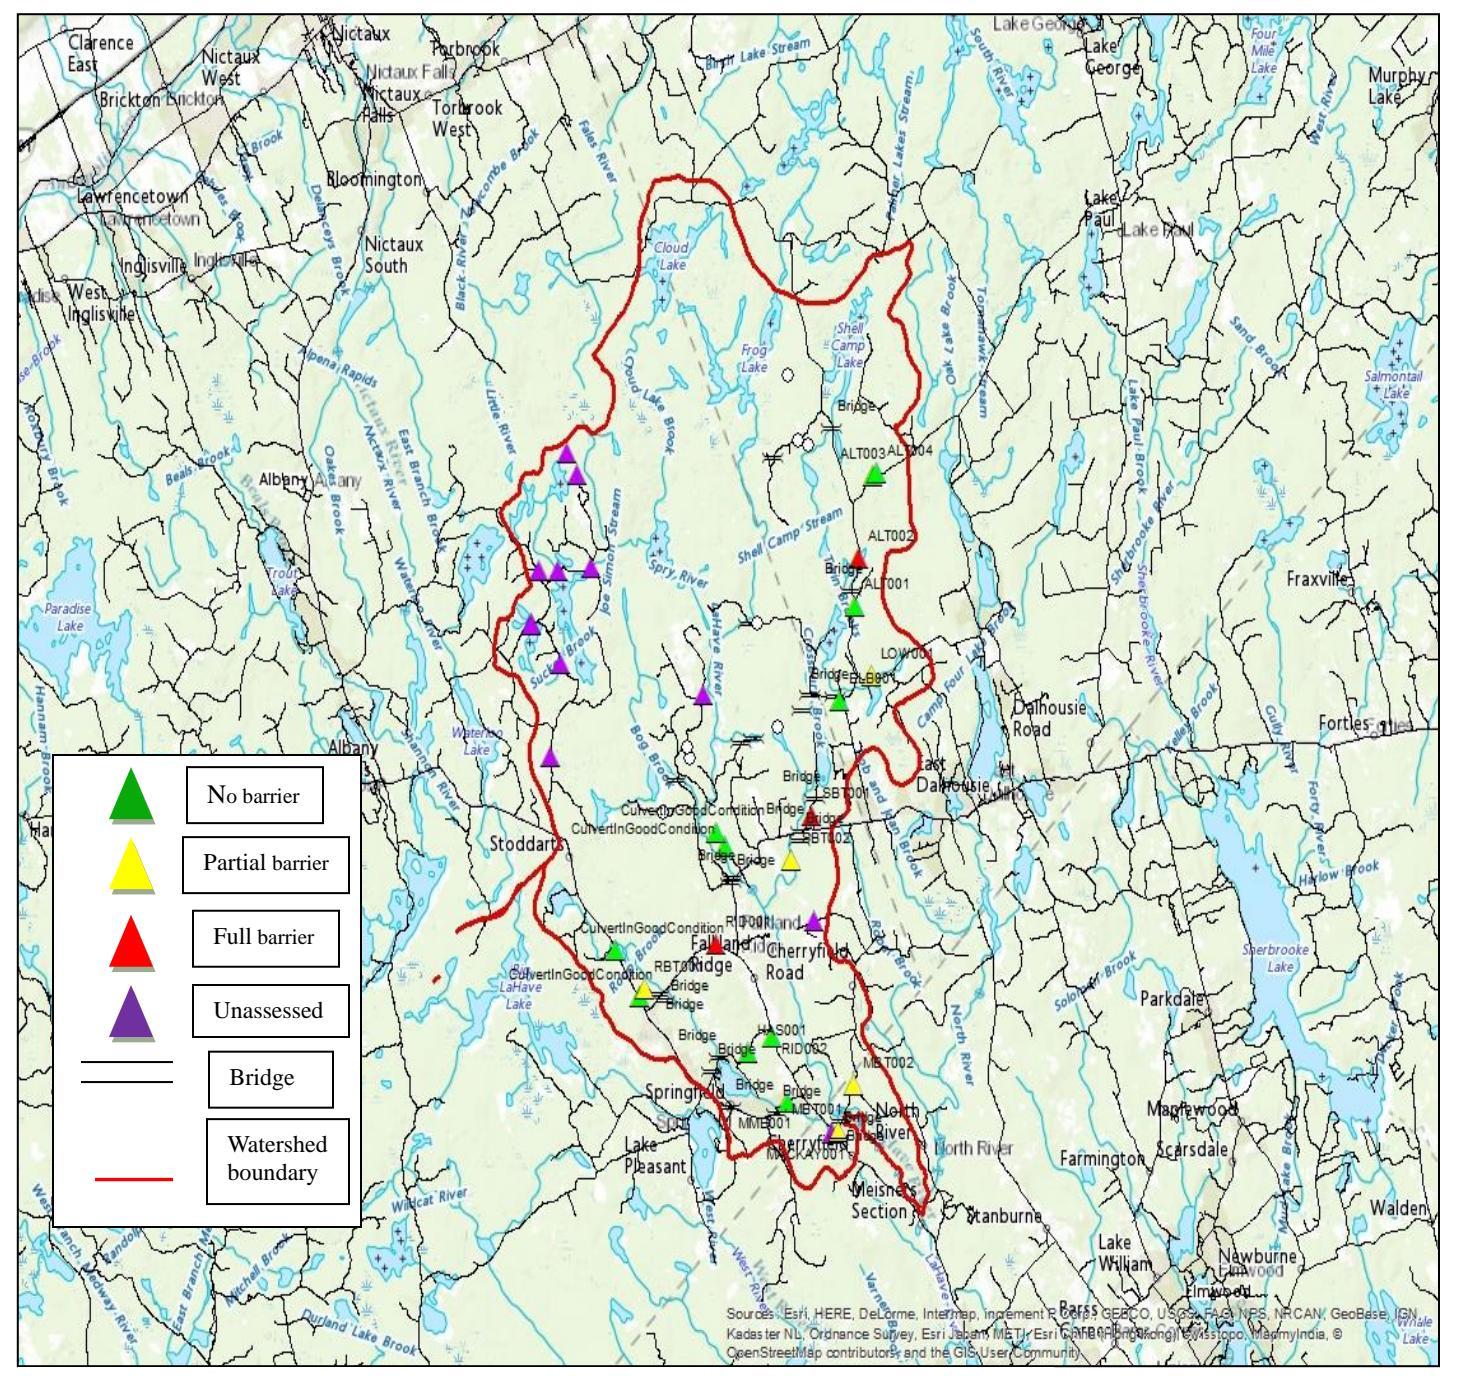
Map showing all crossings assessed thus far in the Main Branch Sub-Watershed.

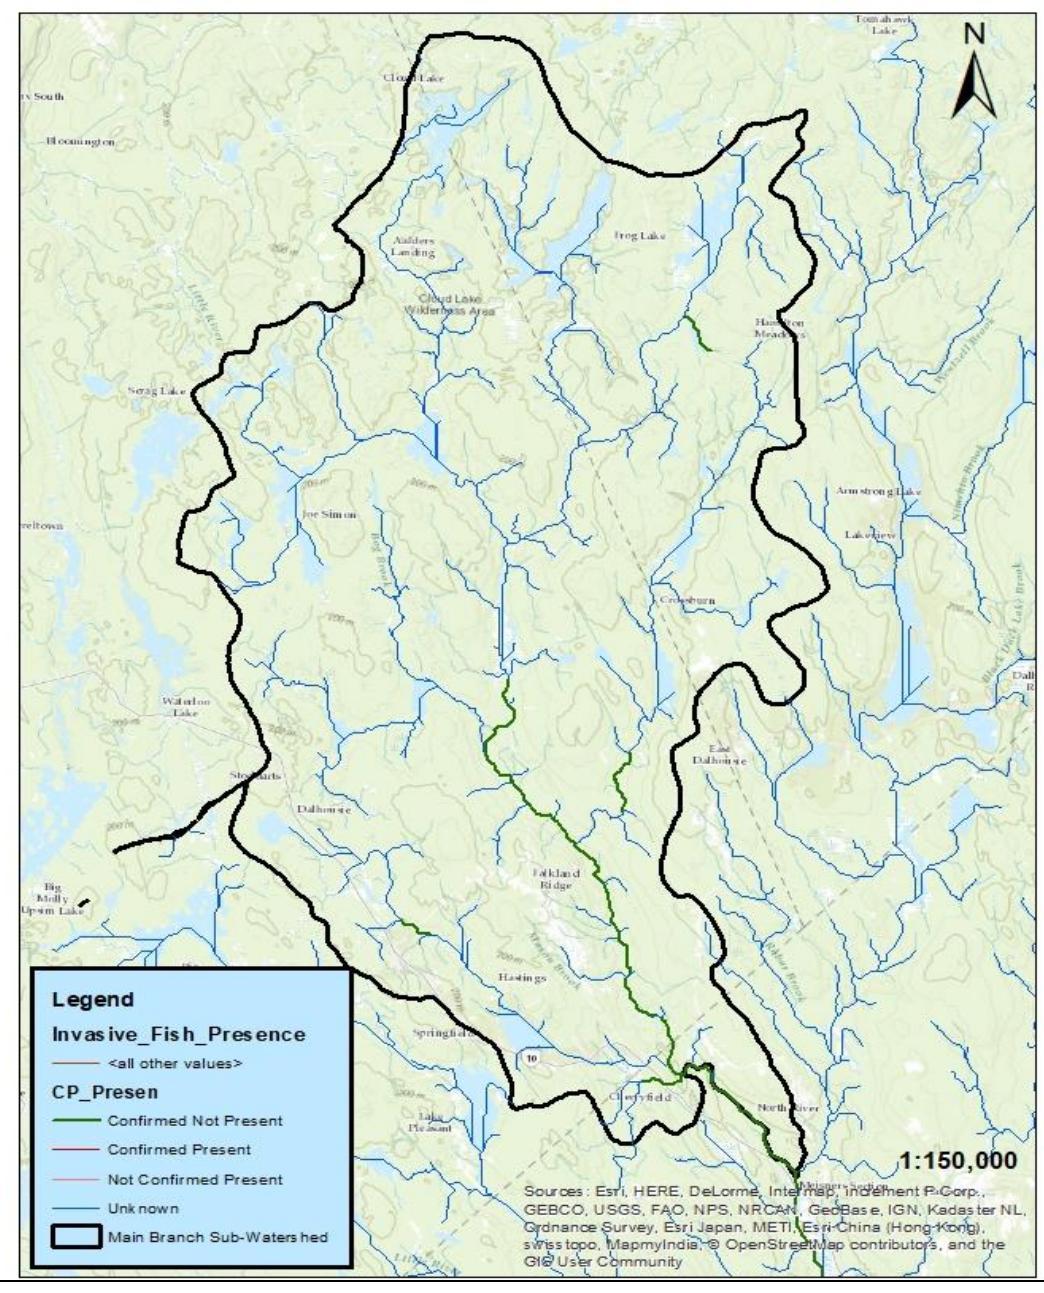
Map showing confirmed presence/absence of <u>chain pickerel</u> (*Esox Niger*) in the Main Branch Sub-watershed. Note: No chain pickerel have been confirmed present in the section of the Main River Sub-watershed above Morgan Falls as well as any sections of the Main Branch Sub-watershed. The areas outlined in green showing confirmed non-presence have been assessed by Coastal Action staff via scientific angling and/or backpack electrofishing.

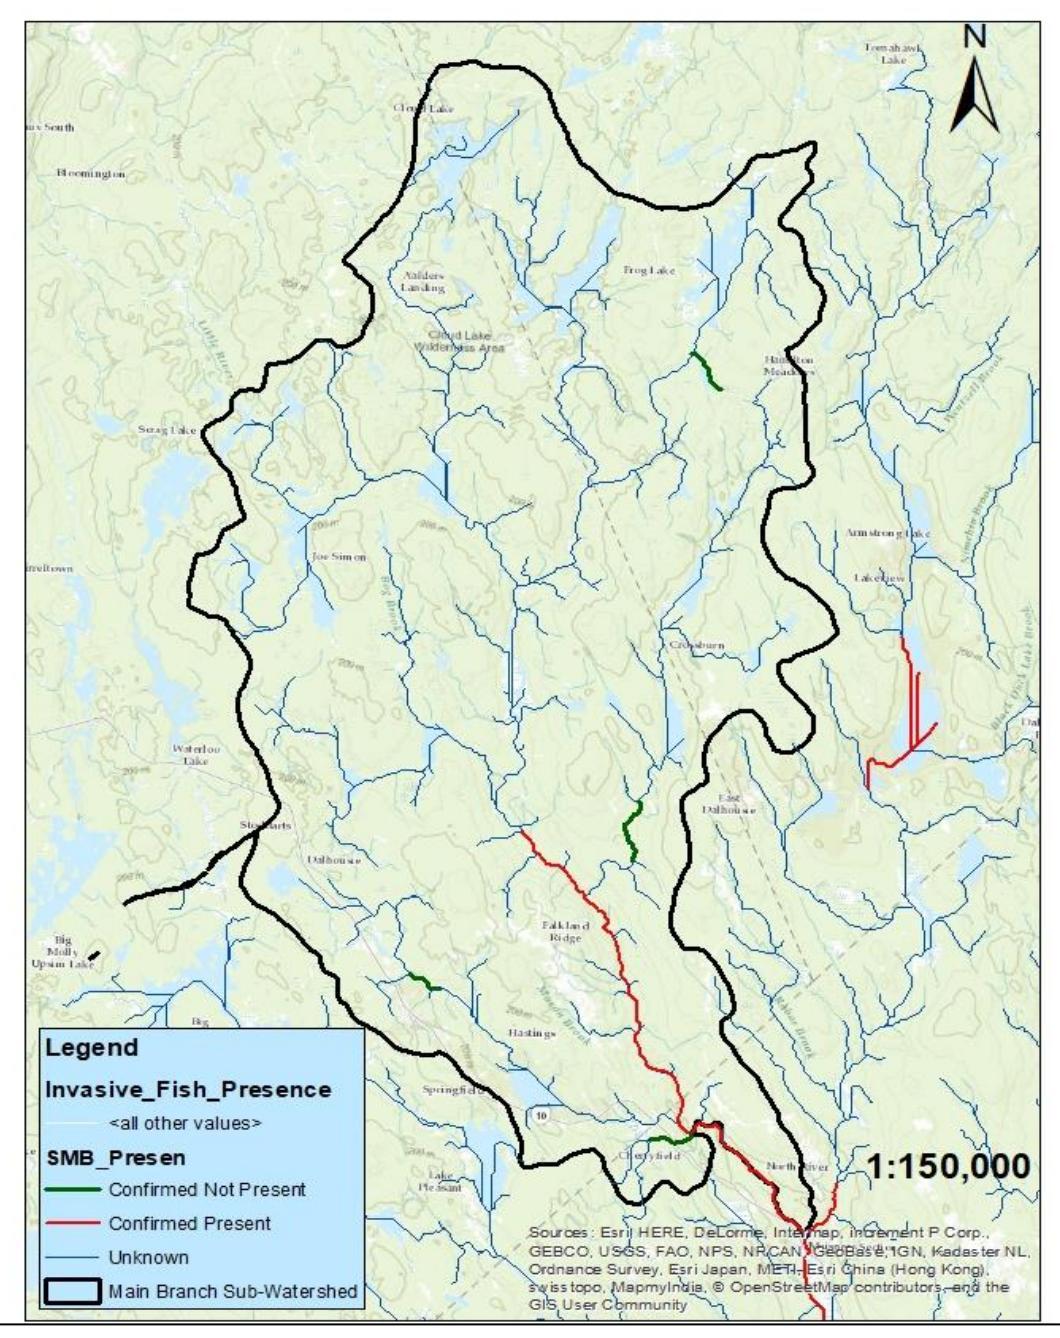
Map showing confirmed presence/absence of <u>smallmouth bass</u> (*Micropterus dolomieu*) in the Main Branch Sub-watershed. The areas outlined in red showing confirmed presence have been assessed by Coastal Action staff via scientific angling and/or backpack electrofishing.
