**DEVELOP HABITAT CONSERVATION PLANS AND RESTORATION FOR RIVERS IN  
BAY ST. GEORGE 2019**

**CRABBES RIVER  
ROBINSONS RIVER**

**BAY ST. GEORGE SOUTH AREA DEVELOPMENT ASSOCIATION**

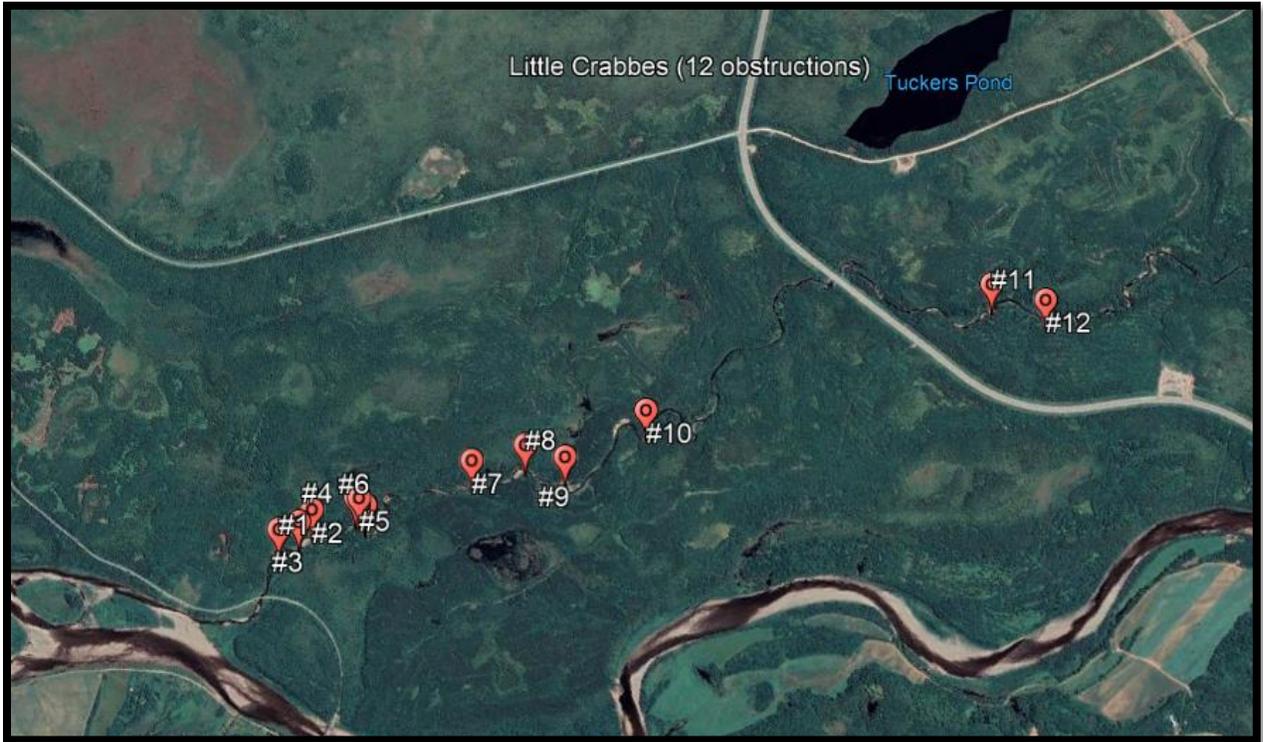
Figure 1: Map of Obstructions on Little Crabbes, a tributary of Crabbes River.

12 obstructions were recorded on Little Crabbes, most of which were identified as large woody debris (LWD). A description of the obstructions recorded are listed in table 1. After surveying Little Crabbes and analyzing the recorded obstructions, two obstructions required immediate attention. Obstruction 6 (N 48.19420°, W -58.81852°) (Fig 19-25), and obstruction 11 (N 48.19044°, W -58.78660°) (Fig 42-45) were removed due to their impact on salmon migration. The remaining obstructions were not posing an actual threat to salmon passage therefore making it more harmful to remove them. In some cases, obstructions provide shelter, food source and habitat for salmon. An example would be obstruction 10 (W 48.19241°, N -58.80455°) (Fig 40-41), where a tree has fallen in the mainstream of the tributary not causing an obstruction to salmon passage but rather providing shelter and food source.

6	LWD	3	13	8	7	48.19420	-58.81852	Y	Y	P	75%	0.25	Large amounts of trees fallen due to high erosion. 75% of stream flow blocked.
7	LWD/ BEAVER	1.2	15	9	13	48.19378	-58.81306	N	N	G	60%	0.2	Large amounts of trees fallen due to high erosion. Beaver has built dam along fallen trees. Dam is inactive.
8	LWD	0.8	10	4.2	8	48.19337	-58.81046	Y	Y	P	40%	0.15	Large patch of trees fallen in to mainstream due to high amounts of erosion.
9	LWD/ BEAVER	9	24	11	14	48.19238	-58.80906	N	Y	F	60%	0.5	Beaver has used tree to build large dam causing 60% blockage. Dam is inactive.
10	LWD	2	16.4	2.3	7	48.19241	-58.80455	Y	Y	P	50%	0.25	Large trees fallen in mainstream due to high amounts of erosion.
11	LWD	2.5	20	11	8.5	48.19044	-58.78660	Y	Y	P	75%	0.3	Trees fallen due to high erosion. Causing 75% blockage. Over time will result in higher blockage to mainstream.
12	LWD	1.5	12	13	9.5	48.18909	-58.78472	N	Y	F	60%	0.25	60% blockage caused by large woody debris.

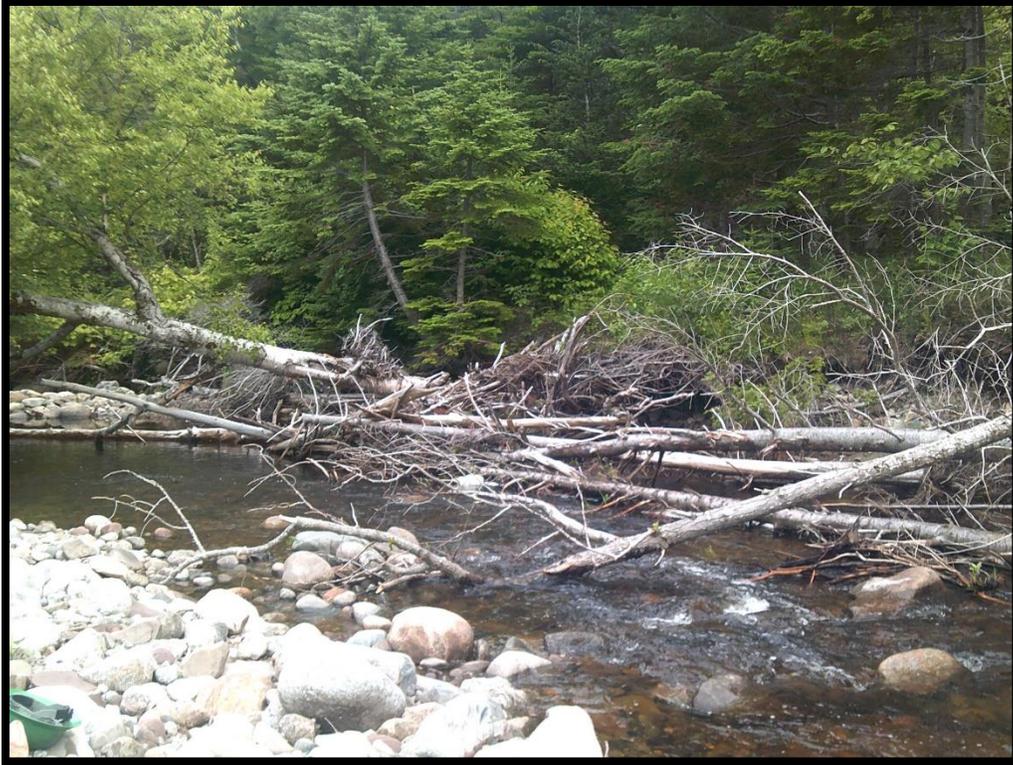
*Figure 18: Downstream view of obstruction 5, Little Crabbes.*

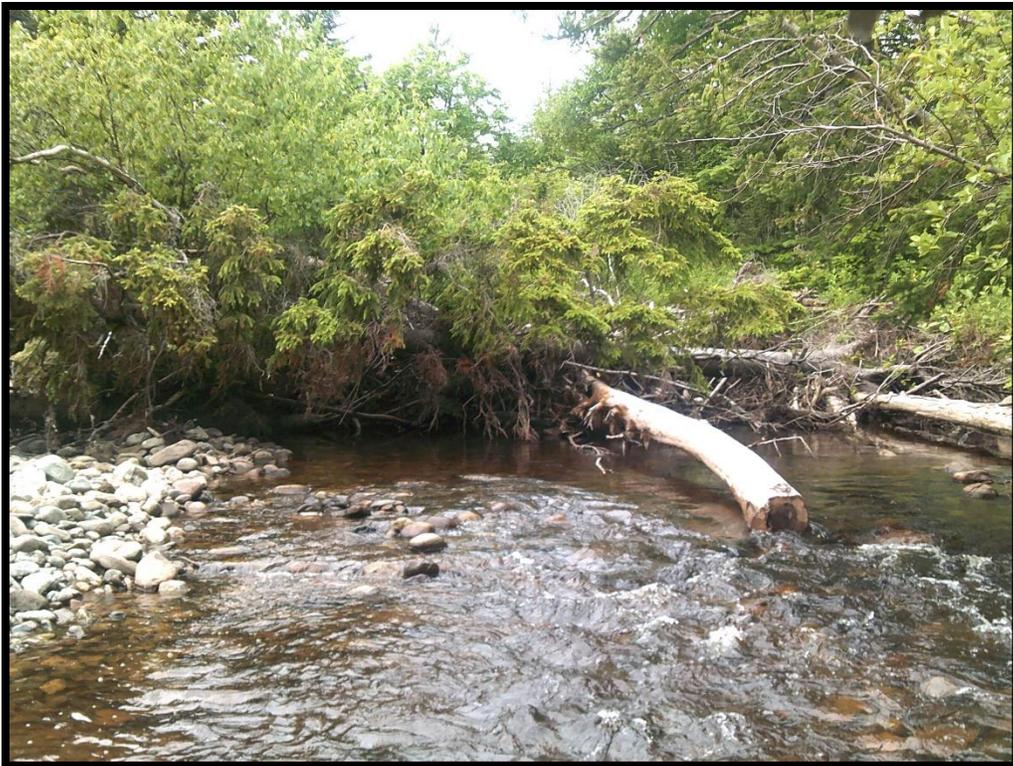
*Figure 19: Upstream view of obstruction 6, Little Crabbes.*

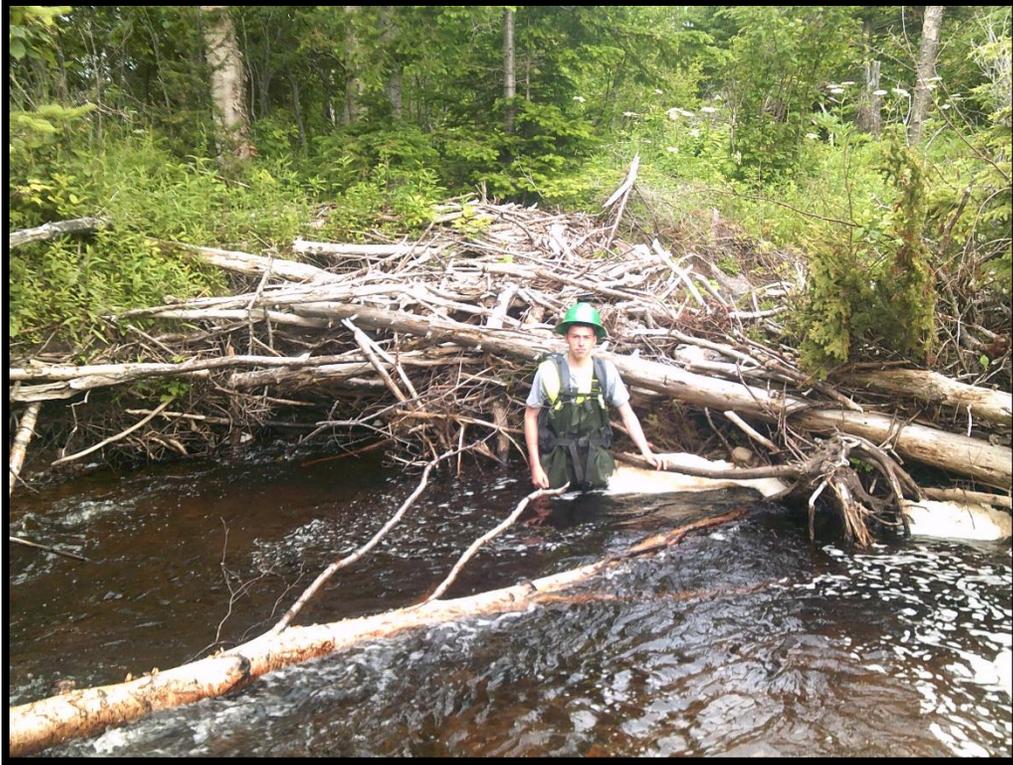
*Figure 22: Closer downstream view of obstruction 6, Little Crabbes.*

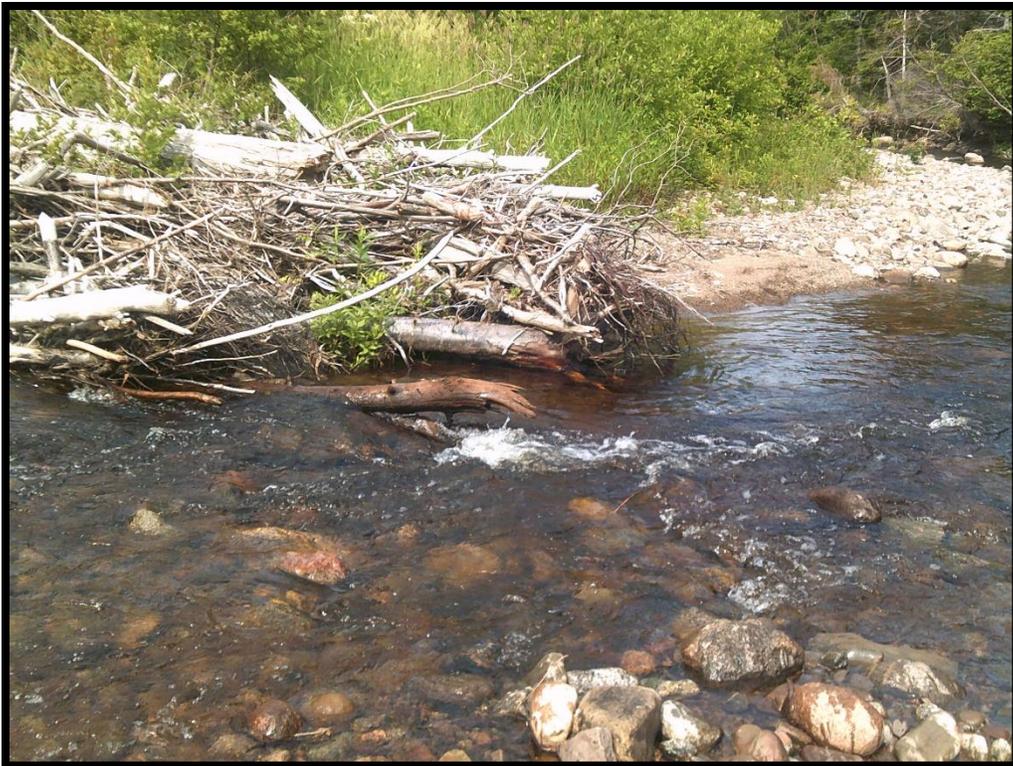
*Figure 29: Closer view of river being diverted from obstruction 7, Little Crabbes.*

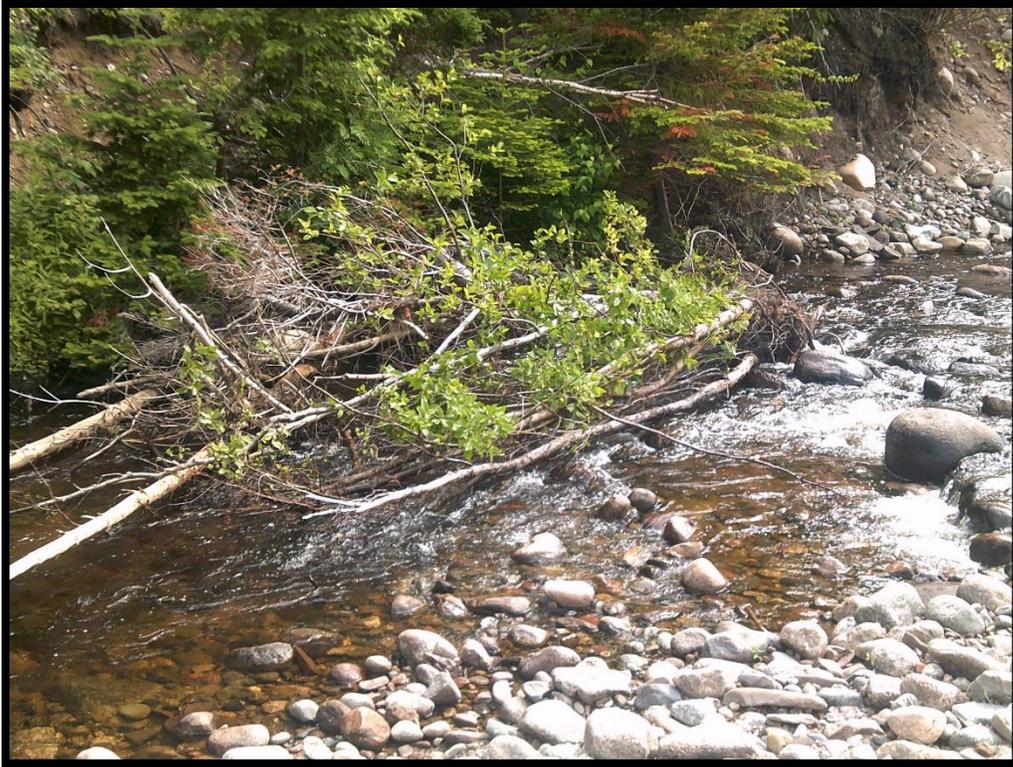
*Figure 32: Sideview of obstruction 8, Little Crabbes. This is a great example of where the obstruction is providing great shade and food source for salmon.*

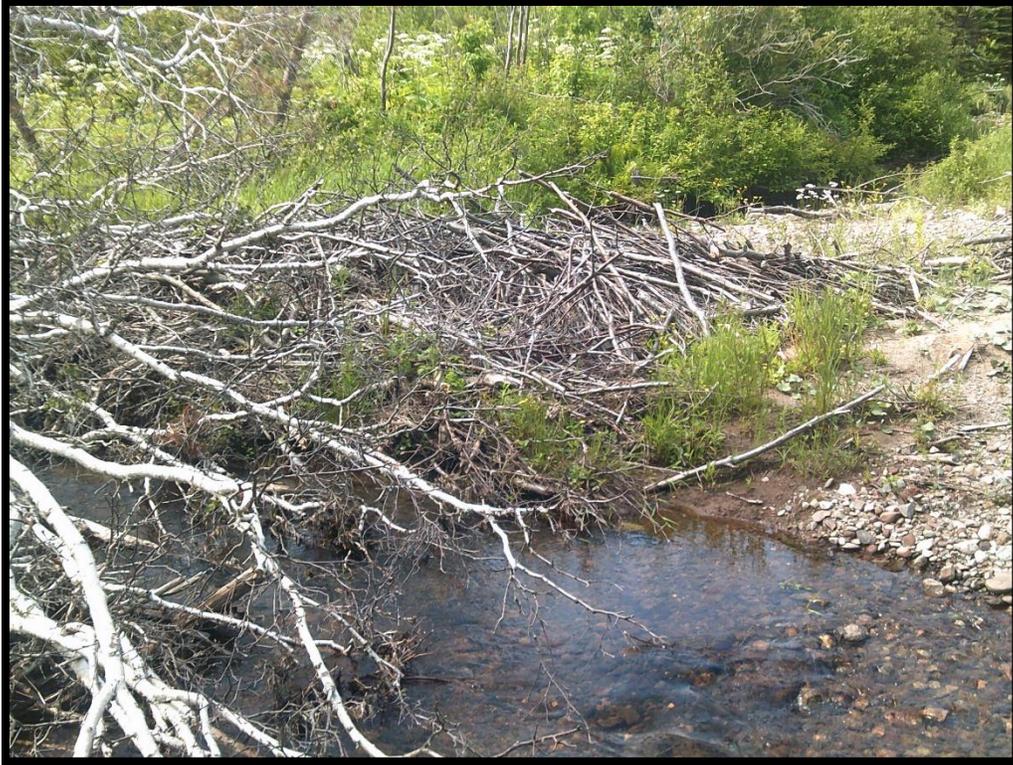
*Figure 36: Sideview of obstruction 9, showing the inactive beaver dam, Little Crabbes.*

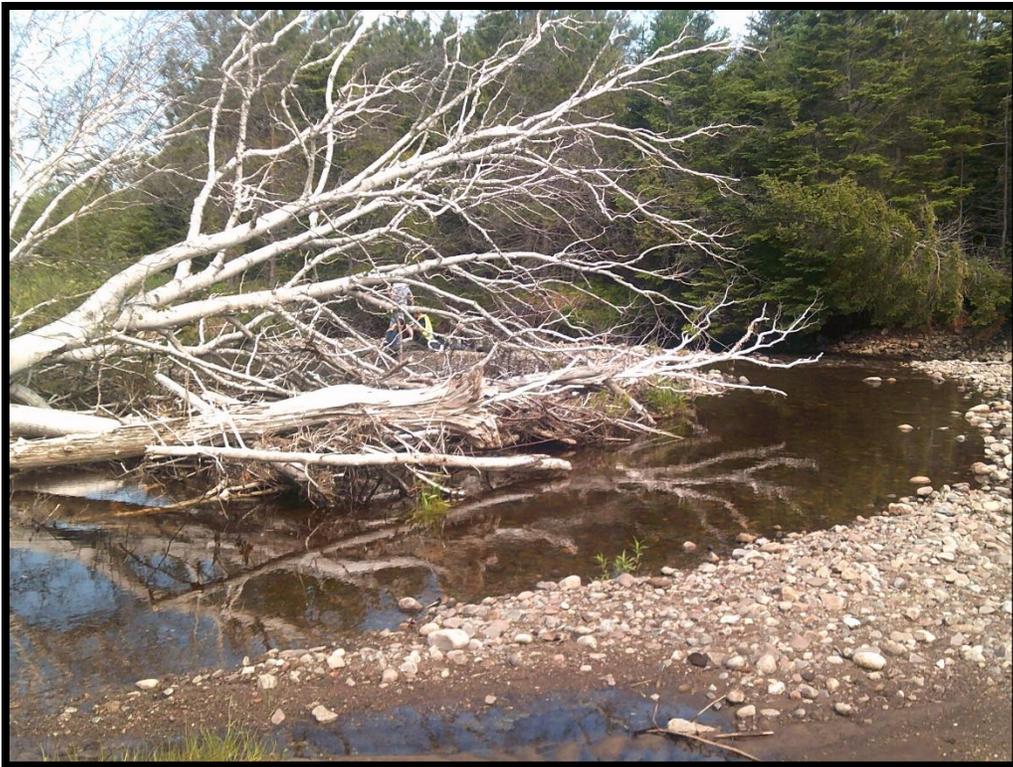
*Figure 37: Downstream view of obstruction 9, Little Crabbes.*

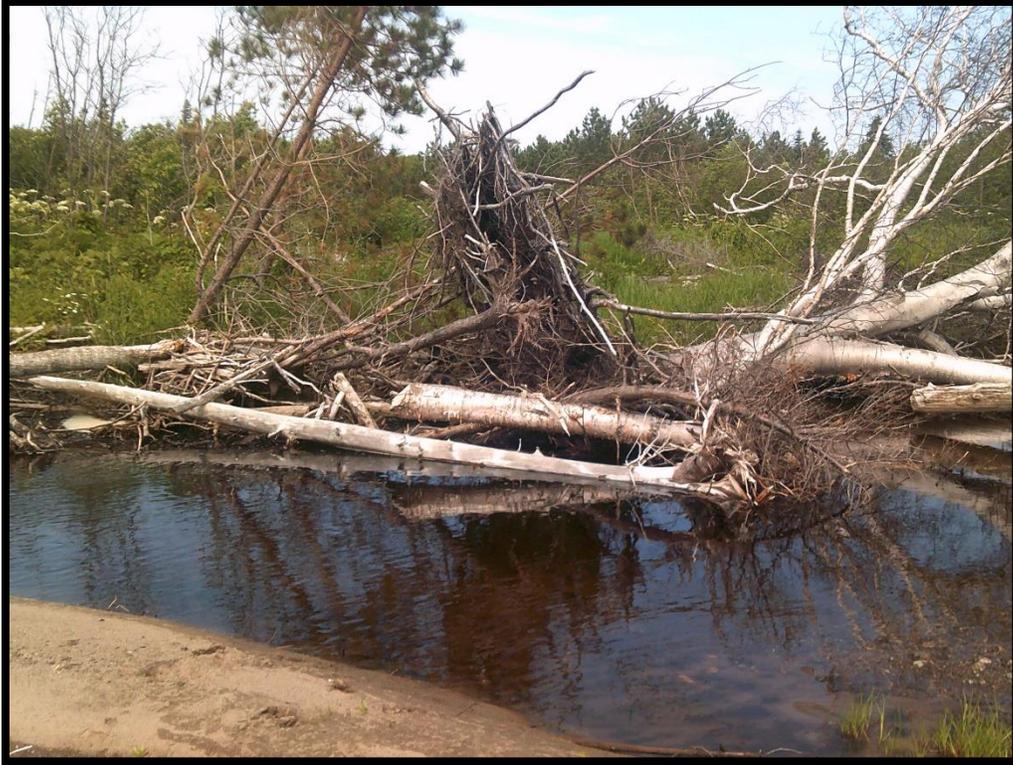
*Figure 38: Closer view looking downstream at obstruction 9. This obstruction provides great shelter for salmon, Little Crabbes.*

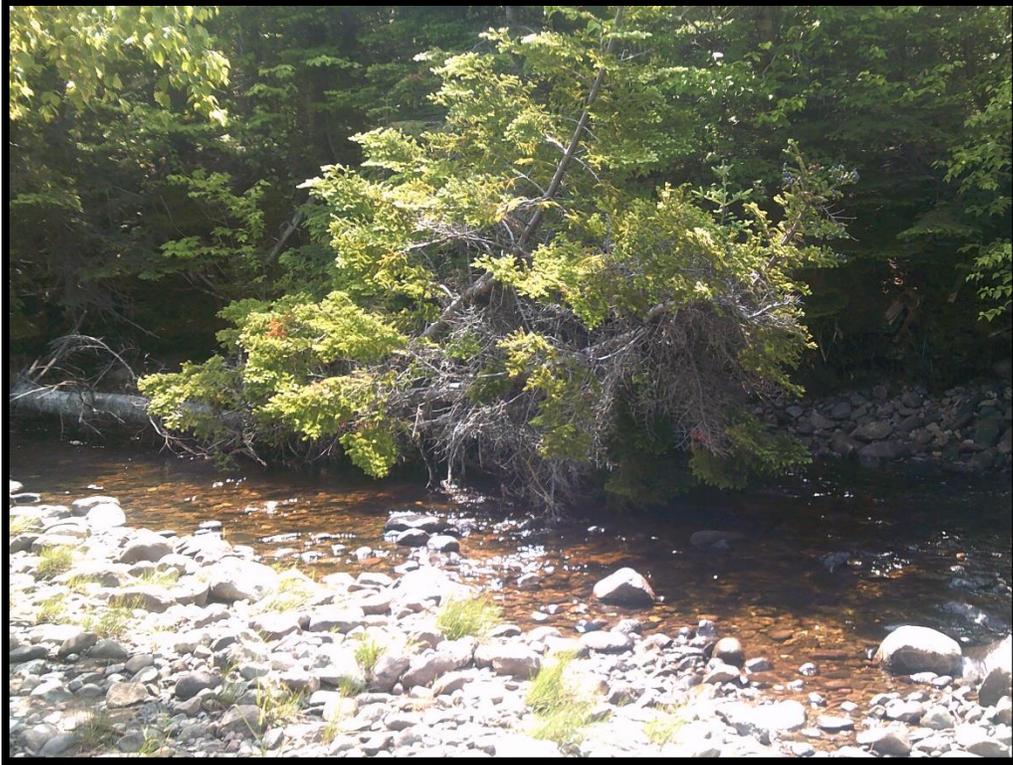
*Figure 40: Sideview of obstruction 10, Little Crabbes.*

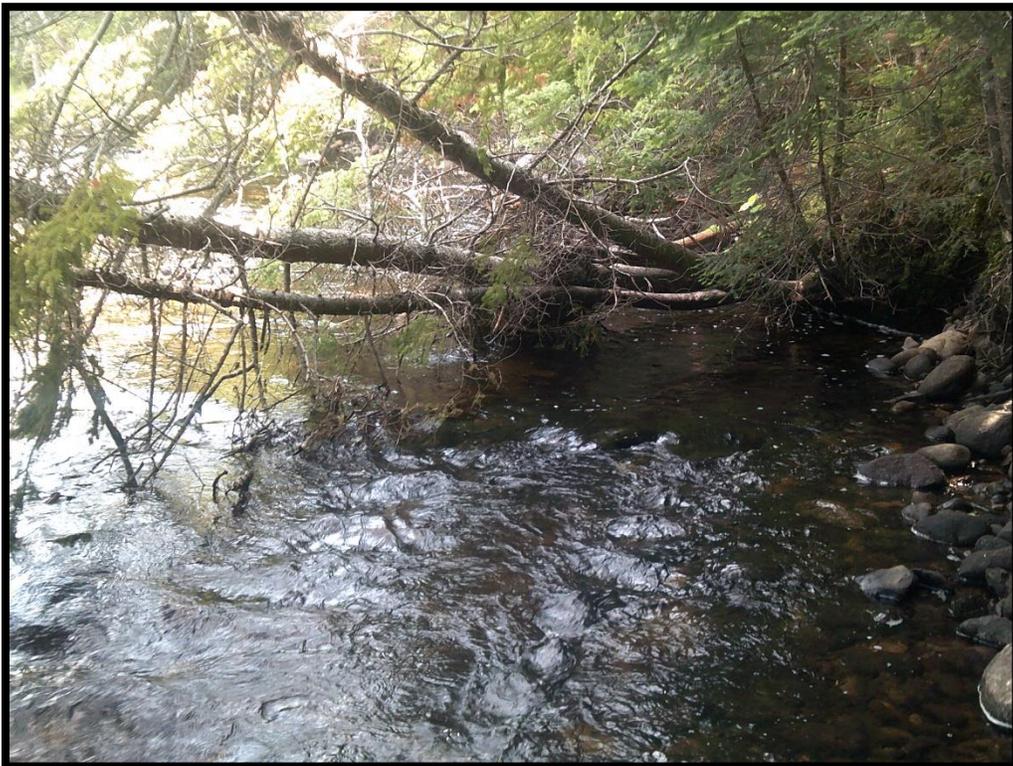
*Figure 41: Upstream view of obstruction 10. The trees are providing excellent shelter and food source for salmon, Little Crabbes.*

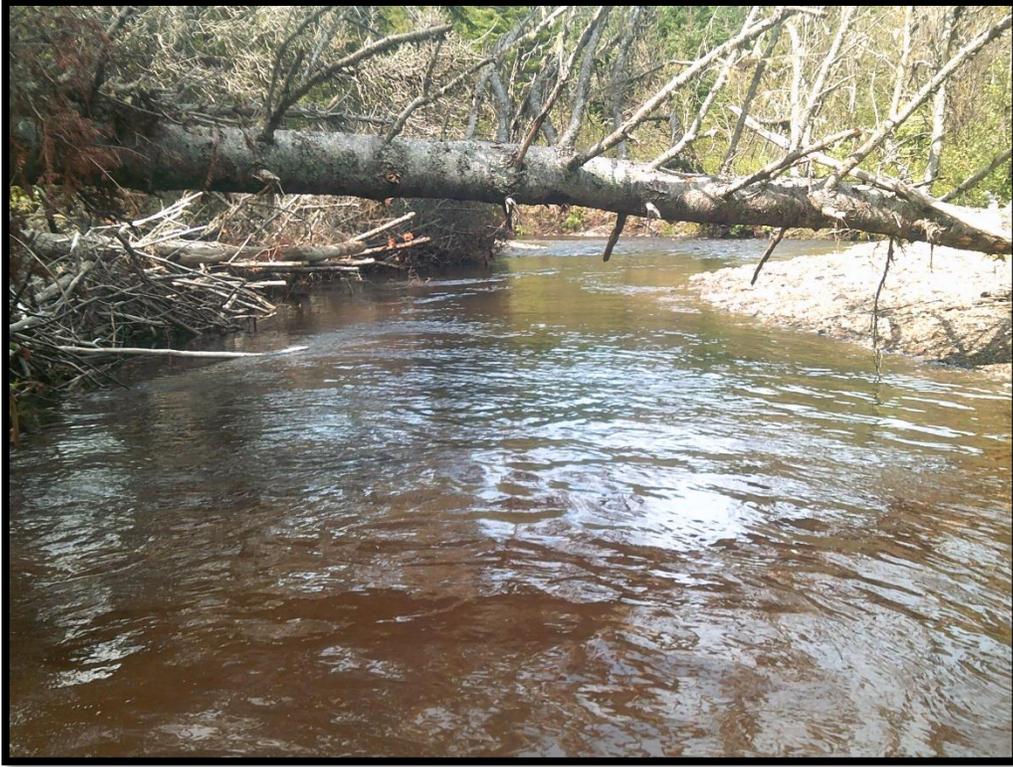
*Figure 44: Downstream view of improved area on obstruction 11. Remaining woody debris acts as a good shelter for salmon, Little Crabbes.*

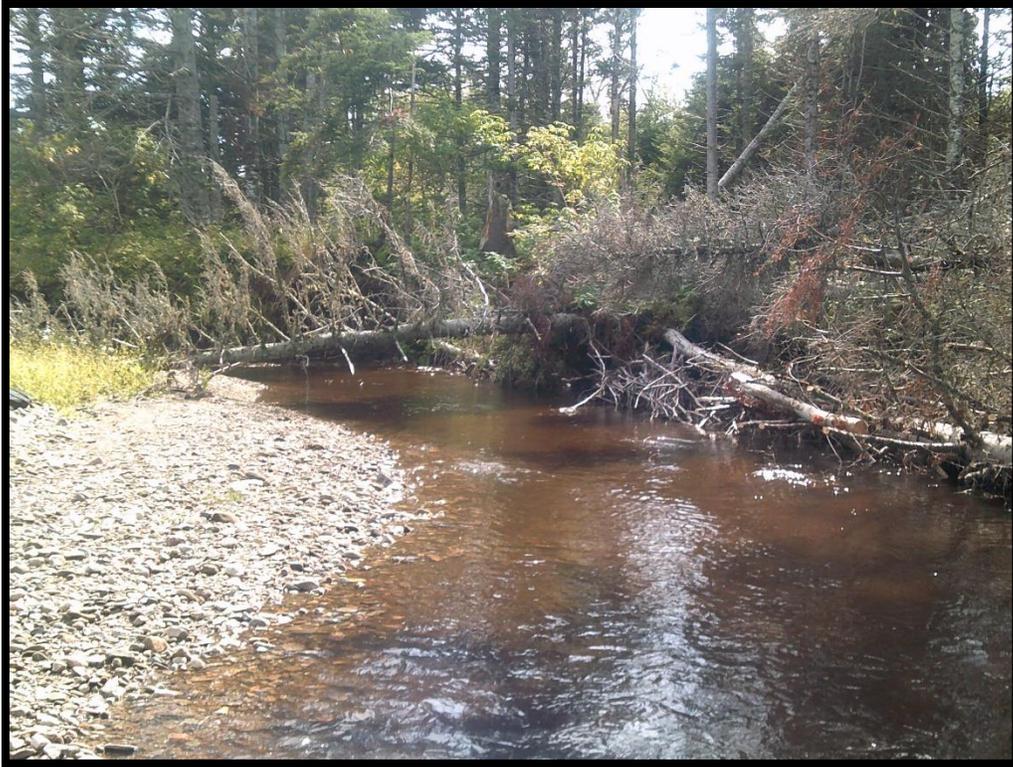
*Figure 45: Upstream view of improved area on obstruction 11, Little Crabbes.*

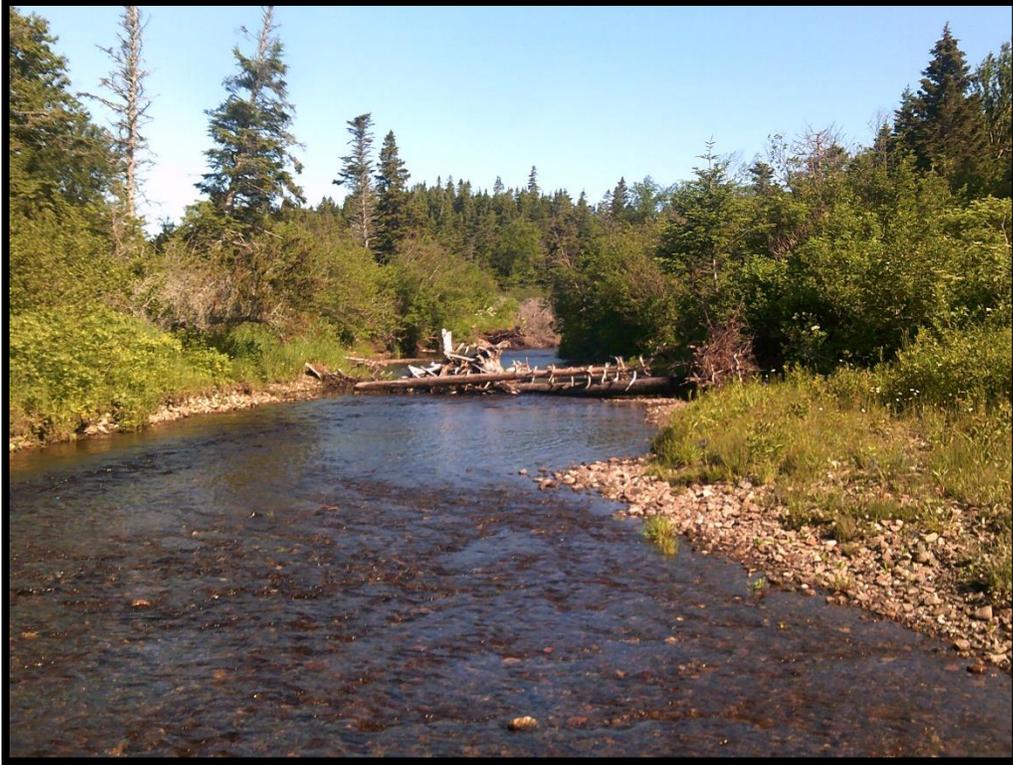
*Figure 46: Looking upstream at obstruction 12, Little Crabbes.*

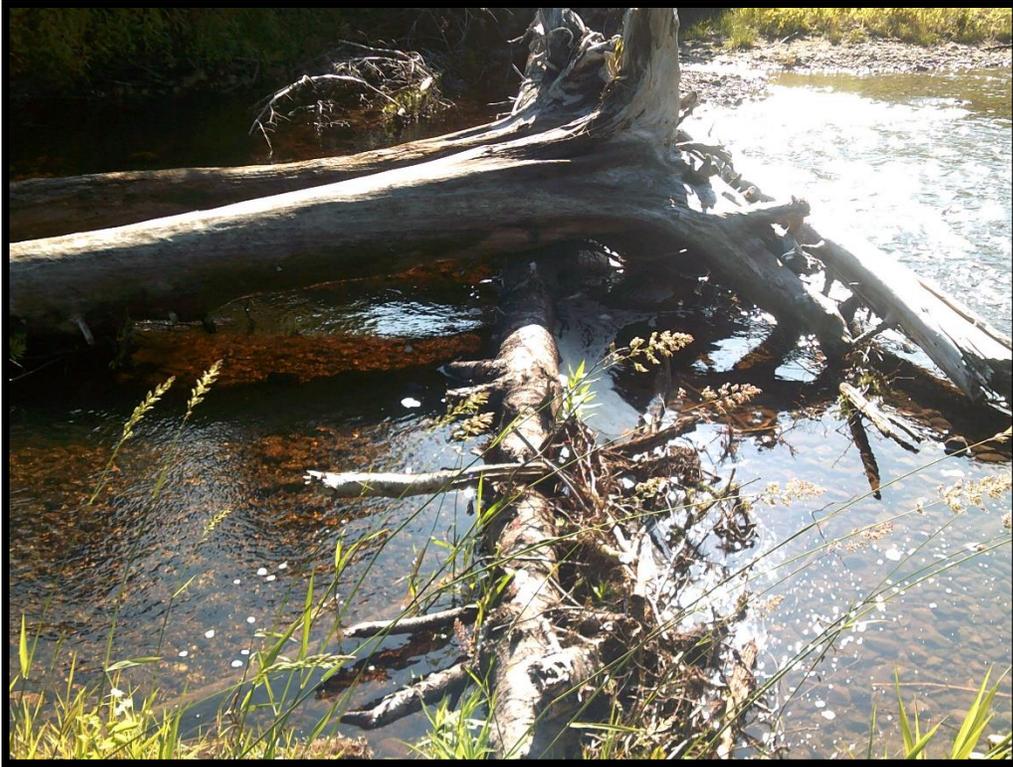
*Figure 48: Sideview of obstruction 12. The fallen trees act as a food source for salmon, Little Crabbes.*
