**DEVELOP HABITAT CONSERVATION PLANS AND RESTORATION FOR
RIVERS IN BAY ST. GEORGE
2019**

Habitat Restoration

**FLAT BAY BROOK
LITTLE BARACHOIS BROOK
MIDDLE BARACHOIS BROOK**

BAY ST. GEORGE SOUTH AREA DEVELOPMENT ASSOCIATION

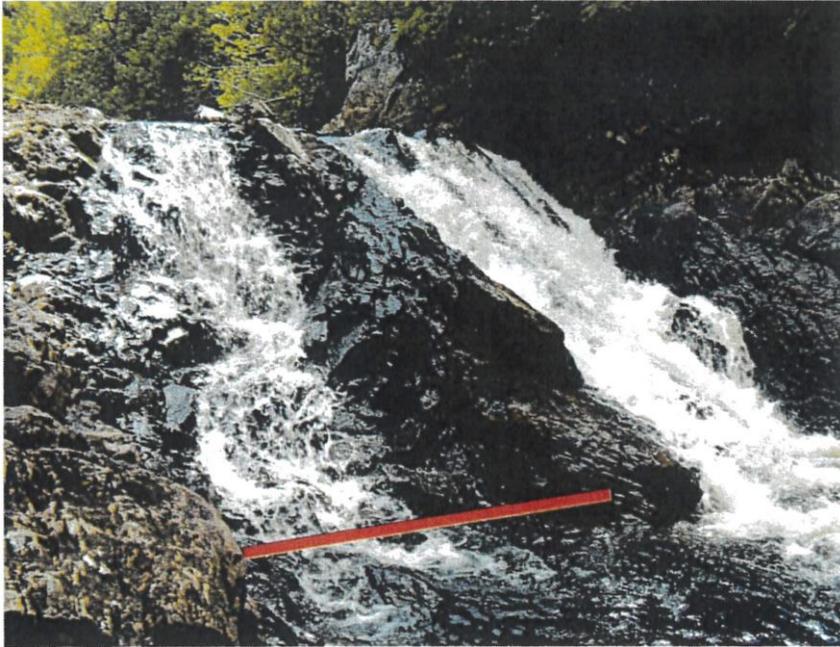
Photo 1: Falls is about 3 meters high at a slope of about 70° (30° off vertical) At the low level when photo taken the falls has 2 channels. The left channel (looking upstream) is about 0.5 m wide at the top; whereas the channel to the right is about 2 m wide and contains most of the river flow at this water level. Note, the rocky slope and base of both falls would prevent salmon from surmounting the falls at this water level.

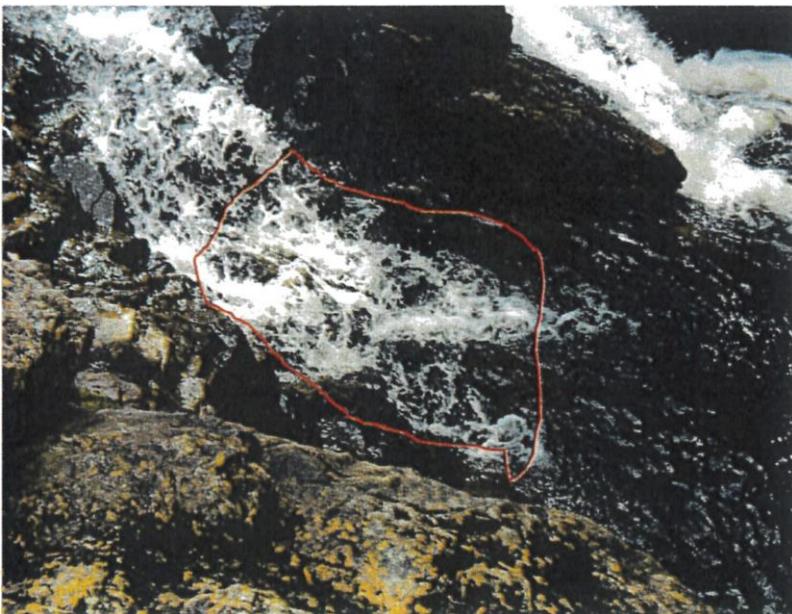
Photo 3. Photo of rocks at base of falls

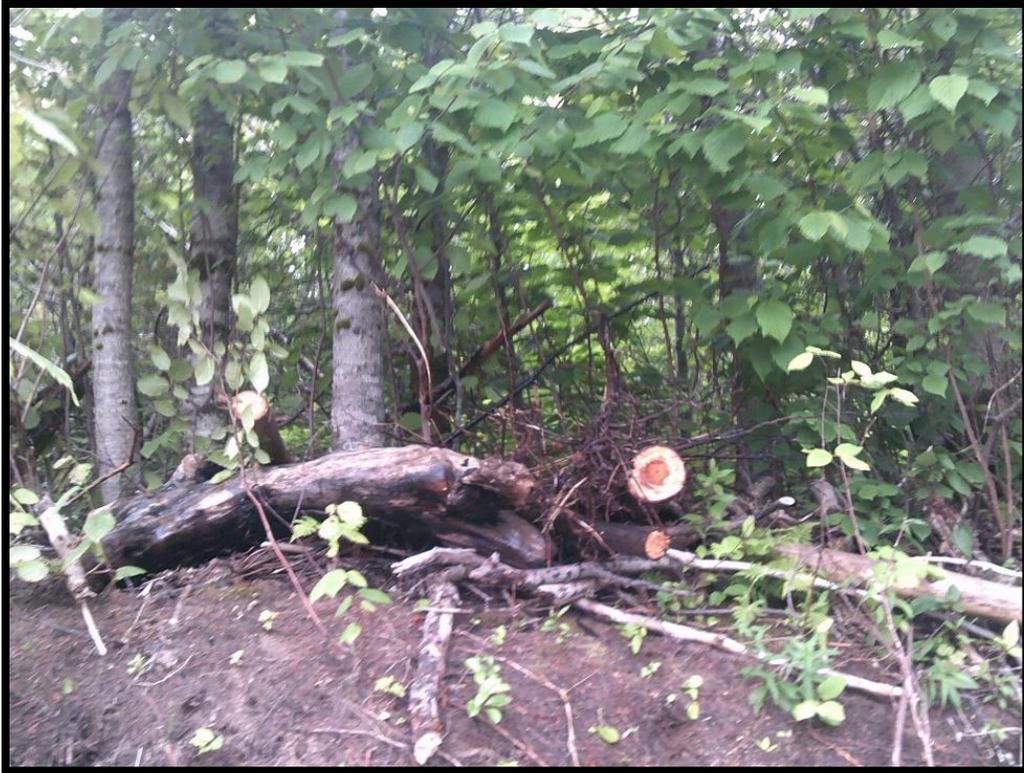
Figure 7: Debris removed from obstruction 2, Sheep Brook

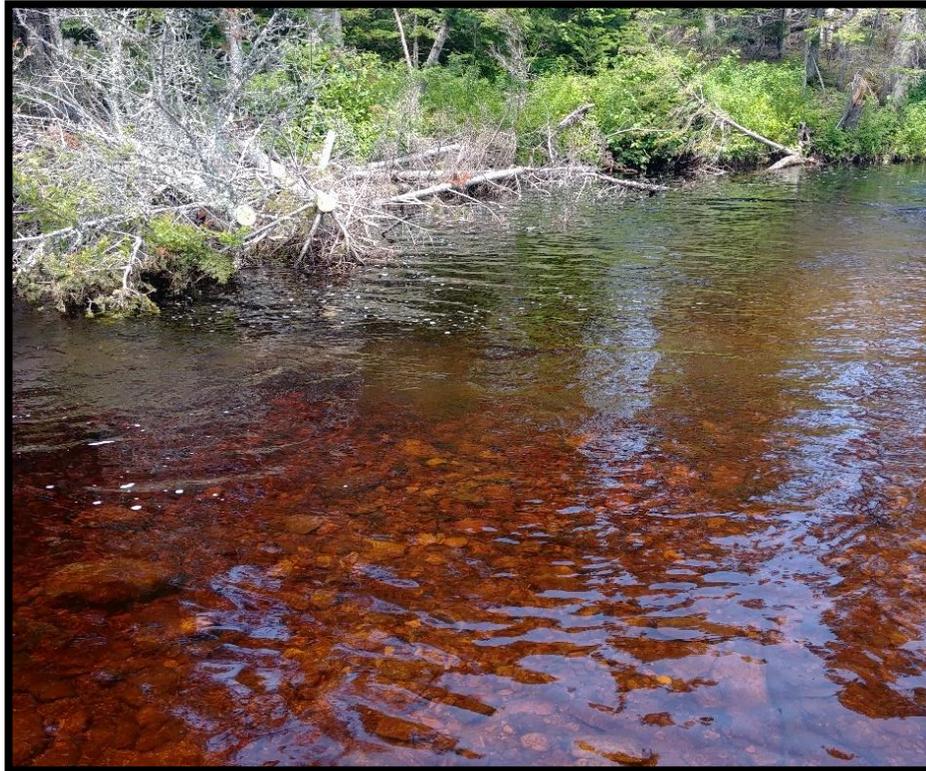
Figure 12: Upstream view of improved area after obstruction 7 was removed, St. Georges Dribble.

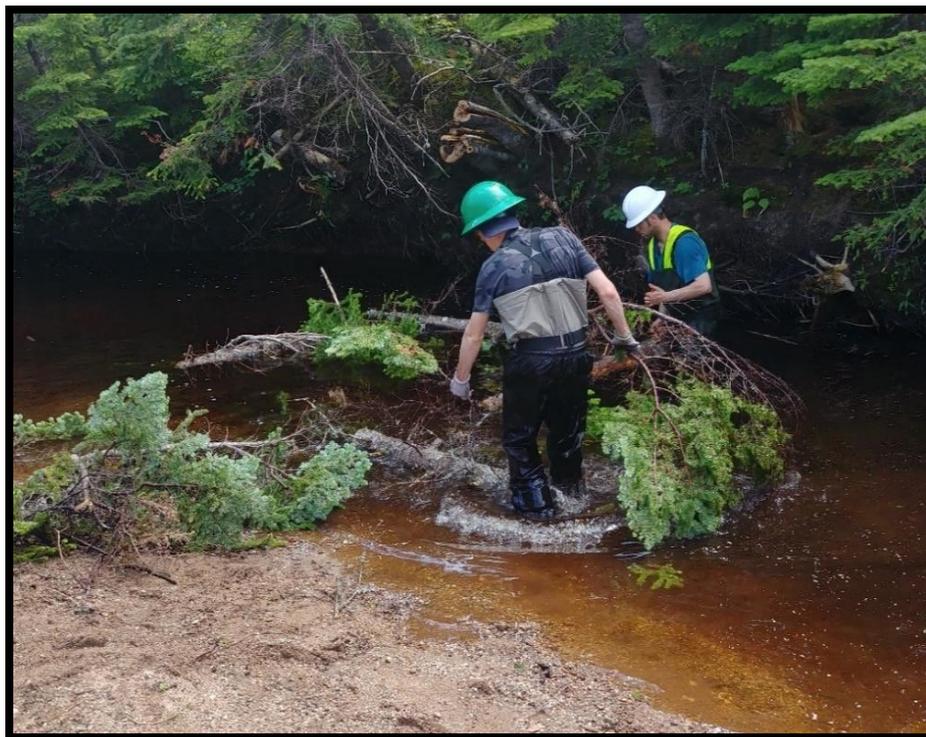
Figure 13: Removal of obstruction 8, St. Georges Dribble.

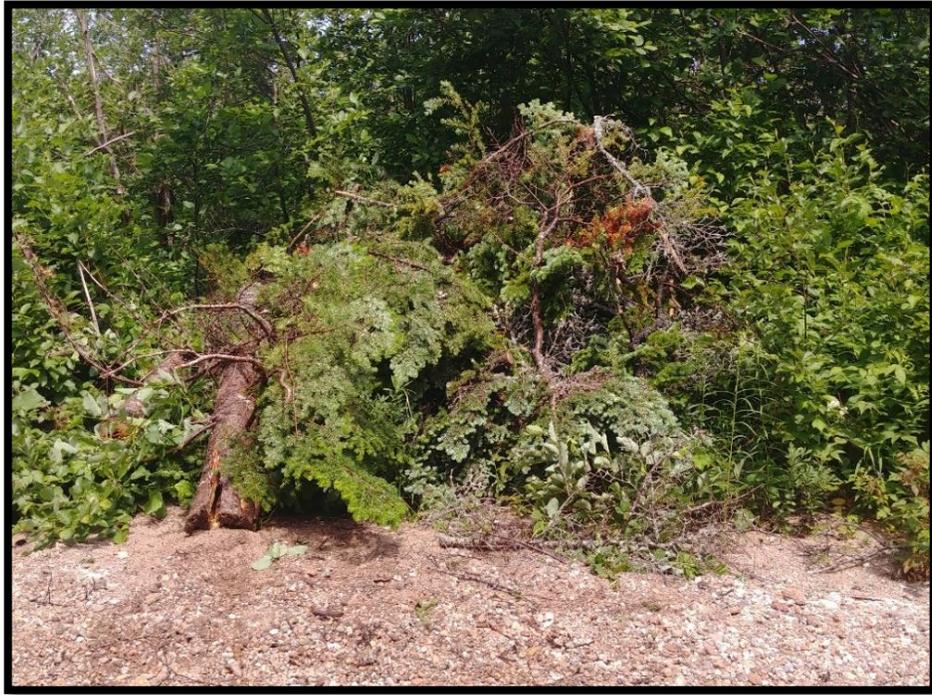
Figure 14: Debris removed away from flood zone, St. Georges Dribble.

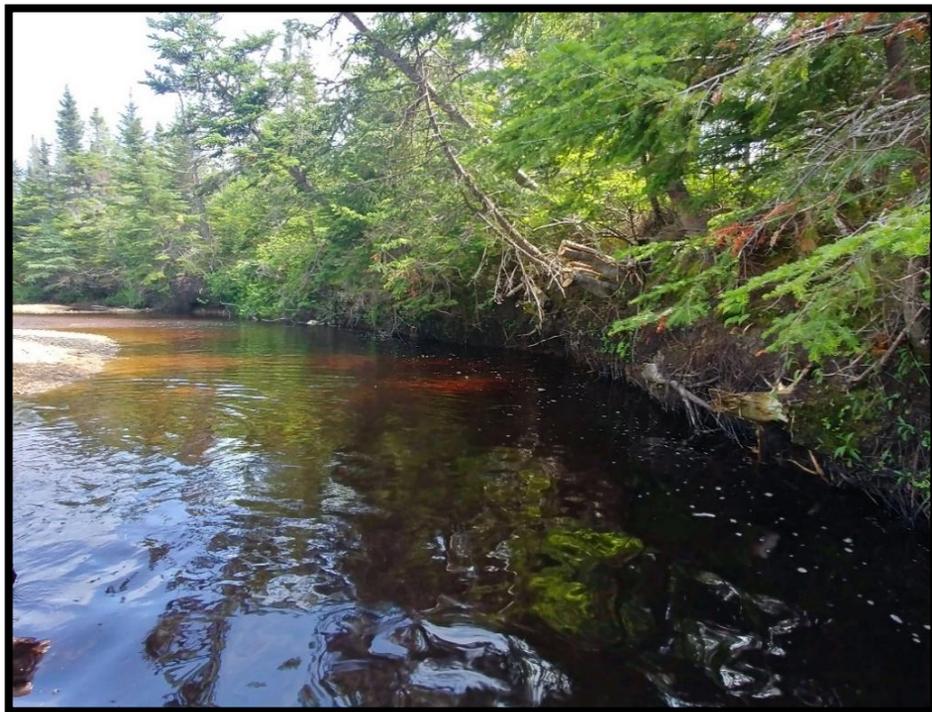
Figure 15: Upstream view of improved area after obstruction 8 removal, St. Georges Dribble.

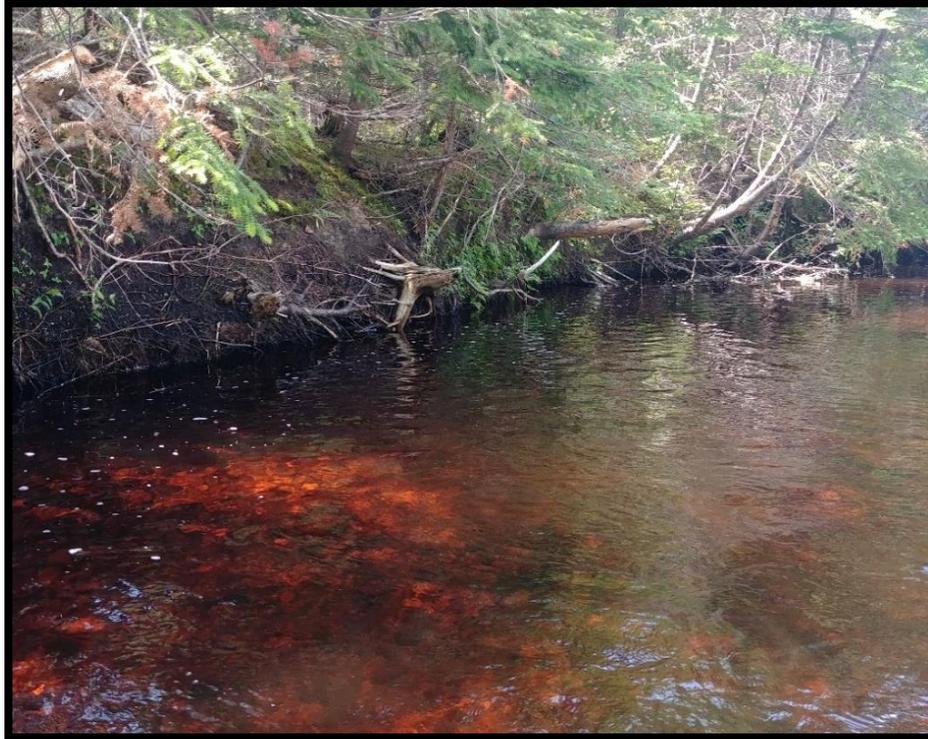
Figure 16: Downstream view of improved fish passage, St. Georges Dribble.

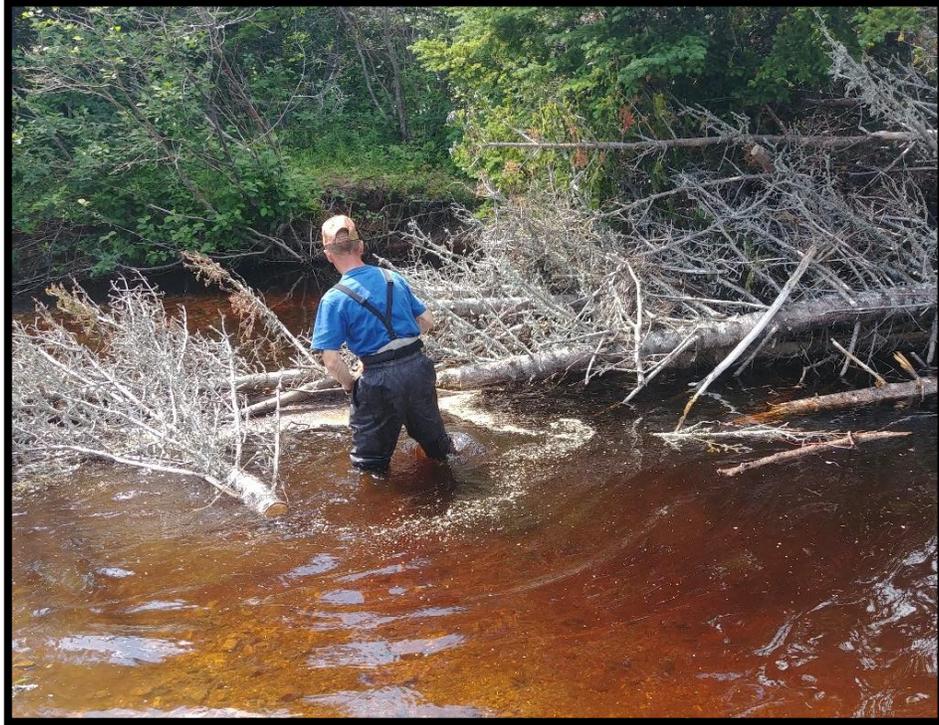
Figure 18: Removal efforts on obstruction 9, St. Georges Dribble.

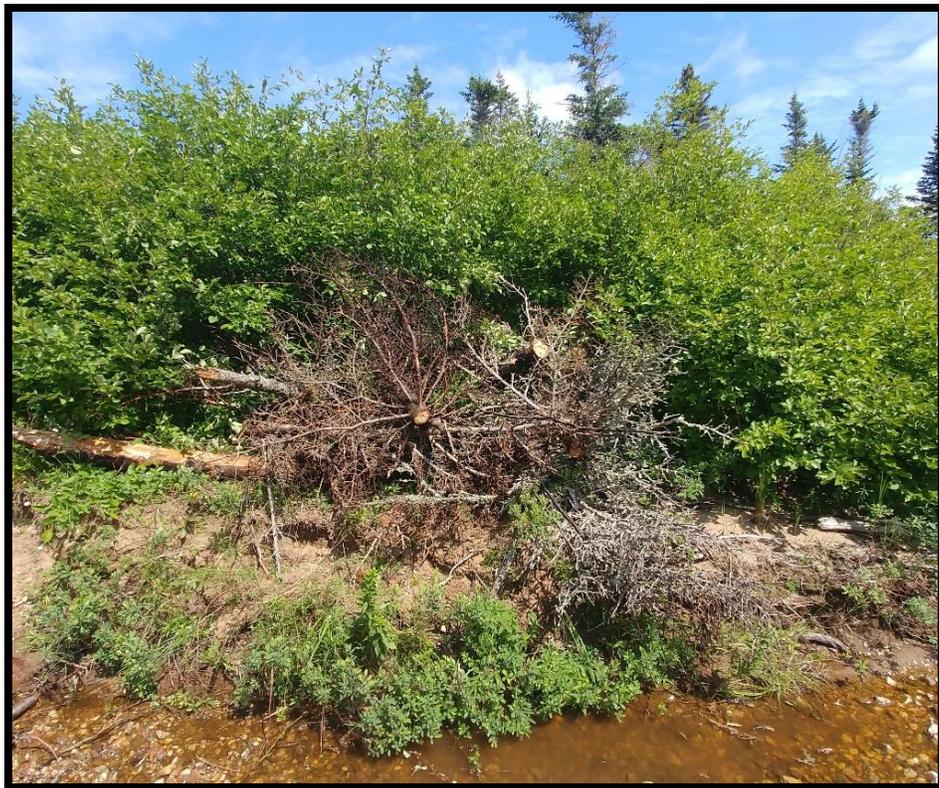
Figure 14: Debris removed from obstruction 9, St. Georges Dribble.

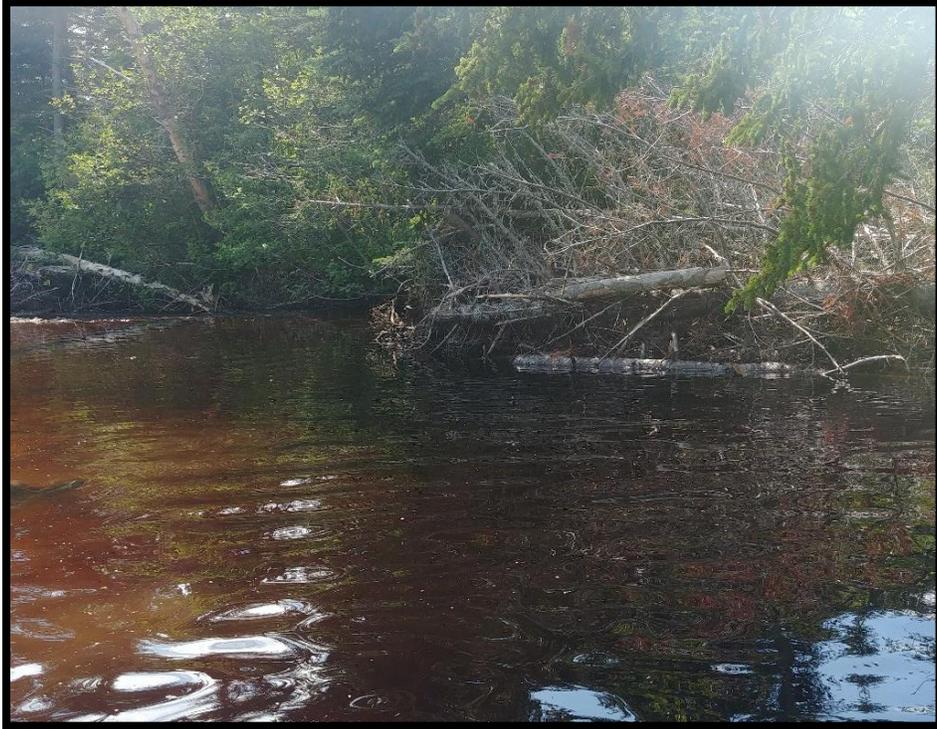
Figure 20: Upstream view of improved area after removal of obstruction 9, St. Georges Dribble.

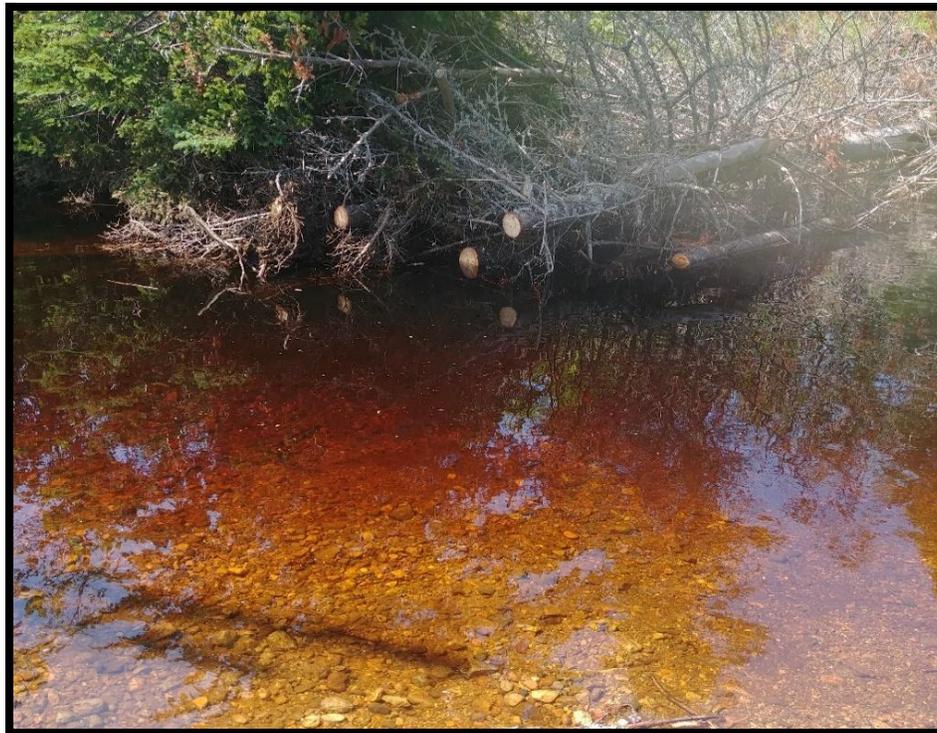
Figure 21: Side view of improved fish passage at Obstruction 9, St. Georges Dribble.

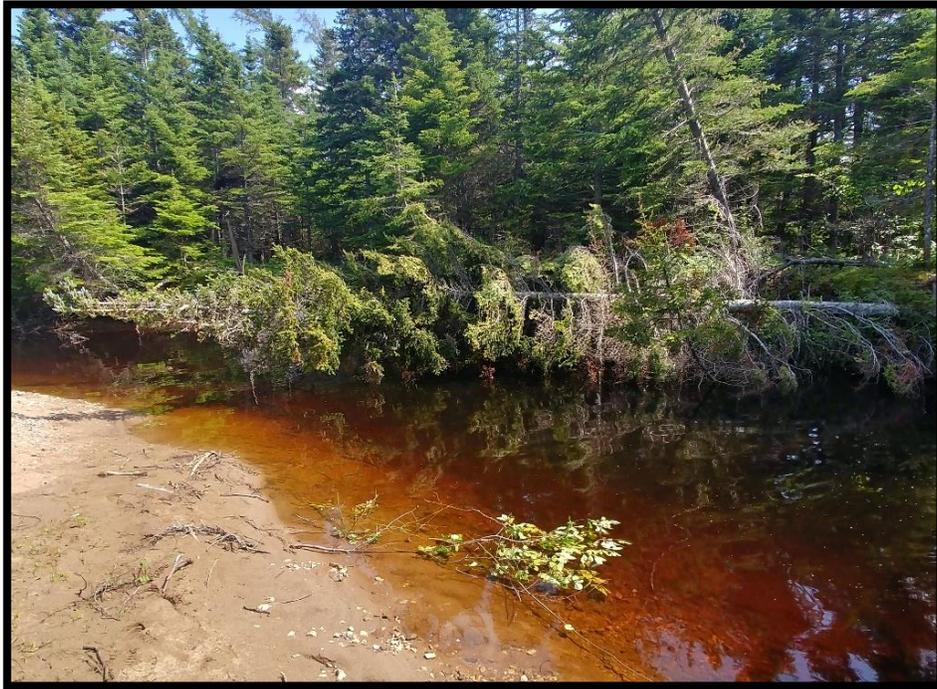
Figure 22: Upstream view of obstruction 10, St. Georges Dribble.

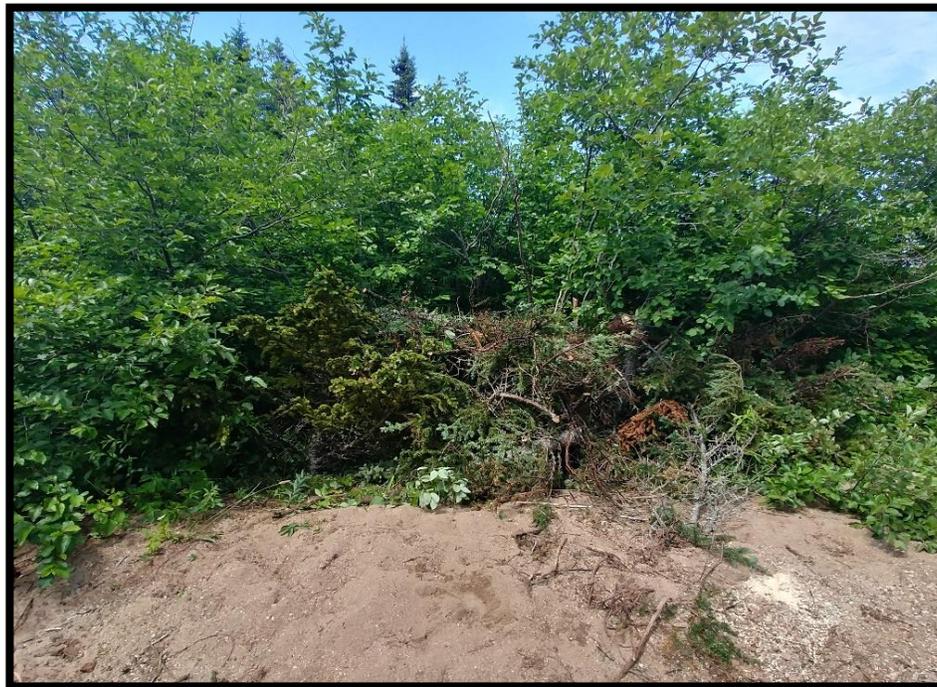
Figure 23: Debris removed from obstruction 10, St. Georges Dribble.

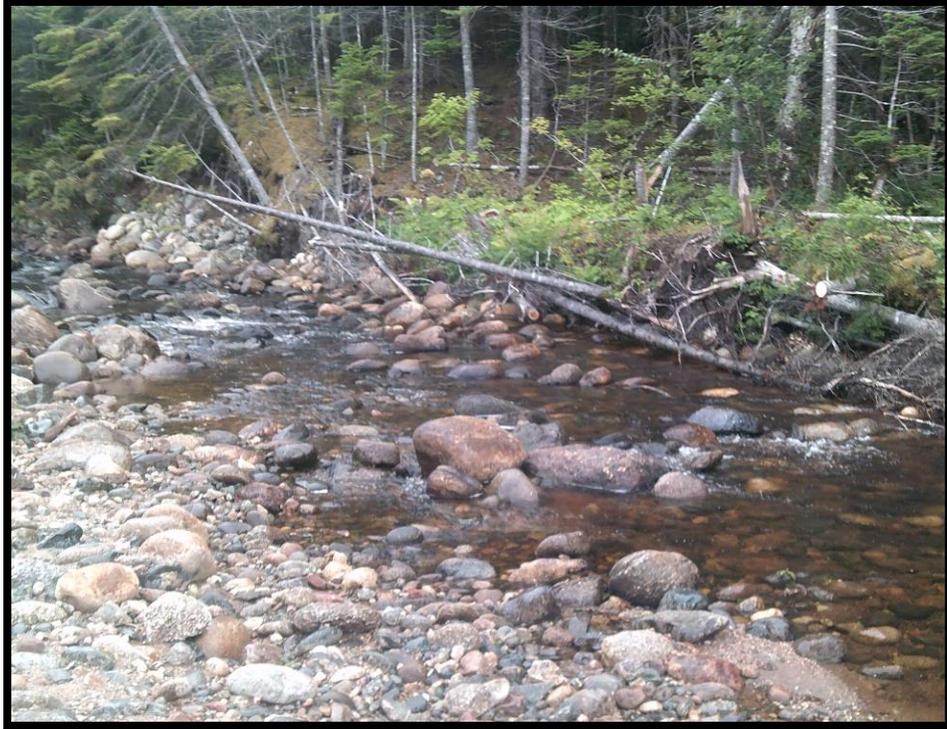
Figure 26: Upstream view of improved fish passage from obstruction 14 removal, St. Georges Dribble.

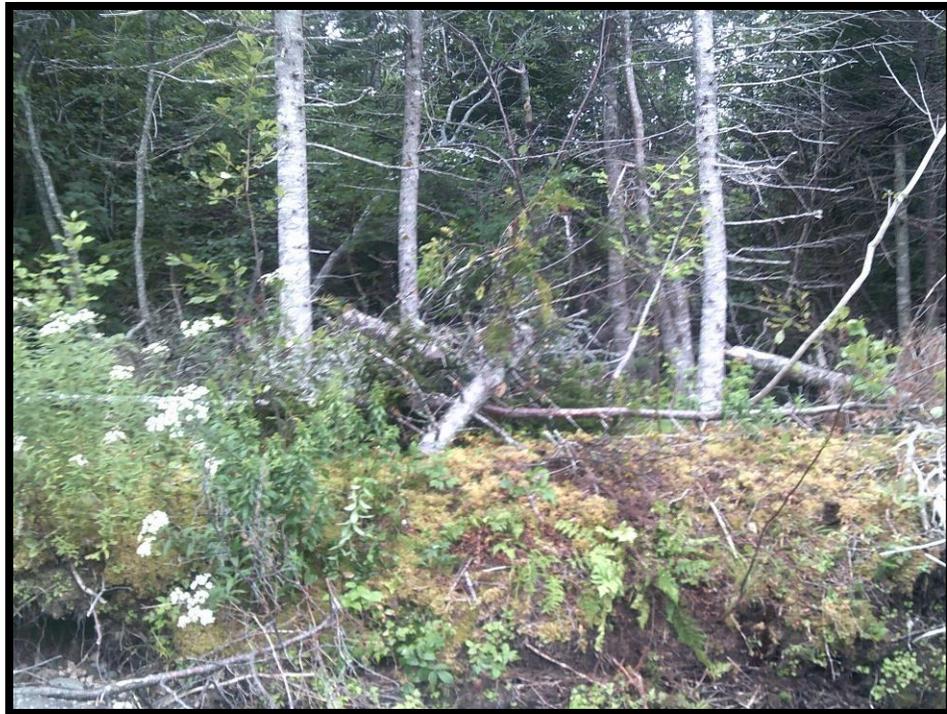
Figure 27: Debris removal from obstruction 14, St. Georges Dribble.

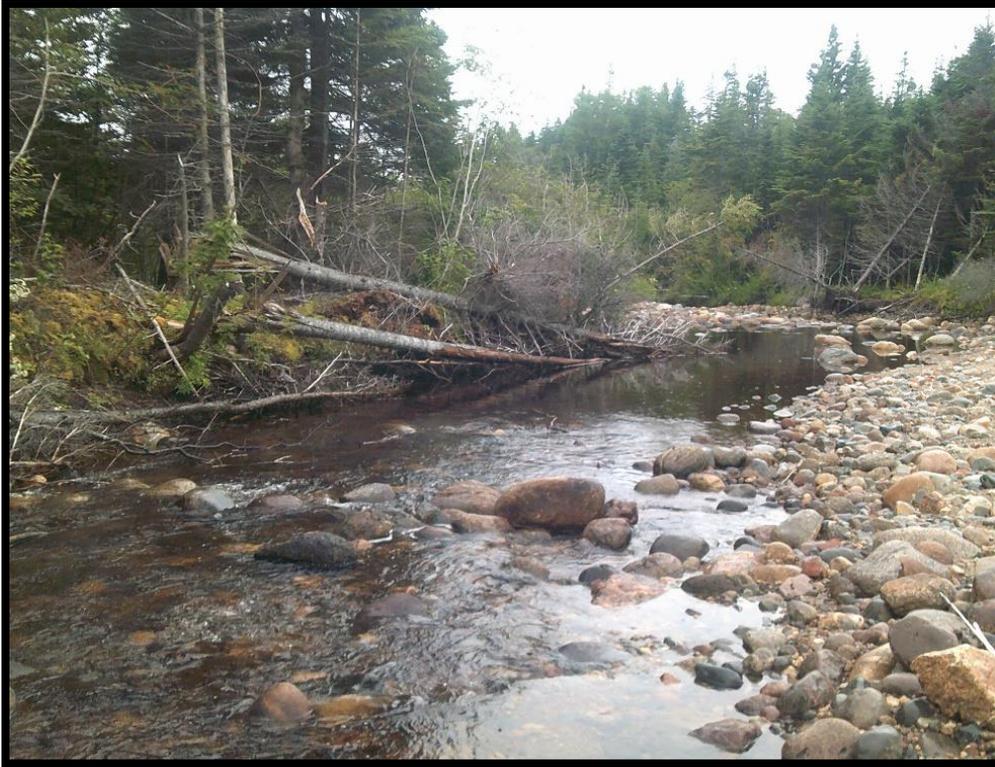
Figure 28: Downstream view of improved area after obstruction 14 was removed, St. Georges Dribble.

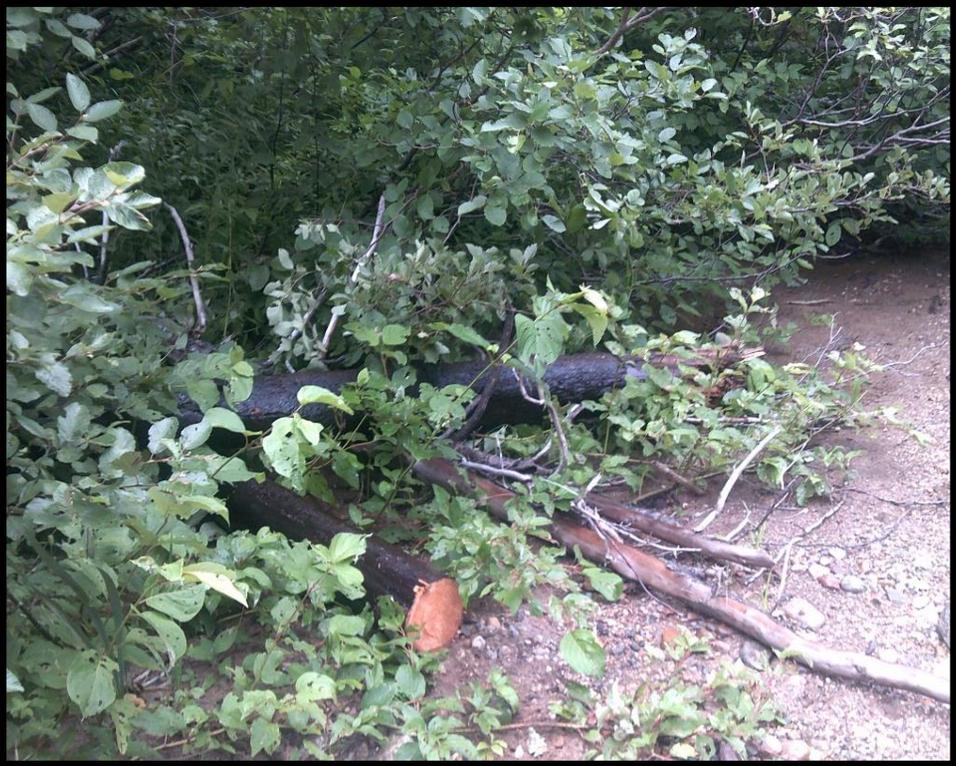
Figure 31: Debris removed from obstruction 16, St. Georges Dribble.

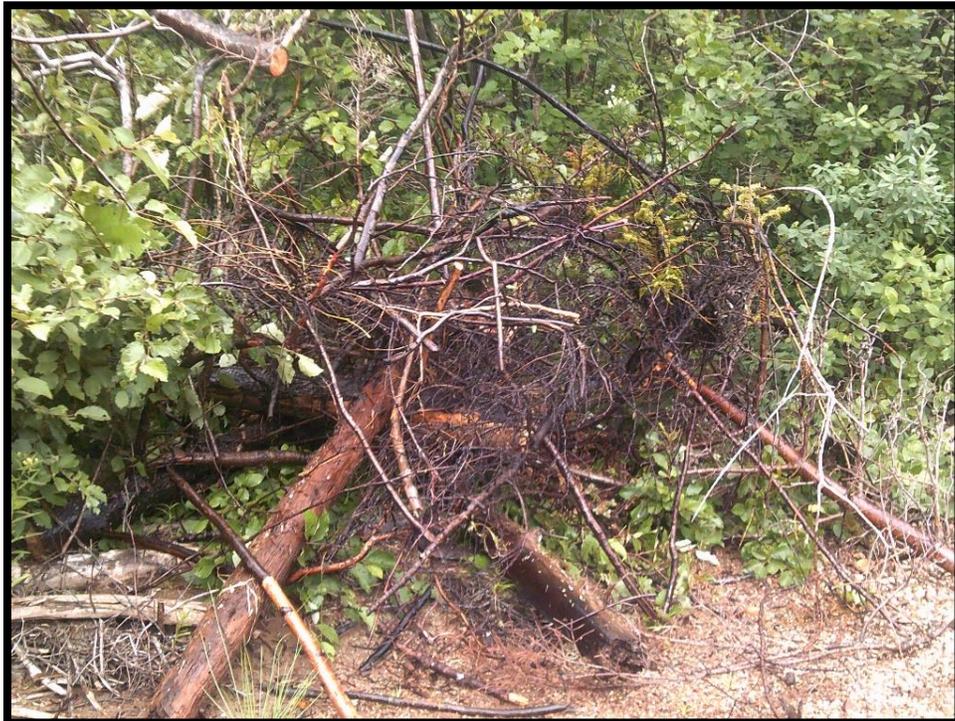
Figure 33: View of debris removed from obstruction 17, St. Georges Dribble.

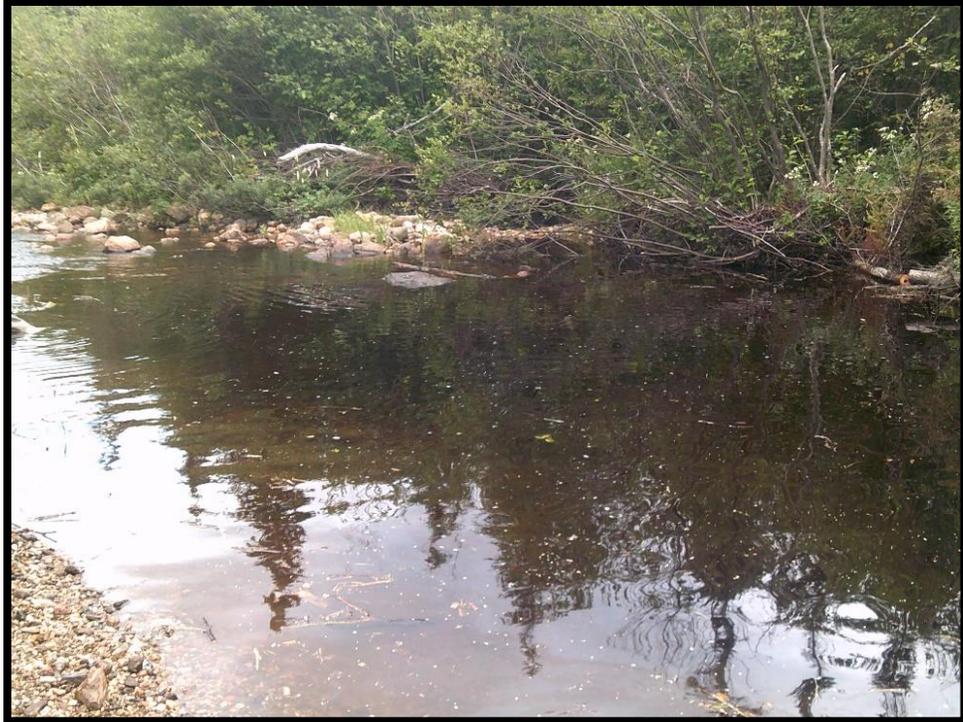
Figure 34: Downstream view of improved salmon habitat after removal of obstruction 17, St. Georges Dribble.

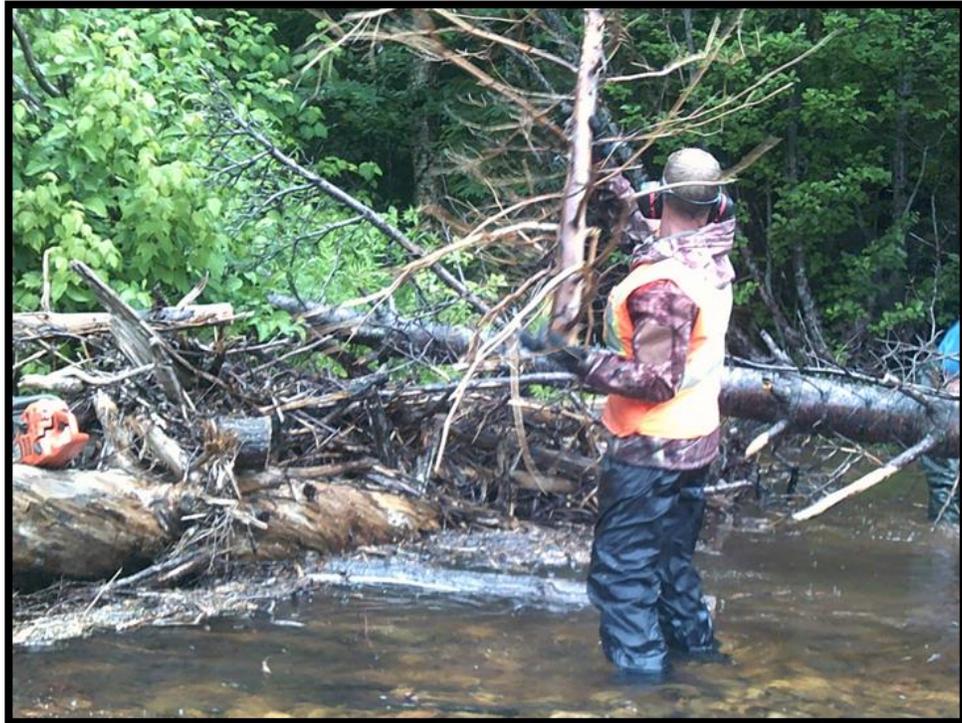
Figure 37: Removal of obstruction 2, Coal Brook.

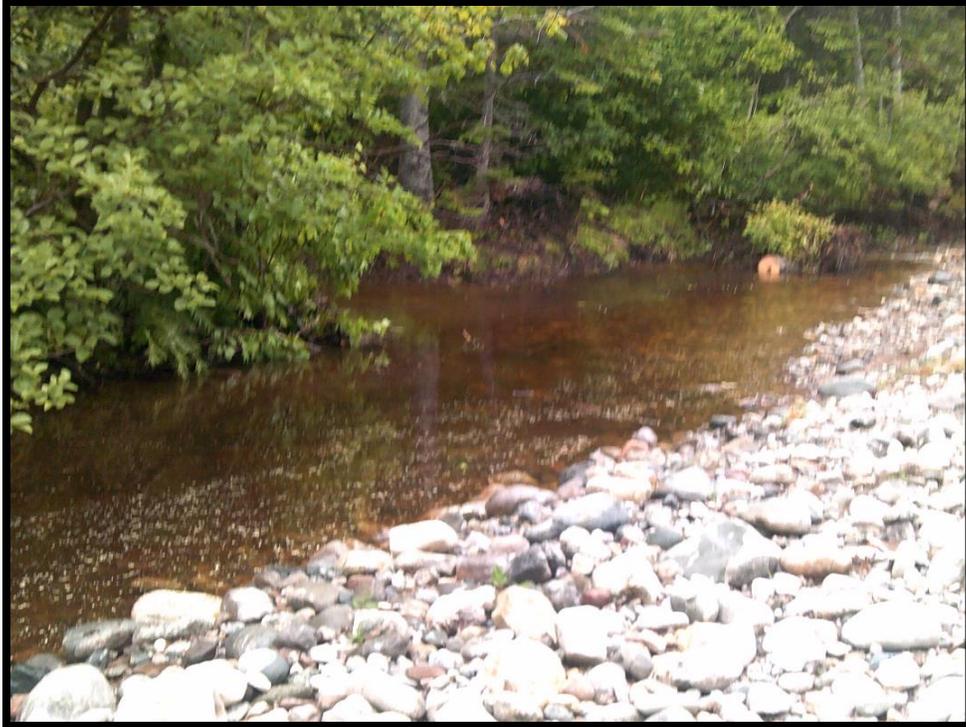
Figure 38: Upstream view of improved fish passage after obstruction 2 removal, Coal Brook.

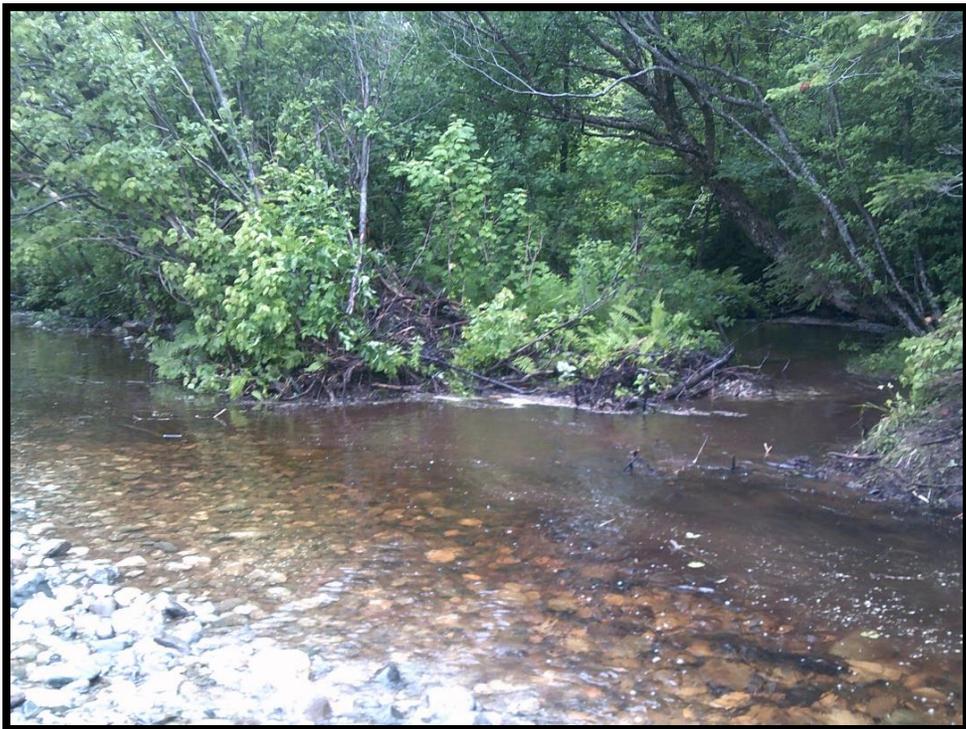
Figure 39: Side view of improved fish passage at Obstruction 2, Coal Brook.

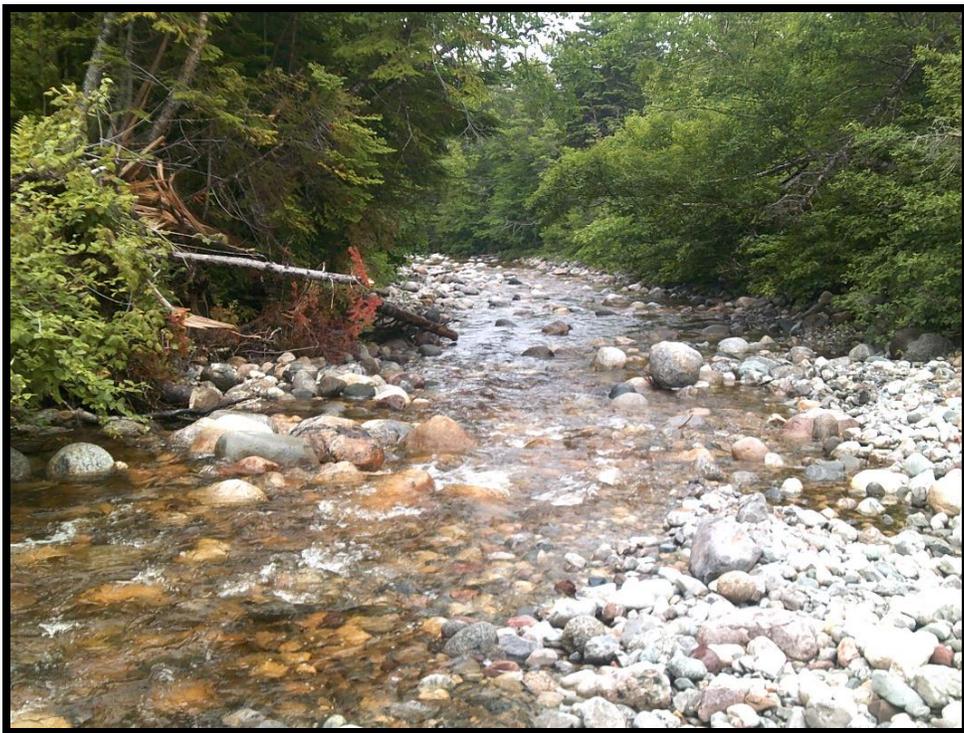
Figure 41: Downstream view of improved salmon habitat after obstruction 5 removal, Coal Brook.

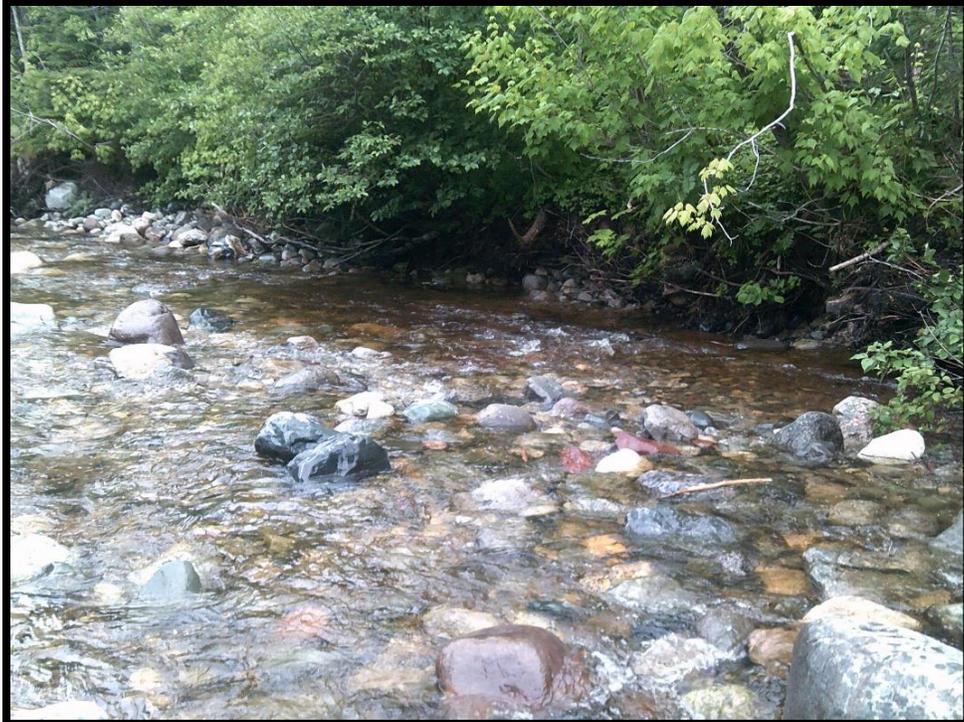
Figure 42: Side view of improved fish habitat at obstruction 5, Coal Brook.

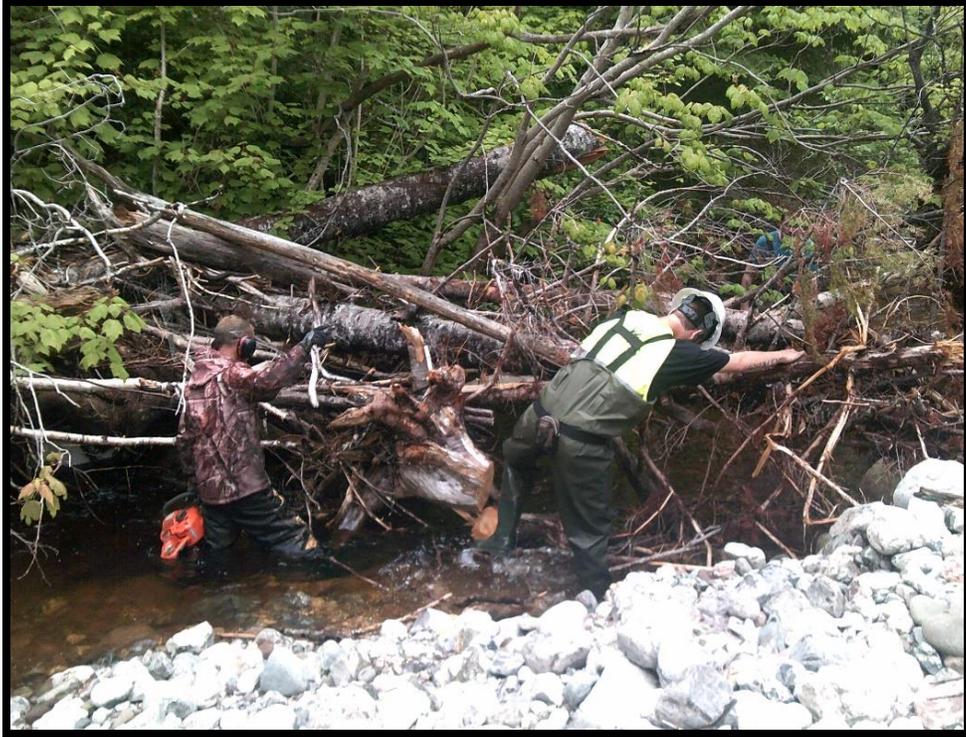
Figure 44: Removal underway of obstruction 6, Coal Brook.

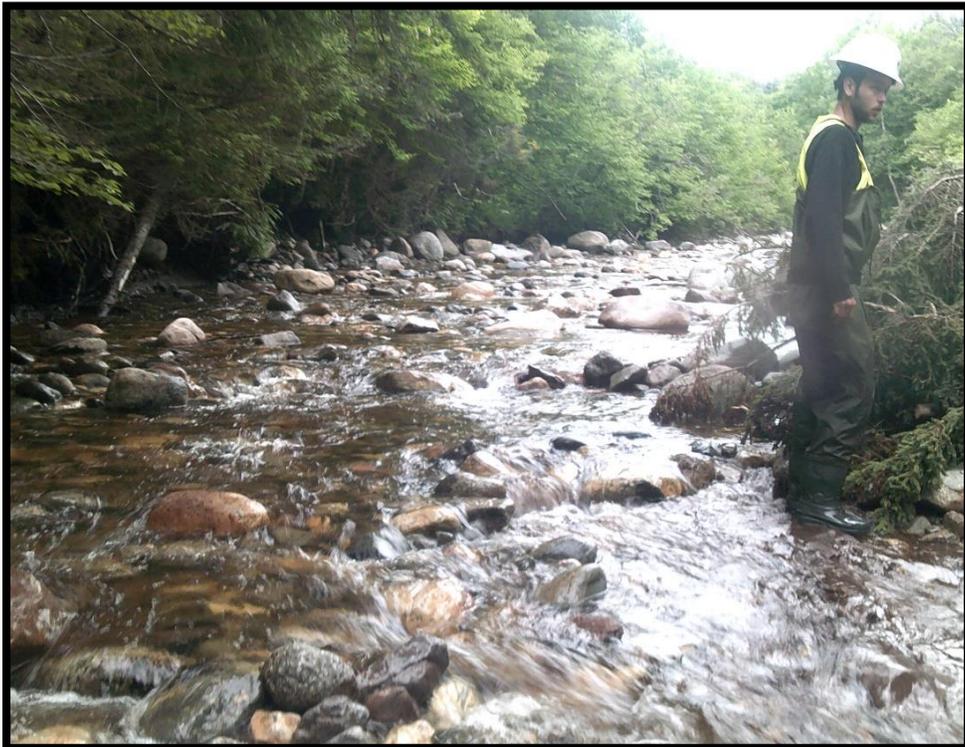
Figure 47: Upstream view of improved fish passage after removal of obstruction 9, Coal Brook.

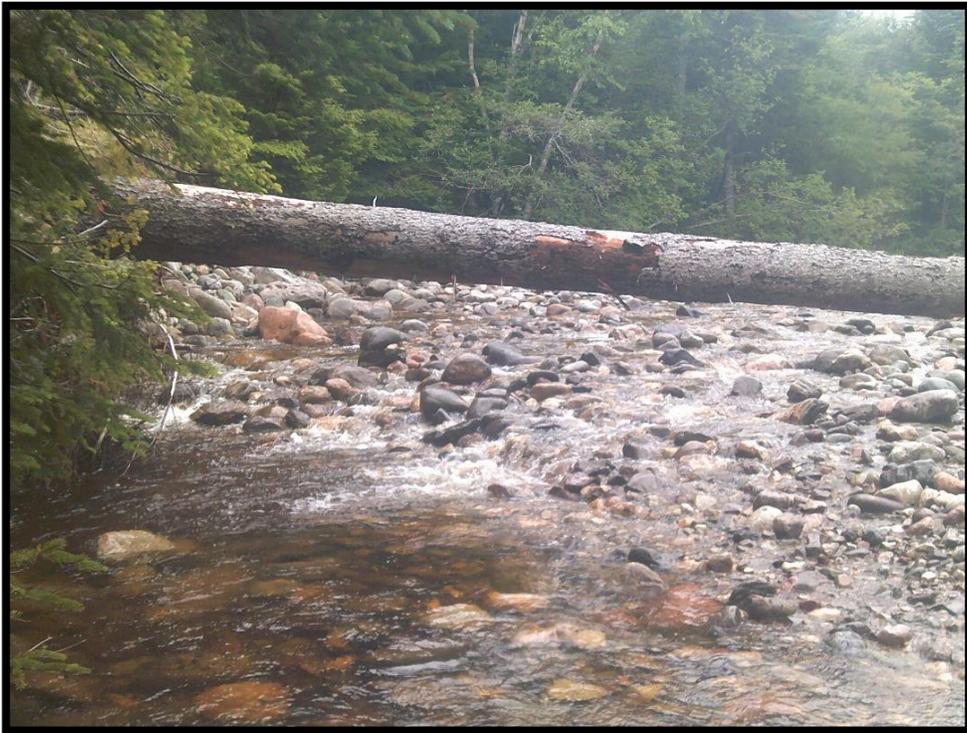
Figure 49: View of improved habitat after obstruction 10 removal, Coal Brook.

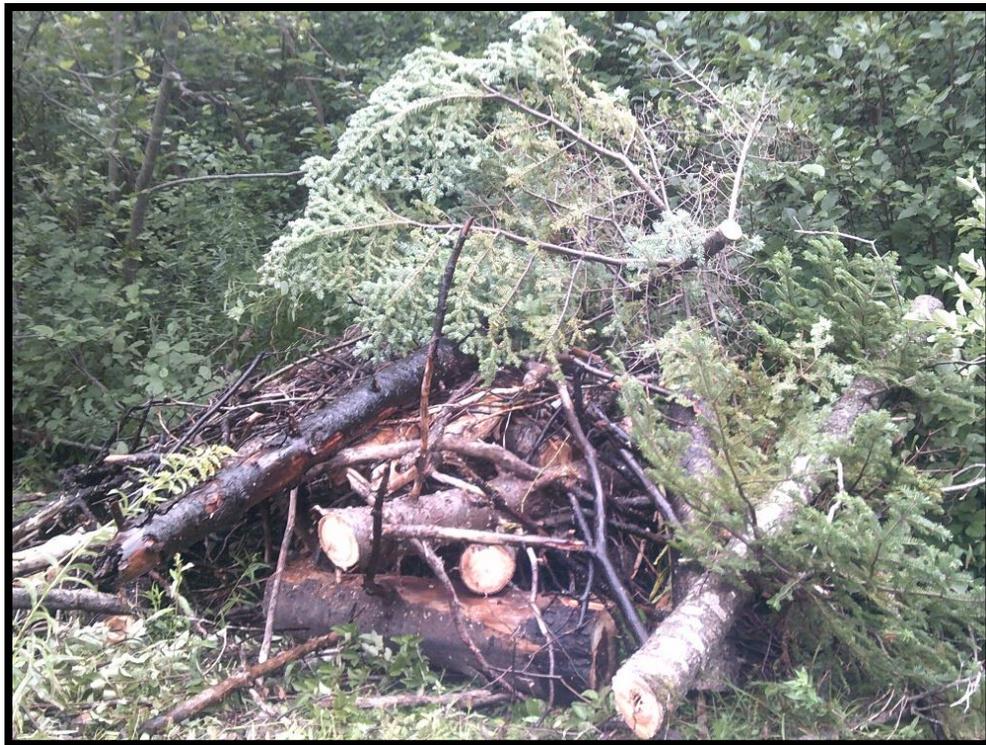
The beaver dam removed, obstruction 1 (N 48.18960, W -58.710353), had been catching lots of excess woody debris thus making it a greater obstruction to salmon migration (Fig. 52). The other two (2) dams were documented and reported to provincial authorities. They are listed as obstruction 2 (N 48.18968, W -58.711144), obstruction 4 (N 48.18979, W -58.71709), obstruction 12 (N 48.18758, W -58.70349), and obstruction 20 (N 48.18533, W -58.698039). Obstruction 12 continues to increase in size and has the entire stream blocked creating a great risk to salmon migration. There is access to this beaver dam off Camp 180 road.

Figure 53: Debris removed from obstruction 1, out of flood zone, Big Dribble Brook.

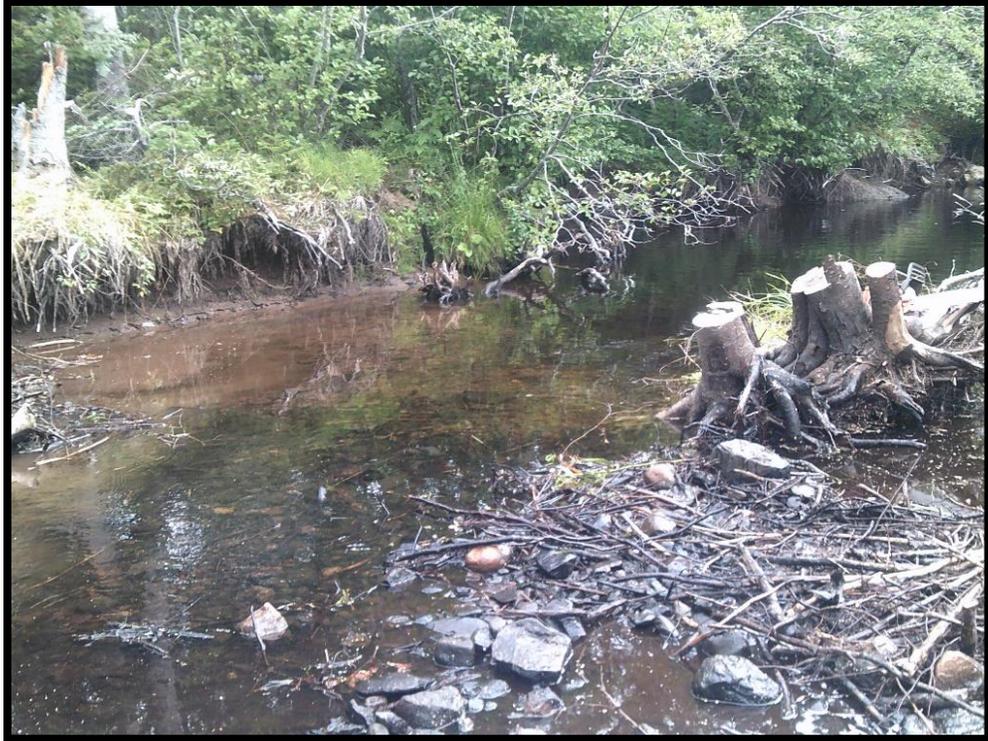
Figure 54: Upstream view of improved fish passage from obstruction 1 removal, Big Dribble Brook.

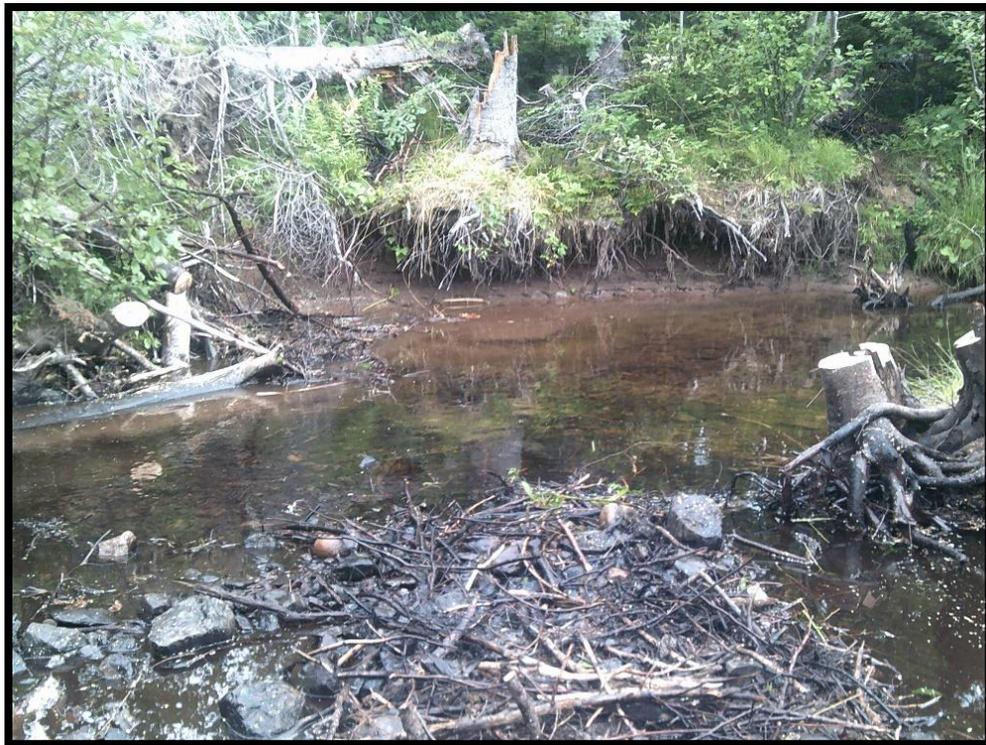
Figure 55: Side view of improved fish passage after obstruction 1 removal, Big Dribble Brook.

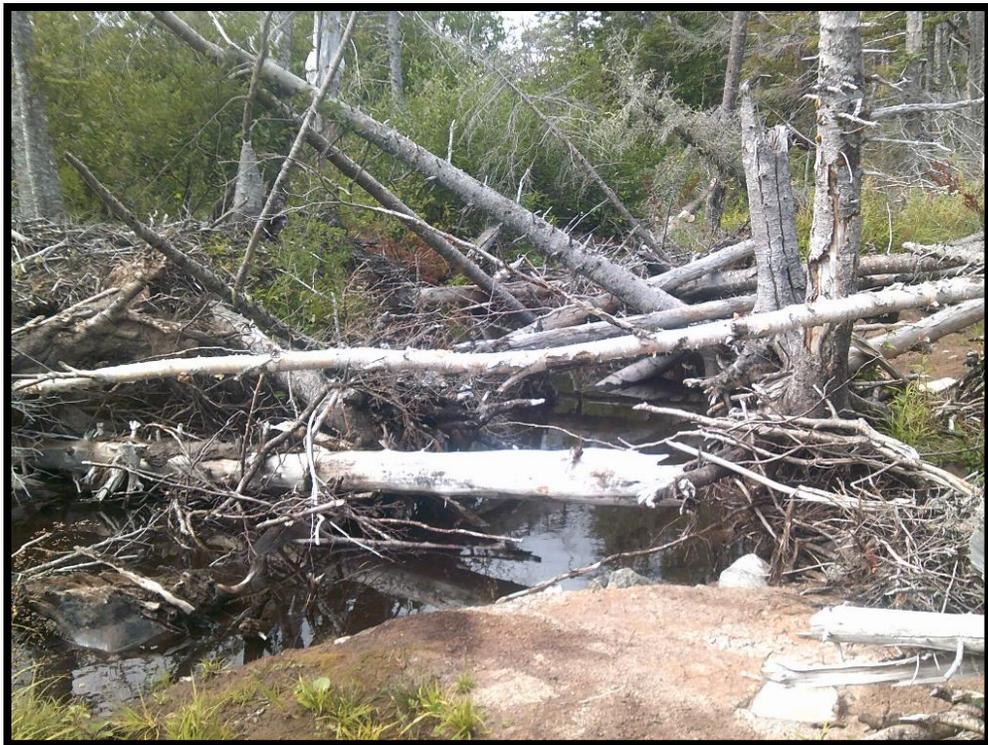
Figure 57: Additional downstream view of obstruction 3, Big Dribble Brook.
