**DEVELOP HABITAT CONSERVATION PLANS AND RESTORATION FOR
RIVERS IN BAY ST. GEORGE
2019**

Habitat Restoration

**FLAT BAY BROOK
LITTLE BARACHOIS BROOK
MIDDLE BARACHOIS BROOK**

BAY ST. GEORGE SOUTH AREA DEVELOPMENT ASSOCIATION

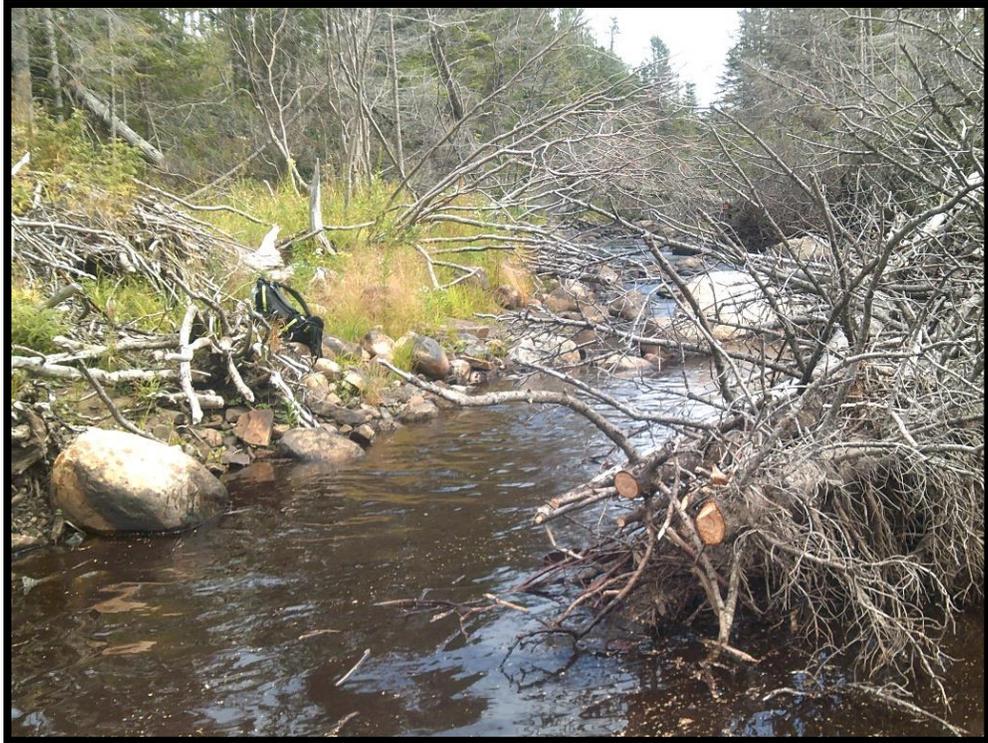
Figure 58: Upstream view of improved salmon habitat after obstruction 3 removal, Big Dribble Brook.

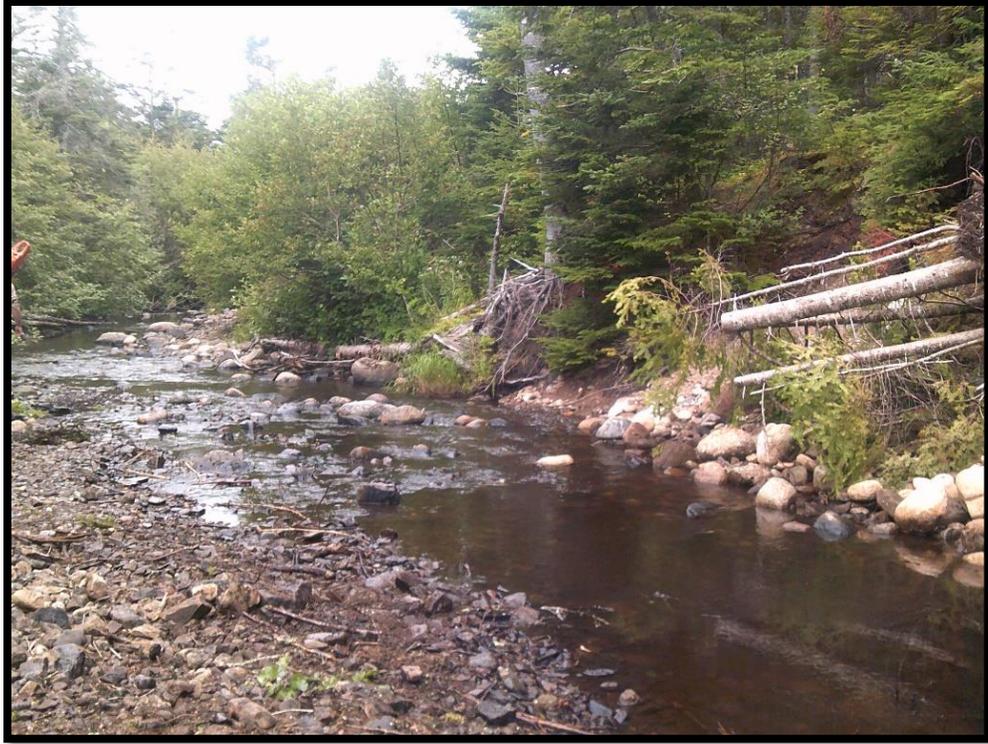
Figure 60: Downstream view of improved habitat from obstruction 6 removal, Big Dribble Brook.

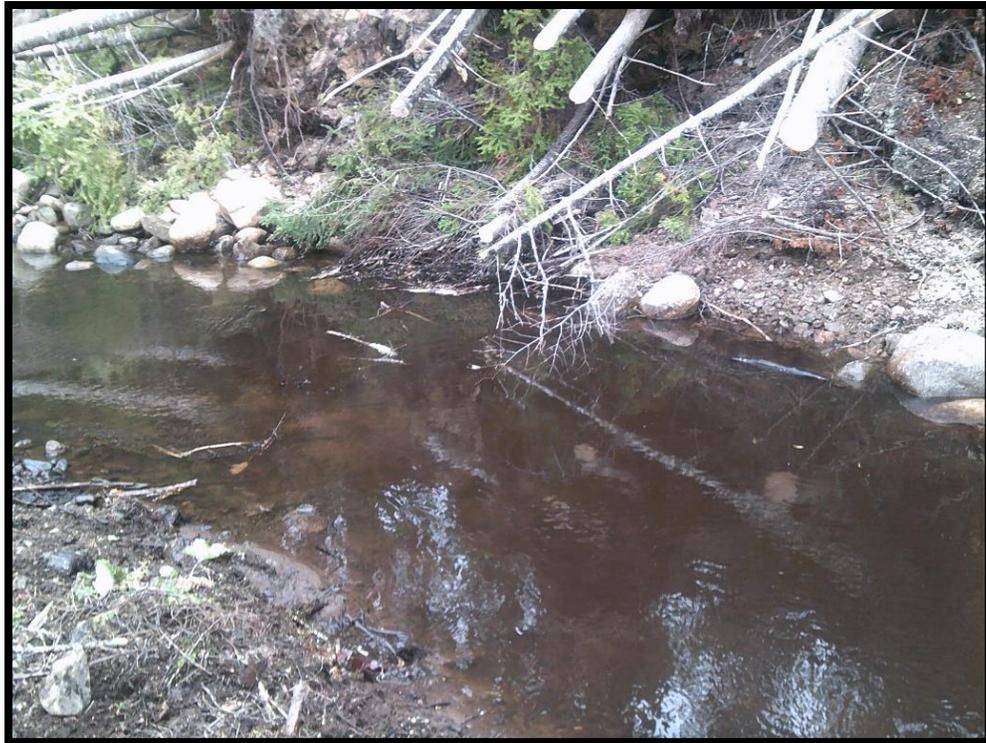
Figure 61: Side view of increased fish passage after obstruction 6 removal, Big Dribble Brook.

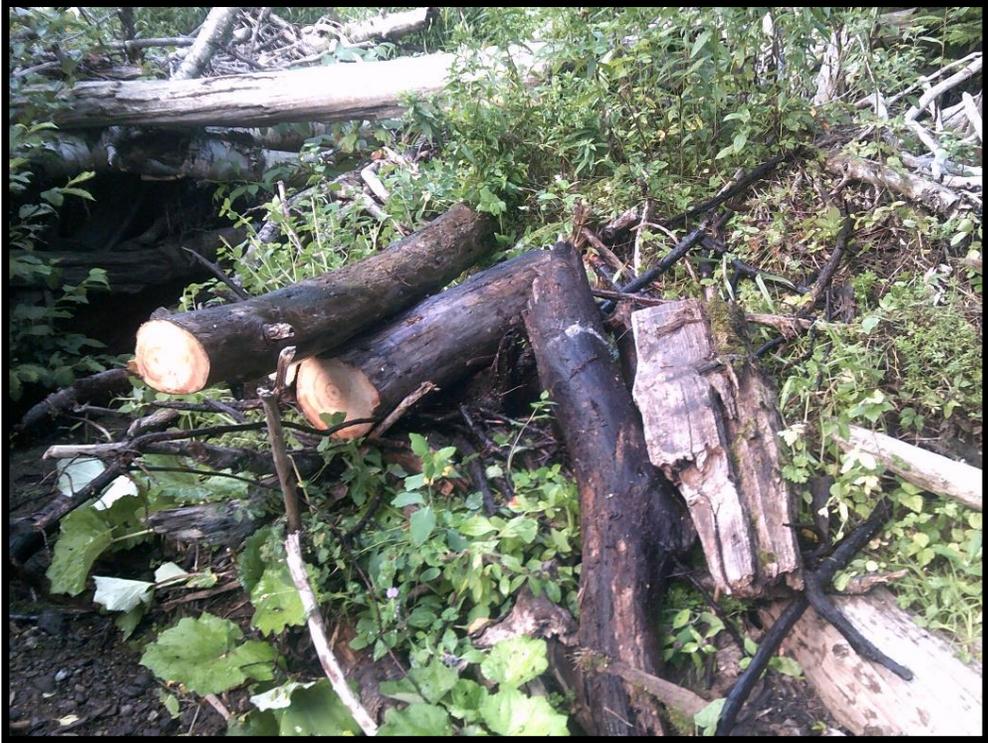
Figure 63: Obstruction 9 debris removed out of flood zone, Big Dribble Brook.

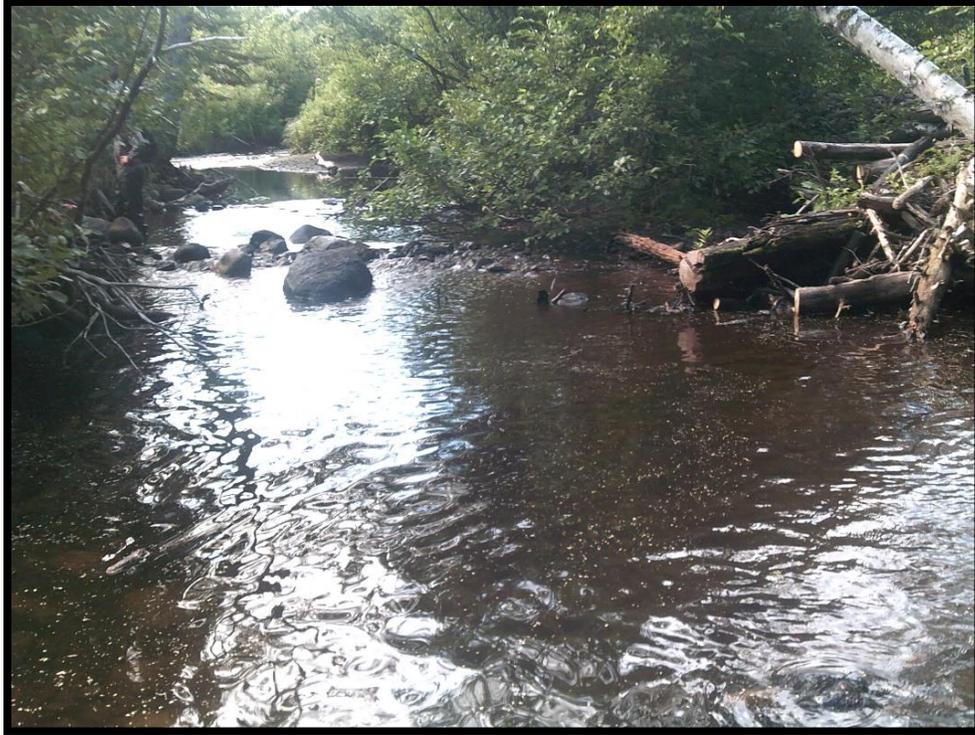
Figure 64: Improved fish passage after removal of obstruction 9, Big Dribble Brook.

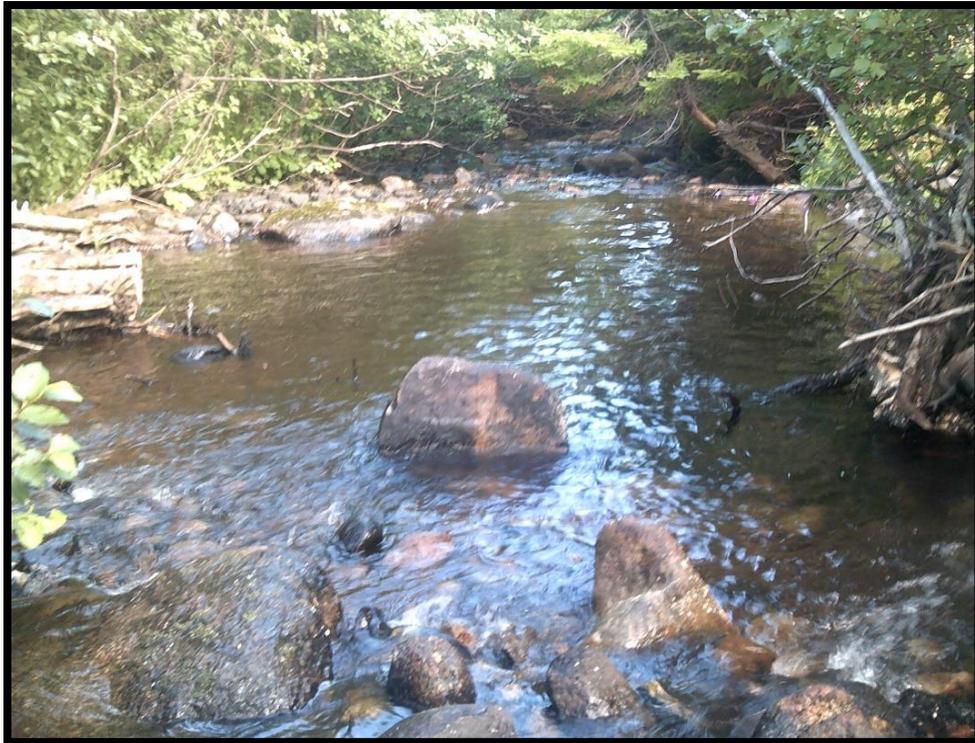
Figure 65: Closer upstream view of improved fish passage, obstruction 9, Big Dribble Brook.

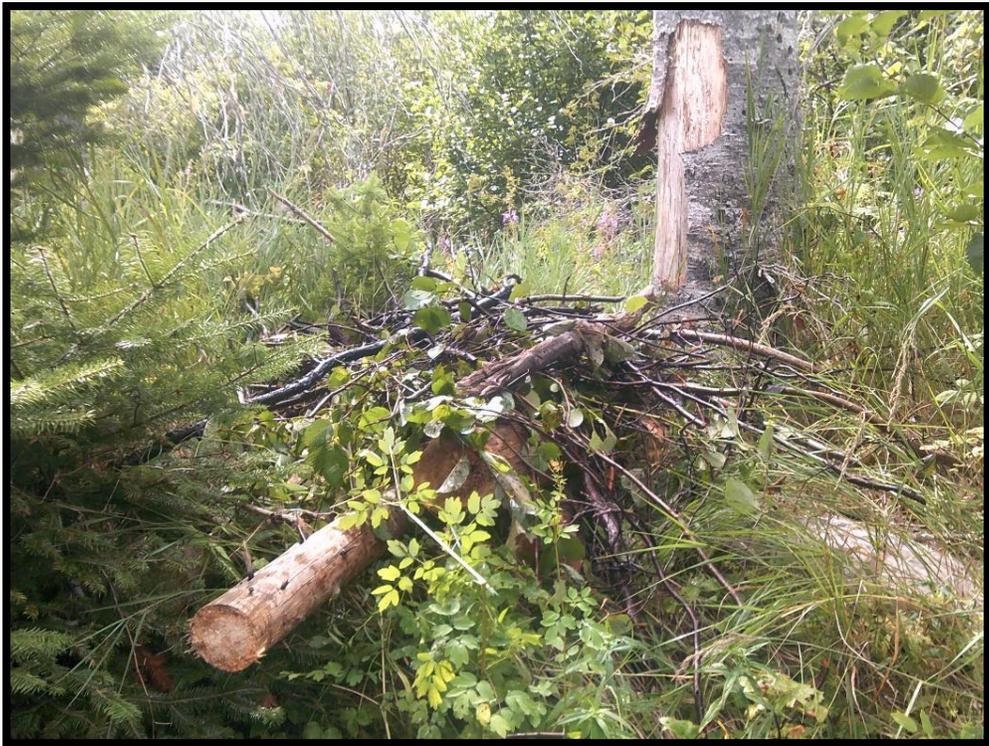
Figure 67: Woody debris removed from obstruction 11, Big Dribble Brook.

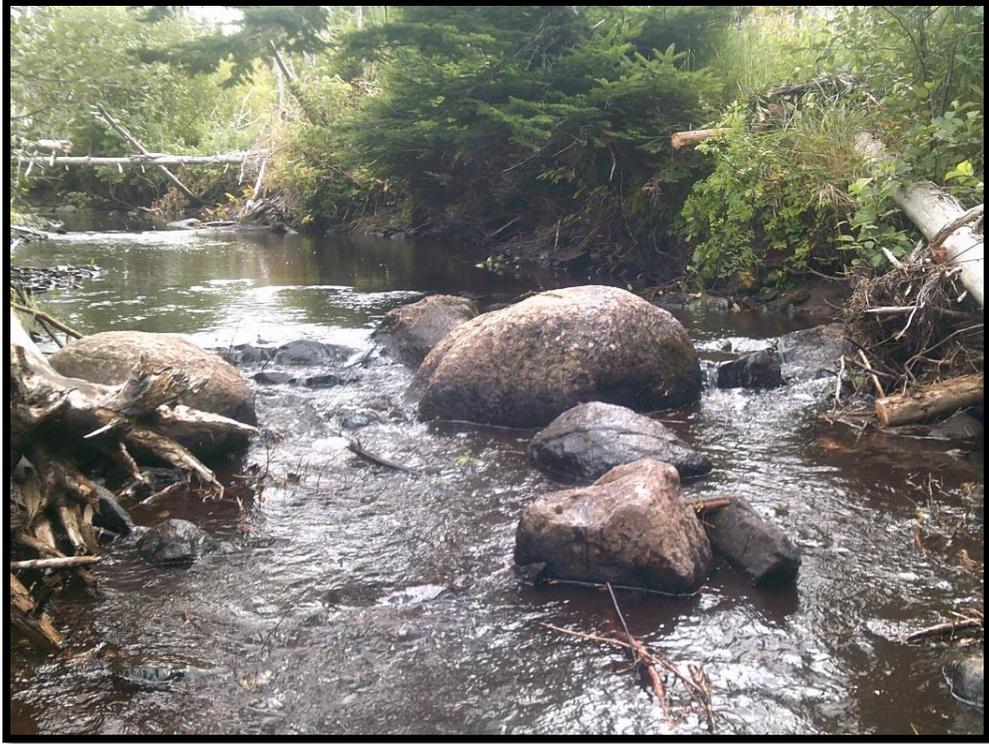
Figure 68: Upstream view of improved fish passage, Obstruction 11, Big Dribble Brook.

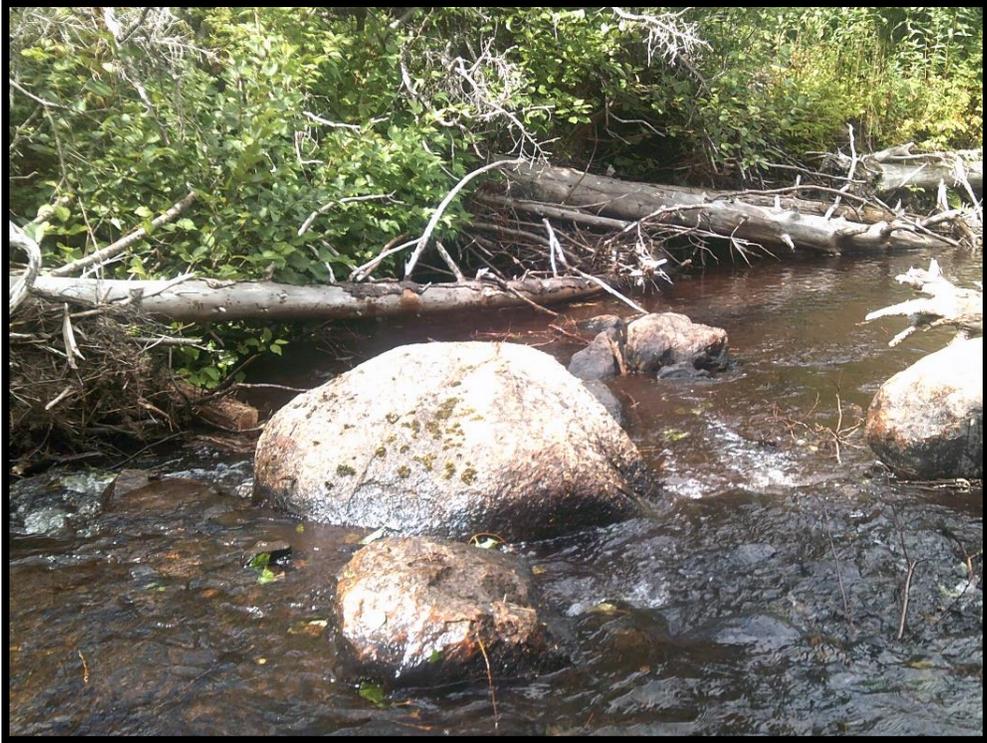
Figure 69: Downstream view of improved habitat after obstruction 11 removal, Big Dribble Brook.
